SUMMARY OF ACTIVITIES

The Caprock Maljamar Unit 152 site was delineated utilizing 5 sample points. (See Site Map) Deepest contamination of chlorides was located at Sample Point 5 and cleaned up at 35 feet. Attached analytical data confirms sampling activities. No Total Petroleum Hydrocarbons were reported to be released.

Release Notification and Corrective Action

Name of Company	Linn Operating Inc.	Contact	E.L. Gonzales
Address	2130 W Bender Blvd Hobbs, NM 88240	Telephone No.	575-738-1739
Facility Name	Caprock Maljamar Unit # 152	Facility Type	Oil producer
Surface Owner	State	Mineral Owner	API No. 30-025-32042

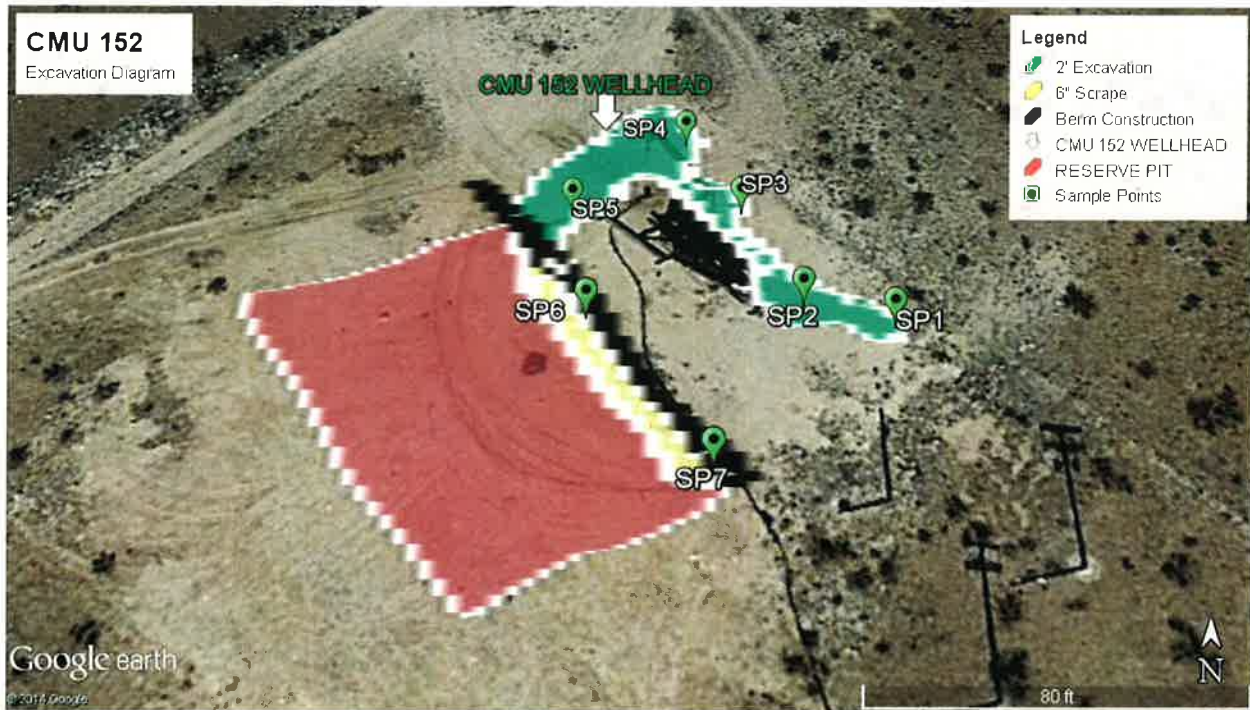
A polygon was excavated around the Sample Points to a depth of 20-26 inches. It was at those depths that the nearly impervious cap-rock was found. As per the request of the New Mexico Oil Conservation Division (OCD), the cap-rock was not removed or disturbed through excavation. (See Excavation Plan in Site Map Section)

Sidewall samples were taken at half the depth of excavation in numerous places in order to ensure no actionable levels of chlorides remained. No sidewall samples were taken near pump-jack due to the inability to excavate closer for fear of disturbing the integrity of the pump-jack foundation. (See Analytical Section)

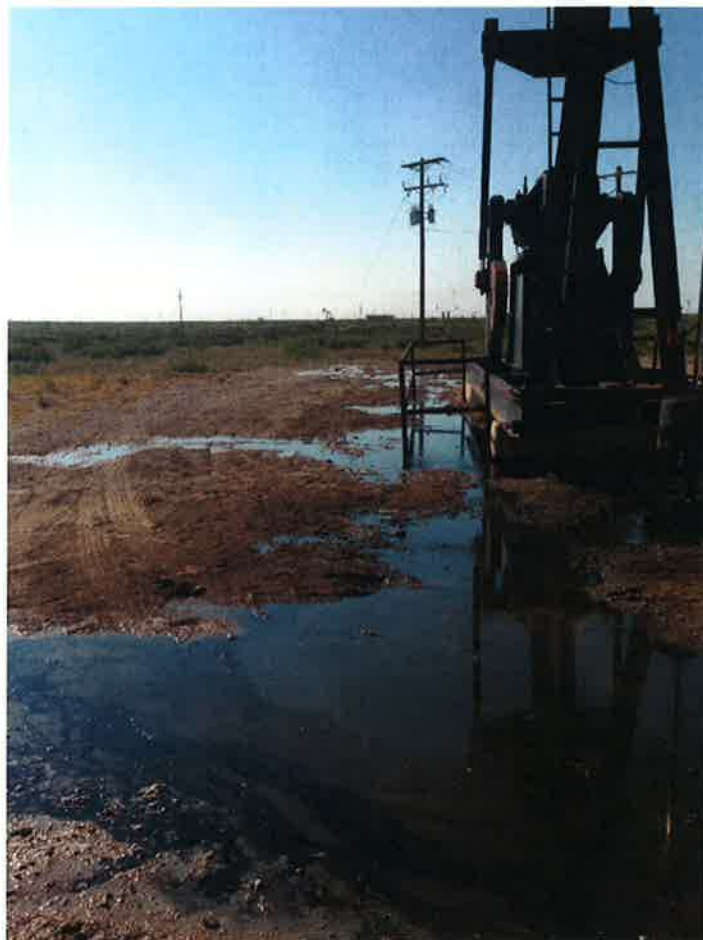
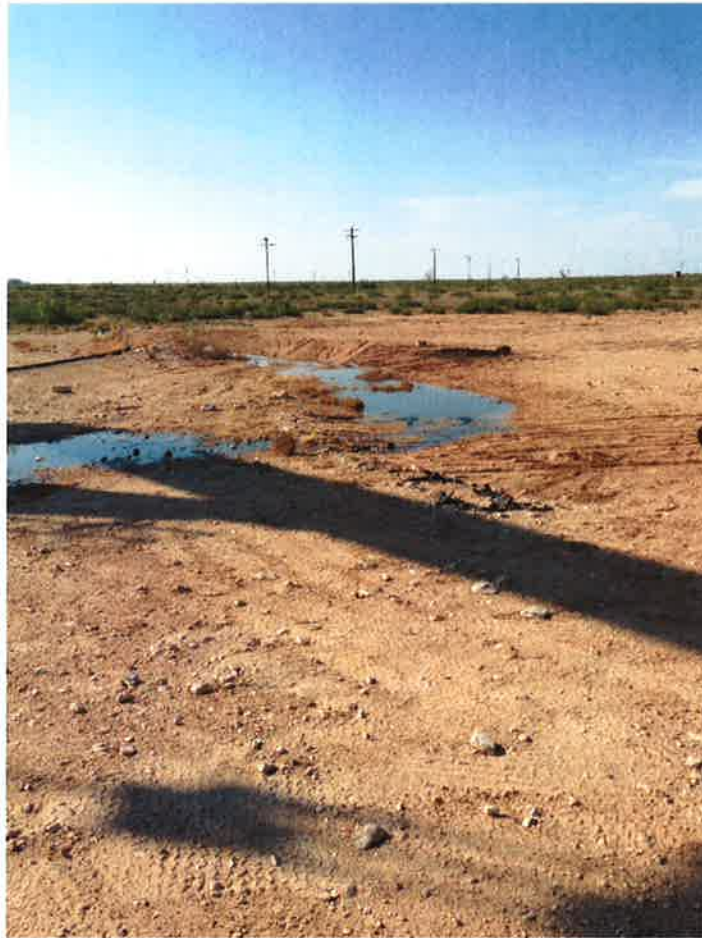
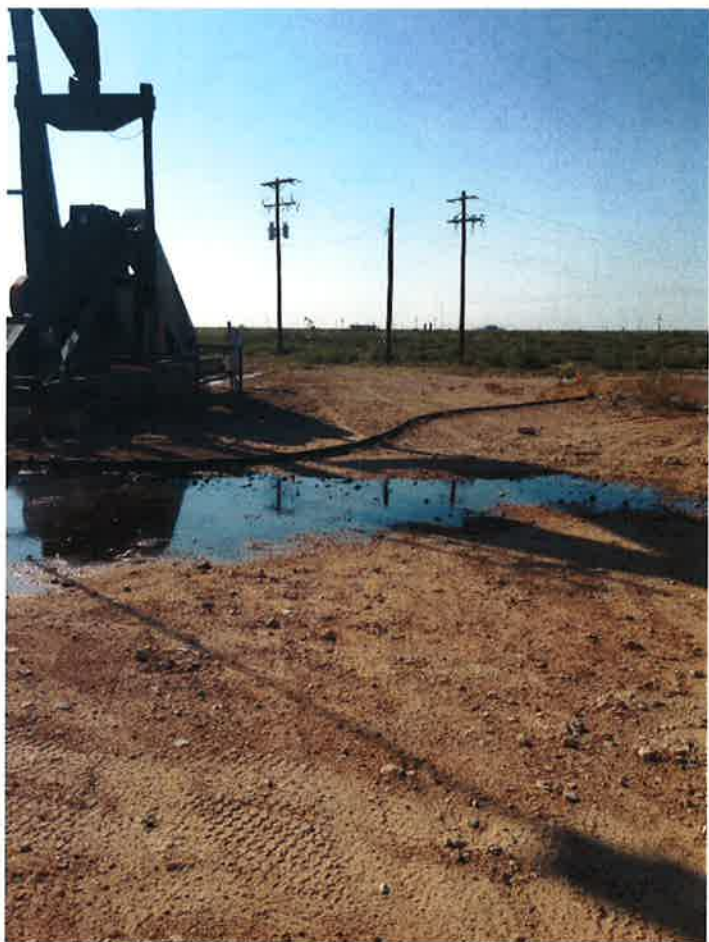
Release

Describe Cause of Problem and Remedial Action Taken.* As I was checking wells I pulled up to CMU 152, and realized the stuffing box was leaking, The well had a trapper on it, but water was running out of it and didn't shut well off. First thing I did was shut well in and got leak to stop, Then I notified my foreman. I got a vacuum truck to pick up water off of ground, he picked up 25bbls of produced water.

Describe Area Affected and Cleanup Action Taken.* The area affected was to the south app. 25' long and 4' wide, and to the north it ran 35" long and was 3' wide. While I had the vacuum truck I changed the packing & greased well, then returned well to production.

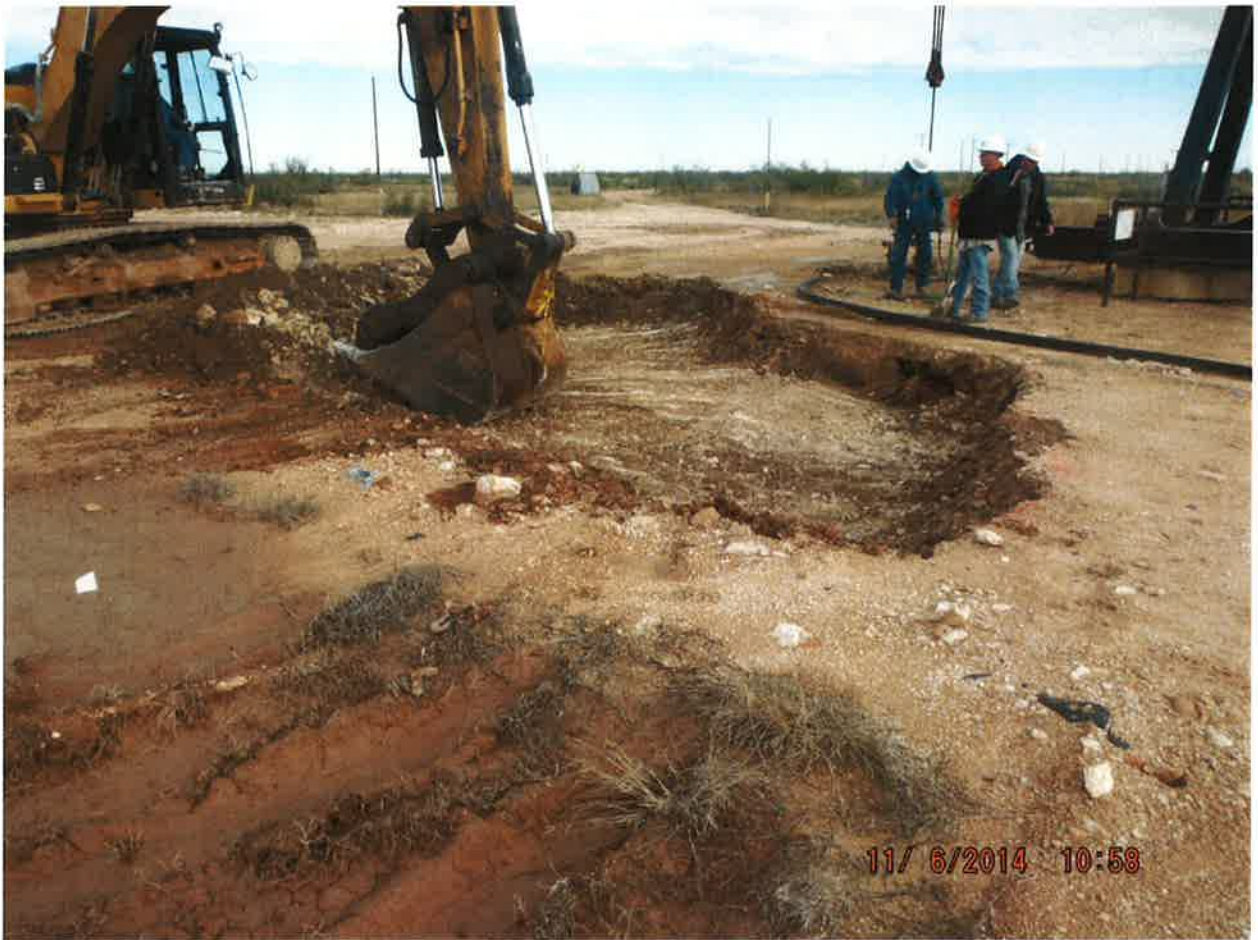
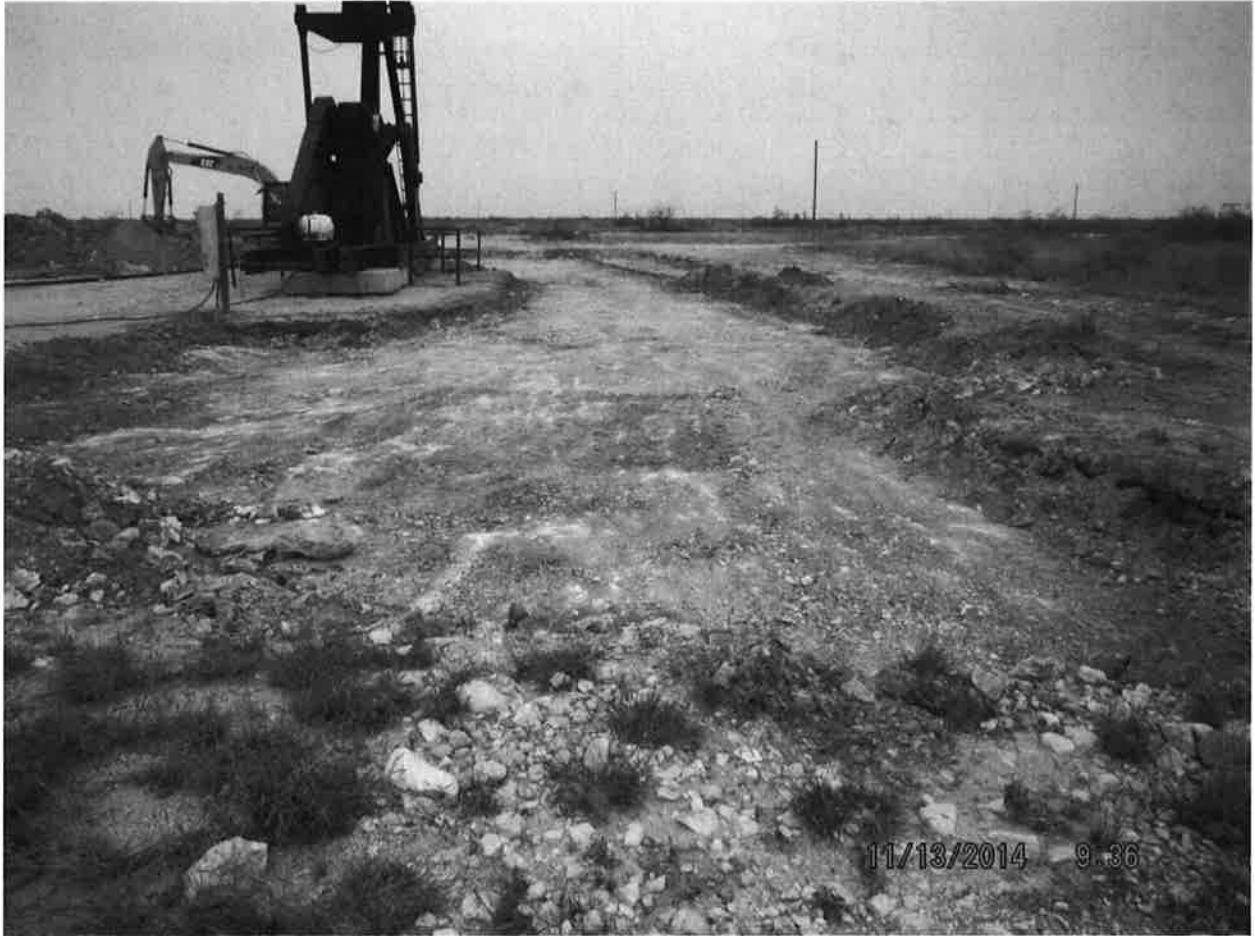
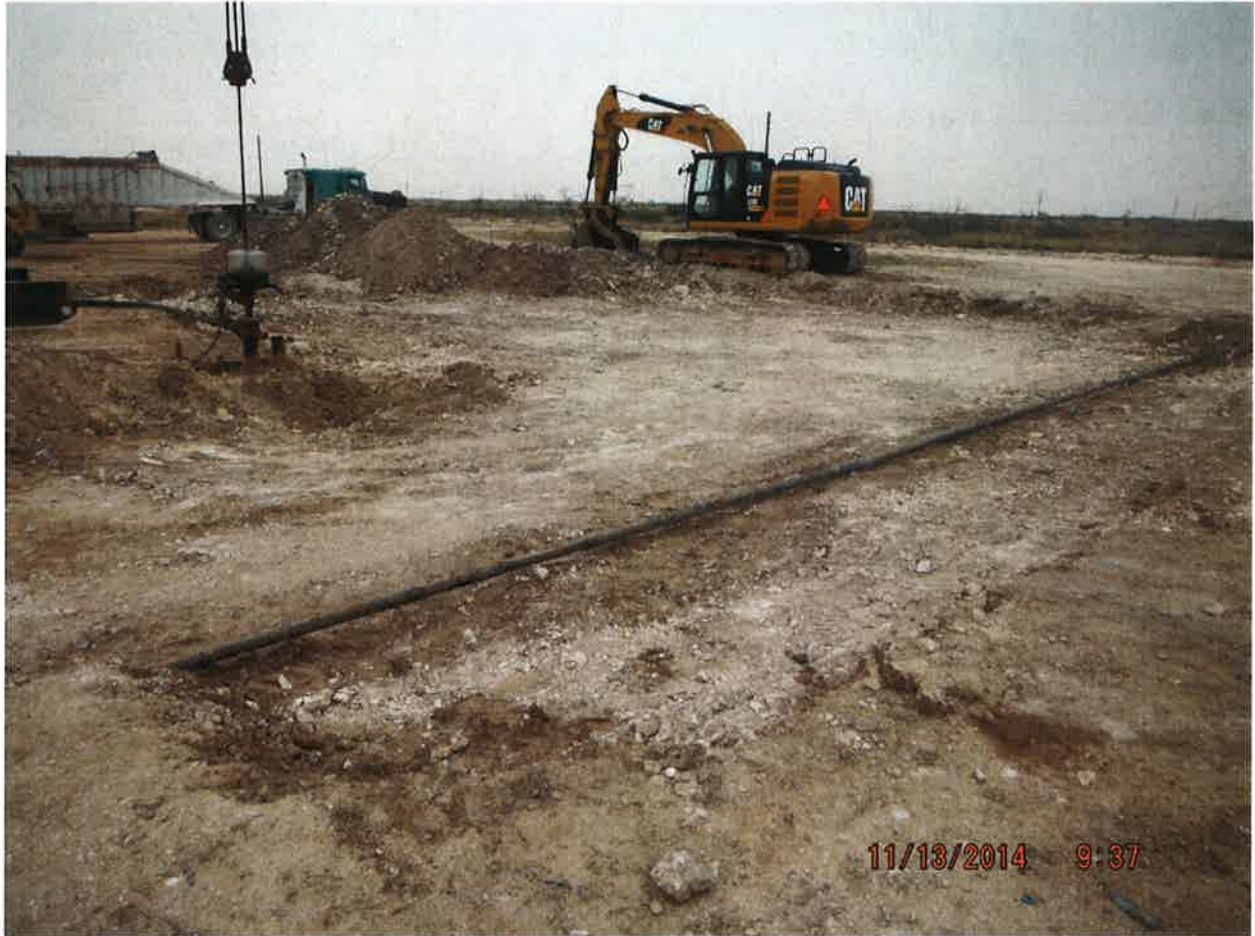
Remediation

Where the release ran onto the reserve pit, a 6-inch scrape was performed in order to remove as much contamination as possible without compromising the liner on top of the reserve pit.

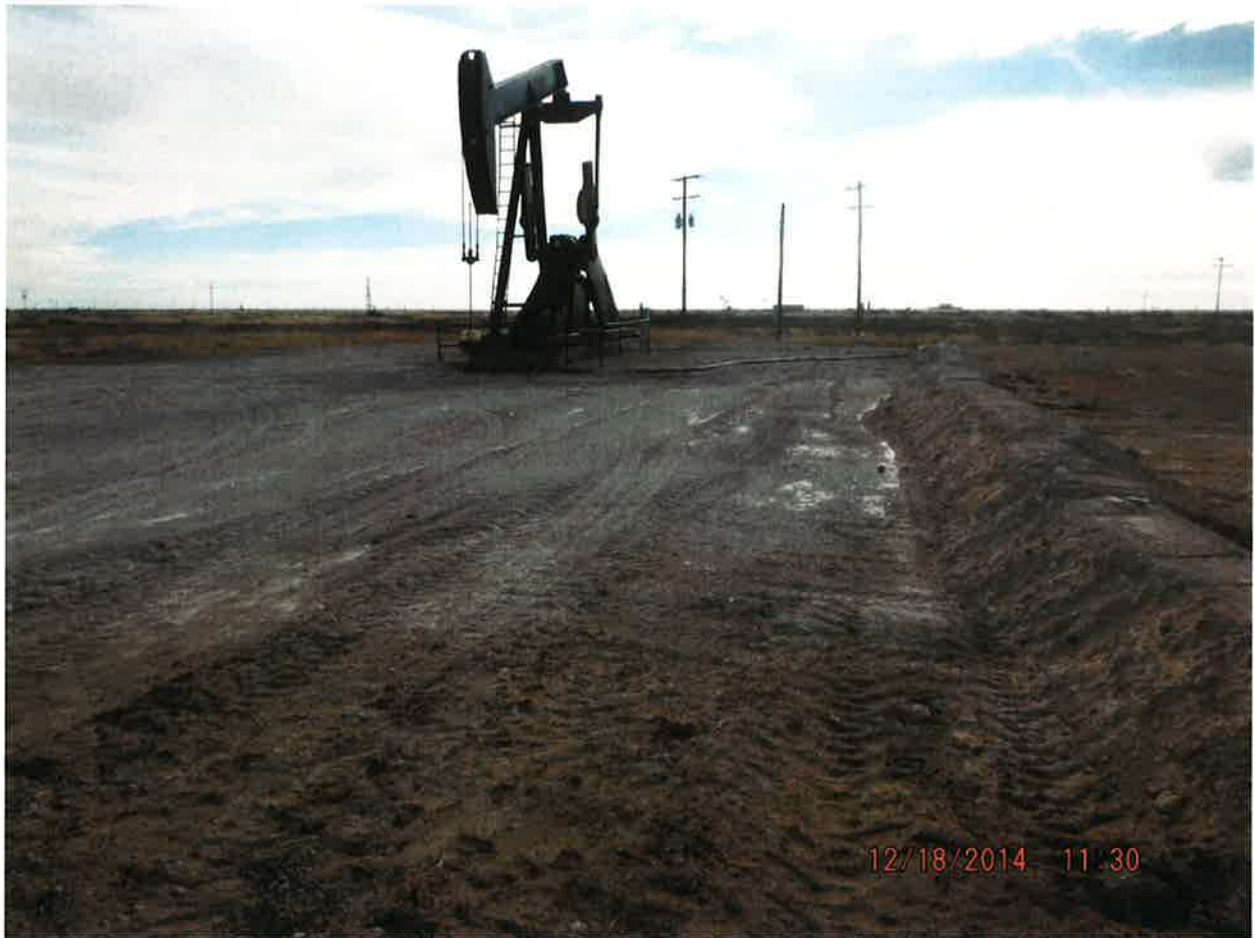
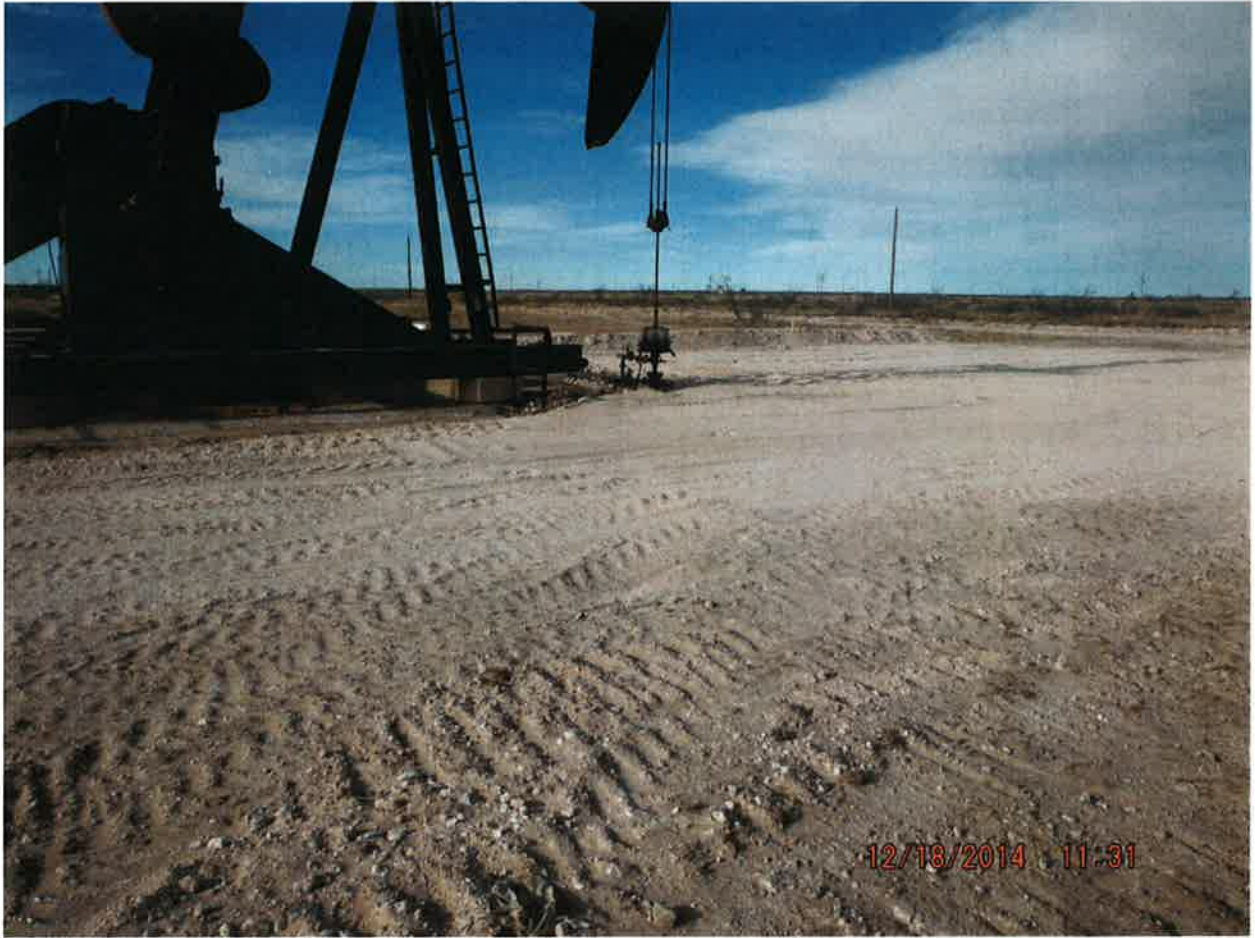
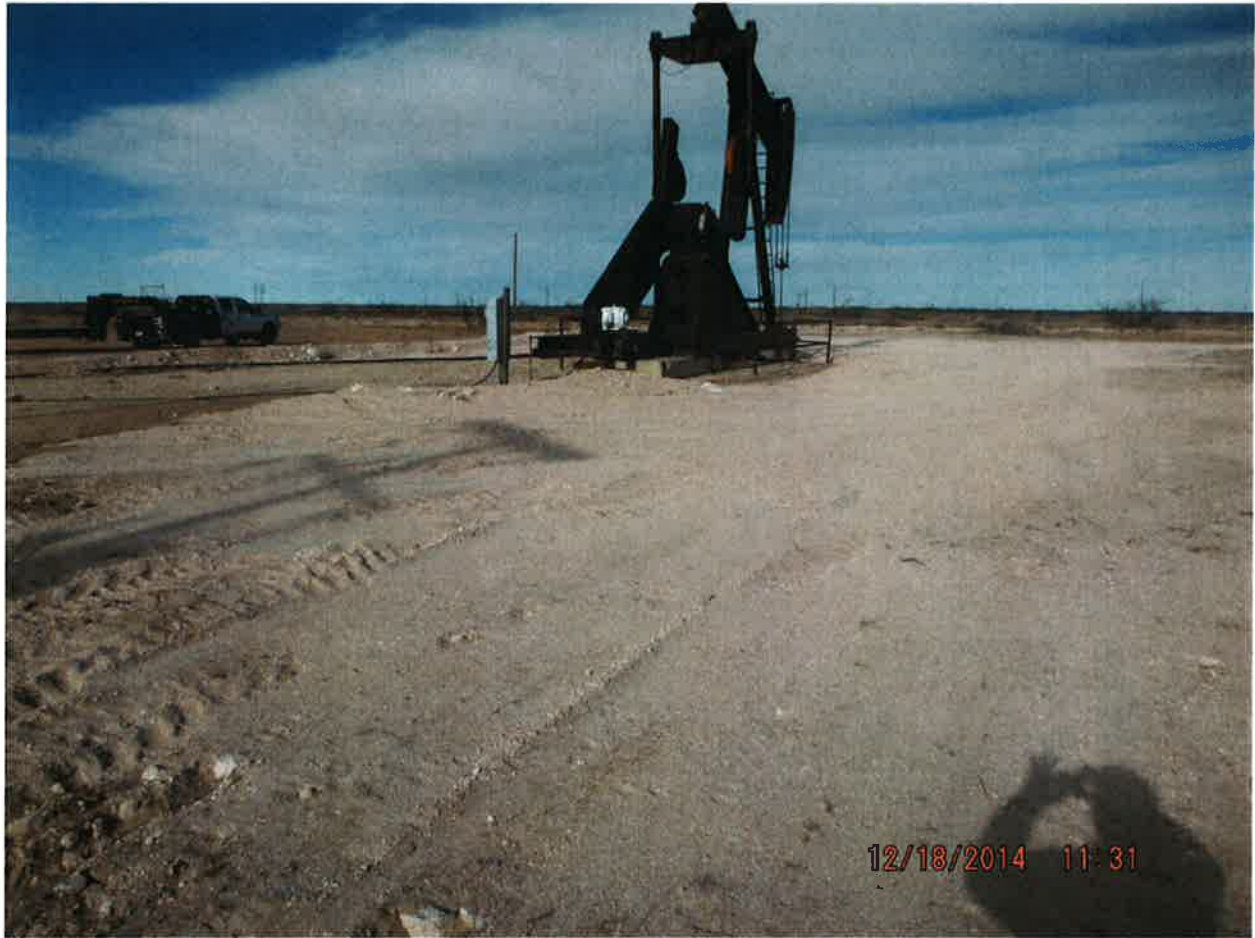
Remediation Completed

Excavated area was backfilled with clean gypsum (caliche) and compacted in order to help shield the chlorides beneath from precipitation which could carry the chlorides further down. A berm was constructed out of caliche to separate the well pad from the reserve pit in order to prevent any future release that might occur from running on top of the reserve pit. (See Photo section)
