Caprock Maljamar Unit #283

REMEDIATION WORK PLAN

API No. 30-025-34193

Unit Letter O, Section 33, Township 17 South, Range 33 East

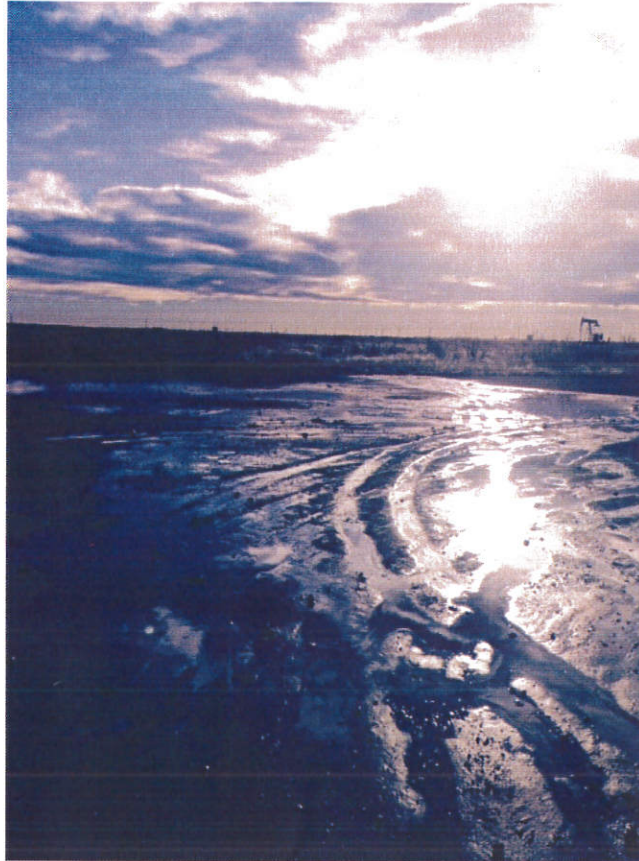
The site is located southeast of Maljamar NM, in Lea County. The leak site resulted from a failure of an injection line. The impacted area is the north and east sides of the caliche pad and some pasture impact east of the pad. A C-141 was submitted to the NMOCD on January 28th, 2015.

Pad facing east

Scrape the caliche pad to 6" bgs and backfill with clean caliche. Remove the pasture impacted soil down to 1' bgs, then backfill with native topsoil. Seed with a BLM, OCD approved seed mix.

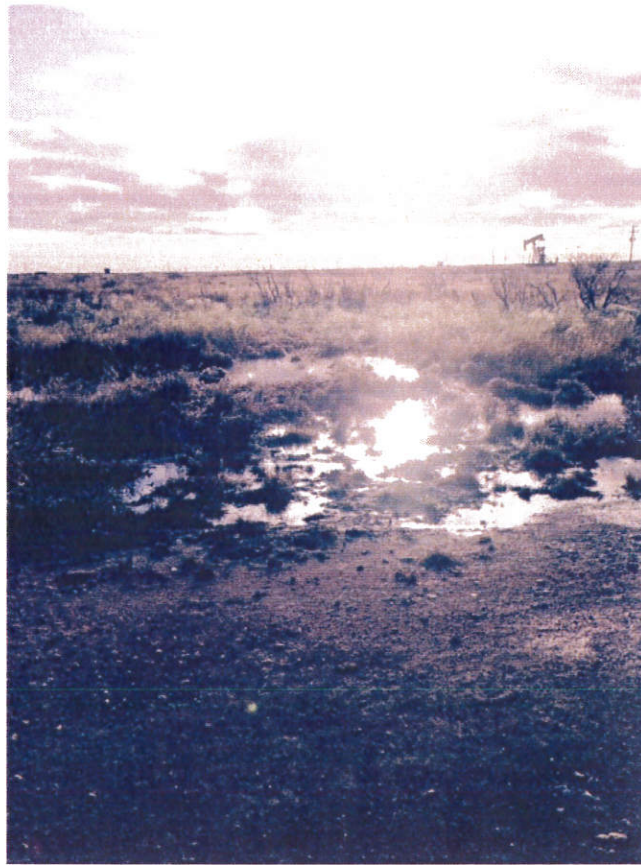
Pasture facing east
