# Government N #2 Battery

## REMEDIATION WORK PLAN

**RE: Linn Energy Government N #2 Battery – Remediation Work Plan**  
UL/N, Section 33, T20S, R34E  
API No. 30-025-23122

## PHOTO PAGE

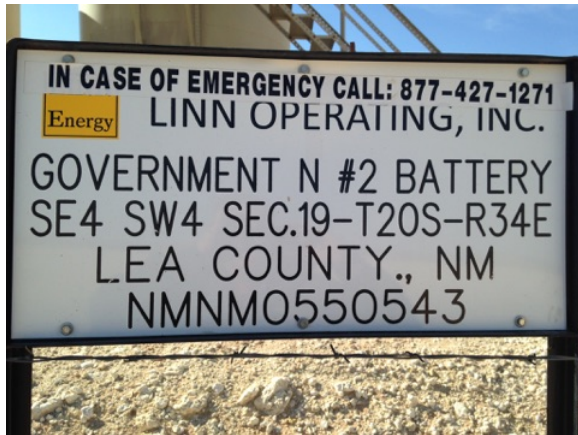
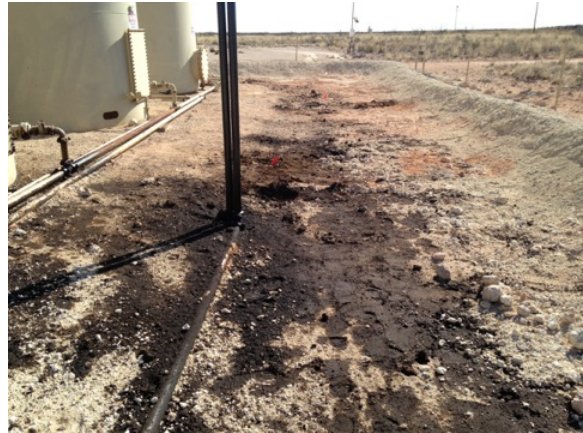
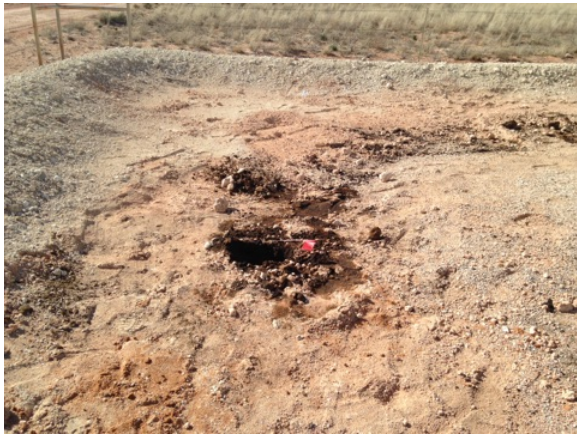
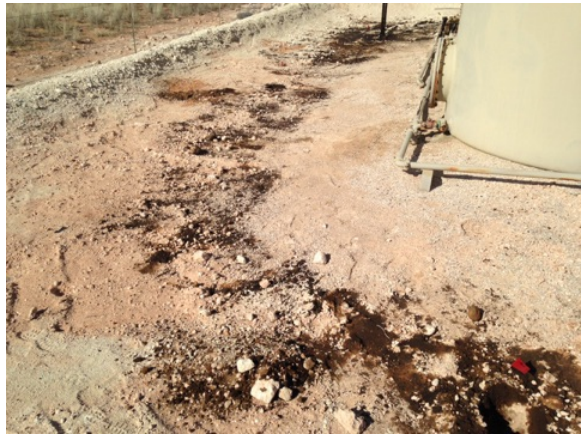
The site is located south of Maljamar, NM, in Lea County. The leak site resulted from the dumps not operating on the heater. A C-141 was submitted to the NMOCD on March 02, 2015.

Describe Cause of Problem and Remedial Action Taken.\* Arriving at location at 10:30, I noticed that oil had spilled out of gas line and onto ground and a little on tank. There was only gas coming out of line at that time. The pressure of heater was 30psi and both dumps were not operating. I opened the kimray 1/2 turn to try and release pressure on heater. Pressure dropped down to about 2 psi.

Describe Area Affected and Cleanup Action Taken.\* Oil was in firewall at battery. Had vac truck suck up any standing fluid and return to tank.

Remove the impacted soil in the area of SP #1 to 2' bgs. Remove the impacted soil in the area of SP #2 to 1' bgs. Remove the impacted soil in the area of SP #3 to 3' bgs.

Haul all contaminated soil to an approved disposal. Backfill with clean caliche and compact.
