REMEDIATION SUMMARY AND SITE CLOSURE REQUEST

BOPCO, LP

HAT MESA 32 STATE #1 FLOW LINE

NMOCD Reference #1RP- 3038

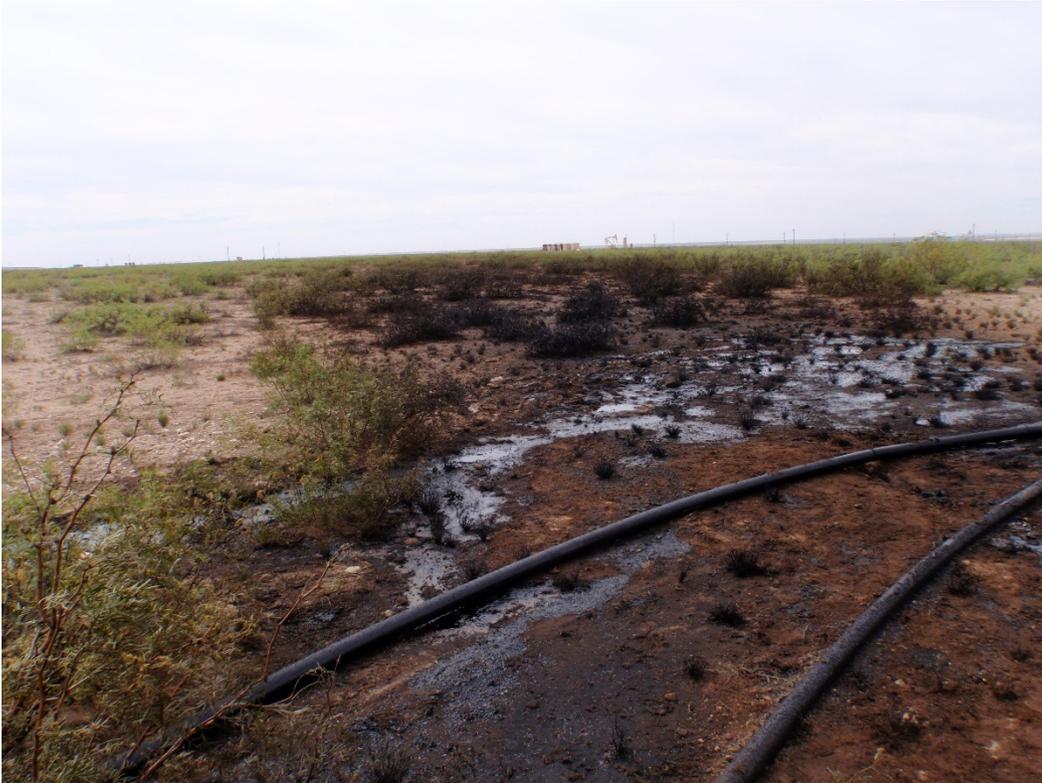
Photograph of the initial release and pooling area at the Hat Mesa 32 State #1 Flow Line Release Site.

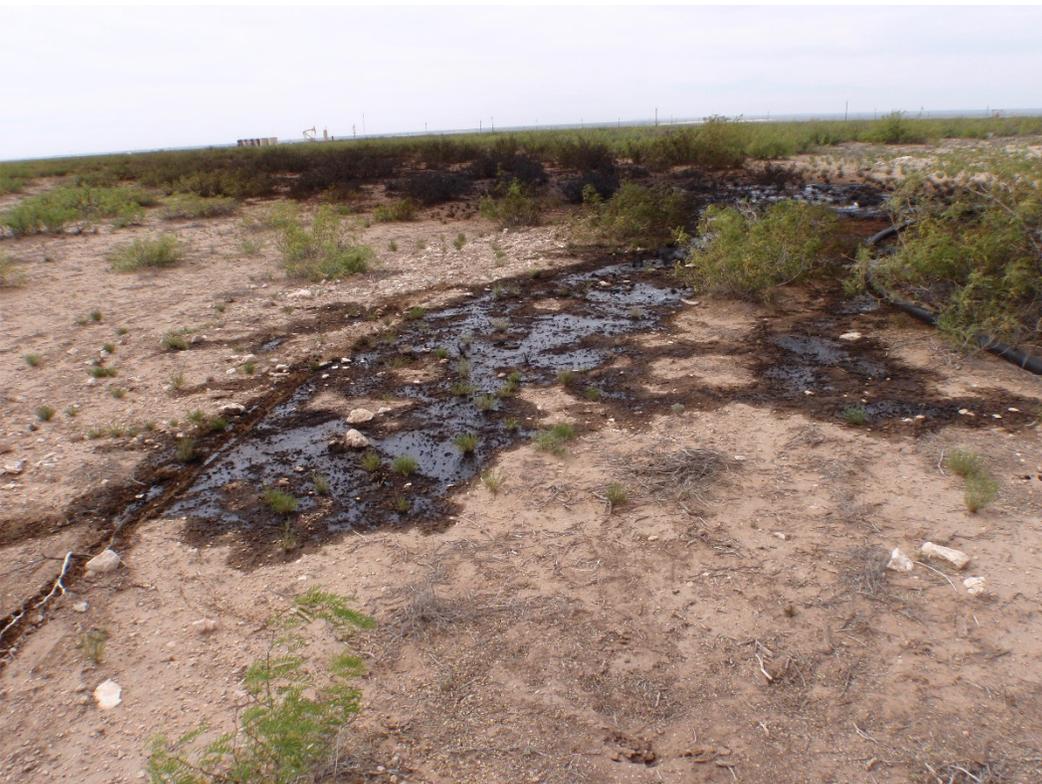
Photograph of the initial release and pooling area at the Hat Mesa 32 State #1 Flow Line Release Site.

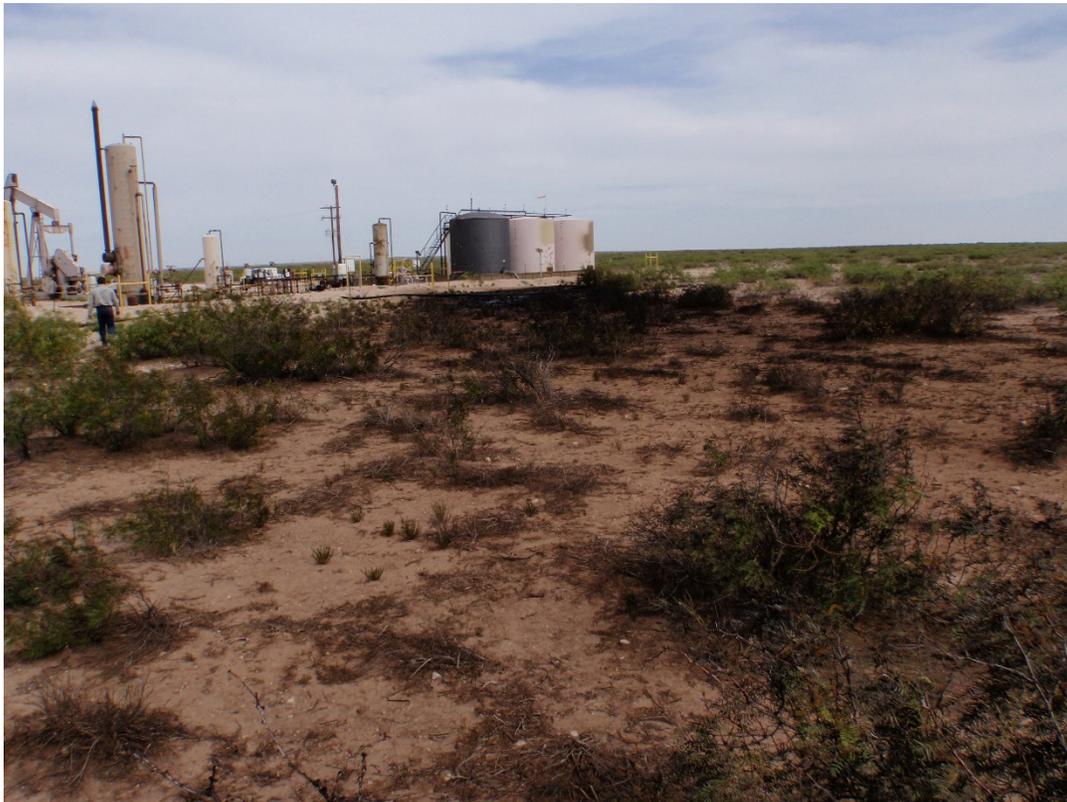
Photograph of the initial release and heavily misted area at the Hat Mesa 32 State #1 Flow Line Release Site.

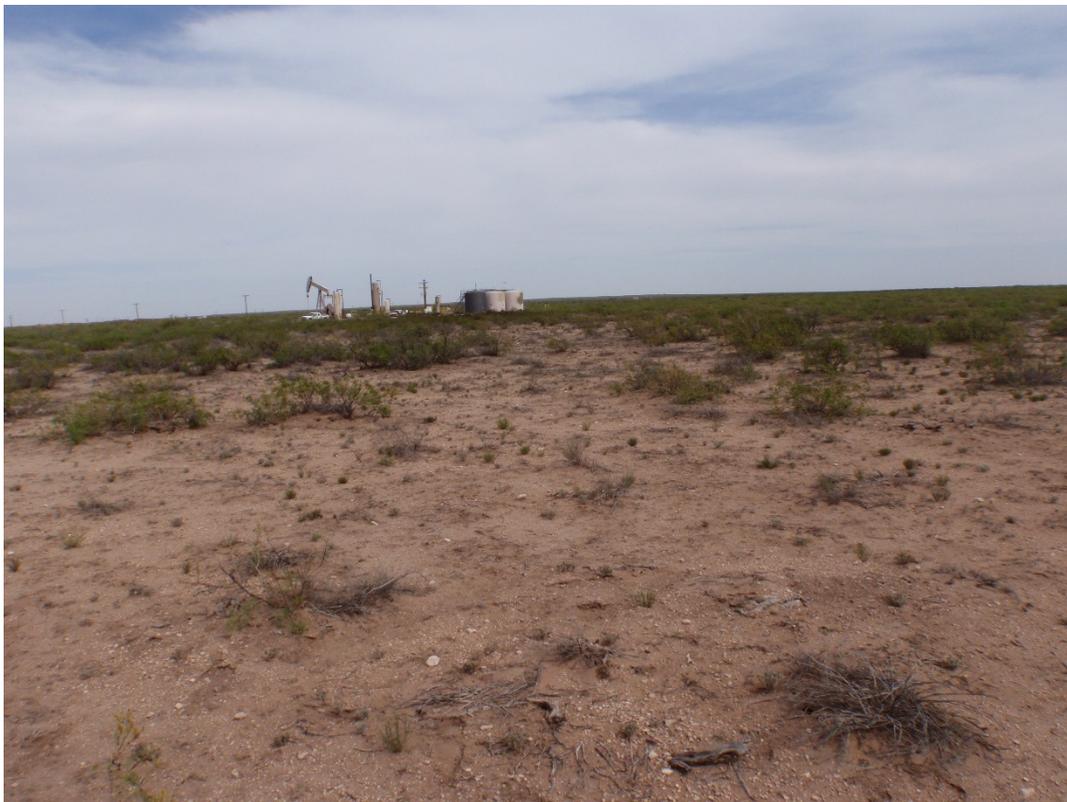
Photograph of the initial release and lightly misted area at the Hat Mesa 32 State #1 Flow Line Release Site.

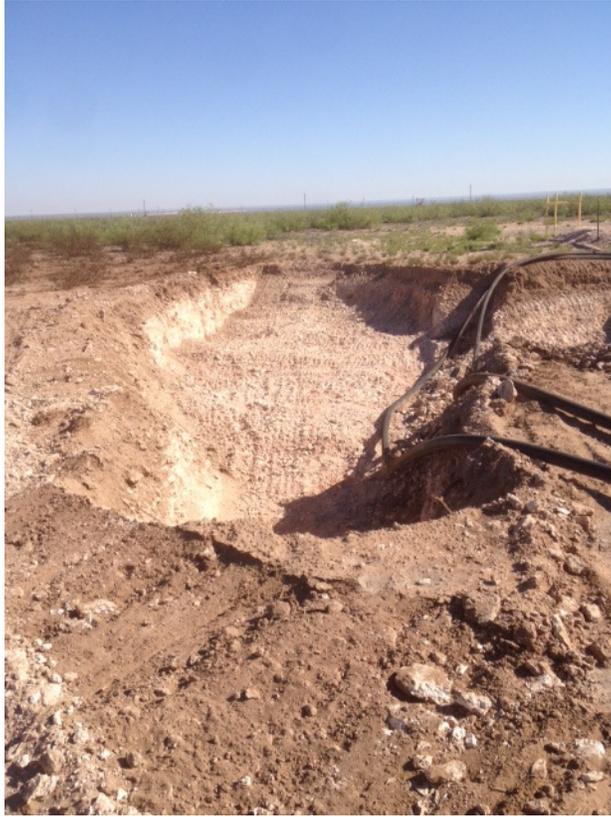
Photograph of the excavated pooling areas at the Hat Mesa 32 State #1 Flow Line Release Site.

The final dimensions of the primary excavation were approximately twelve (12) to sixty (60') in width, eighty feet (80') in length and four feet (4') in depth. Upon receiving laboratory analytical data from confirmation soil samples, the excavated area was backfilled with locally purchased, non-impacted material. Following backfilling, areas affected by the remediation activities were contoured to match the surrounding topography. Areas within the affected pasture will be reseeded in accordance with the NMSLO at a time more conducive to germination.

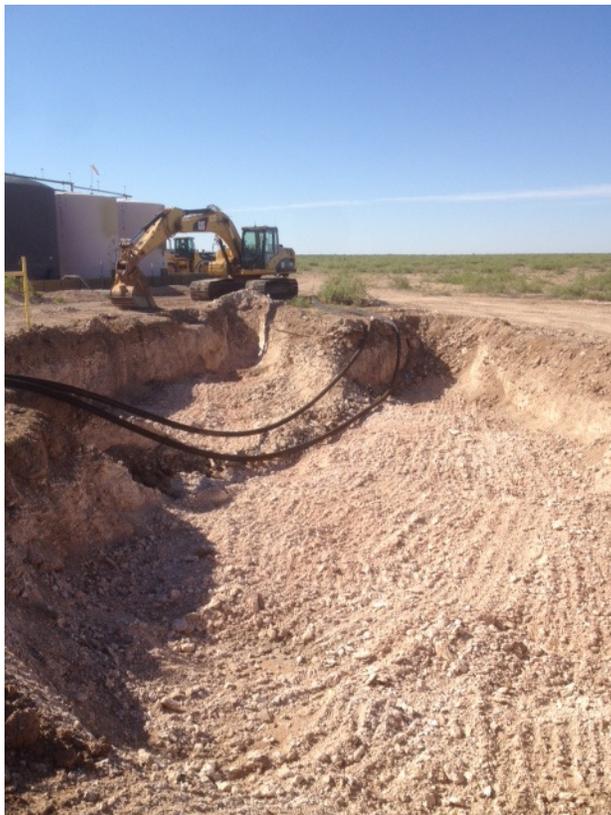
Photograph of the excavated pooling areas at the Hat Mesa 32 State #1 Flow Line Release Site.

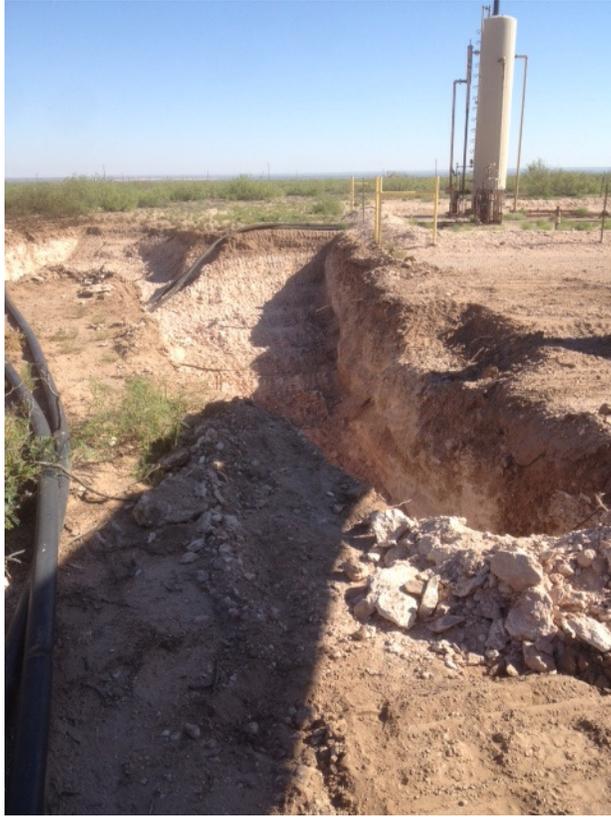
Photograph of the excavated pooling areas at the Hat Mesa 32 State #1 Flow Line Release Site.

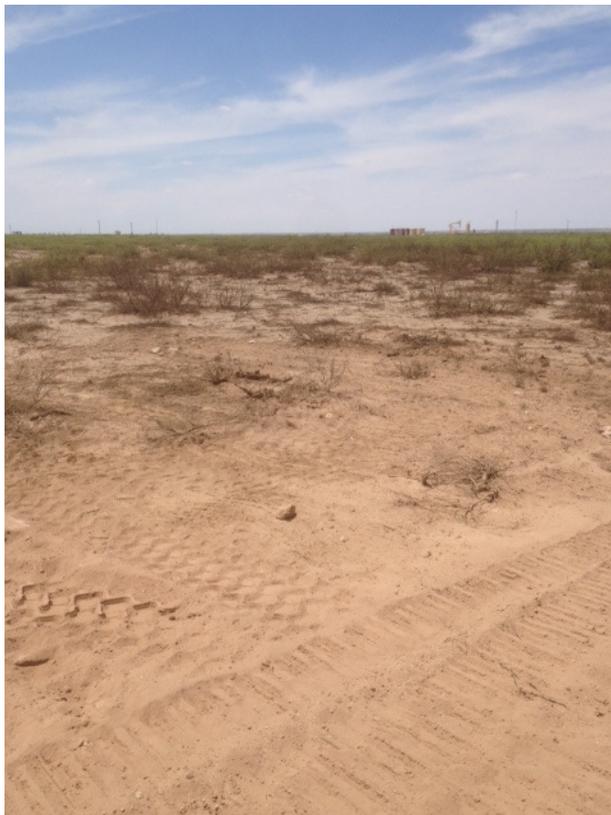
Photograph of the heavily misted area at the Hat Mesa 32 State #1 Flow Line Release Site after Micro-Blaze® treatment.

On May 21, 2014, Basin began remediation activities at the release site. Affected vegetation and soil outside the primary pooling areas were treated with a Micro-Blaze[®] solution in an effort to enhance bioremediation and natural attenuation of hydrocarbon-impacted soils and vegetation. An excavation was advanced in the areas characterized by the primary pooling areas. The floor and sidewalls of the excavation were advanced until field tests suggested concentrations of BTEX, TPH and chloride were below NMOCD regulatory standards. Excavated soil was stockpiled on-site, pending final disposition.

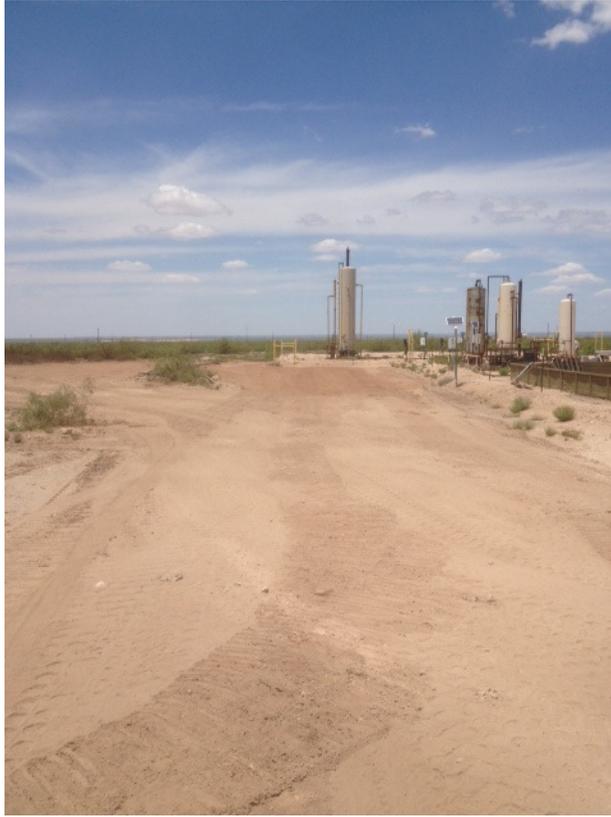
Photograph of the Hat Mesa 32 State #1 Flow Line Release Site after remediation activities.

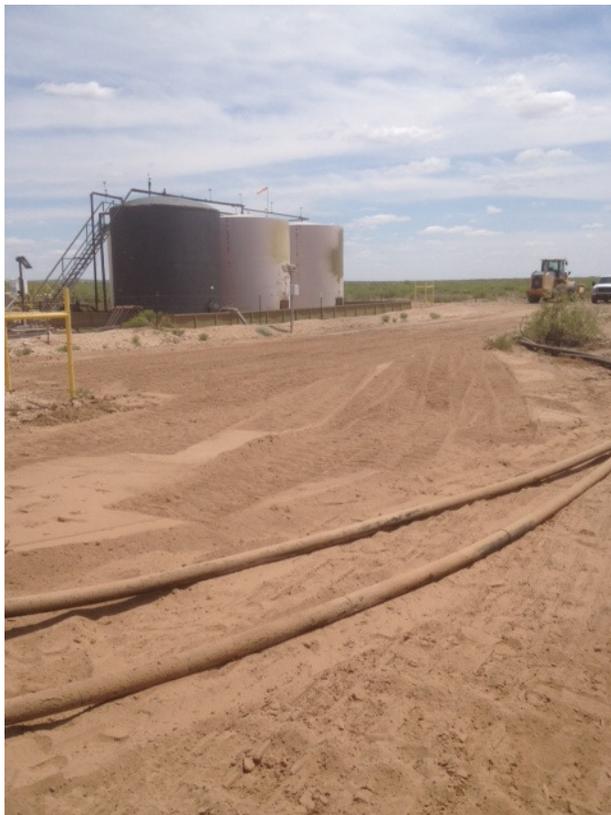
Photograph of the Hat Mesa 32 State #1 Flow Line Release Site after remediation activities.
