**OXY USA, Inc.
South Hobbs Unit Satellite 5
Closure Report**

**Section 4, T19S, R38E
Lea County, New Mexico**

**1RP-3533-0
March 26, 2015**

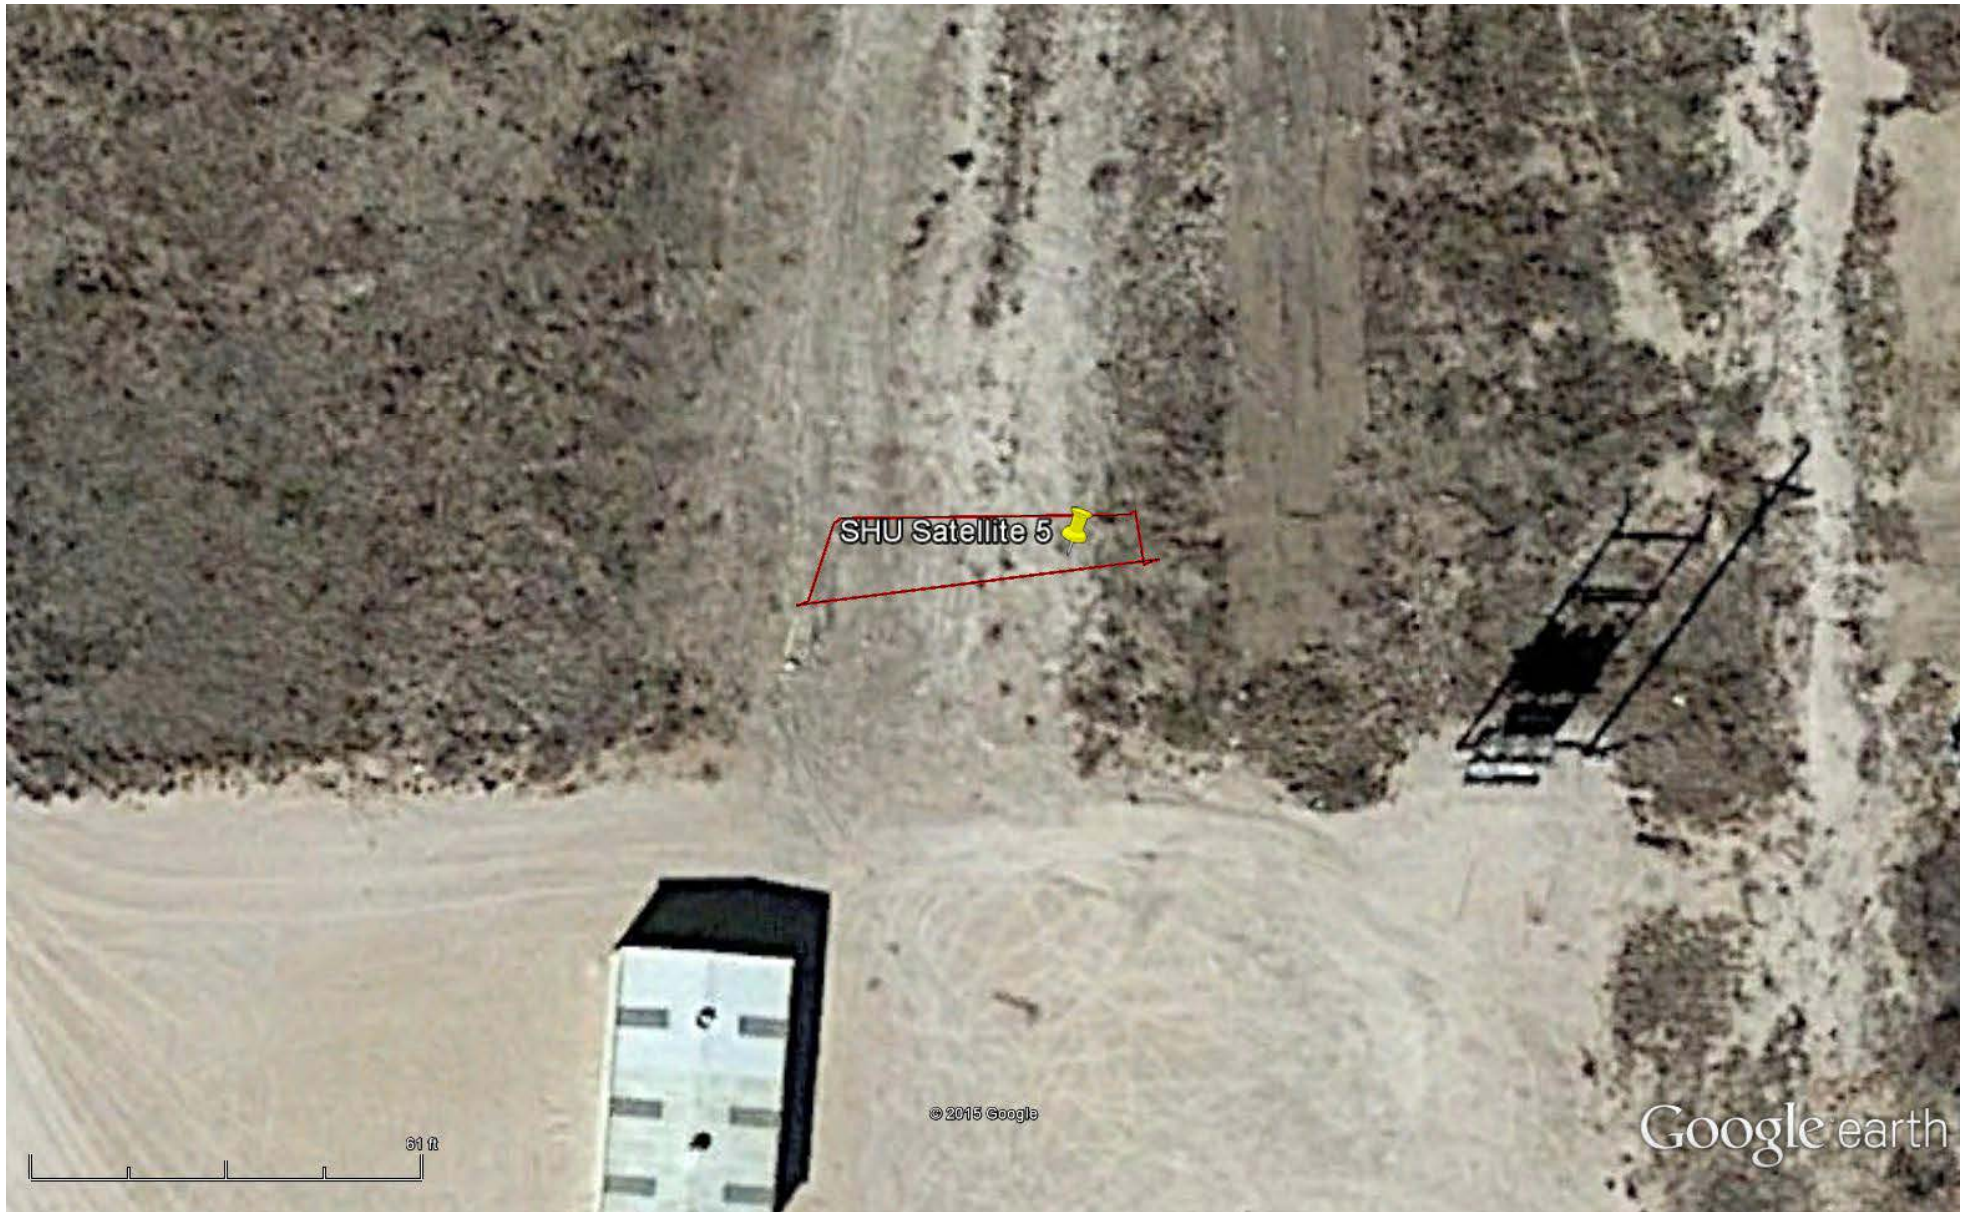
Figure 2
Site Plan

On March 5, 2015, SESI was onsite to determine vertical extent of contamination. Sample Bottom hole was taken at a depth of 11' ft. Sample South Wall was taken from the south wall of the excavation area. All samples were properly packaged, preserved and transported to the Laboratory, Hobbs New Mexico and analyzed for Benzene,

South Hobbs Unit Satellite 5

On March 05, 2015 Safety and Environmental Solutions, Inc. personnel revisited the site and retrieved the aforementioned soil representative samples from the excavation floor and South sidewall. The aforementioned results returned confirmation of acceptable regulatory levels for BTEX and TPH analyses. According to visual examination, as documented by photos there is no visual staining present. Due to the number of lines in the area, no further action is prudent. Therefore, Safety and Environmental Solutions, Inc. respectfully requests closure of the regulatory file on the aforementioned site.
