## Vacuum Glorieta East Unit Well #20 (1RP-3333)

### Termination Request

API No. 30-025-37850

**ConocoPhillips Vacuum Glorieta East Unit Well #20 (1RP-3333)**

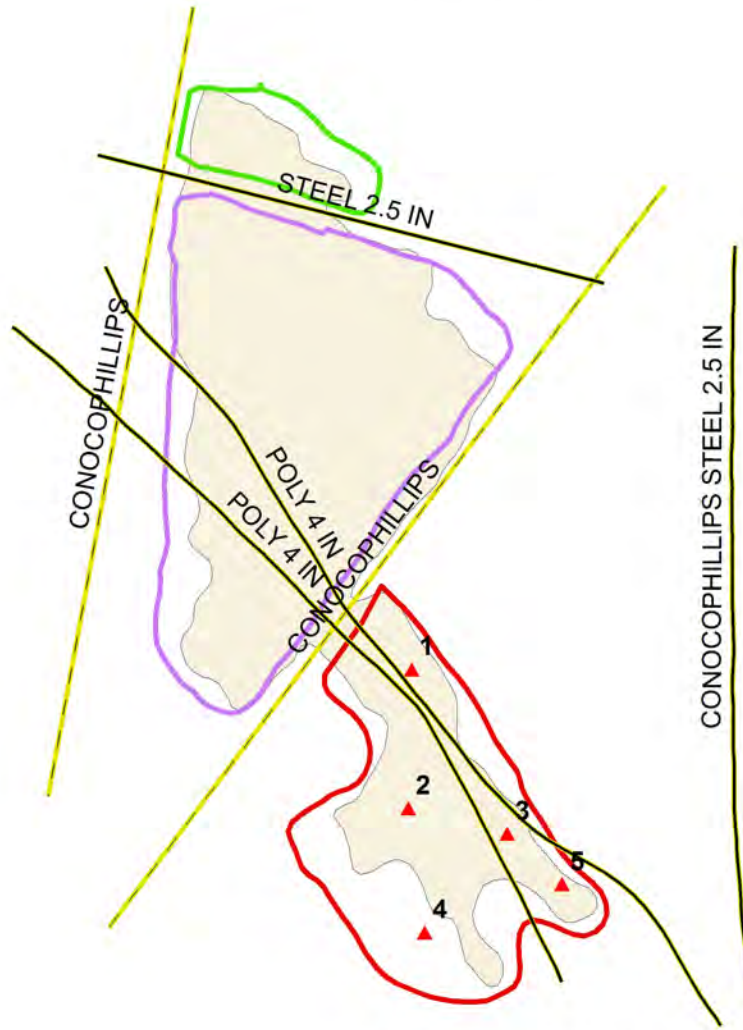
Figure 2

# Excavation Data

5 PT. BOTTOM COMP.

CI-	GRO	DRO
3'	192	<10	<10

Corrective Actions began at the site on October 13<sup>th</sup>, 2014. The release was excavated in three portions to 3 ft bgs (Figure 2). All excavated soil, for a total of 1,245 cubic yards, was taken to a NMOCD approved facility for disposal. A total of 1,342 cubic yards of top soil was imported to the site to pad the liners and to serve as backfill. A sample of the imported soil was taken to a commercial laboratory for analysis and returned a chloride value of non-detect (Appendix C). The bottoms of the north excavation and the north excavation (2) were padded with 6 inches of the imported top soil to protect the liners from punctures. 20-mil reinforced poly liners were then installed and properly seated into the base of both excavations.

A 5 point bottom composite of the south excavation was taken to a commercial laboratory for analysis. The bottom composite returned a laboratory chloride reading of 192 mg/kg with GRO and DRO readings of non-detect. On October 29<sup>th</sup>, 2014, a request was sent to NMOCD with the excavation data and a request to backfill the site. NMOCD approved the site to be backfilled the same day. All three excavations were backfilled with the imported top soil and contoured to the surrounding location. On November 7<sup>th</sup>, 2014, the disturbed area was seeded with BLM mix #2.

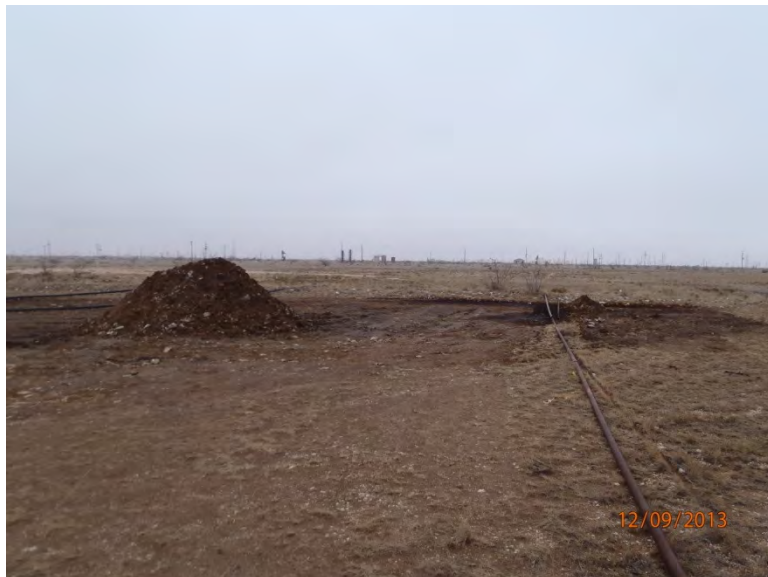
Initial site photo, facing west

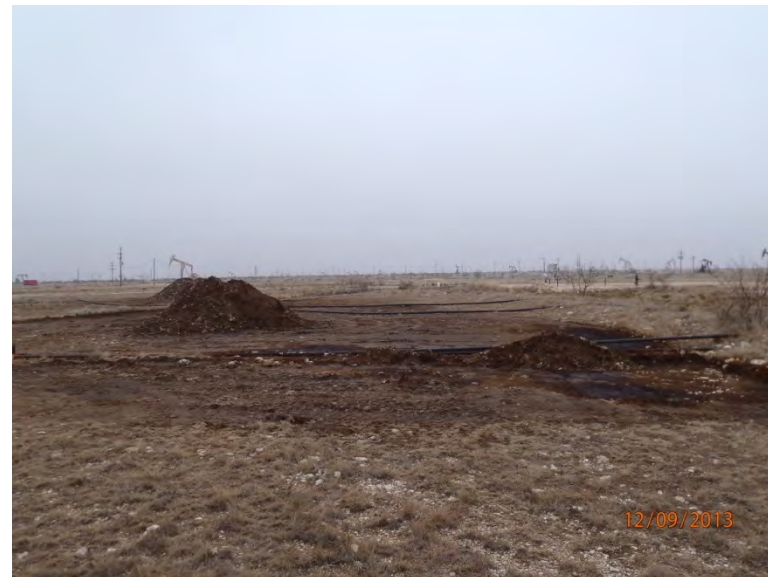
Initial site photo, facing south

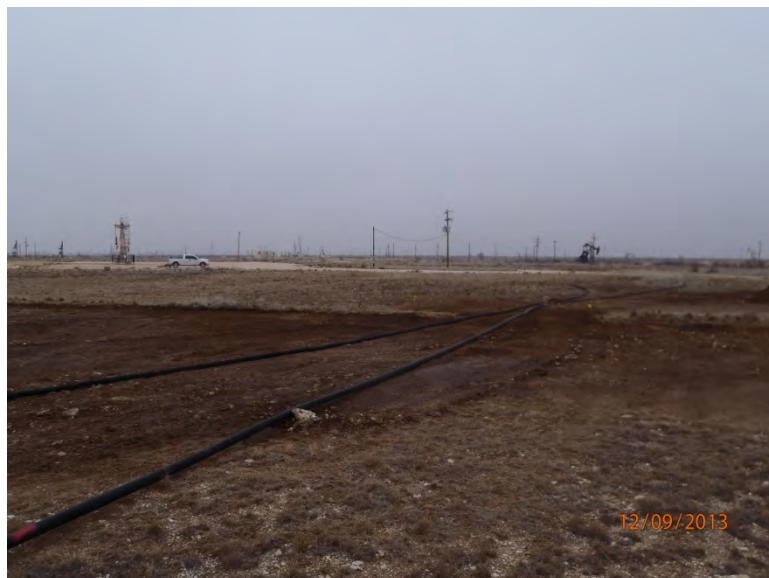
Initial site photo, facing east

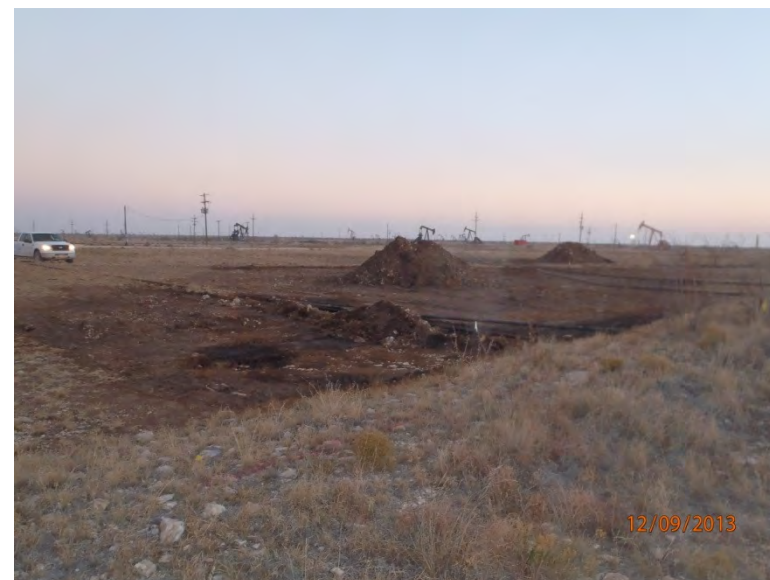
Initial site photo, facing southeast

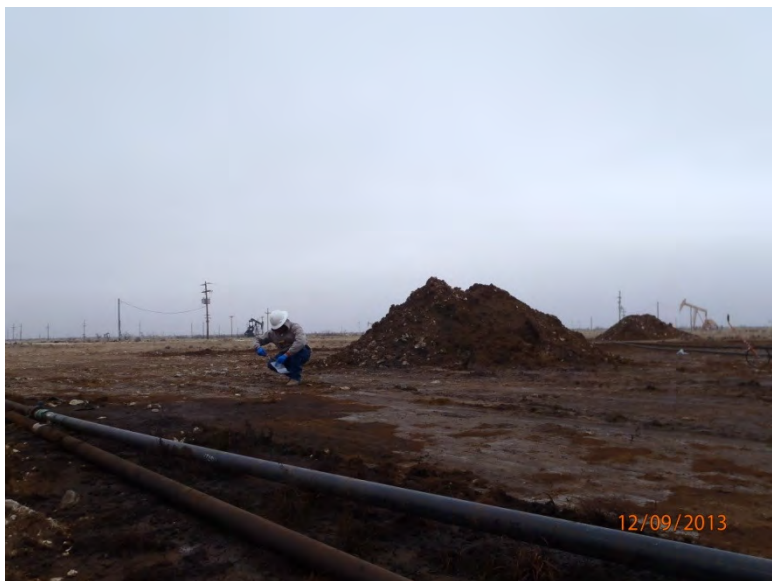
Sampling release, facing south

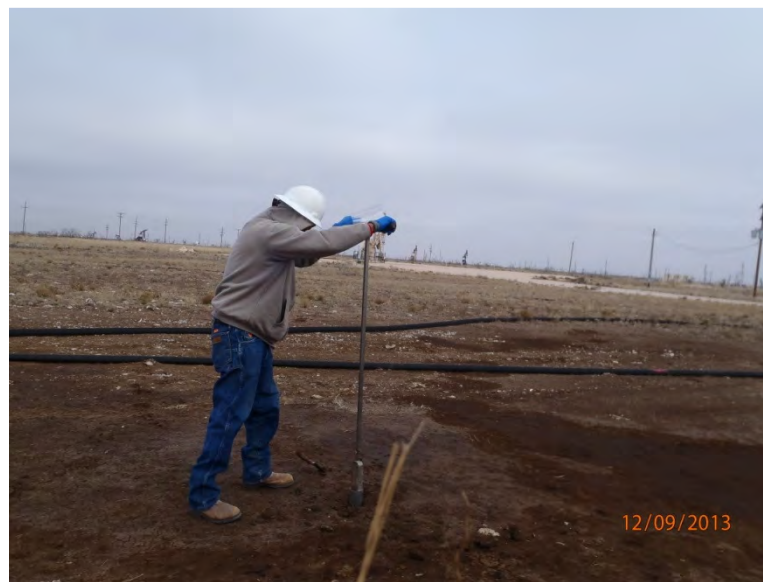
Auguring for depth, facing east

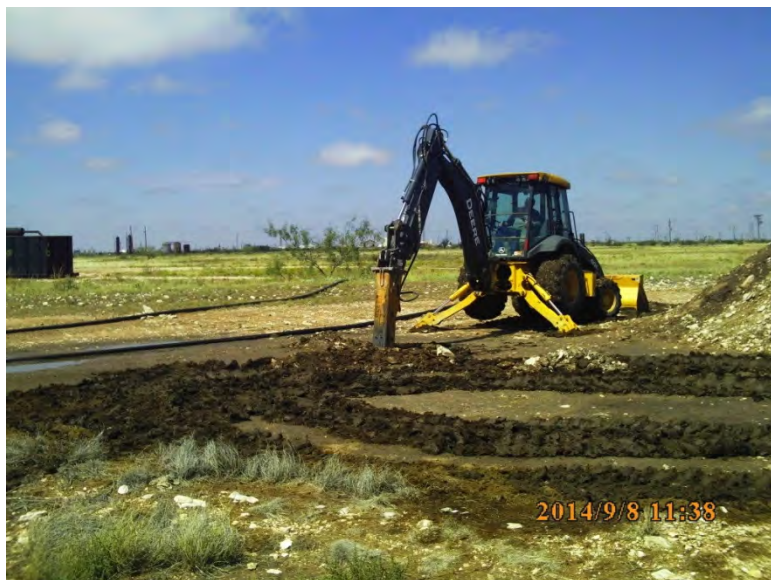
Installing verticals, facing northwest

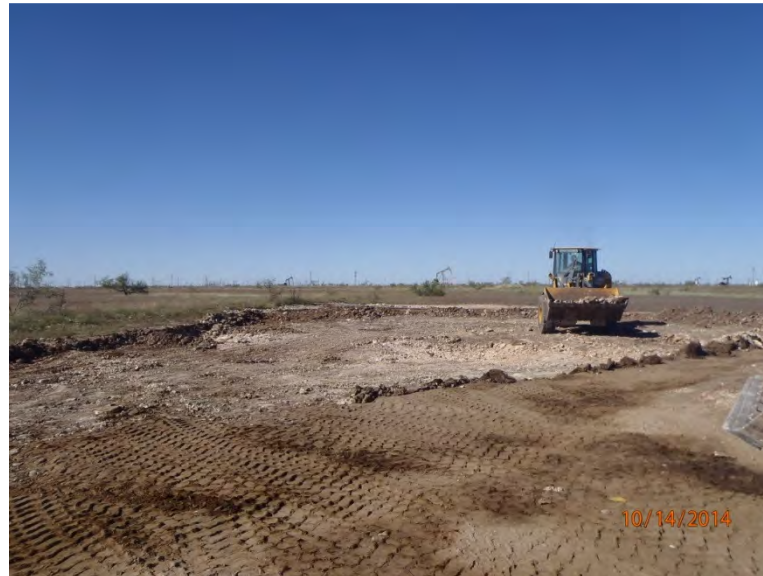
Excavating to 3 ft bgs, facing northwest

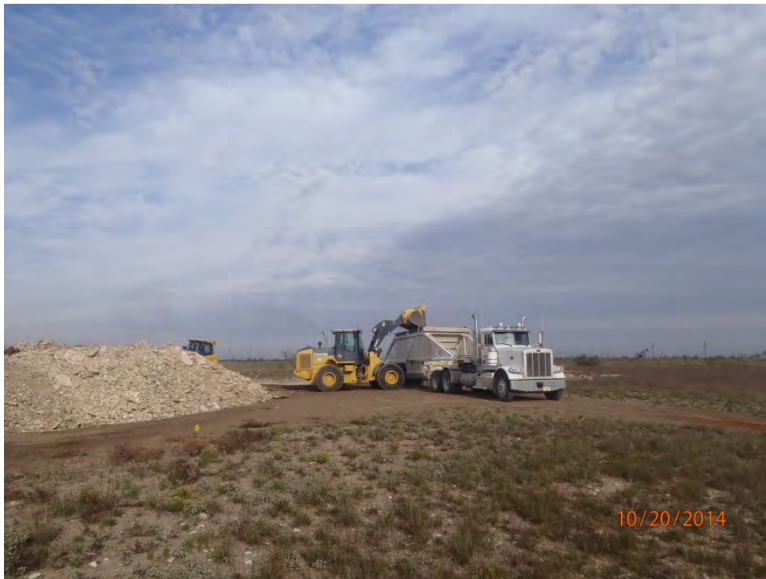
Exporting soil, facing northwest 10/20/14

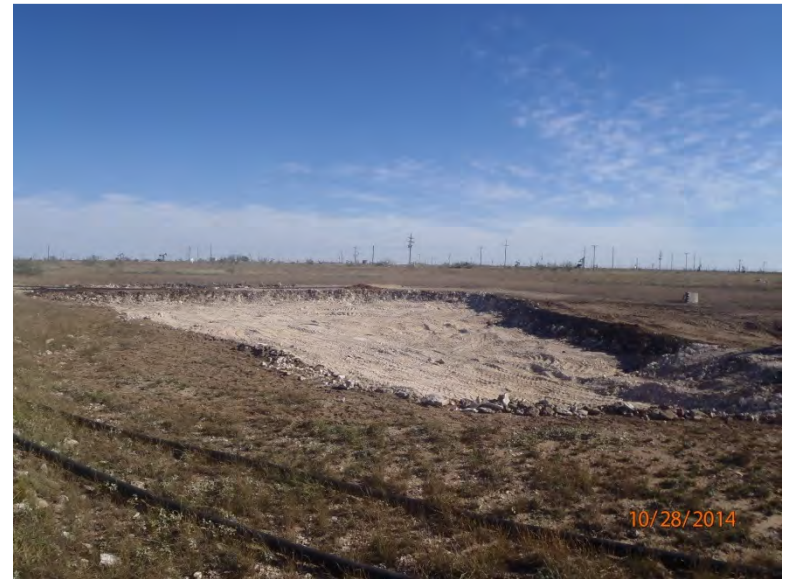
North excavation completed, facing northeast 10/28/14

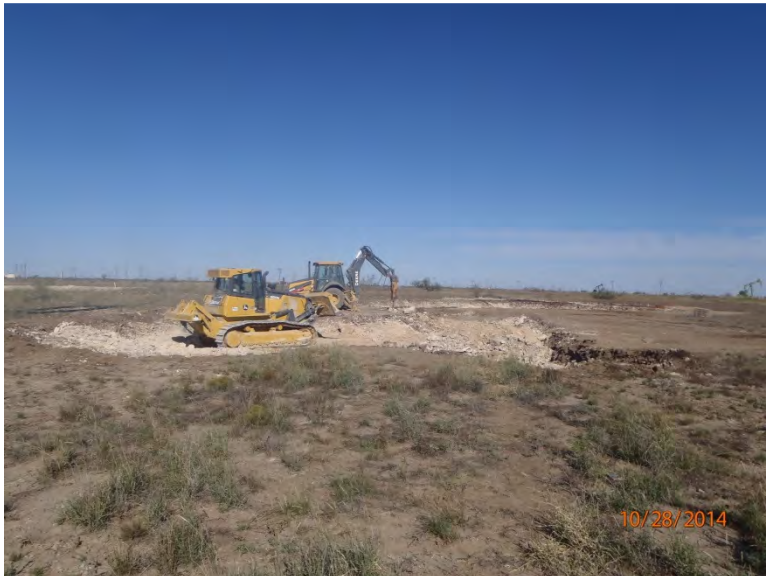
Excavating to 3 ft in the south, facing northwest 10/28/14

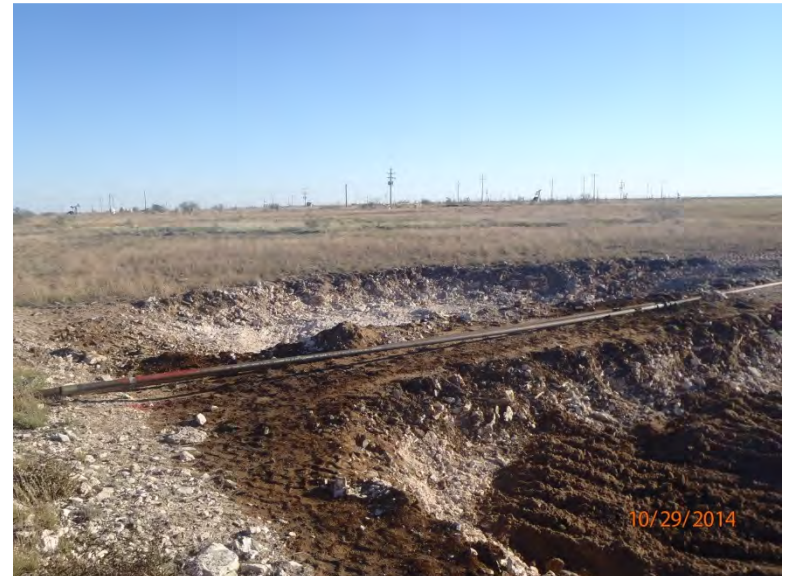
North excavation (2) completed, facing northeast 10/29/14

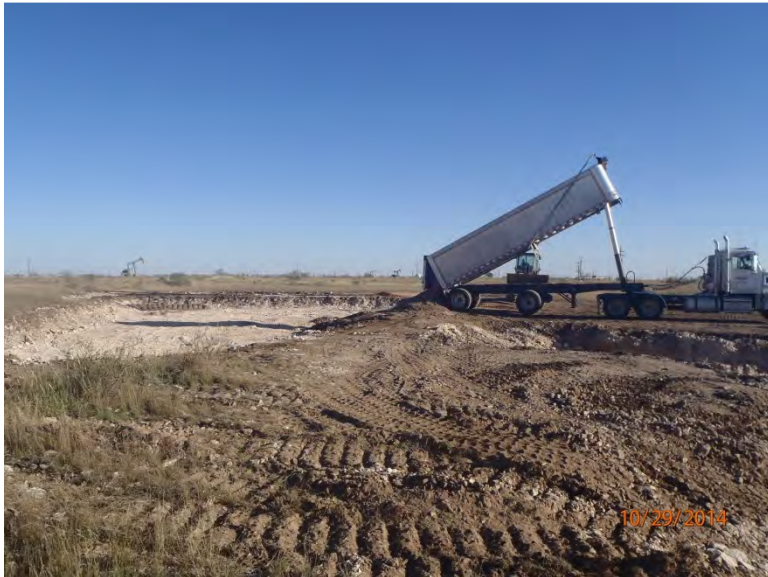
Importing top soil to pad for liner, facing north 10/29/14

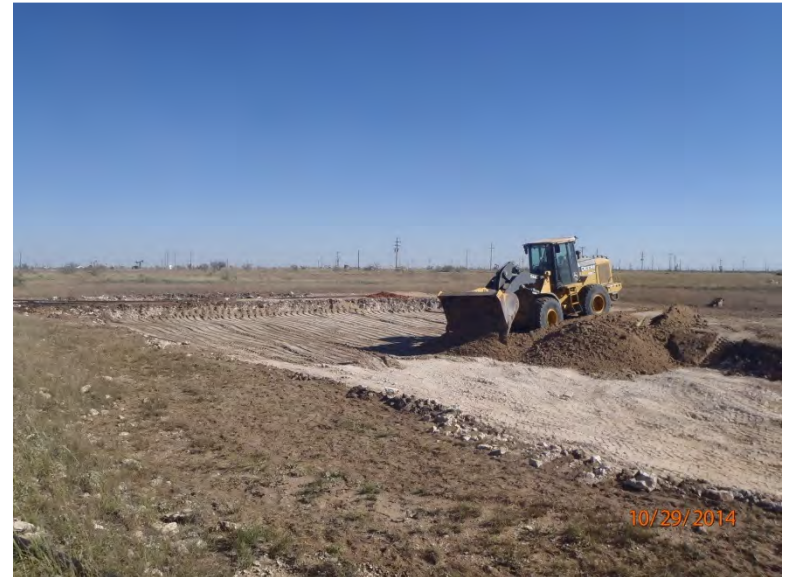
Padding north excavation for liner installation, facing northeast 10/29/14

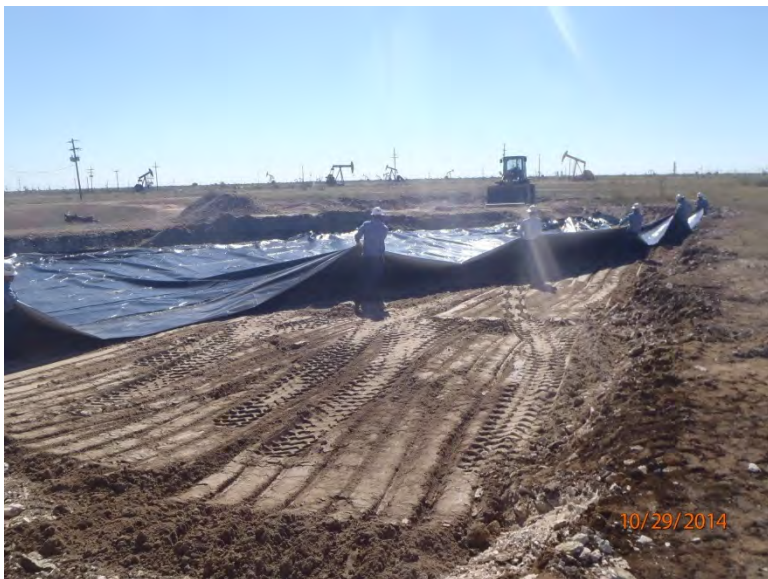
North excavation padded with imported soil and installing liner, facing southeast 10/29/14

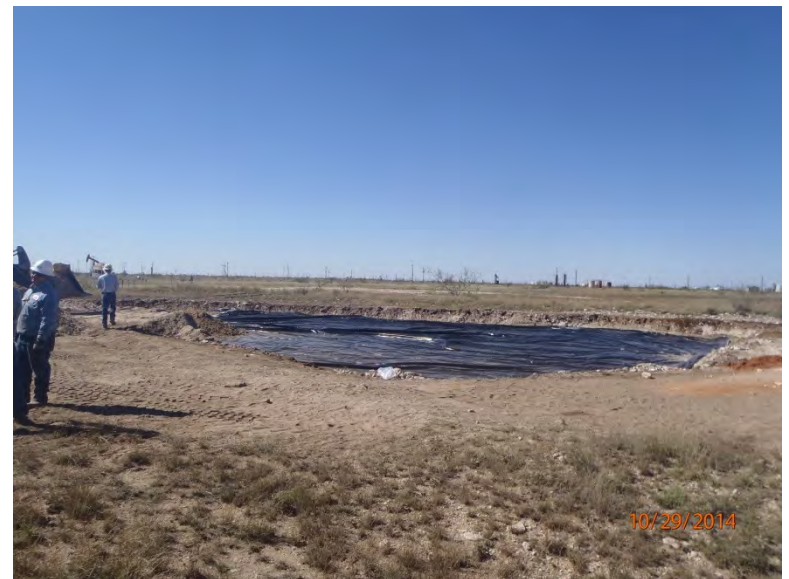
Liner installation completed, facing southwest 10/29/14

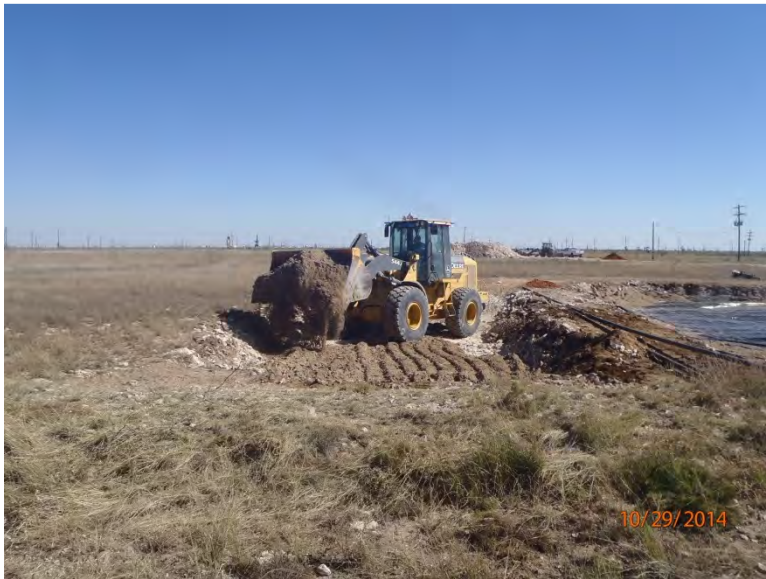
Padding north excavation (2) for liner installation,  
facing east 10/29/14

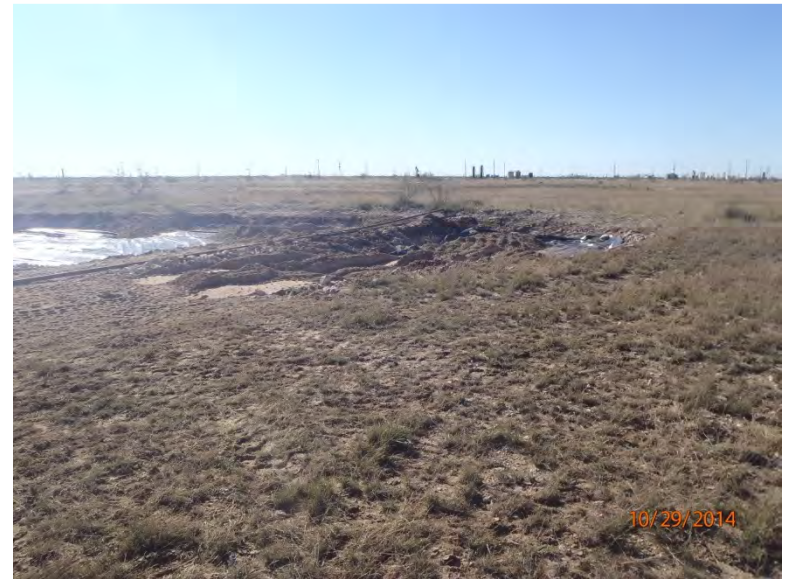
Liner installation in north excavation (2) completed and  
begin backfilling, facing southwest 10/29/14

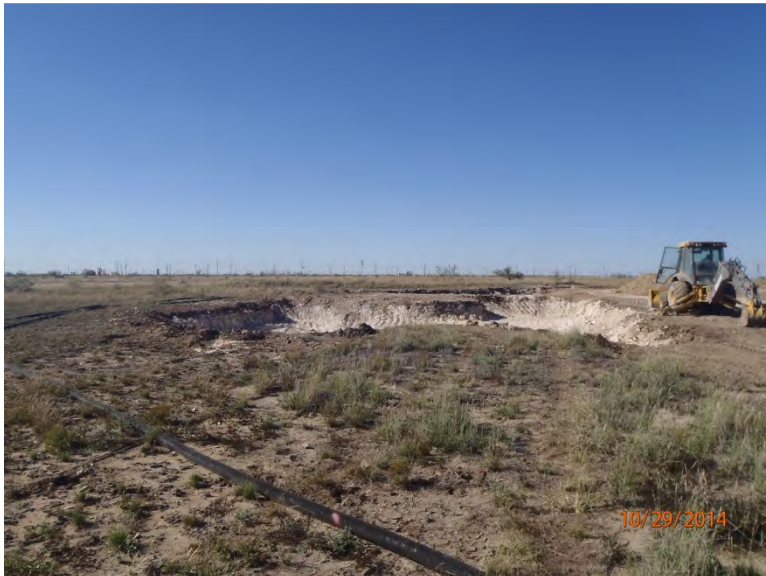
South excavation completed, facing northwest  
10/29/14

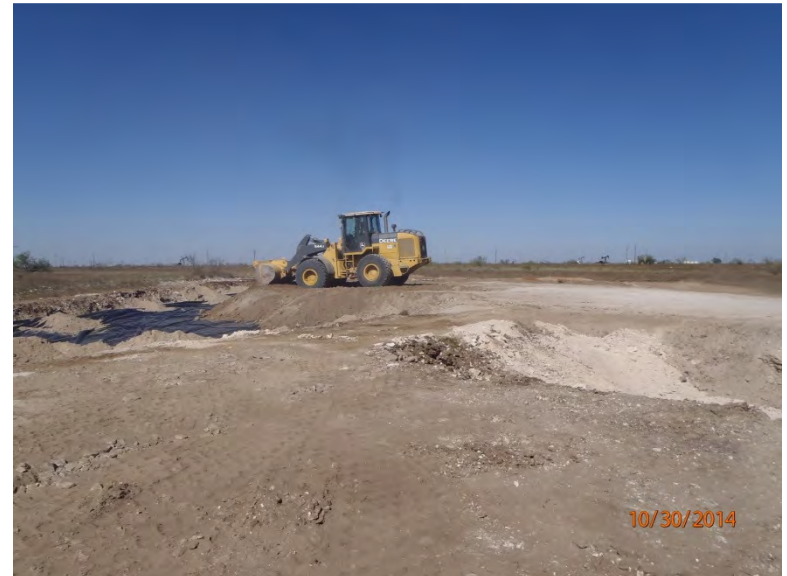
Backfilling the north excavation, facing north 10/30/14

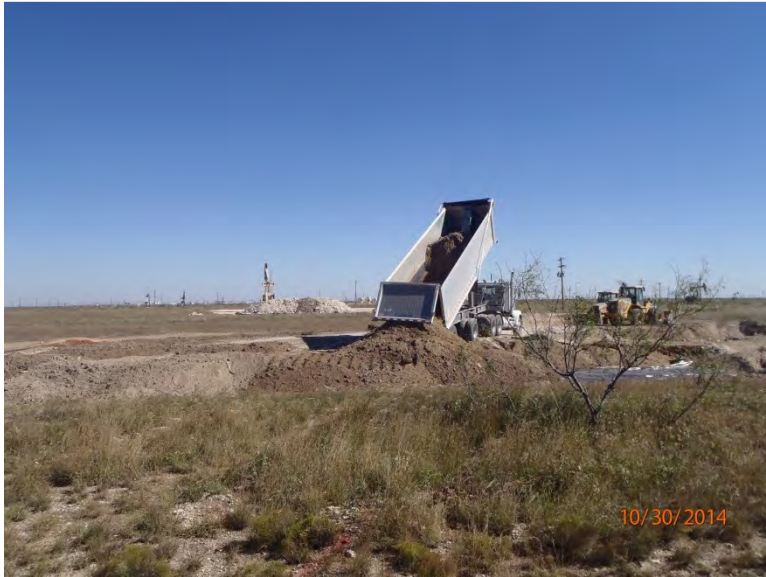
Importing soil, facing east

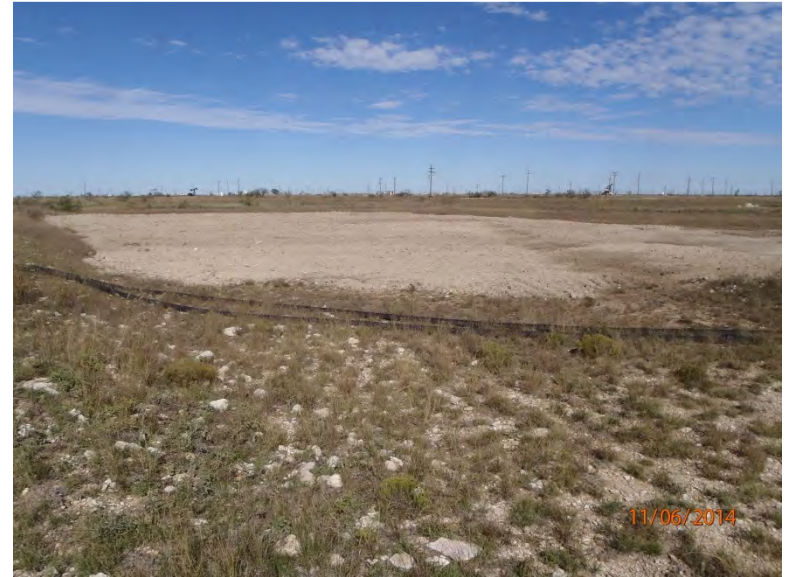
North excavation backfilled, facing northeast

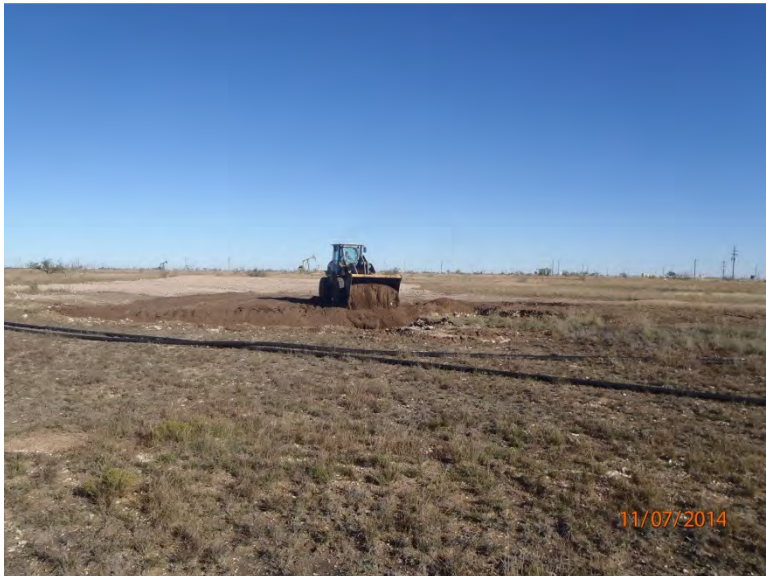
Backfilling south excavation, facing northeast

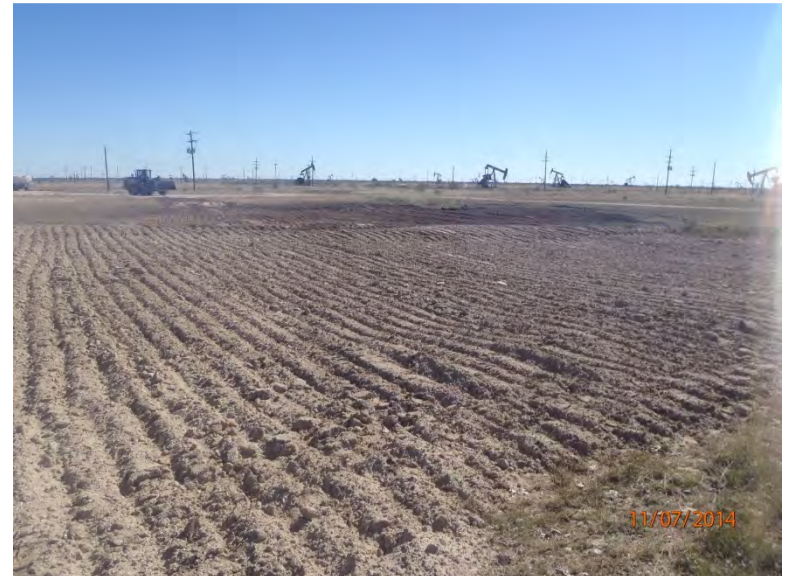
Site backfilled, facing southeast

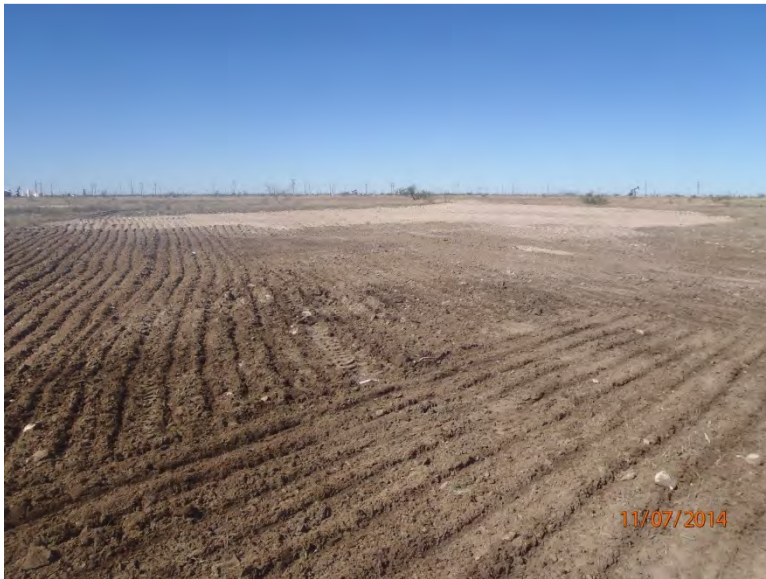
Site backfilled, facing northwest

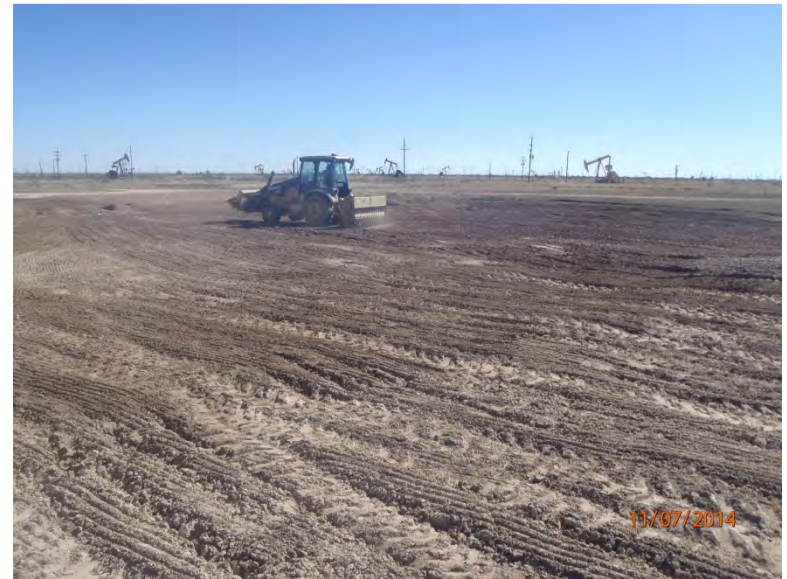
Seeding site, facing southeast

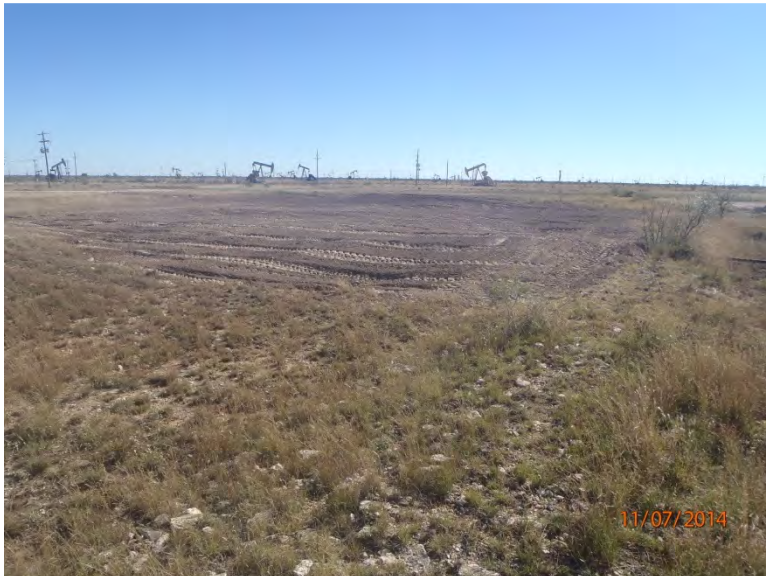
Site completed, facing southeast

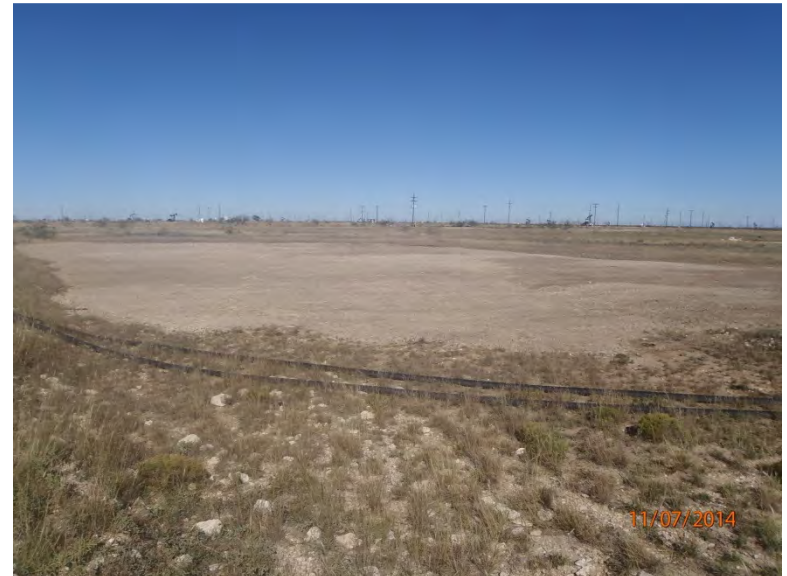
Site completed, facing northeast
