BMT Battery (1RP-3411)

Termination Request

**RE: Termination Request
ConocoPhillips BMT Battery (1RP-3411)
UL/N sec. 20 T20S R38E**

ConocoPhillips BMT Battery

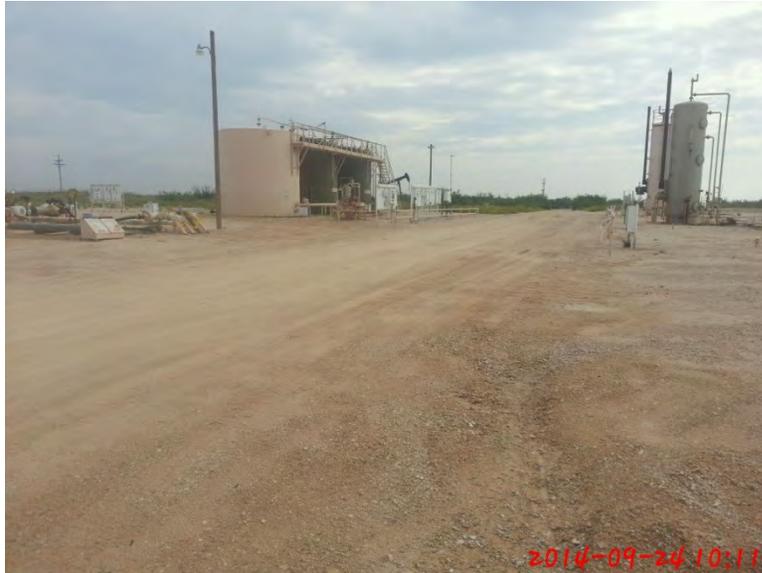
Release backfilled, facing northeast 9/24/14

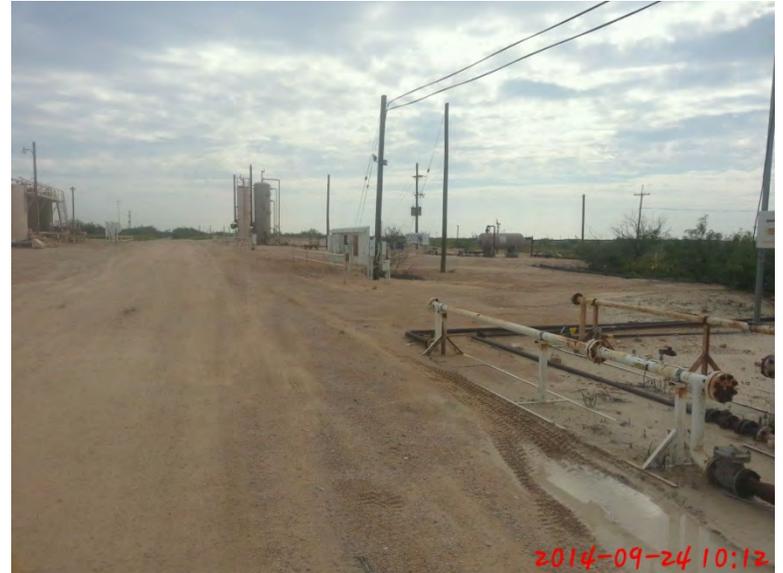
Release backfilled, facing east 9/24/14

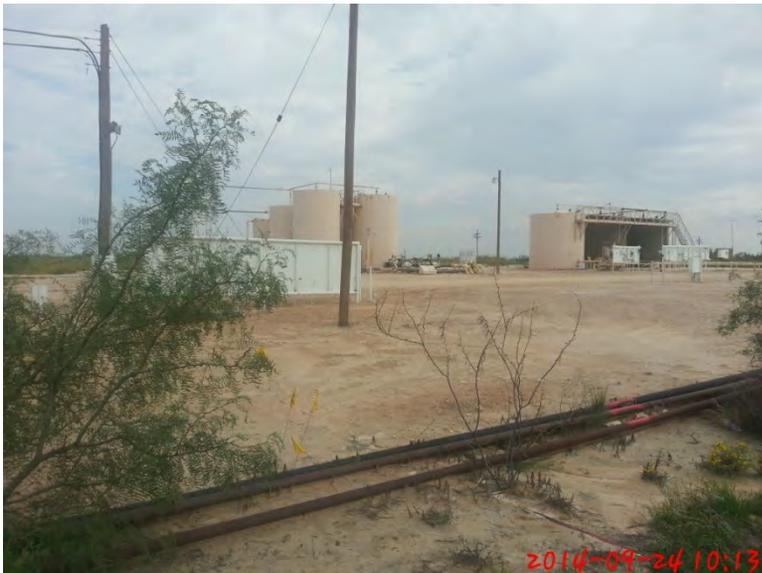
Release backfilled, facing northeast 9/24/14

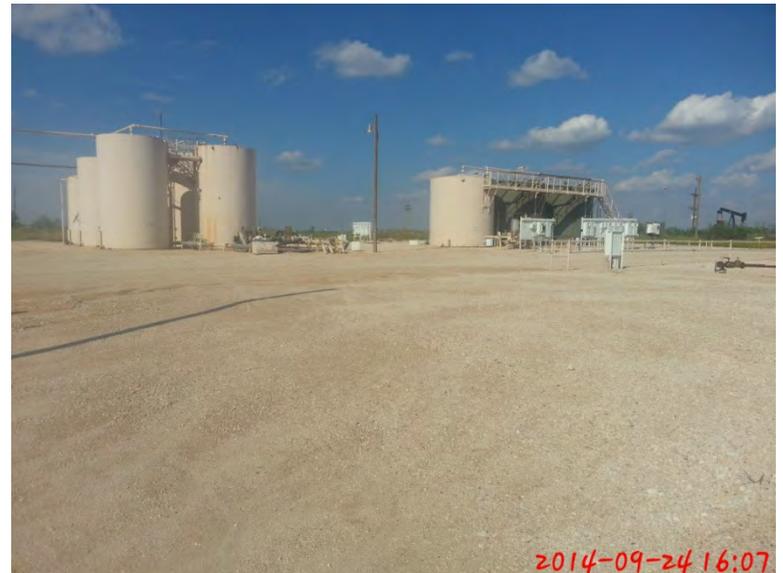
Release backfilled, facing northeast 9/24/14
