Release Notification and Corrective Action

Name of Company: ConocoPhillips	Contact:	
Address: 29 Vacuum Complex Lane	Telephone No.	
Facility Name: VEGU West Battery	Facility Type: Battery	
Surface Owner: NMOCD	Mineral Owner NMOCD	API No. 3002521012

**CONOCOPHILLIPS
VACUUM GLORIETTA
WEST UNIT**
UL A SECTION 31
T-17-S R-35-E
LEA COUNTY, NM

Photo Documentation

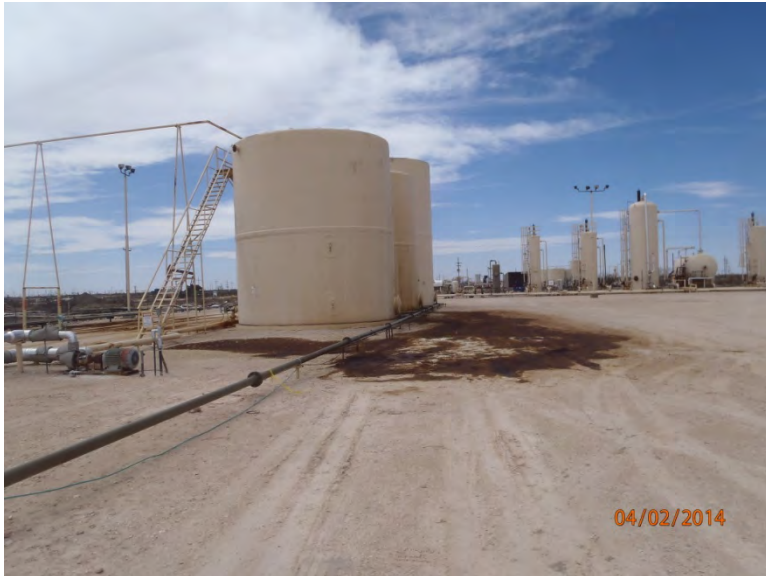
4/2/14

Initial release area, facing west

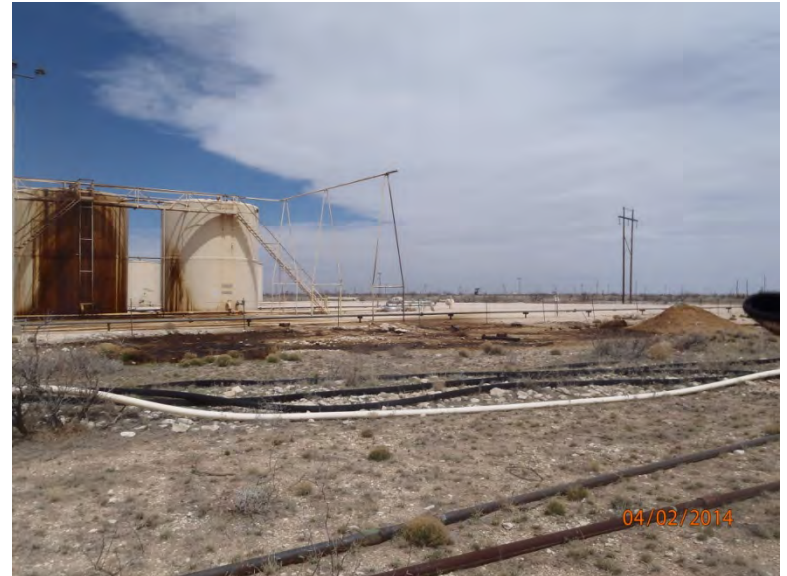
4/2/14

Initial release area, facing northeast

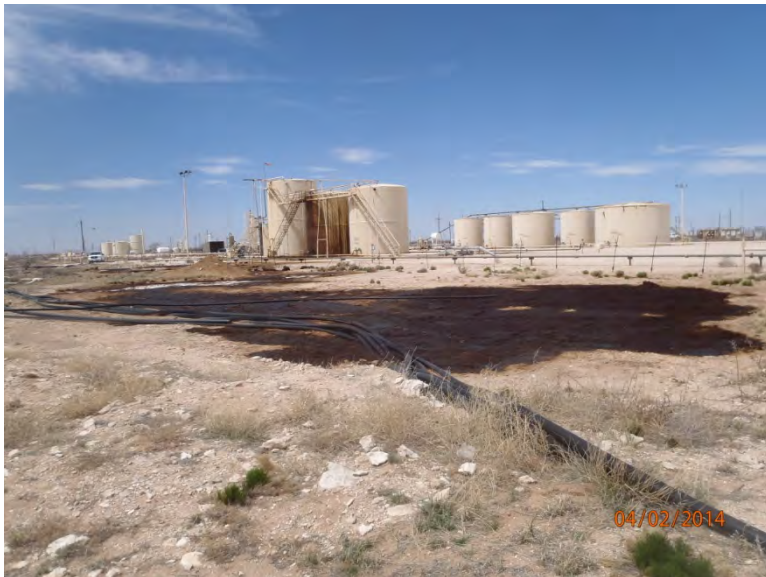
4/2/14

Initial release area, facing northwest

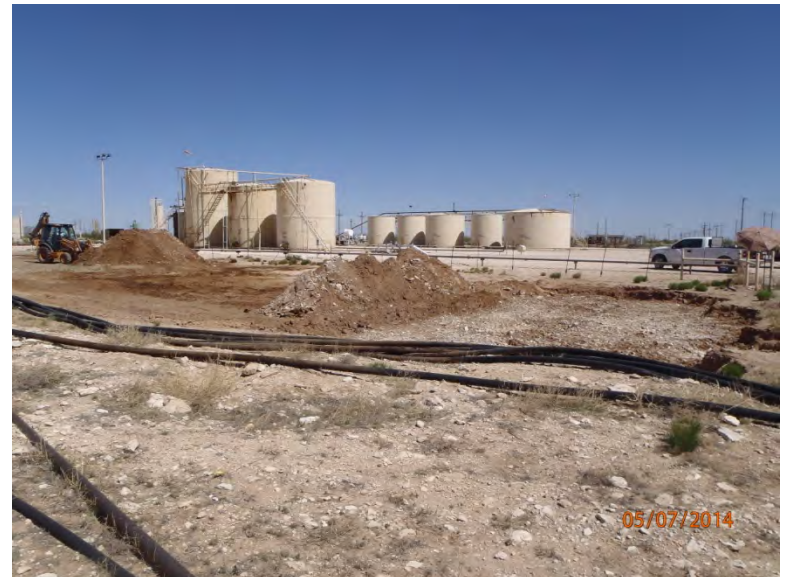
5/7/14

Excavating to 1.5 ft, facing northwest

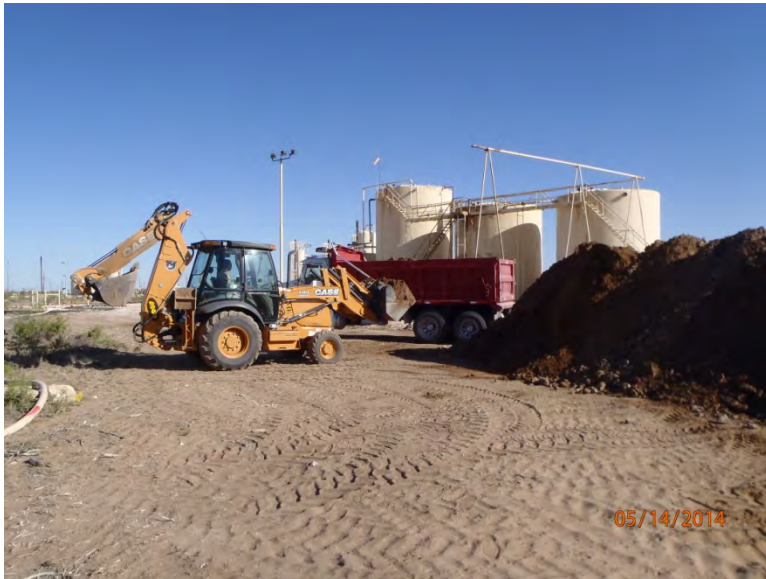
5/14/14

Exporting soil, facing northwest

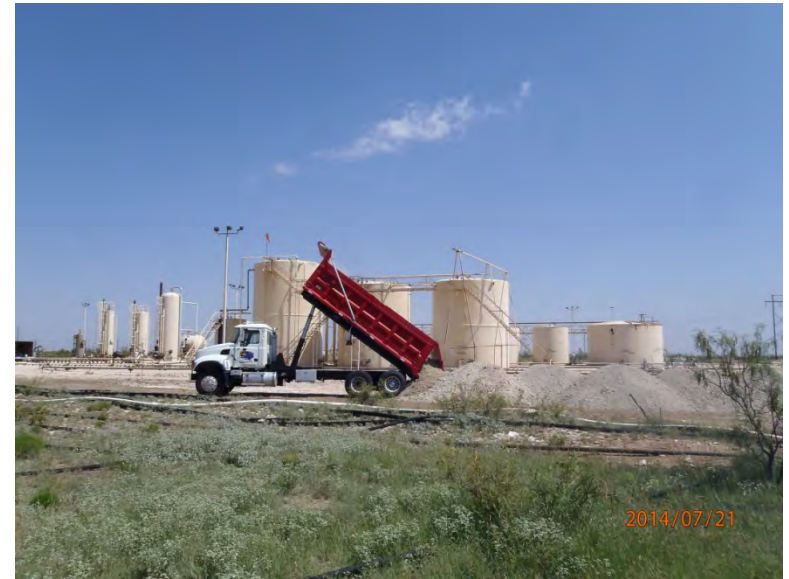
7/21/14

Importing top soil, facing northwest

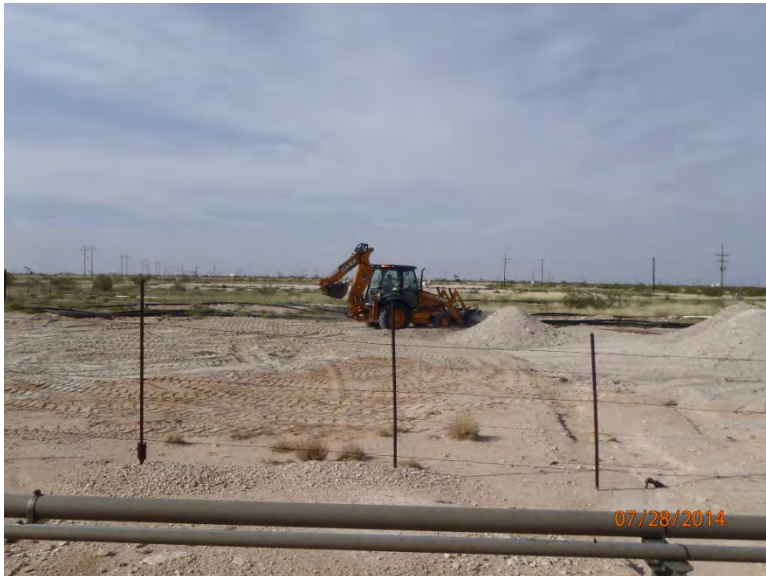
7/28/14

Backfilling excavation, facing south

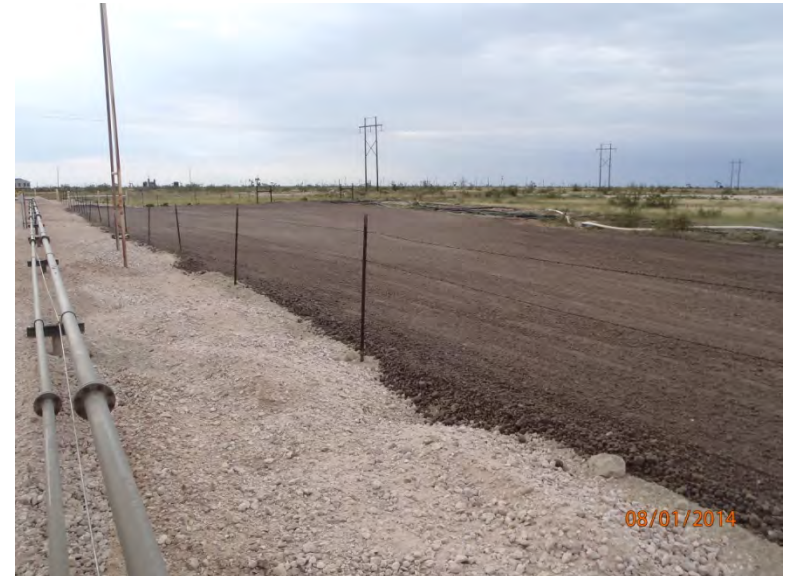
8/1/14

Completed backfill, facing southeast

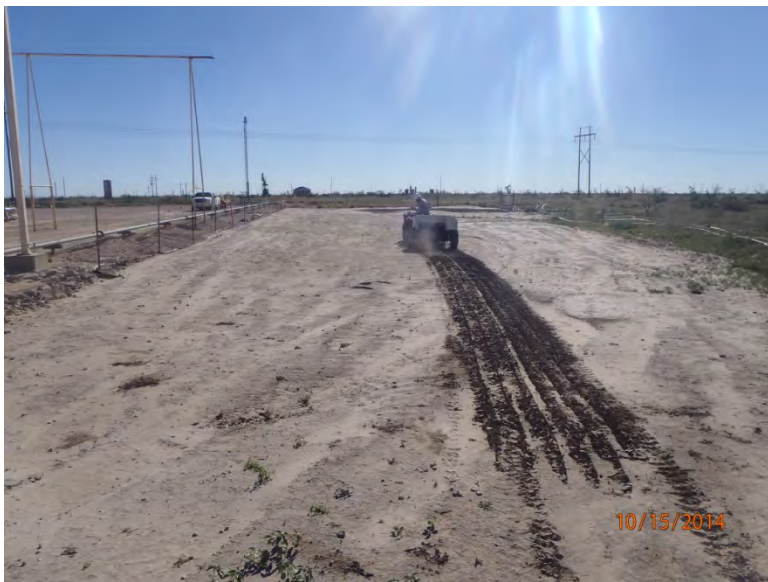
10/15/14

Tilling area, facing east

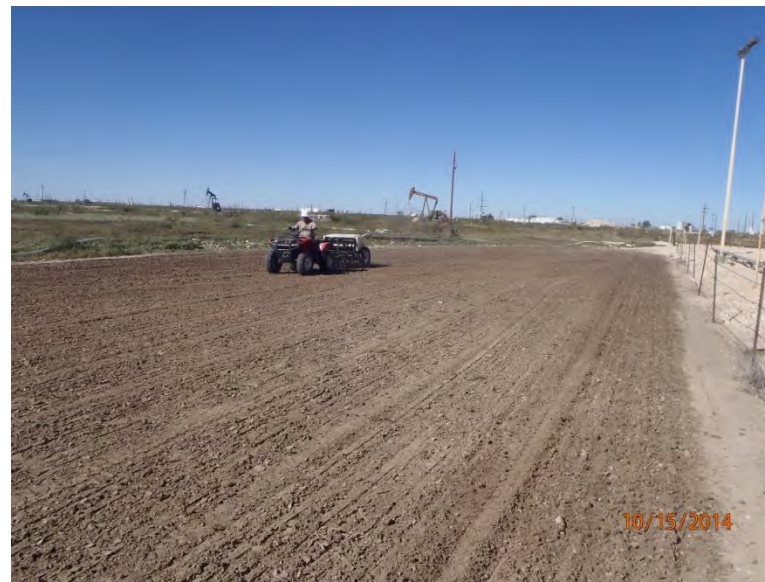
10/15/14

Seeding, facing southwest

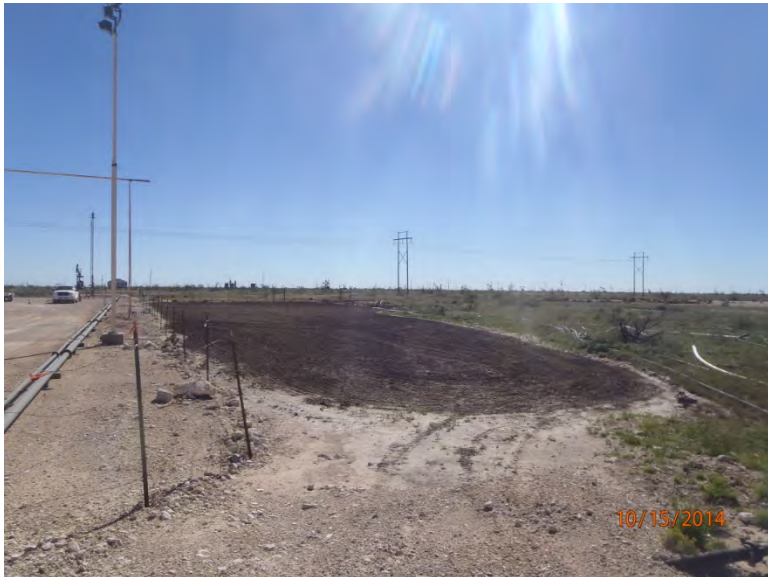
10/15/14

Completed site, facing southeast

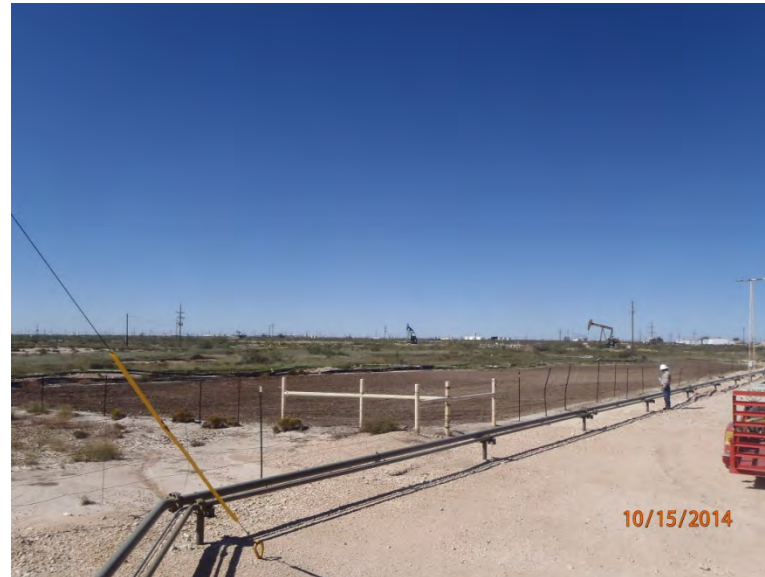
10/15/14

Completed site, facing southwest
