**RE: Supplemental Corrective Action Report and Corrective Action Work Plan
Enterprise S. Carlsbad Compressor Station (OCD Permit No. 2R-422)
SE ¼ of SE ¼ in S12, T23S, R27E
Carlsbad, Eddy County, New Mexico**

**SUPPLEMENTAL CORRECTIVE ACTION REPORT &
CORRECTIVE ACTION WORK PLAN**

Enterprise S. Carlsbad Compressor Station

NWC of Carrasco Road and CR 710
Carlsbad, Eddy County, New Mexico
(OCD Permit No. 2R-422)

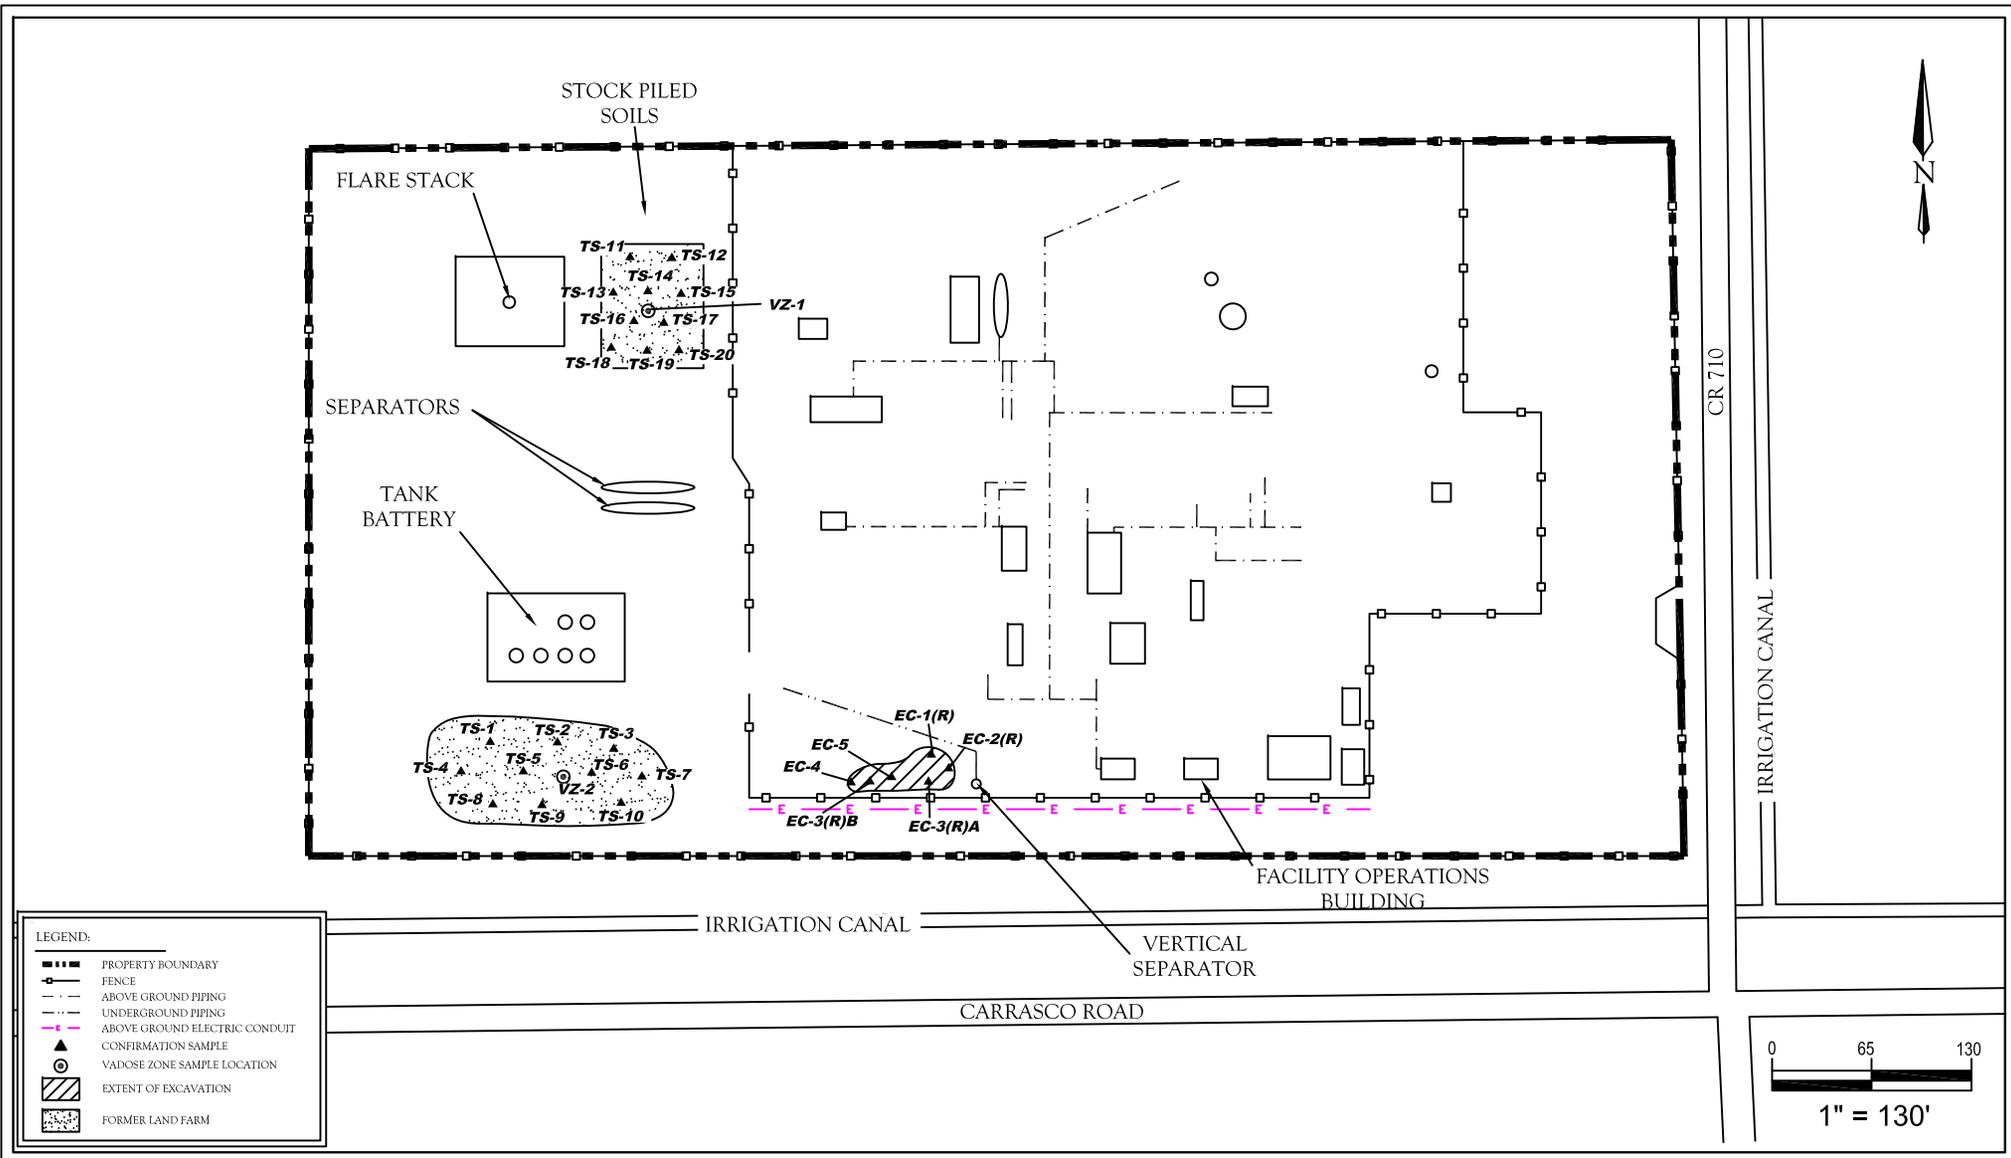
FIGURE 3A
 Excavation/Remediation
 Sample Location Map

Apex TITAN, Inc. (Apex), formerly Southwest Geoscience, has completed a Supplemental Corrective Action Report and Corrective Action Work Plan for the Enterprise Products Operating LLC (Enterprise) S. Carlsbad Compressor Station located at the northwest corner of Carrasco Road and CR 710, approximately ten (10) miles southeast of Carlsbad in Eddy County, New Mexico [SE1/4 of SE1/4 of S12, T23S, R27E], referred to hereinafter as the “Site” or “subject Site.” The Site is currently improved as a natural gas compressor station. A topographic map depicting the location of the Site is included as **Figure 1** and a site vicinity map is included as **Figure 2 of Appendix A**. A site map depicting on-site improvements and the location of investigation and corrective action activities, described herein, is included as **Figure 3A and 3B in Appendix A**.

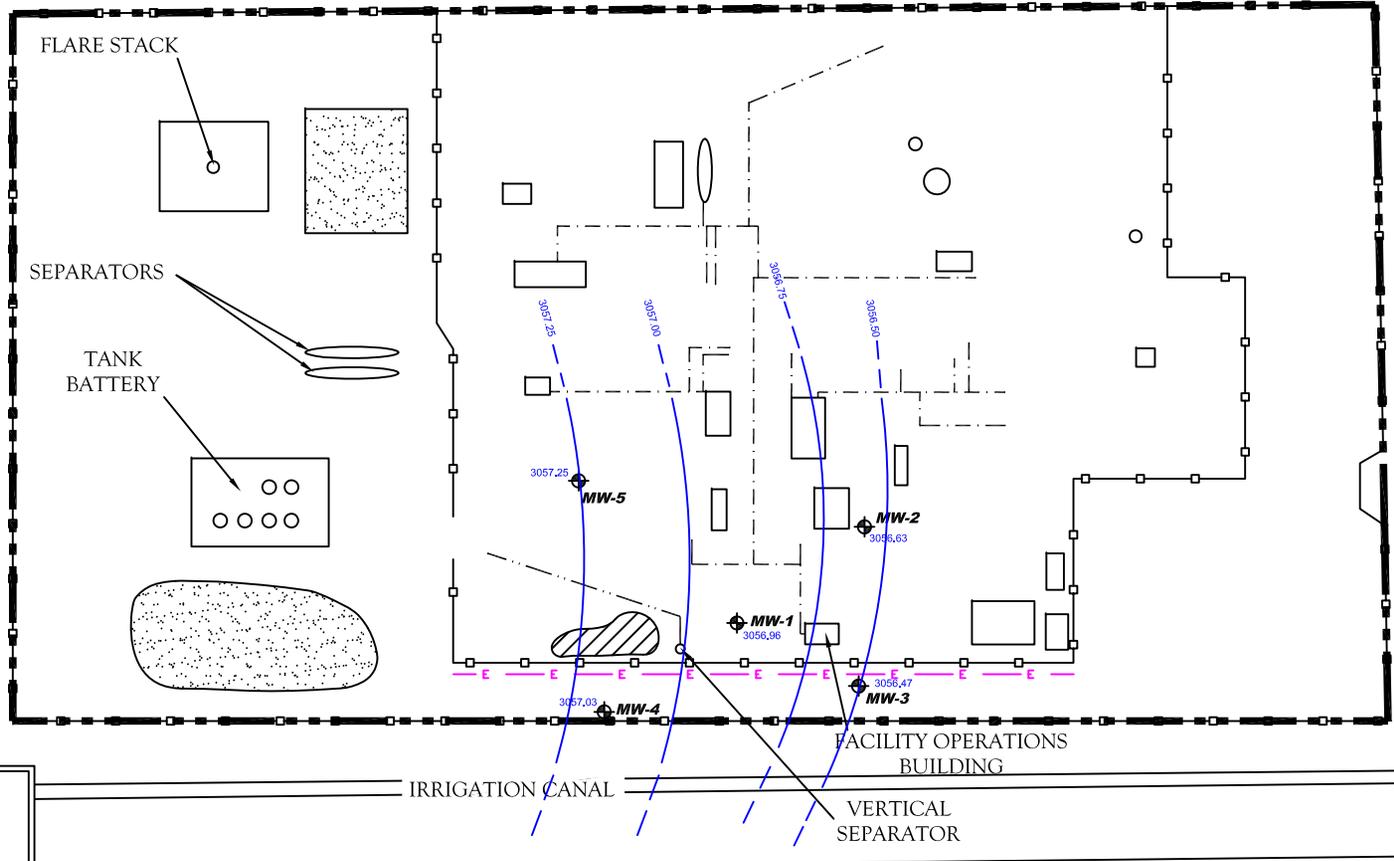
FIGURE 4A
 Groundwater Gradient Map
 Gauging Date: 12.19.2014

The on-Site monitoring wells were surveyed in for top-of-casing (TOC) above mean sea level (AMSL) elevations. Groundwater measurements were collected utilizing an interface probe capable of detecting the presence of phase-separated hydrocarbons (PSH). Groundwater measurements were collected during gauging events performed on December 19, 2014 and January 20, 2015. Based on the groundwater elevations associated with each of the on-site monitoring wells, groundwater generally flows to the east/northeast at an average hydraulic gradient of 0.005 ft/ft.

PSH was identified in monitoring well MW-2 during both gauging events ranging from 6.31 feet to 11.05 feet in thickness. Groundwater/PSH measurements collected during each gauging event are presented with top-of-casing (TOC) elevations, ground surface elevations, and corrected groundwater elevations in **Table 4** in **Appendix D**. Groundwater Gradient Maps for each gauging event are included as **Figures 4A** and **Figure 4B**.

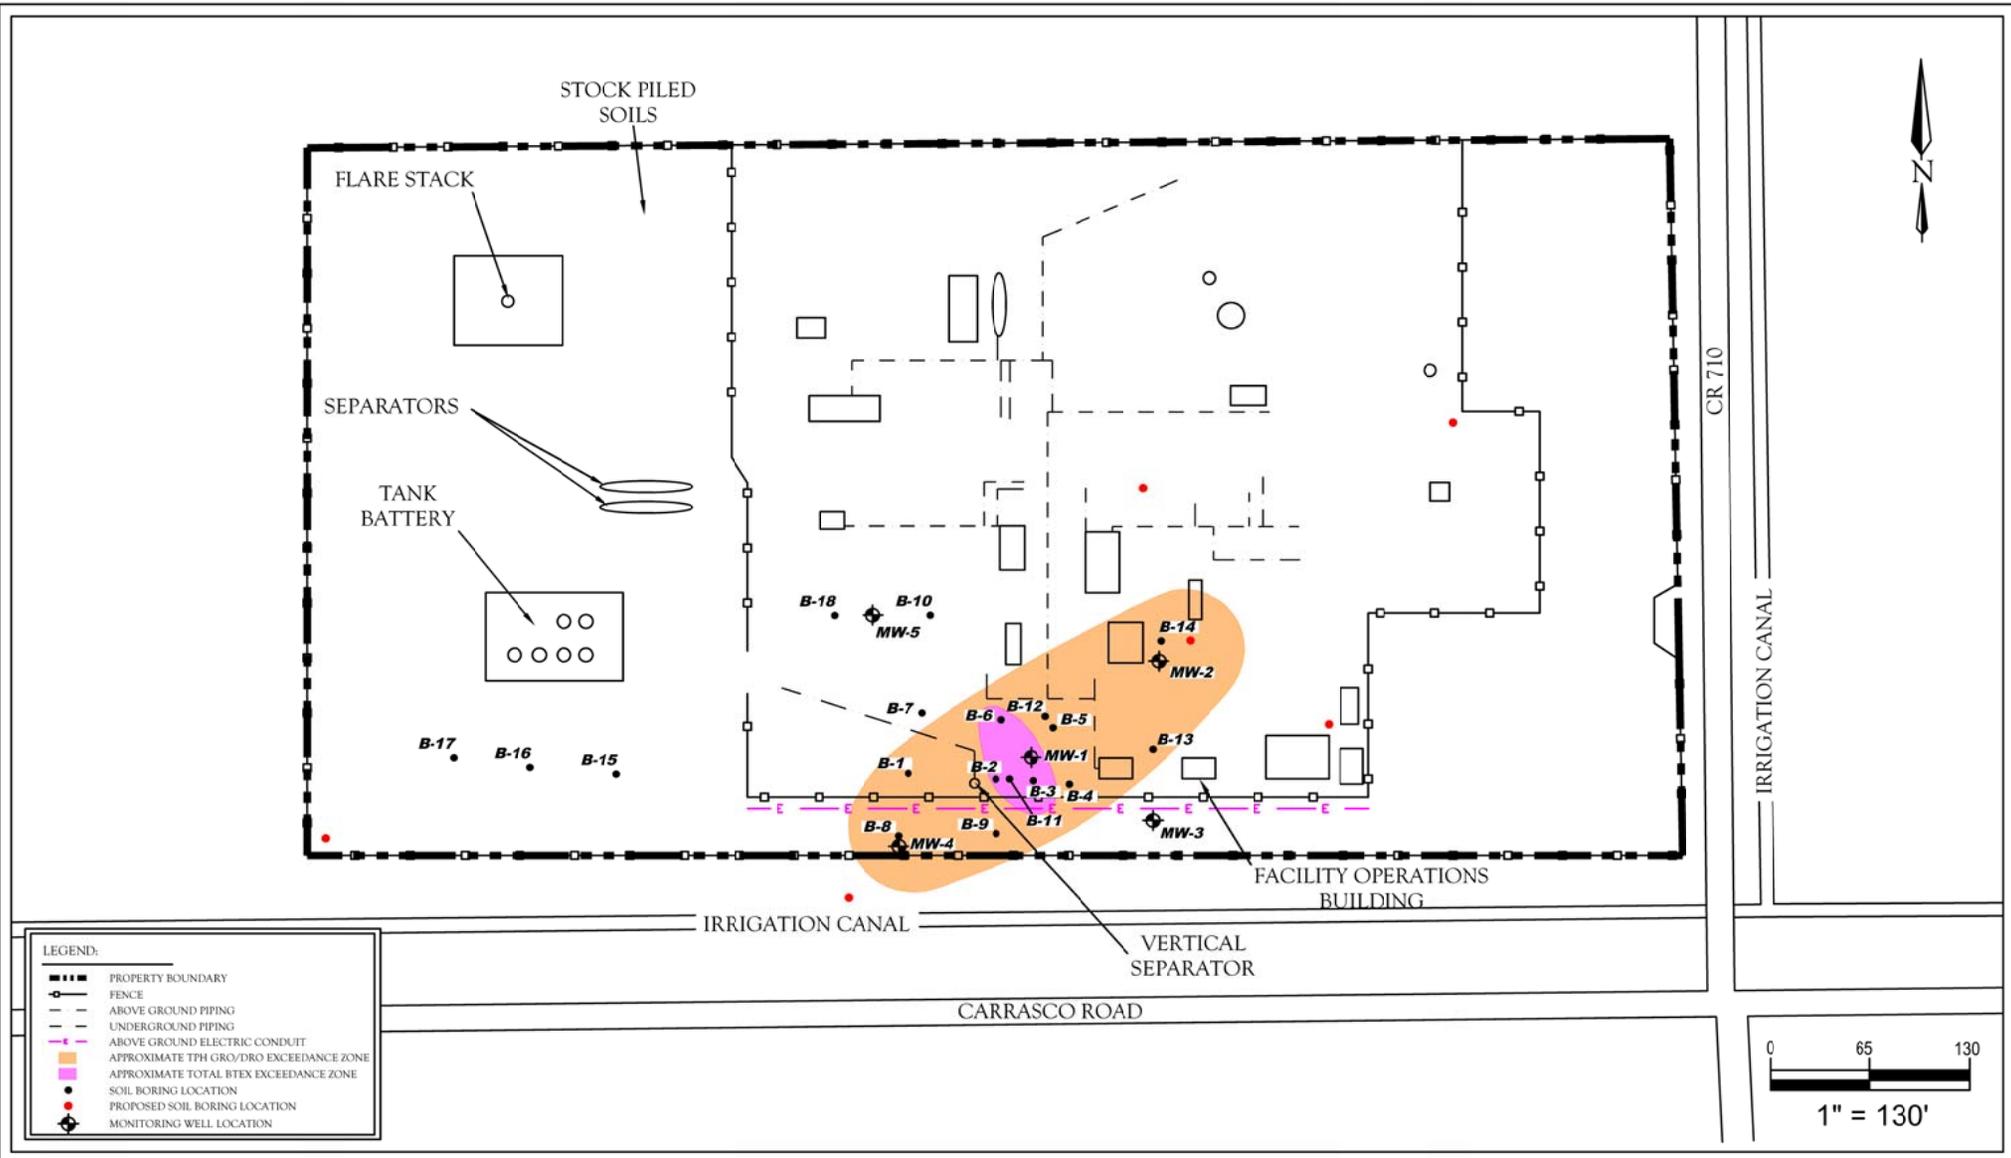
FIGURE 5A
 Soil Exceedance Zone Map

The Site is subject to regulatory oversight by the New Mexico OCD. To address activities related to crude oil/condensate related releases, the OCD utilizes the *Guidelines for Remediation of Leaks, Spills and Releases* as guidance, in addition to the OCD rules, specifically NMAC 19.15.30 Remediation. These guidance documents establish investigation and abatement action requirements for sites subject to reporting and/or corrective action. Apex compared the benzene, total BTEX, TPH GRO/DRO concentrations or sample Reporting Limits (RLs) associated with the soil samples collected from the soil borings to the OCD *Remediation Action Levels*. The results of the soil sample analysis along with the respective OCD *Remediation Action Levels* are provided in **Table of Appendix D**. **Figure 5A** in **Appendix A** is a map that indicates the approximate location of soil exceedances at the Site.

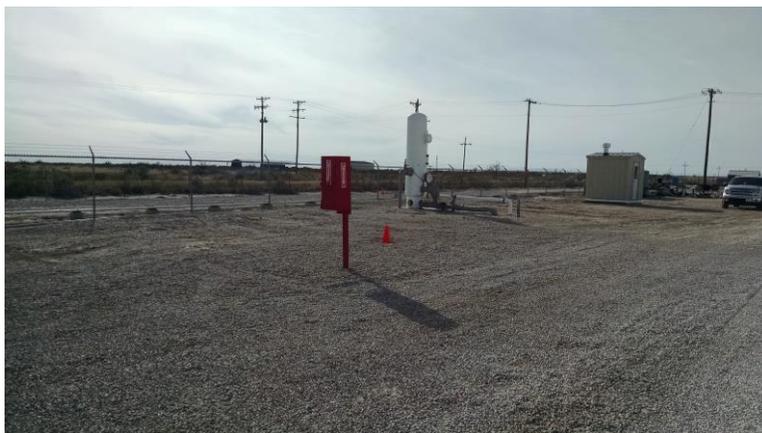
Photograph 1

View of the location for soil boring/groundwater monitoring well MW-1, looking southwest.

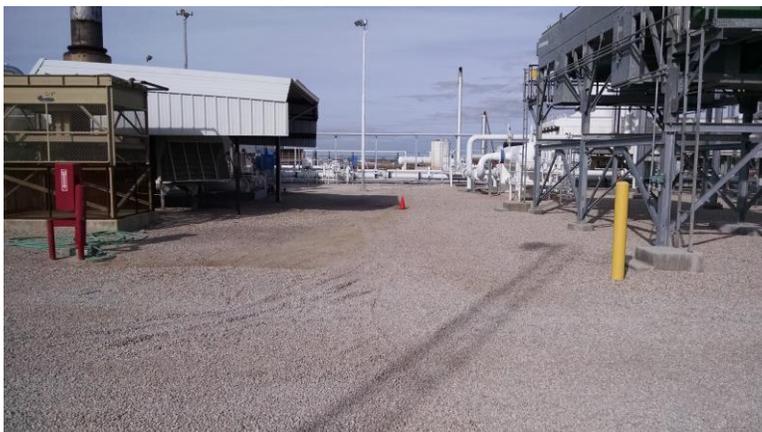
Photograph 2

View of the location for soil boring/groundwater monitoring well MW-2, looking north.

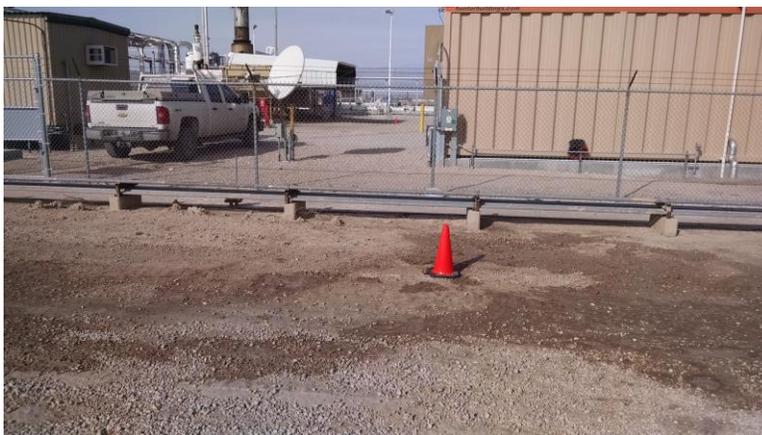
Photograph 3

View of the location for soil boring/groundwater monitoring well MW-3, looking north.

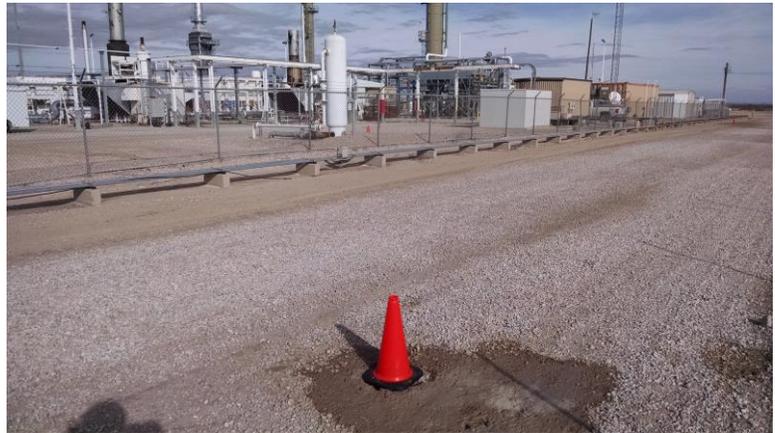
Photograph 4

View of the location for soil boring/groundwater monitoring well MW-4, looking northeast.

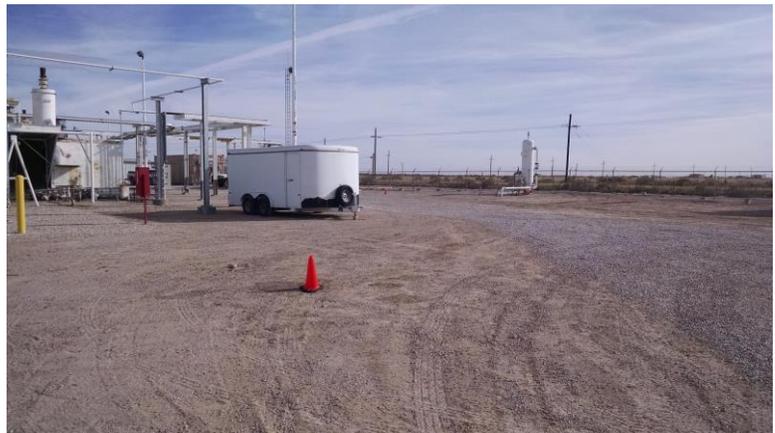
Photograph 5

View of the location for soil boring/groundwater monitoring well MW-5, looking southeast.

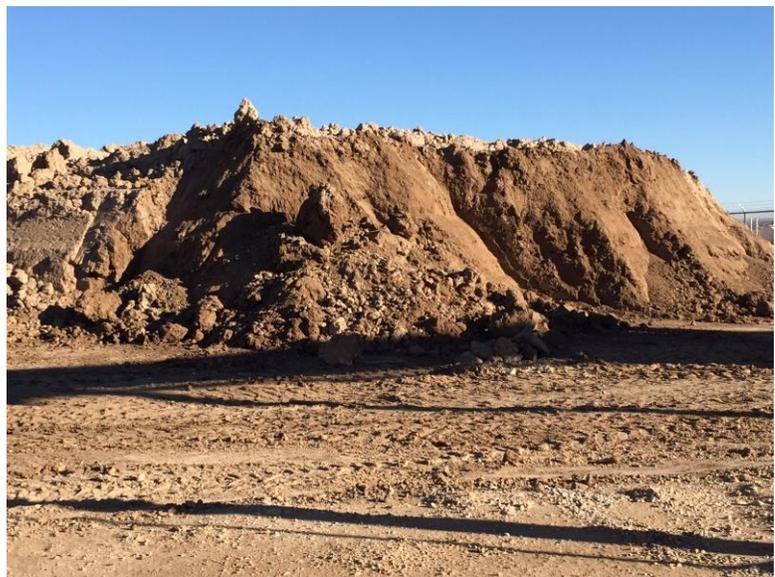
Photograph 6

View of the stockpiled soils located on the northwest portion of the Site, looking north.

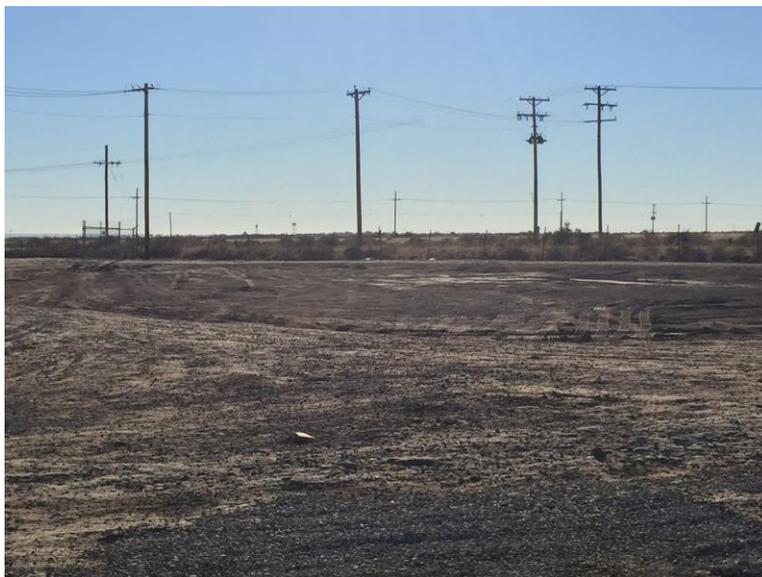
Photograph 7

View of the stockpiled soils having been dispersed in the vicinity of the former land farm on the western portion of the Site, looking south.

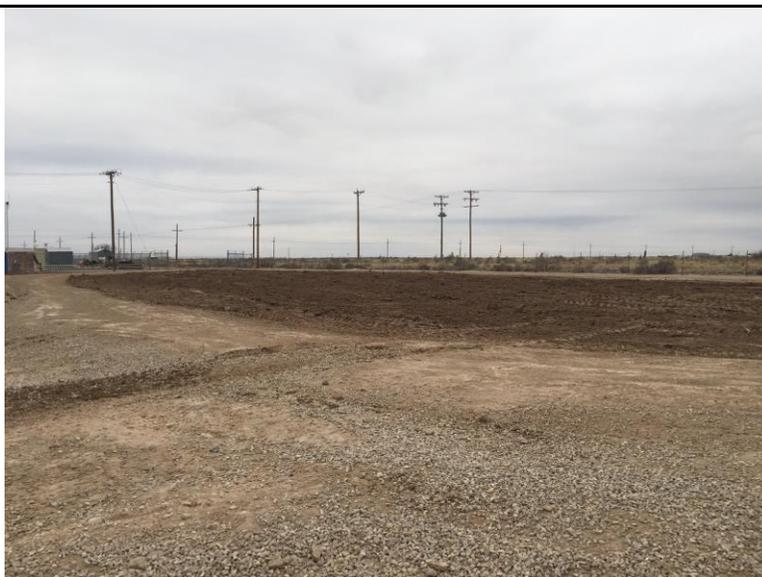
Photograph 8

View of the stockpiled soils having been dispersed in the vicinity of the former land farm on the western portion of the Site, looking southeast.

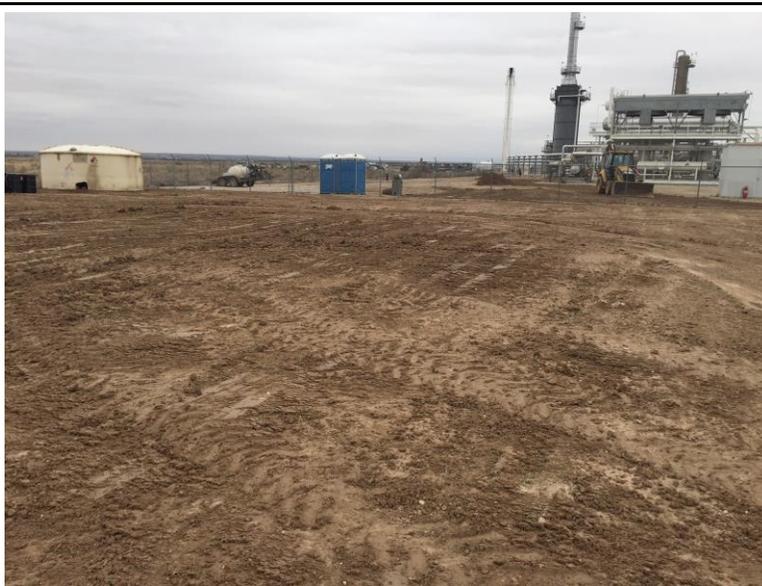
Photograph 9

View of the former location of the stockpiled soils on the northwest portion of the Site, looking northeast.
