RE: Date BTB State Com #4H  
30-025-41377  
Section 14, T21S-R33E  
Lea County, New Mexico

Yates Petroleum Corporation would like to submit the following closure letter and documentation to you regarding the release that occurred at the above mentioned facility on February 19, 2015 (1RP-3545).

## Release Notification and Corrective Action

Photo Documentation: Date BTB State Com #4H, 1RP-3545, 32.48648, -103.53667  
14-21S-33E, Lea County

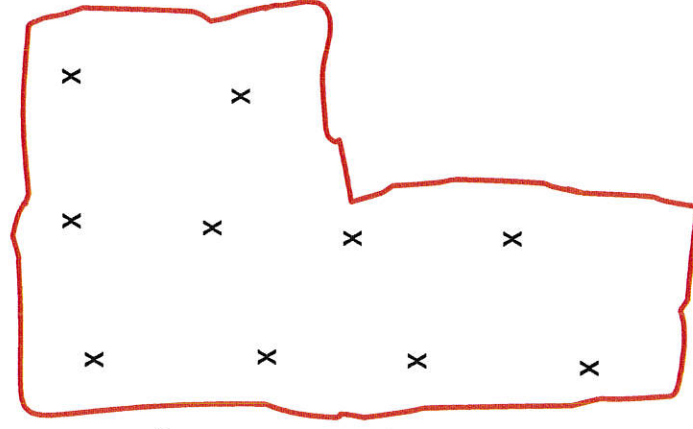
Cranberry BSU State  
#5H Wellhead

Cranberry BSU State  
#1H Wellhead

Date BTB State Com  
#8H Wellhead

Date BTB State Com  
#4H Wellhead

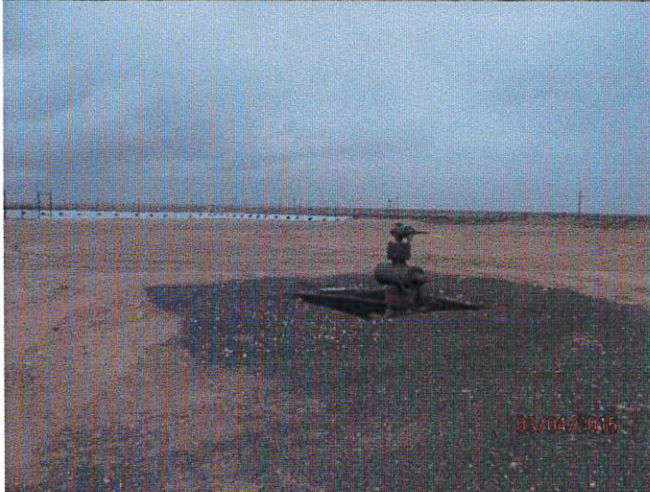
The release was 20 barrels of crude oil with 0 barrels of oil recovered. The release occurred when production was setting a packer in the well, and while circulating packer fluid a hose that was connected to a vacuum truck busted. The release was contained on the production well pad and is represented by the red outline on the attached site diagram (please note that this drawing is not to scale). Photo documentation and all analytical results are also attached to this letter for your review.

This photo was taken 3/4/2015 and is of the spill area looking to the northeast from the Date BTB State Com #4H wellhead. The wellhead seen in the photo is the Cranberry BSU State #1H (which is on the same production pad as the Date BTB State Com #4H).

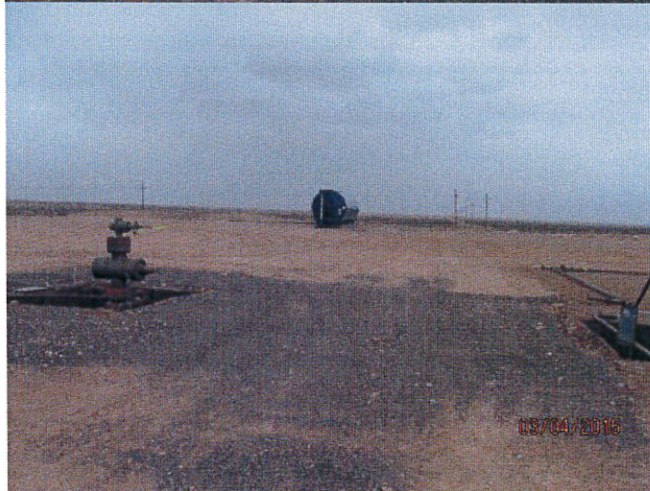
This photo was taken 3/4/2015 and is of the spill area looking to the east near the Date BTB State Com #4H wellhead. The wellhead seen in the photo (left hand side) is the Cranberry BSU State #1H. You can see the wellhead cellar for the Date BTB State Com #4H (right hand side).

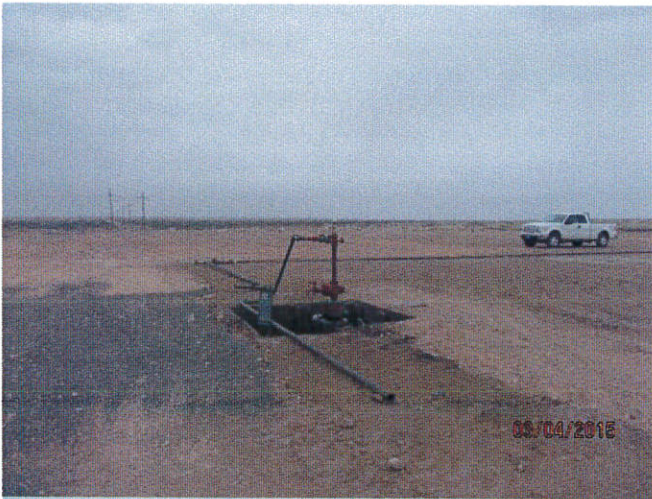
This photo was taken 3/4/2015 and is of the spill area looking to the southeast near the Date BTB State Com #4H wellhead. The wellhead seen in the photo is the Date BTB State Com #4H.

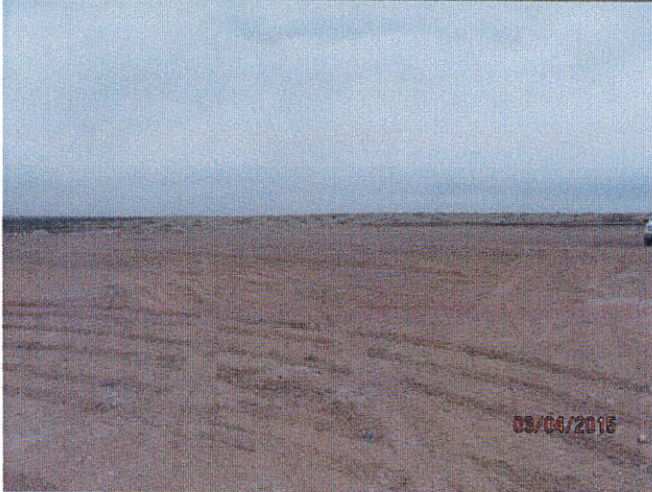
This photo was taken 3/4/2015 and is of the spill area looking to the south, southeast. Photo was taken near the Date BTB State Com #4H wellhead.

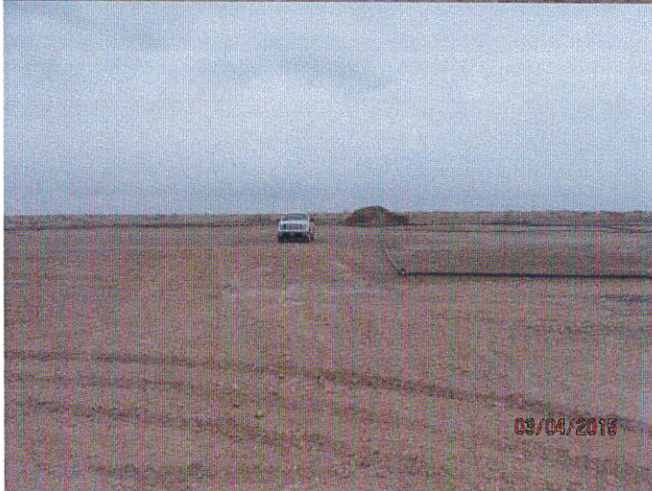
This photo was taken 3/4/2015 and is of the spill area looking to the south. Photo was taken near the Date BTB State Com #4H wellhead.

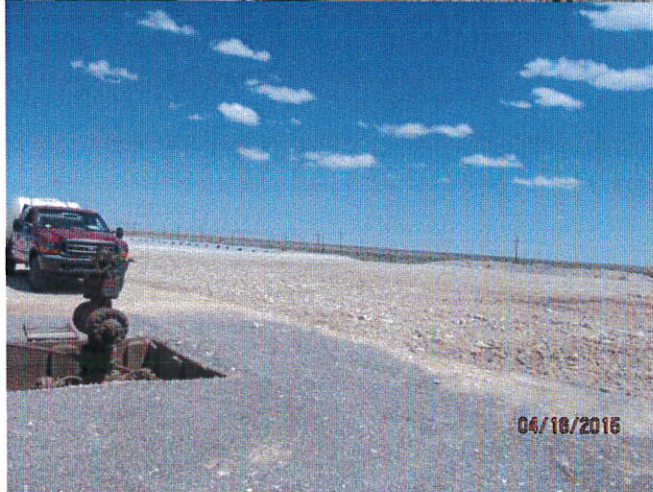
This photo was taken 4/16/2015 after the location had been scraped with a box blade and rippers and sprayed with a microblaze solution. This photo was taken near the Date BTB State Com #4H wellhead and is looking to the northeast.

On April 16, 2015 Yates had a dirt work contractor out on location to scrape/rip the release area with a box blade and rippers. The release area was ripped to a depth of approximately 3" below surface level. Once the area was ripped it was sprayed with a microblaze solution and then the area was once again ripped to mix the soils with the microblaze solution.

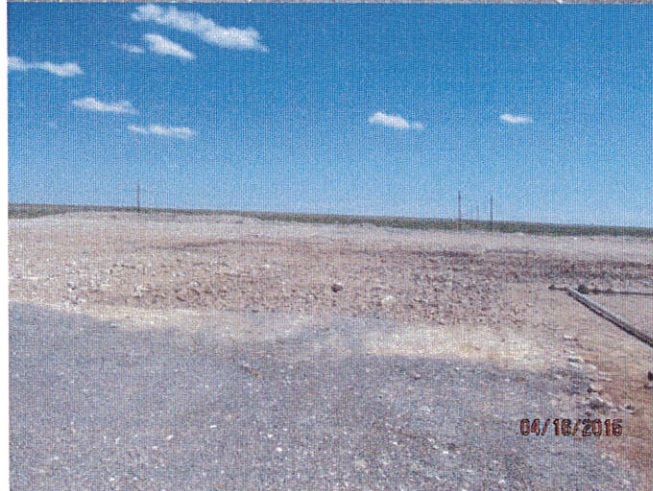
This photo was taken 4/16/2015 after the location had been scraped with a box blade and rippers and sprayed with a microblaze solution. This photo was taken near the Date BTB State Com #4H wellhead and is looking to the east.

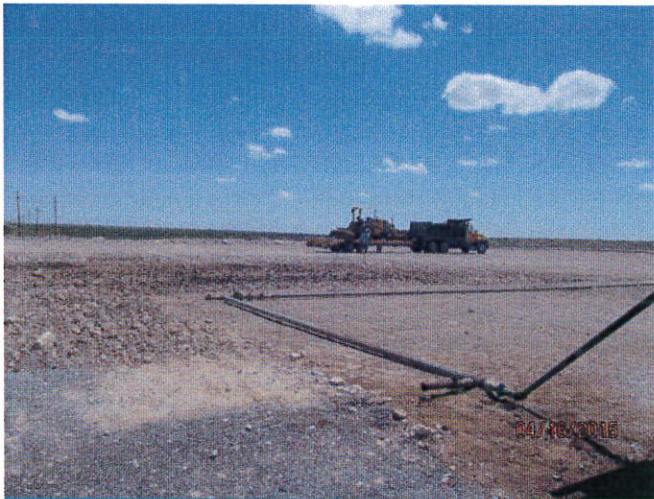
This photo was taken 4/16/2015 after the location had been scraped with a box blade and rippers and sprayed with a microblaze solution. This photo was taken near the Date BTB State Com #4H wellhead and is looking to the southeast.

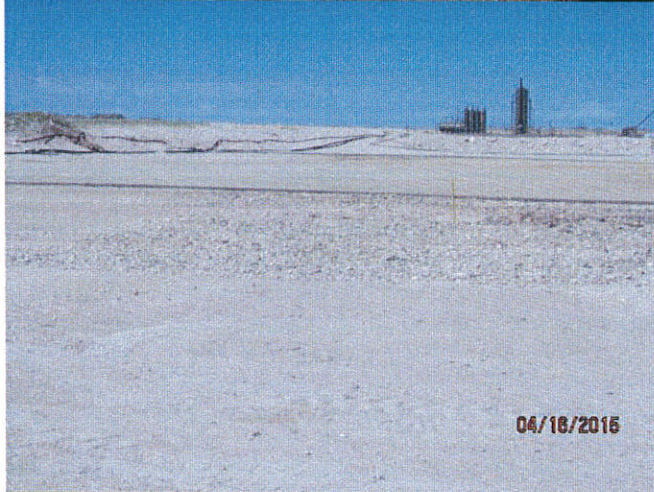
This photo was taken 4/16/2015 after the location had been scraped with a box blade and rippers and sprayed with a microblaze solution. This photo is looking to the west, southwest.

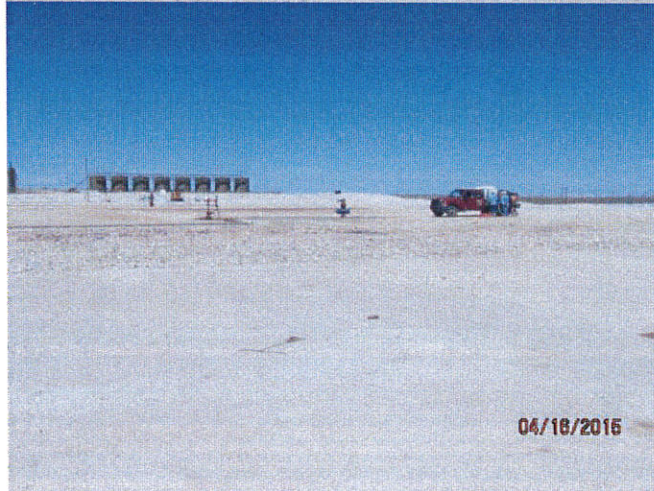
This photo was taken 4/16/2015 after the location had been scraped with a box blade and rippers and sprayed with a microblaze solution. This photo is looking to the west, northwest.

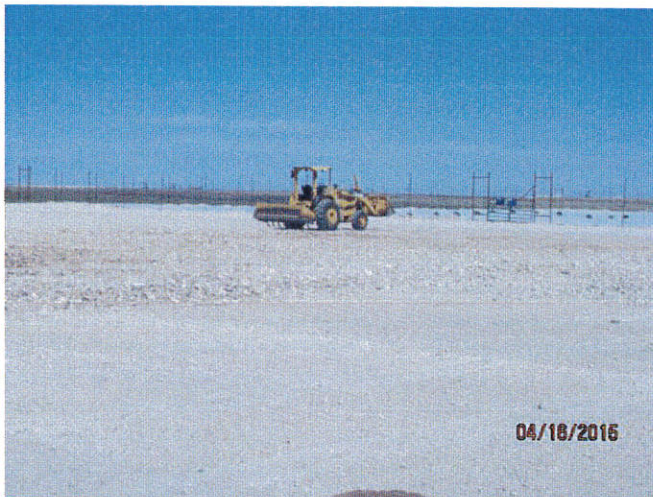
This photo was taken 4/16/2015 after the location had been scraped with a box blade and rippers and sprayed with a microblaze solution. This photo is looking to the northwest.

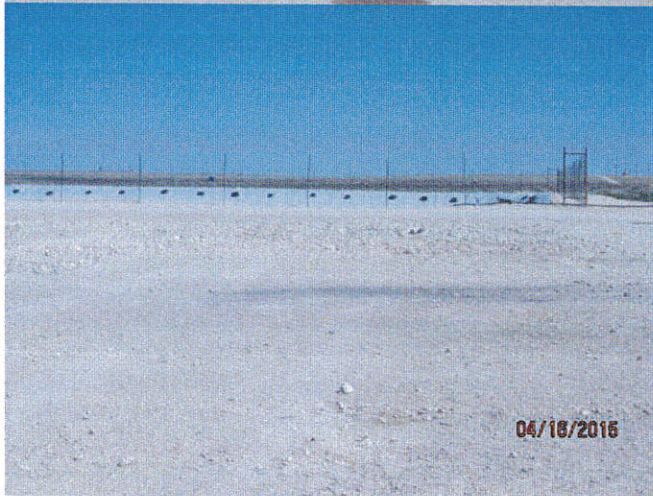
This photo was taken 4/16/2015 after the location had been scraped with a box blade and rippers and sprayed with a microblaze solution. This photo is looking to the north.

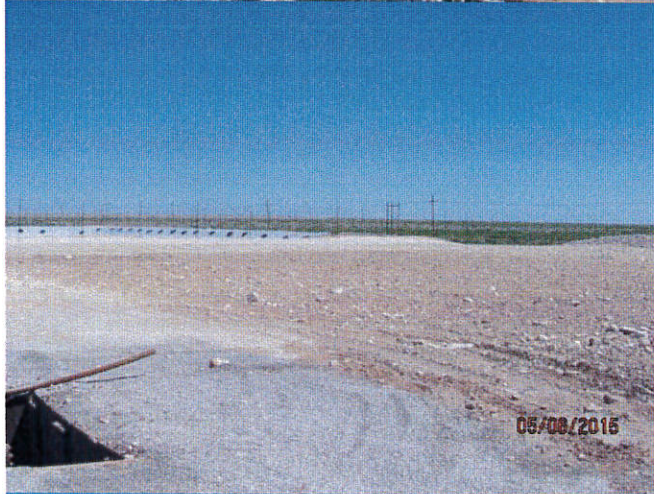
This photo was taken 5/6/2015 of the release area to be re-sampled again, 20 days after microblaze solution was applied to release. This photo is looking to the northeast from the west side of the release.

Yates returned to the location on May 6, 2015 to re-sample the location for TPH. The sample was a 10-point composite that consisted of depths between 1" and 3". The analytical results (H501194) after microblaze treatment show that the TPH was remediated to below NMOCD RRAL's with a result of 21.8 mg/kg.

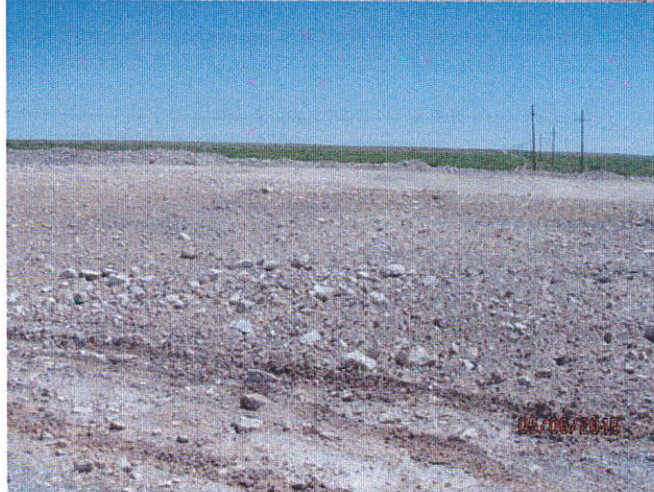
This photo was taken 5/6/2015 of the release area to be re-sampled again, 20 days after microblaze solution was applied to release. This photo is looking to the east from the west side of the release.

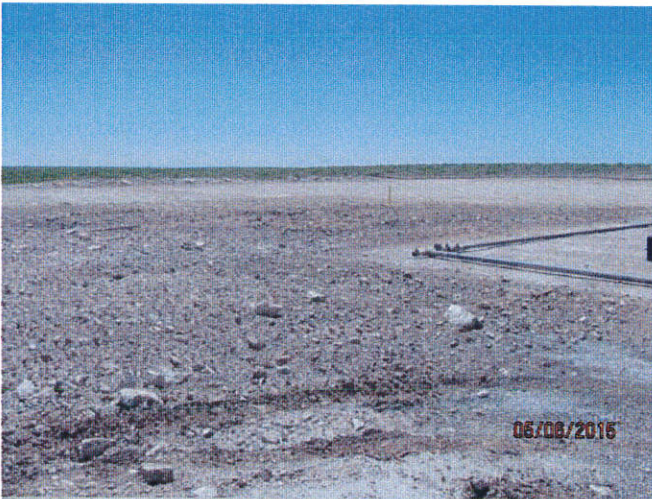
This photo was taken 5/6/2015 of the release area to be re-sampled again, 20 days after microblaze solution was applied to release. This photo is looking to the southeast from the west side of the release.

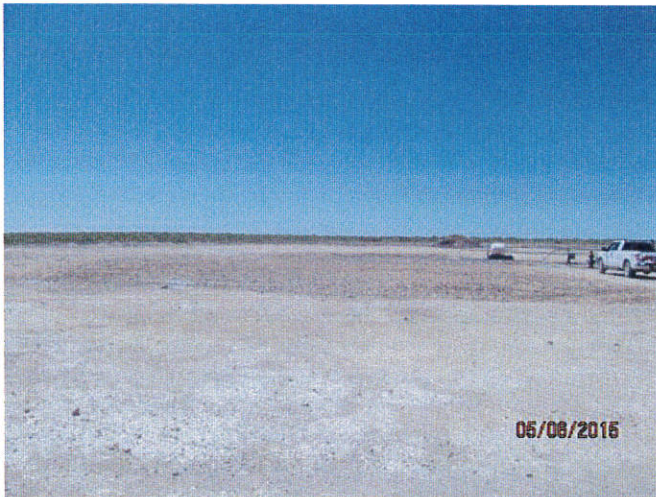
This photo was taken 5/6/2015 of the release area to be re-sampled again, 20 days after microblaze solution was applied to release. This photo is looking to the south from the north side of the release.

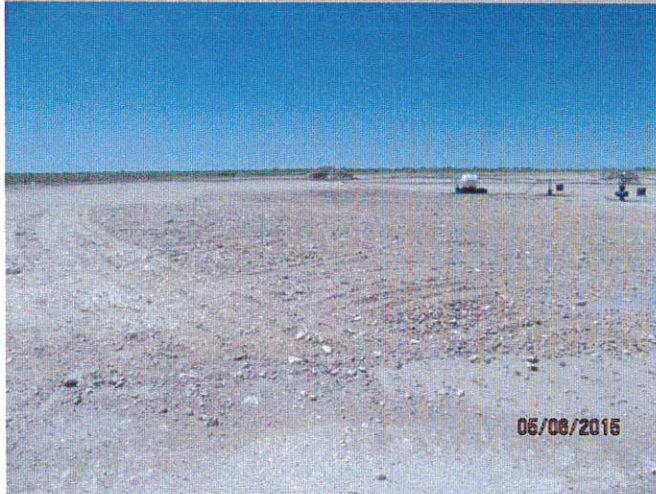
This photo was taken 5/6/2015 of the release area to be re-sampled again, 20 days after microblaze solution was applied to release. This photo is looking to the southwest from the northeast side of the release.
