OXY USA, Inc. Monsanto State Battery Closure Report

**Section 16, T25S, R32E
Lea County, New Mexico**

May 28, 2015

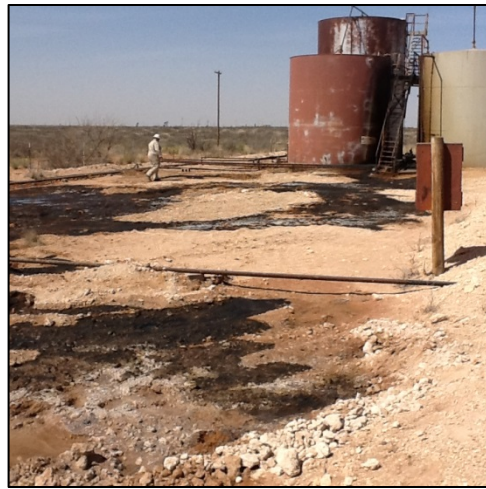
Spill facing northwest

On March 20, 2015 a written Plan of Remediation was submitted to the NMOCD. The site was then remediated according to the approved plan and in accordance with NMOCD guidelines. Due to the extreme depth to groundwater in this area, the entire spill site was excavated to a depth of 2' bgs.

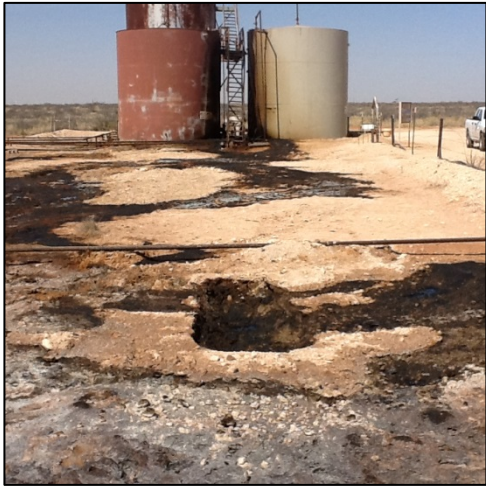
Spill facing north

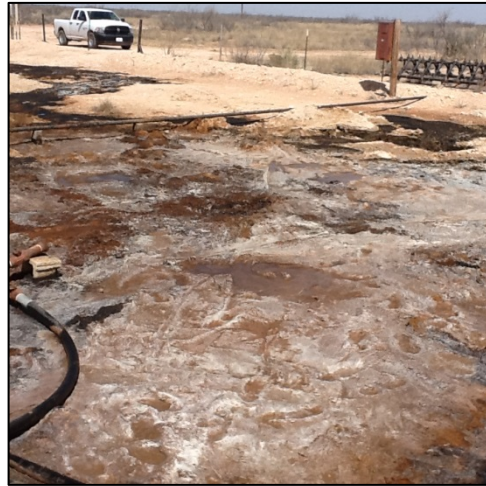
Spill facing northeast

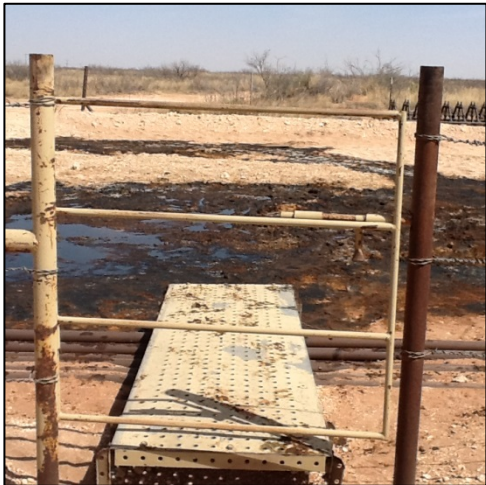
Spill facing east

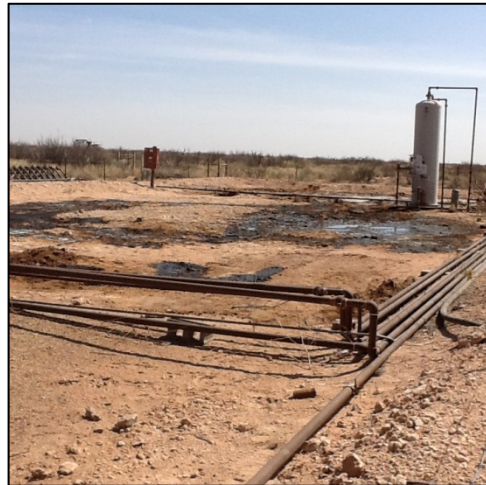
Spill facing southeast

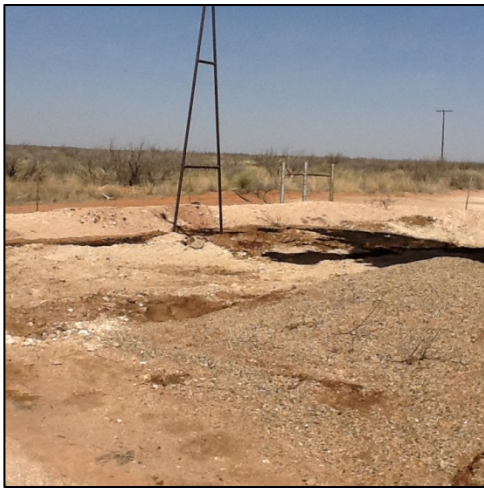
Spill facing northeast

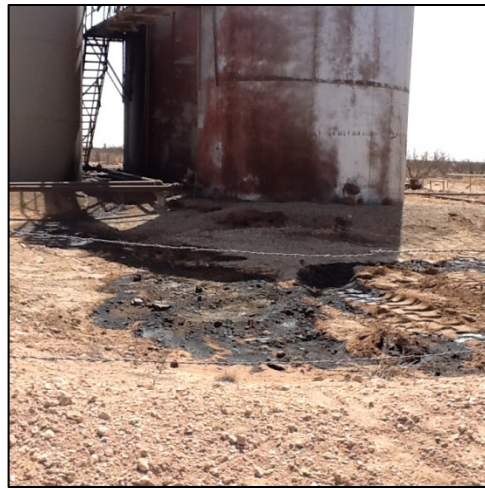
Spill facing southwest

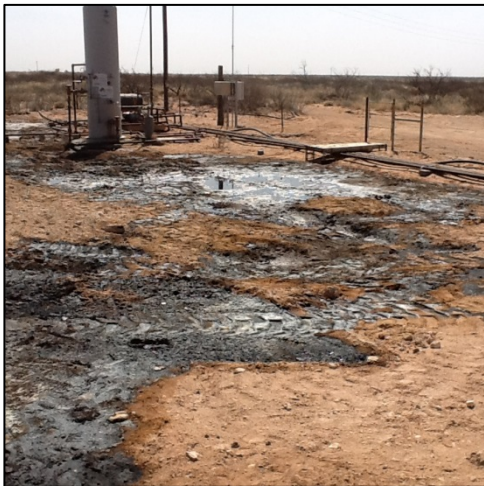
Spill facing southwest

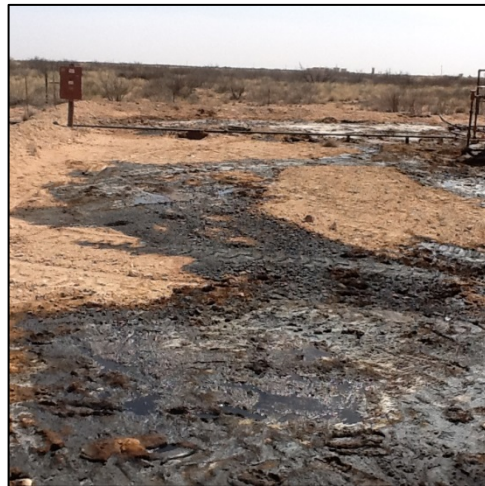
Spill facing south

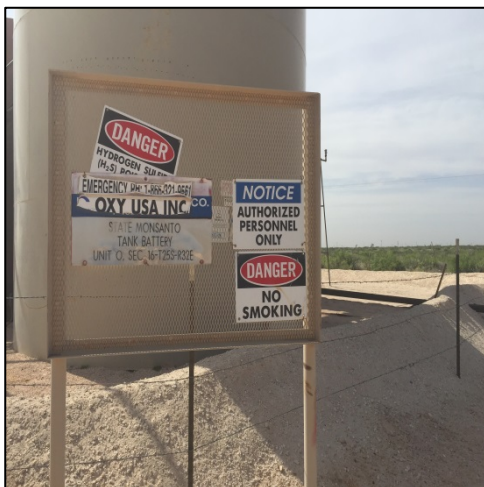
Location at Completion

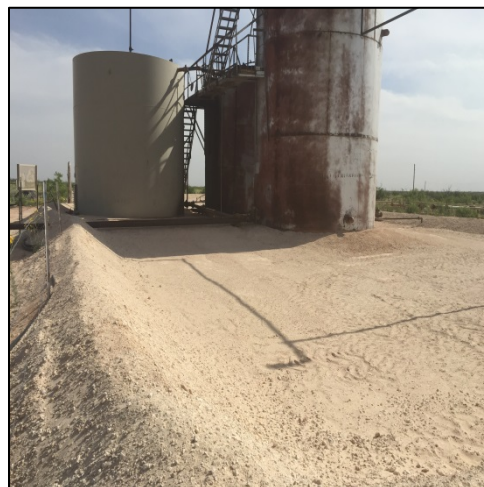
Completed bermed area

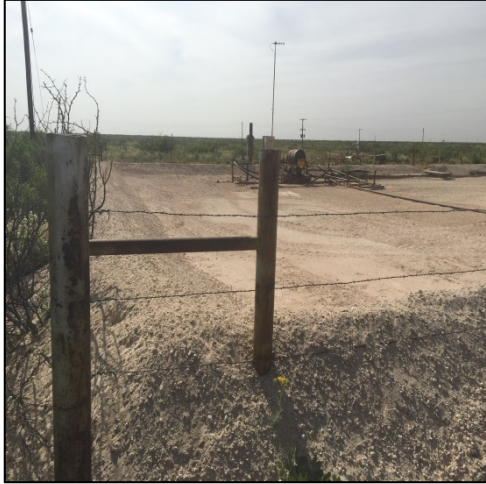
Northeast at completion

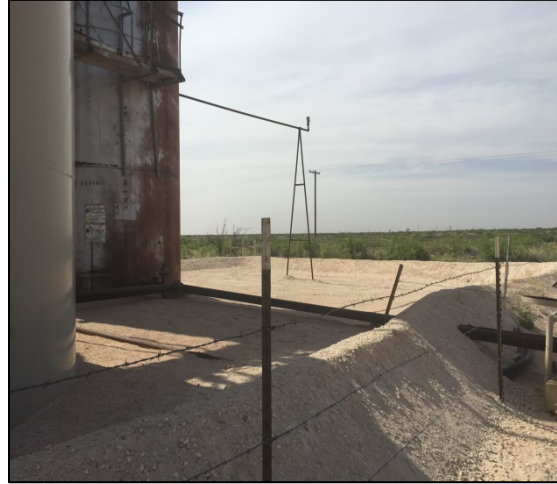
Southwest at completion
