R. T. HICKS CONSULTANTS, LTD.

1RP-3820

RE: Remediation Plan for Paloma State #1 - API # 30-025-31153
8/25/15 Tank Battery Release., UL O, Section 36, T18S R32E
Strata Production

Contractor Instructions – Strata Production Paloma State #1

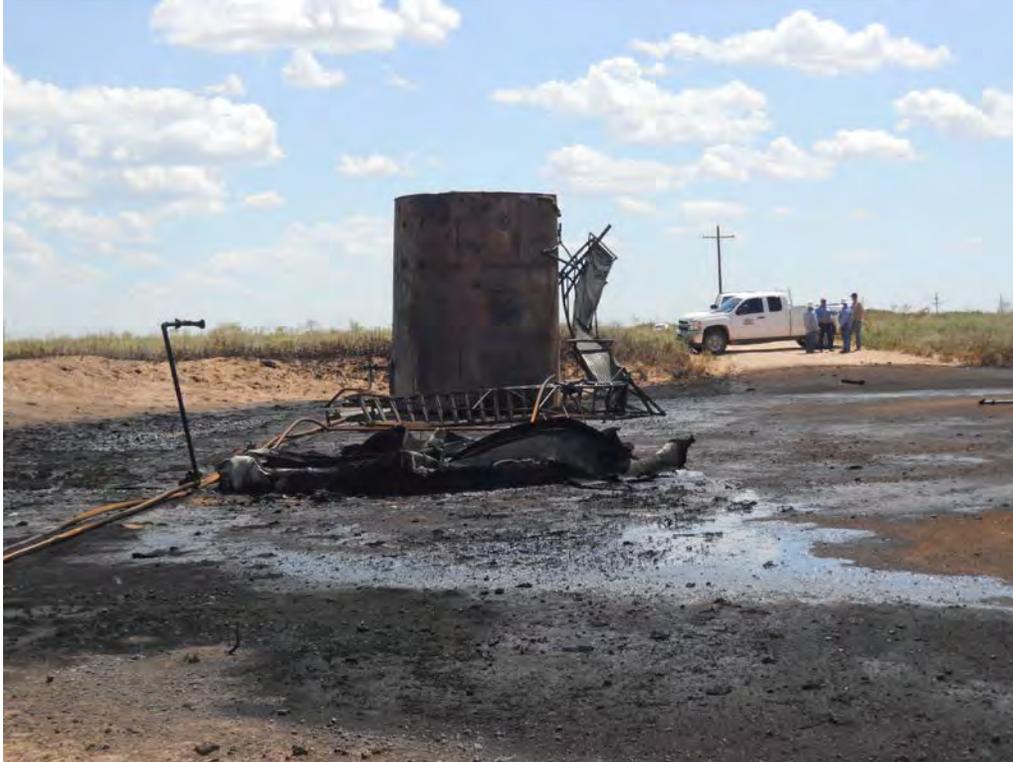
Figure 1 – The remains of the fiberglass produced water tank is in the foreground. One of the two oil tanks is in the background. Some liquid crude is on the location and some of the black material in the photograph is ash from the fire.

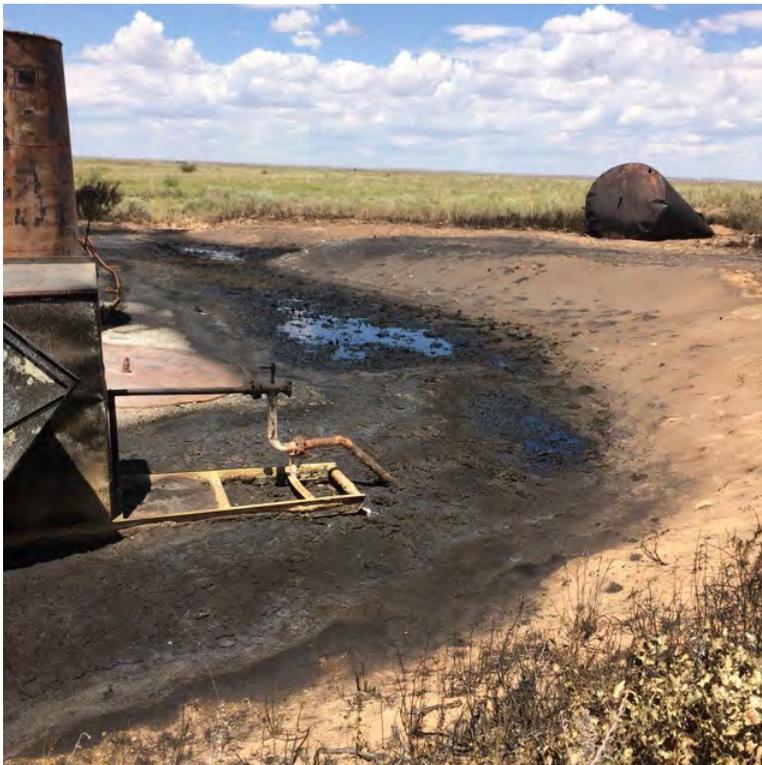
Figure 2 – One oil tank landed in the nearby pasture.

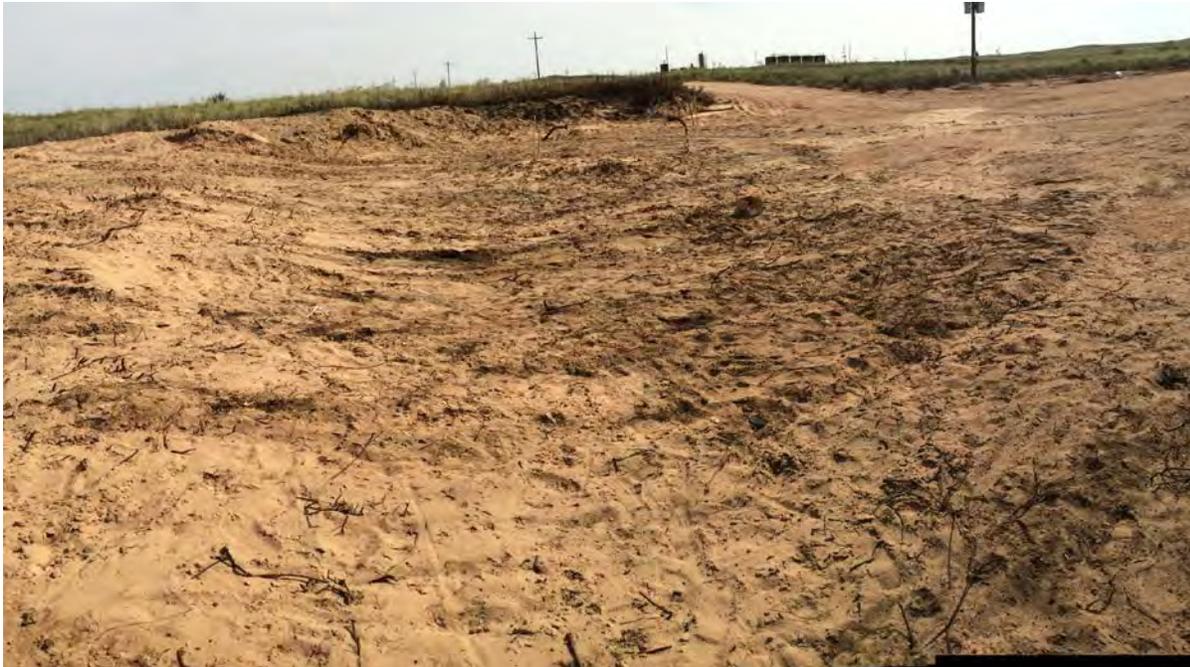
Figure 3 – View to the south from the same location as Figure 1. The initial response removed as much liquid crude as possible with a backhoe, creating a stockpile of impaired material near the heater treater. The area of impact (ash and residual oil) was then dragged by the end-loader of the backhoe to cover the crude to reduce the potential of exposure to cattle.

The initial response by Strata involved using a backhoe/end loader to scoop the crude from the surface. The crew removed as much liquid crude as possible, creating a stockpile of impaired material near the heater treater. The area of impact (ash and residual oil) was then dragged by the end-loader of the backhoe to cover the crude to reduce the potential of exposure to cattle. Figures 3 and 4 show the result of the initial response.

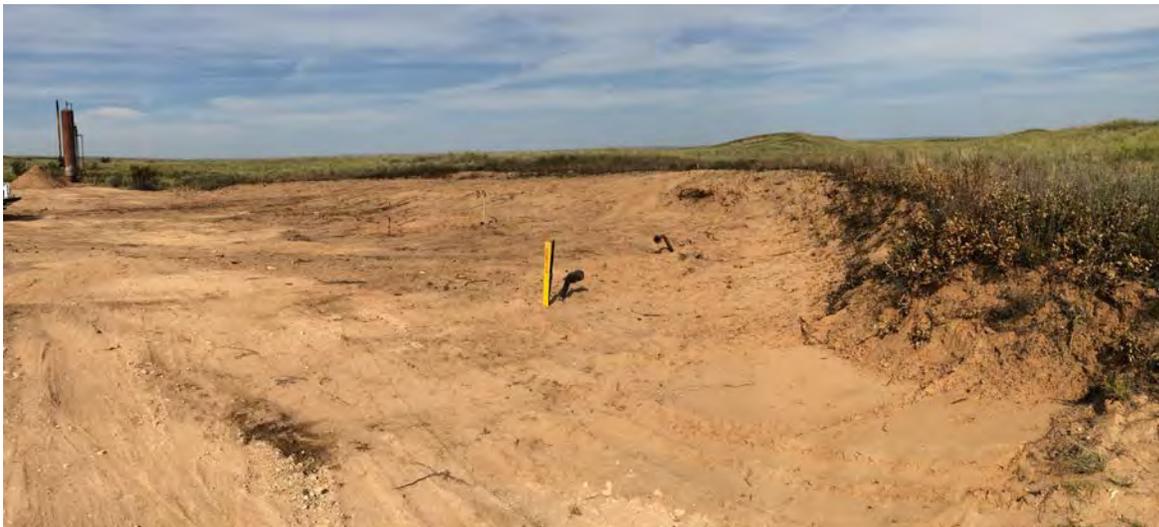
Figure 4 – View north from the access road. The tank battery was north of the yellow pipeline marker (center of photograph). The stockpile of impacted sand is near the heater treater (left). This image also shows the stabilized dunes that characterize the area. The new tank battery will be north of the yellow pipeline marker.

- A. Moving stained soil from the stockpile created during the initial response (Figure 4) and any stained soil excavated during construction of the remediation area to the southern portion (see Plate 6) of the remediation area.

1. Remove crude-stained soil in the area northeast of the battery (where the tank fell) with a rake, shovel and wheel barrow to the existing Stockpile (Stockpile #S shown in Figure 4– for stained soil).

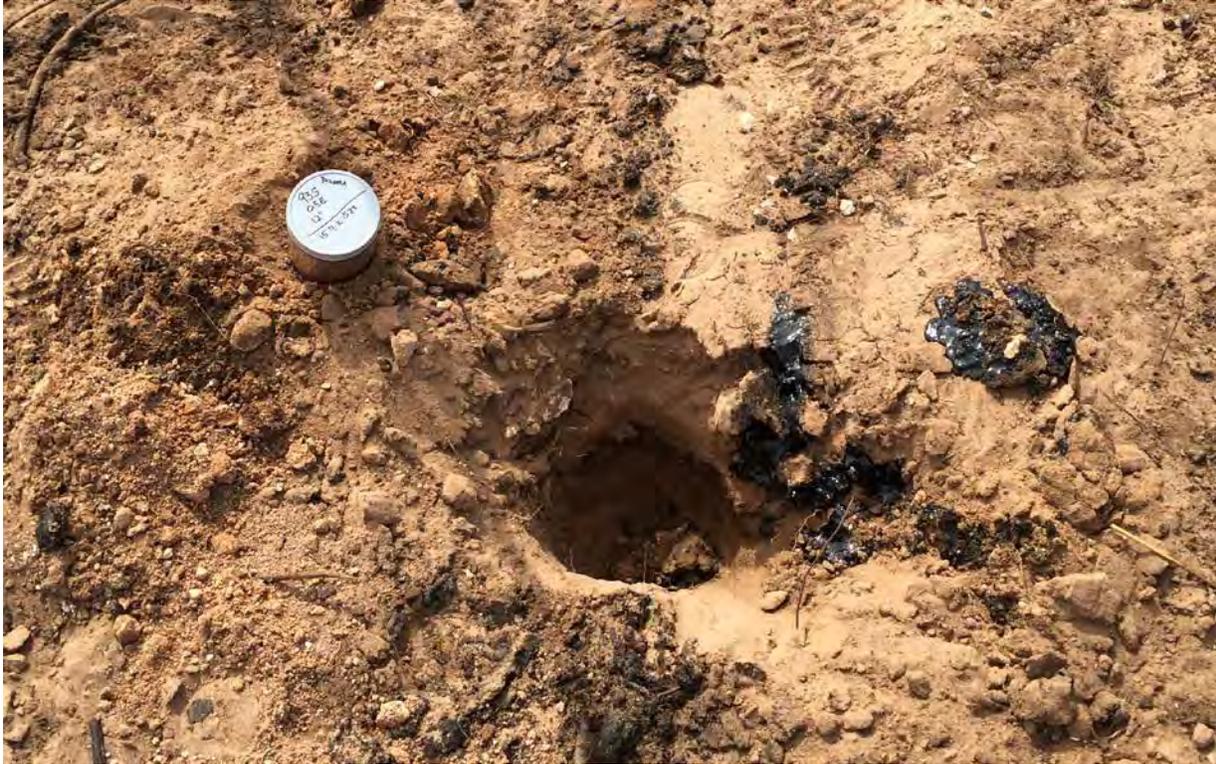
Figure 5 – Sample 93S 05E (measured from the heater treater) is a 12-inch boring. This sample, like all samples, shows that the crude oil is in discrete, small pockets. Thus, a 1-oz sample could be 100% crude or 100% clean dune sand. The largest pocket of crude observed during the sampling was slightly smaller than a football.

Hicks Consultants obtained several samples on September 2, 2015 and October 1, 2015. The samples were taken from various places measured from the heater treater. The photograph Figure 5 shows the boring for Sample 93S 5E (93 feet south of the heater treater and 5 feet east of due south) and illustrates the nature of all sample locations: the crude is either 100% of a particular volume of earth or 0%. At each of the five sampling locations taken in September, the boring terminated at dune sand that showed no evidence of any release (recent crude, old crude, produced water). We found no evidence of crude below a depth of 6-18 inches. The October 1 sampling event used a backhoe to excavate eight sampling trenches within the area of impact. The laboratory results of the sampling are presented in Table 1 and Appendix A.

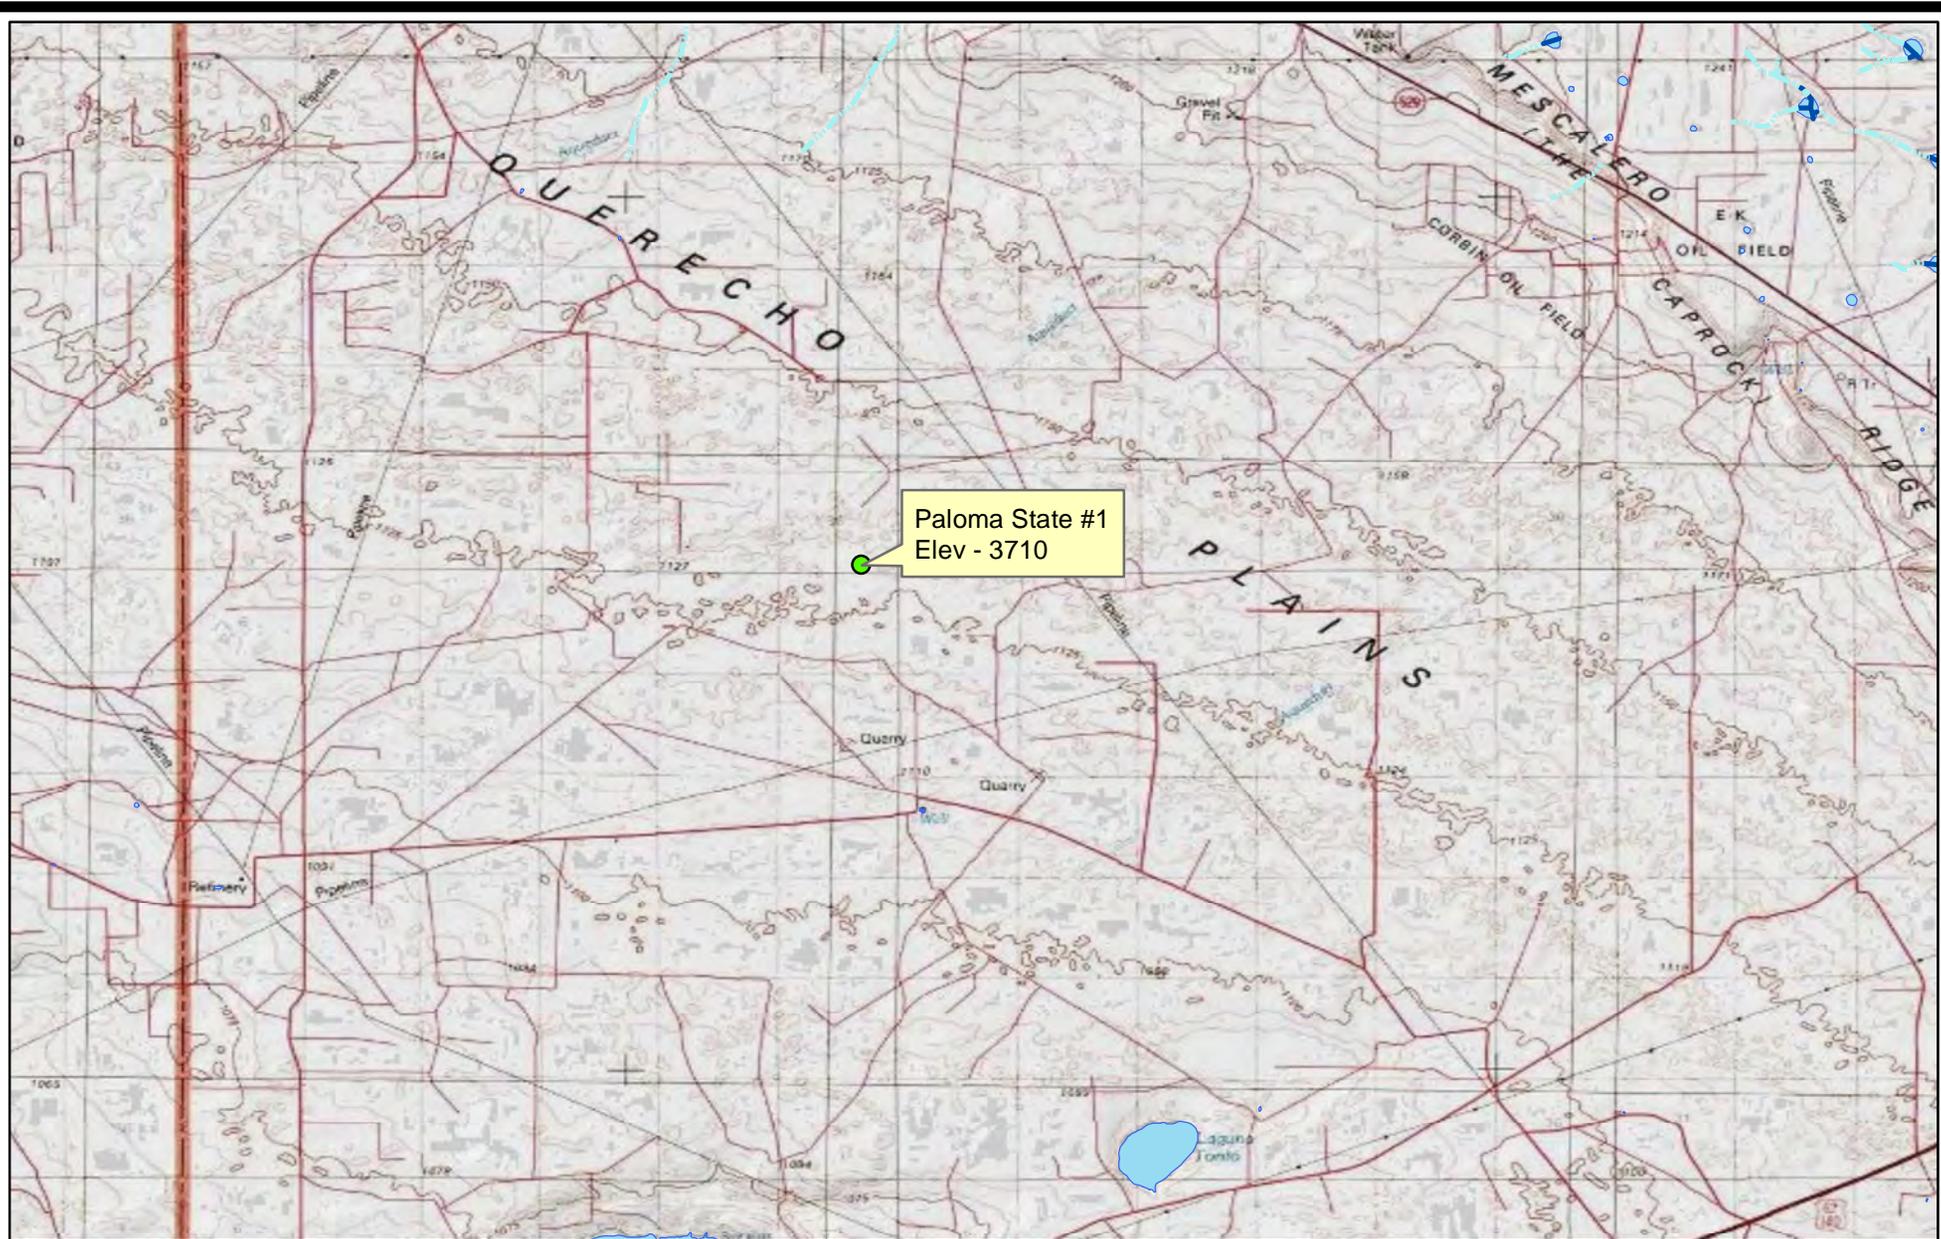
Plate 3

The site is relatively flat, sloping from northeast to south-southwest. There are no defined watercourses nearby. The nearest water body is Laguna Tonto, about 6 miles to the southeast (Plate 3). The nearest mapped watercourses lie about 4 miles north. Our surface investigation shows no watercourses near the site as it is characterized by sand dunes.

Mapped Surface Water and Wetlands
