ENTERPRISE PRODUCTS OPERATING LLC

**Re: Notification of Affected Groundwater -
Cohn 29-10-25 #1 Pipeline Release (November 8, 2013 Release)
Enterprise Field Services, LLC
NMOCD RP# 3RP-1018
Unit Letter A, Section 25, T29N, R10W
San Juan County, New Mexico**

The attached *Corrective Action Report* documents the results of the December 2013 and April 2014 initial remediation actions to mitigate the pipeline release. This report also documents removal of hydrocarbon impacted soil exceeding NMOCD standards. The attached *Supplemental Site Investigation Report*, dated September 22, 2014, documents a groundwater investigation conducted at the release site during August 2014. During this investigation, eight (8) temporary monitoring wells were installed to total depths ranging from 12 to 13 feet below ground surface. Each monitoring well was developed, purged and sampled and then properly plugged and abandoned in accordance with NMOCD and New Mexico Office of the State Engineer regulations. Laboratory analytical results indicate contaminant concentrations above New Mexico Water Quality Control Commission (NMWQCC) standards for Benzene and Total Xylenes in five (5) of the temporary monit

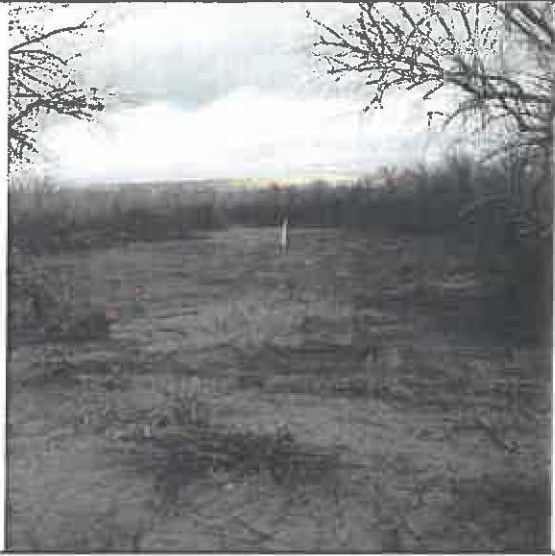
Photograph 1

Release area prior to excavation activities.

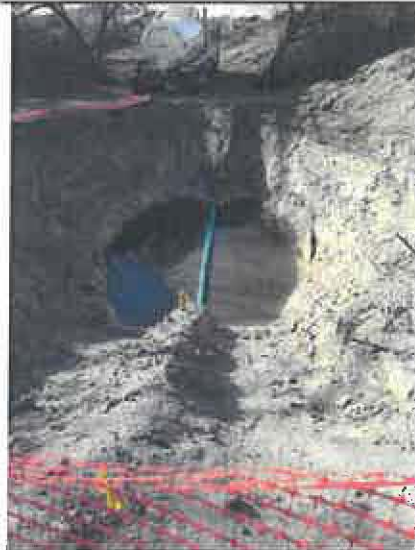
Photograph 2

Initial excavation after line repairs completed.

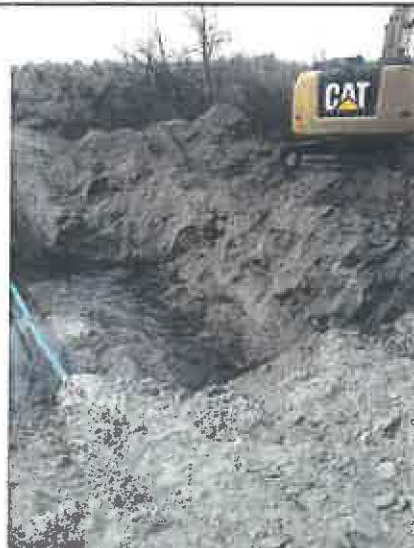
Photograph 3

Removing impact on west side of excavation. Note dark anaerobic material from natural decay processes.

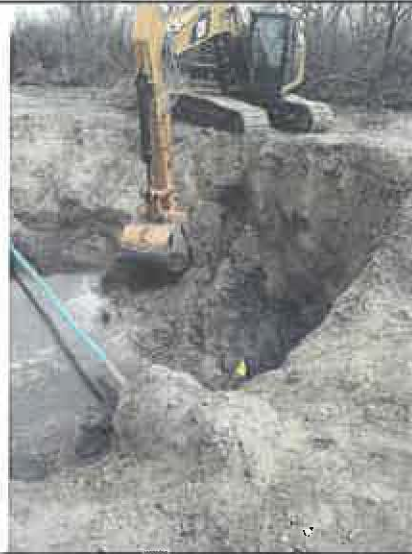
Photograph 4

Removing impacted material from northwest portion of excavation.

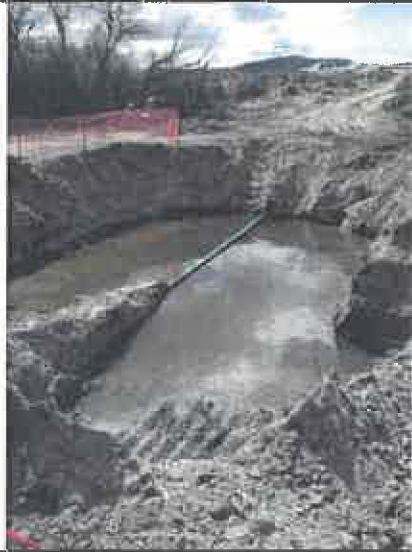
Photograph 5

Excavation prior to stripping back soil along pipeline.

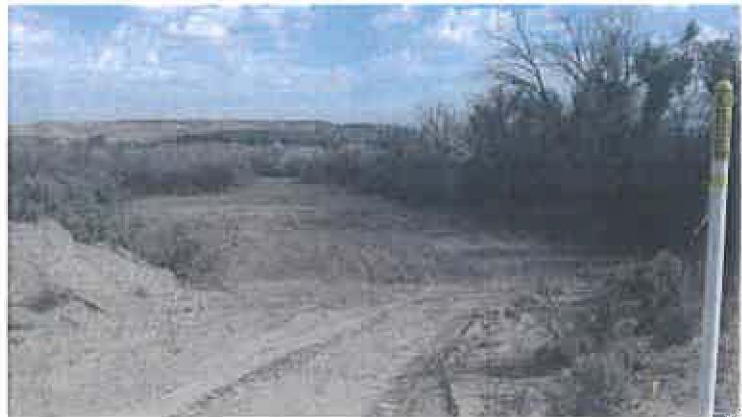
Photograph 6

General view of reclaimed area after excavation backfill.

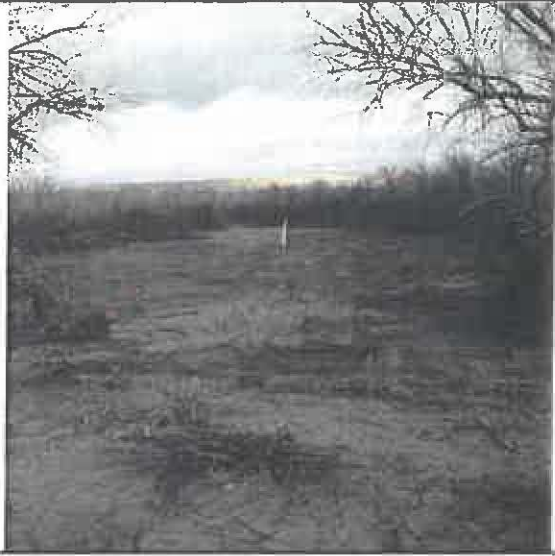
Photograph 1

Release area prior to excavation activities.

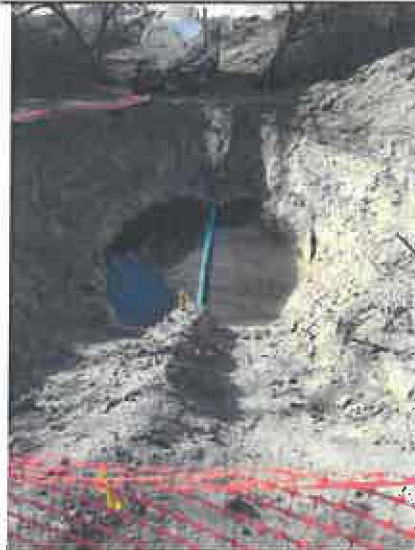
Photograph 2

Initial excavation after line repairs completed.

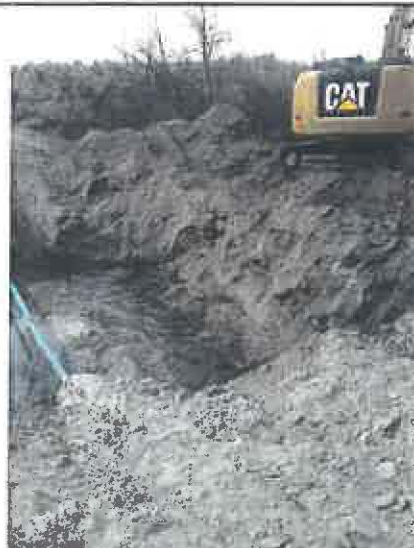
Photograph 3

Removing impact on west side of excavation. Note dark anaerobic material from natural decay processes.

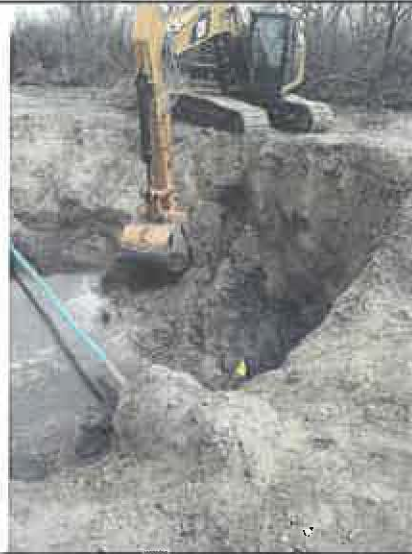
Photograph 4

Removing impacted material from northwest portion of excavation.

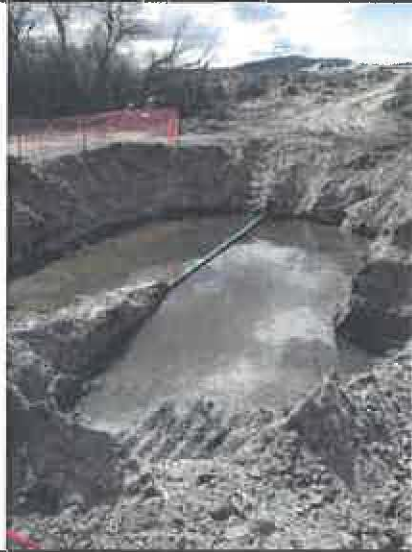
Photograph 5

Excavation prior to stripping back soil along pipeline.

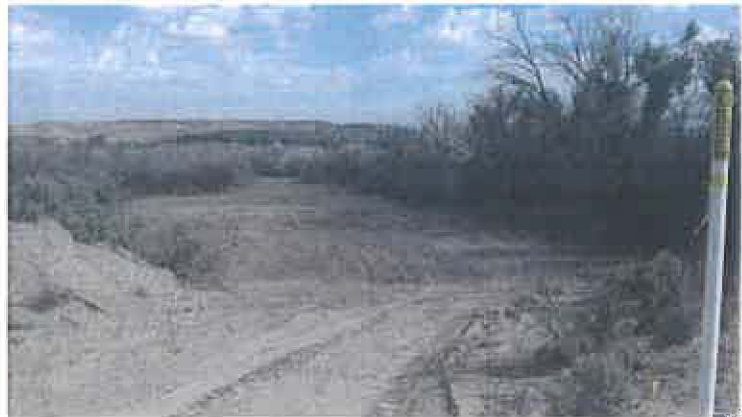
Photograph 6

General view of reclaimed area after excavation backfill.
