**Re: Groundwater Investigation Report
Lateral C-64 July 2013 Line Drip Release
NW ¼ NE ¼, Sec 24, T27N, R6W
Rio Arriba County, New Mexico**

**GROUNDWATER INVESTIGATION REPORT
LATERAL C-64 NATURAL GAS PIPELINE DRIP RELEASE
UNIT B, SECTION 24, TOWNSHIP 27 NORTH, RANGE 6 WEST,
36.563695°, -107.414268°
RIO ARRIBA COUNTY, NEW MEXICO
April 14, 2015**

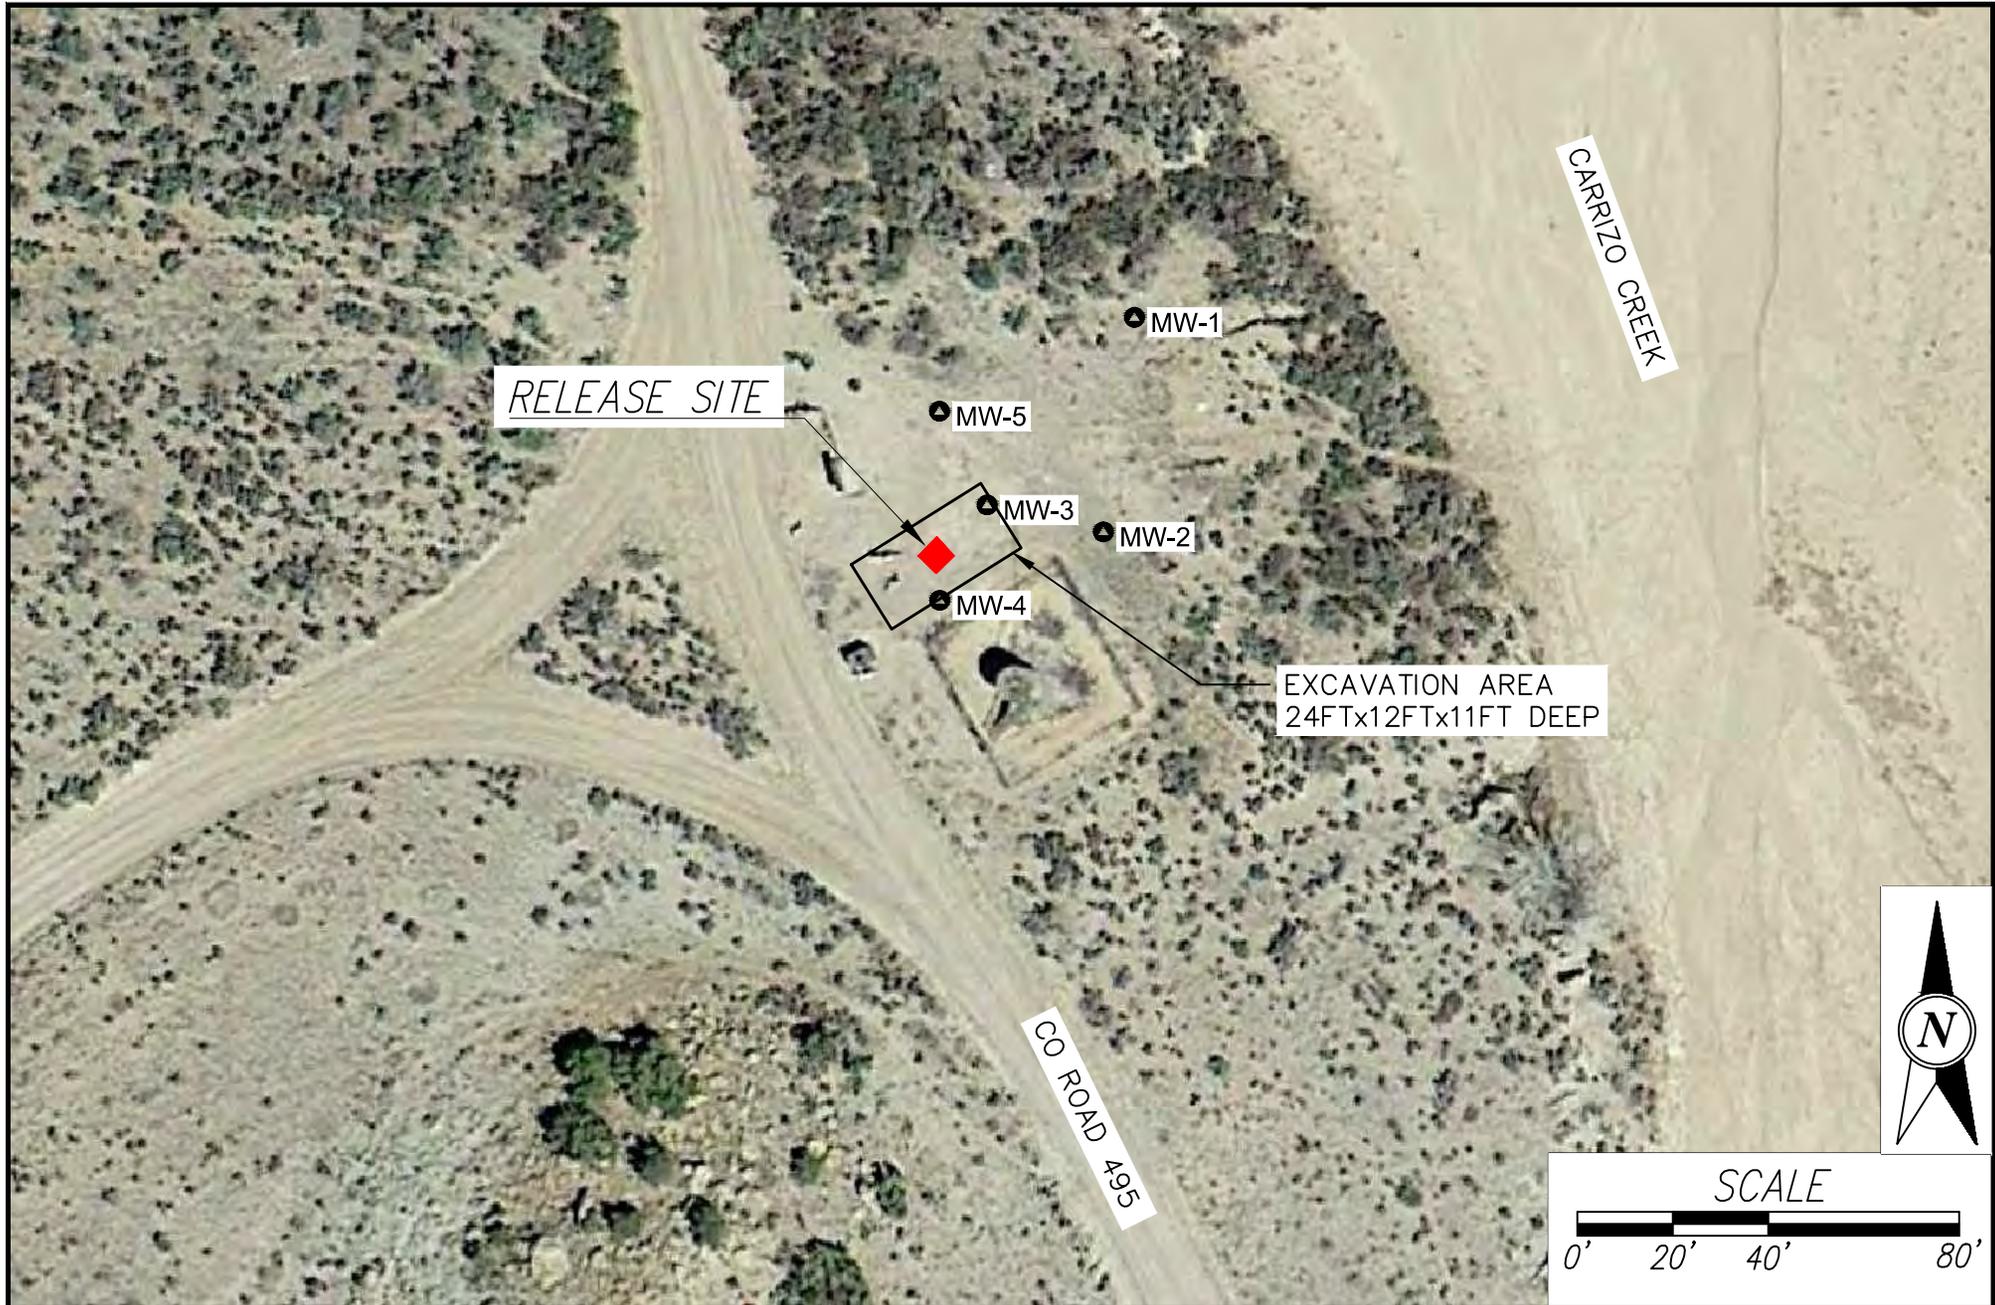
Designed SM	Drawn DJB	Checked RSA
Date: APRIL, 2015		
Scale: Horiz: 1"=40' Vert: N/A		
Project No: 5123699		
Sheet: 2

SITE LOCATION MAP WITH WELL LOCATIONS
LATERAL C-64
SECTION 24, T27N, R6W

Soil Boring and Monitoring Well Locations: The five monitoring well locations were chosen to establish the groundwater gradient and to determine the extent of possible groundwater contamination at the Lateral C-64 site. Figure 2 illustrates the drilling locations.

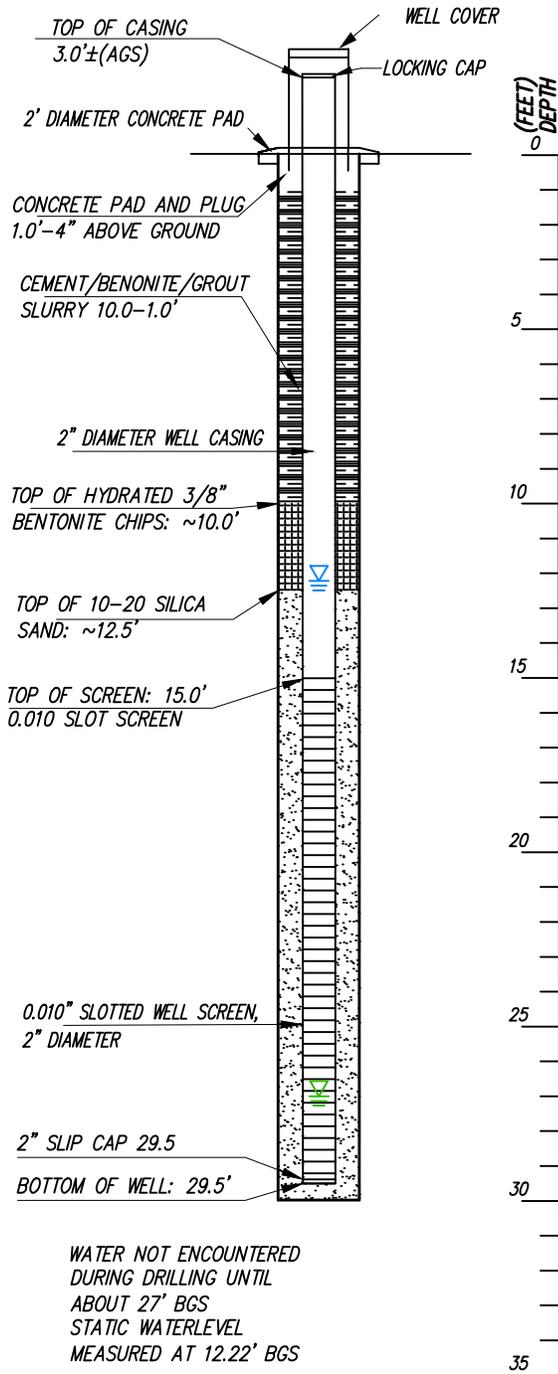
SOIL TYPE	PID (PPM)	COLOR	SAMPLE DESCRIPTION
			NS
	2.5	7.5YR 4/4	BROWN CLAYEY SAND, FINE TO MEDIUM GRAINED SUB ANGULAR POORLY GRADED SAND LOW MOISTURE CONTENT
			NS
	100.7	7.5YR 4/3	BROWN SANDY CLAY SAND IS SUB ANGULAR, FINE, LOW MOISTURE CONTENT
			NS
	65.1	7.5YR 25/2	BROWN SANDY CLAY, 30% FINE GRAIN SUB ANGULAR WELL GRADED SAND, LOW MOISTURE CONTENT
			NS
	44.6	7.5YR 4/4	BROWN SANDY CLAY, FINE GRAIN SUB ANGULAR WELL GRADED SAND, LOW MOISTURE CONTENT
			NS
	SAMPLED WET		BROWN SANDY CLAY, FINE GRAIN SUB ANGULAR WELL GRADED SAND, HIGHER MOISTURE CONTENT THAN 20' SAMPLE
			NS
	SAMPLED WET	7.5YR 6/6	YELLOW COURSE GRAINED SAND, MODERATELY GRADED, SUB ANGULAR WITH BROWN CLAY LENSES, WET
END OF HOLE

DRILLER: ENVIRO-DRILL, INC.
DATE COMPLETED: FEBRUARY 17, 2015
BOREHOLE DIAMETER: 6" O.D.
SAMPLER TYPE: SPLIT SPOON
DRILLING METHOD: HOLLOW STEM AUGER
TOTAL BORING DEPTH: 30 FT.
LOGGED BY: JES
NS = NOT SAMPLED

Drilling and Monitoring Well Completions: From February 17, 2015 through February 20, 2015 the drilling and well installations were performed by Enviro-Drill, Inc. of Albuquerque, NM utilizing a CME 75 drill rig with a Hollow Stem Auger (HSA) tool string. Split spoon samples were collected at 5 foot intervals for field screening using a calibrated PID. Laboratory samples were collected from the capillary fringe and also from the sample with the highest PID reading. Field screening results ranged from 2.6 ppm to 2,931 ppm, field screening results and borehole lithology logs are included on the Monitoring Well Completion Diagrams (Figures 3-7).

Due to underground infrastructure limiting access and mobility on the site, the well installation order progressed from farthest from the road to closest to the road. All five soil borings were advanced to 30 feet bgs with decontaminated augers. Monitoring wells MW-1, MW-2, MW-3 were constructed with 15' of threaded PVC 0.010" slotted screen and 15' of threaded 2" PVC well pipe, MW-4 and MW-5 were constructed with 20' of threaded PVC 0.010" slotted screen and 10' of threaded 2" PVC well pipe. Well Completion Diagrams for each monitoring well are included as Figures 3-7.

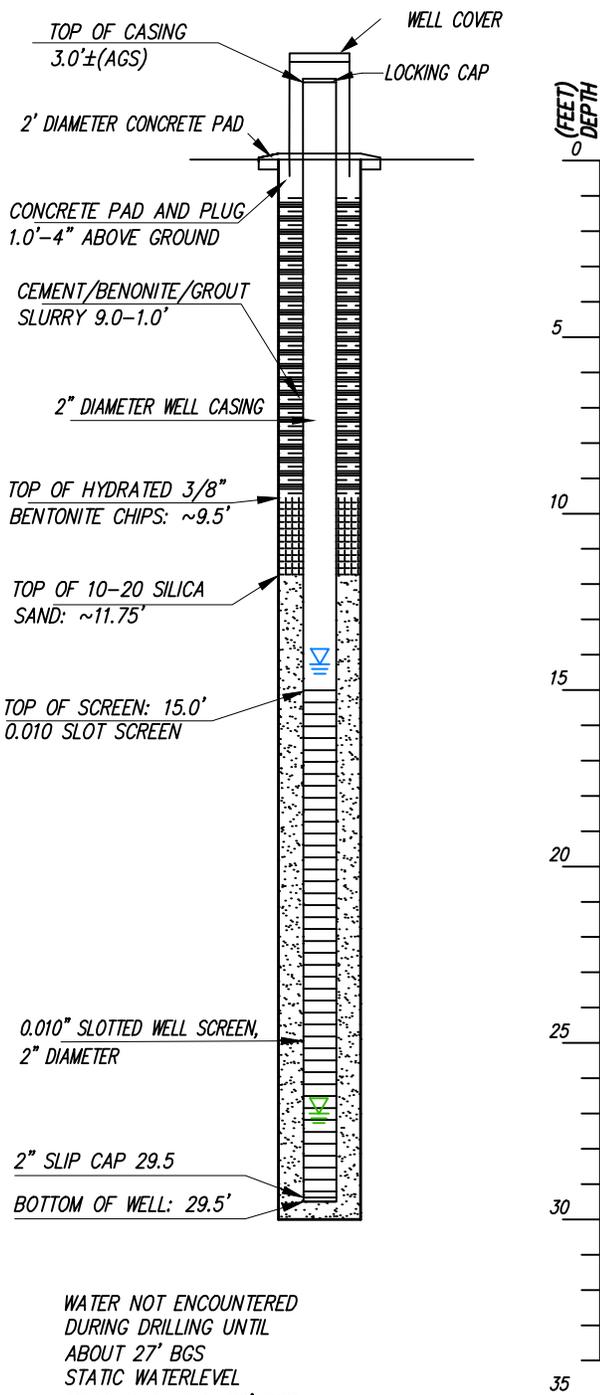
SOIL TYPE	PID (PPM)	COLOR	SAMPLE DESCRIPTION
			NS
	38.2	10YR 4/3	CLAYEY SAND; FINE TO MEDIUM GRAIN, WELL GRADED SUB ANGULAR SAND
			NS
	49.1	2.5YR 7/3	LIGHT TAN SAND FINE TO MEDIUM GRAIN, POORLY GRADED (MOSTLY MEDIUM GRAIN) QUARTZ SAND, LOW MOISTURE, CLAY FILMS, 5% CLAY
			NS
	2355		BLACK LAYER STRONG HYDROCARBON ODOR, ABOUT 1' THICK, BOUNDED ABOVE AND BELOW BY SANDY CLAY. 25% SAND, BROWN THICK CLAY
			NS
	562	10YR 4/3	SOME BLACK STAINING, SLIGHT ODOR, SANDY CLAY, WELL GRADED SUB ANGULAR SAND IN BROWN (TIGHT) CLAYS
			NS
	70.6	10YR 3/1	THICK TIGHT CLAY WITH QUARTZ GRAINS
			NS
	SAMPLED WET	10YR 6/4	INTERBEDDED WET CLAY LENSES AND WET SAND, COURSE GRAINED POORLY GRADED SUB ANGULAR SAND

DRILLER: ENVIRO-DRILL, INC.
 DATE COMPLETED: FEBRUARY 18, 2015
 BOREHOLE DIAMETER: 6" O.D.
 SAMPLER TYPE: SPLIT SPOON
 DRILLING METHOD: HOLLOW STEM AUGER
 TOTAL BORING DEPTH: 30 FT.
 LOGGED BY: JES
 NS = NOT SAMPLED

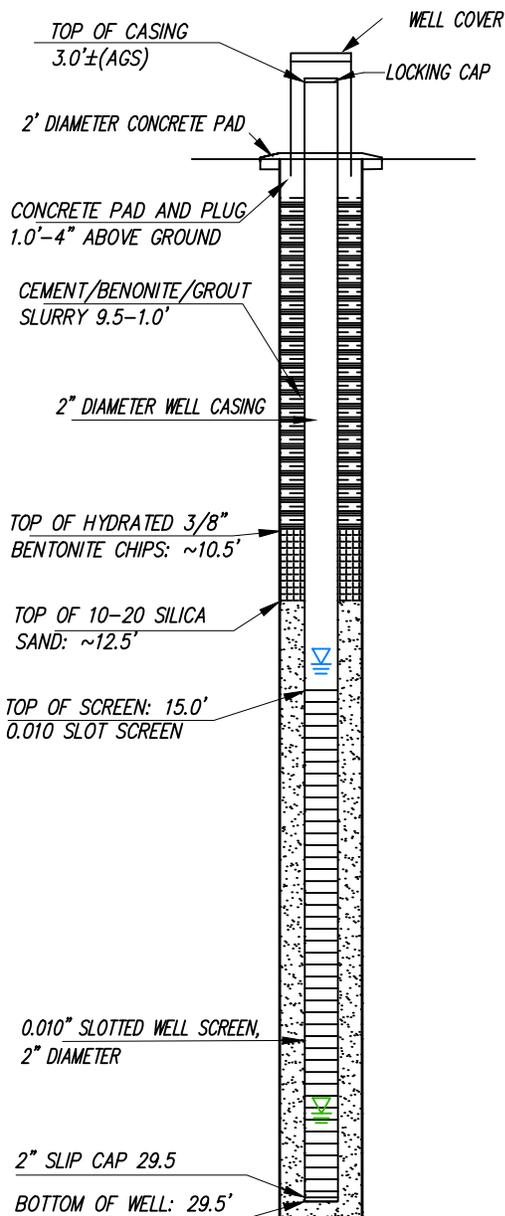
ENTERPRISE	FARMINGTON, NEW MEXICO
MW-3 CONSTRUCTION LOG	Designed: JES Drawn: GJF Checked: RSA
LATERAL C-64	Date: 2/11/15
SECTION 24, T27N, R6W	Scale: Horiz: n/a Vert: n/a
	Project No: 5123699
	Figure: 5

WATER NOT ENCOUNTERED DURING DRILLING UNTIL ABOUT 27' BGS
 STATIC WATERLEVEL MEASURED AT 14.26' BGS

SOIL TYPE	PID (PPM)	COLOR	SAMPLE DESCRIPTION
			NS
	84.3	10YR 4/3	CLAYEY SAND, WELL GRADED, SUB ANGULAR FINE TO COURSE GRAIN SAND
			NS
	2931	10YR 4/3	BROWN CLAY LAYER OVER BLACK LAYER WITH STRONG HYDROCARBON ODOR
			NS
	1948	10YR 5/4	SOME BLACK STAINING IN SANDY CLAY; WELL GRADED FINE TO COARSE GRAIN SAND
			NS
	514	10YR 4/4 5YR 2.5/1	BROWN SANDY CLAY TO GRAY SHALE (DARK) SANDY CLAY 10YR 4/4 SHALE STONE 5YR 2.5/
			NS
	107.9	10YR 4/3	BROWN SANDY CLAY, FINE GRAIN SUB ANGULA MODERATE MOISTURE CONTENT
			NS
	SAMPLED WET	10YR 4/3	INTERBEDDED WET CLAY AND SANDSTONE

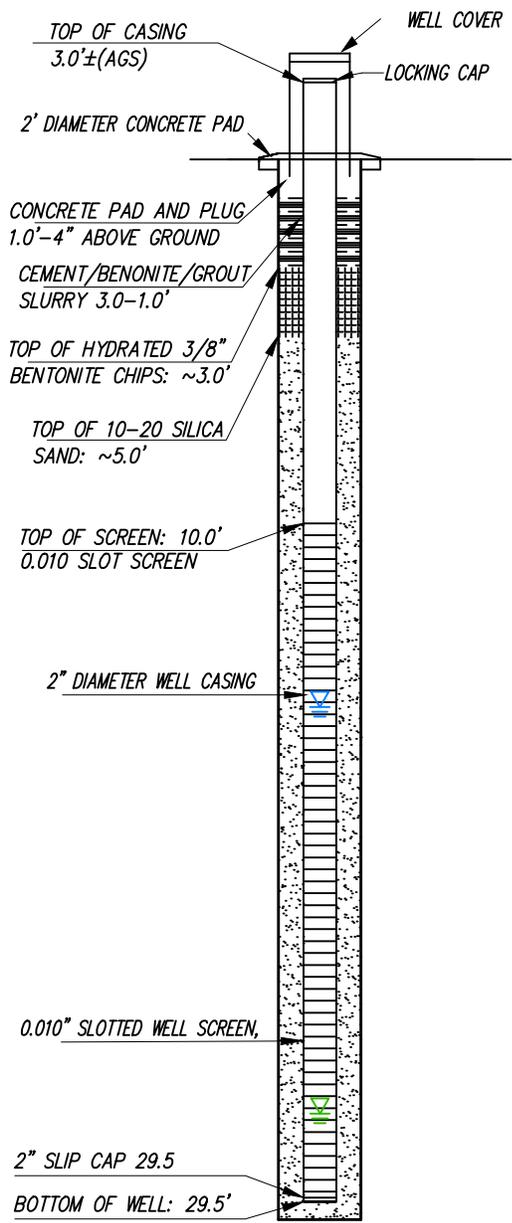
WATER NOT ENCOUNTERED DURING DRILLING UNTIL ABOUT 27' BGS
 STATIC WATERLEVEL MEASURED AT 15.48' BGS

SOIL TYPE	PID (PPM)	COLOR	SAMPLE DESCRIPTION
NS			
[Pattern]	57.3	10YR 4/2	SANDY CLAY, WELL GRADED ANGULAR SAND, DRY HARD CLAY
NS			
[Pattern]	74.2	10YR 5/2	FINE TO MEDIUM GRAVEL, SUB ANGULAR WELL GRADED QUARTZ SAND WITH 45% CLAY
NS			
[Pattern]	456	BLACK PCS	HYDROCARBON STAINED BLACK LAYER WITH STRONG ODOR, CONTACT ABOVE WITH BROWN CLAY SAND, WELL GRADED FINE TO COARSE
NS			
[Pattern]	171.2	10YR 4/1	SOME STAINING, SOME ODOR, SANDY TIGHT CLAY, FINE TO MEDIUM GRAIN WELL GRADED SAND
NS			
[Pattern]	32.7	10YR 4/4 10TR 4/1	MOTTLED BROWN AND GRAY CLAY, HARD MINIMAL SAND, SHALE MATERIAL, POORLY GRADED
NS			
[Pattern]	7.5YR 6/6		YELLOW COURSE GRAIN SAND WITH BROWN CLAY LENSES, WET

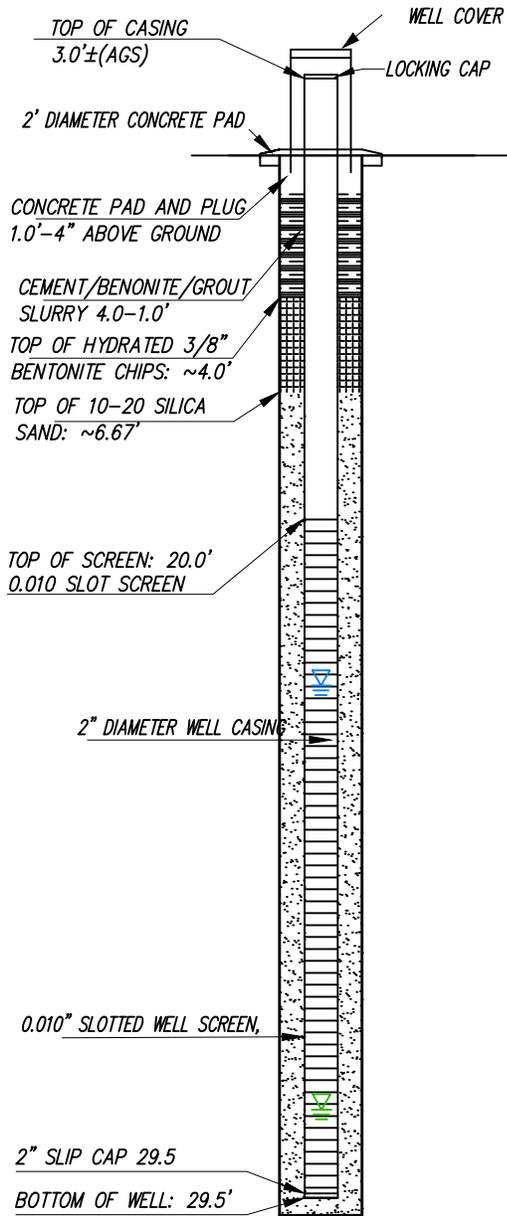
<table><tr> <td>Designed JES</td> <td>Drawn GJF</td> <td>Checked RSA</td> </tr><tr> <td colspan="3">Figure: 7</td> </tr></table>

WATER NOT ENCOUNTERED DURING DRILLING UNTIL ABOUT 27' BGS
 STATIC WATERLEVEL MEASURED AT 14.99' BGS

SOIL TYPE	PID (PPM)	COLOR	SAMPLE DESCRIPTION
			NS
	11.1	10YR 5/3	BROWN CLAYEY SAND, FINE TO MEDIUM GRAIN . ANGULAR WELL GRADED SAND GRAINS
			NS
	41.2	10YR 5/3	BROWN SANDY CLAY FINE TO MEDIUM GRAIN, SUB ANGULAR WELL GRADED SAND
			NS
	43.8	10YR 4/1 10YR 4/4	INTERBEDDED GRAY SHALES (60%) BROWN CLAYS (30%) FINE TO MEDIUM GRAIN SAND (~10%)
			NS
	46.6	10YR 4/1 10YR 4/4	INTERBEDDED HARD GRAY SHALE (60%) HARD BROWN CLAY (30%) FINE TO MEDIUM GRAIN SAND (~10%)
			NS
	24.8	10YR 4/1 10YR 4/4	INTERBEDDED HARD GRAY SHALE (60%) HARD BROWN CLAY (20%) FINE TO MEDIUM GRAIN SAND (~20%)
			NS
			MUDDY SAND, SANDSTONE LENSE ~ 3" THICK, GRAY SHALE
END OF HOLE

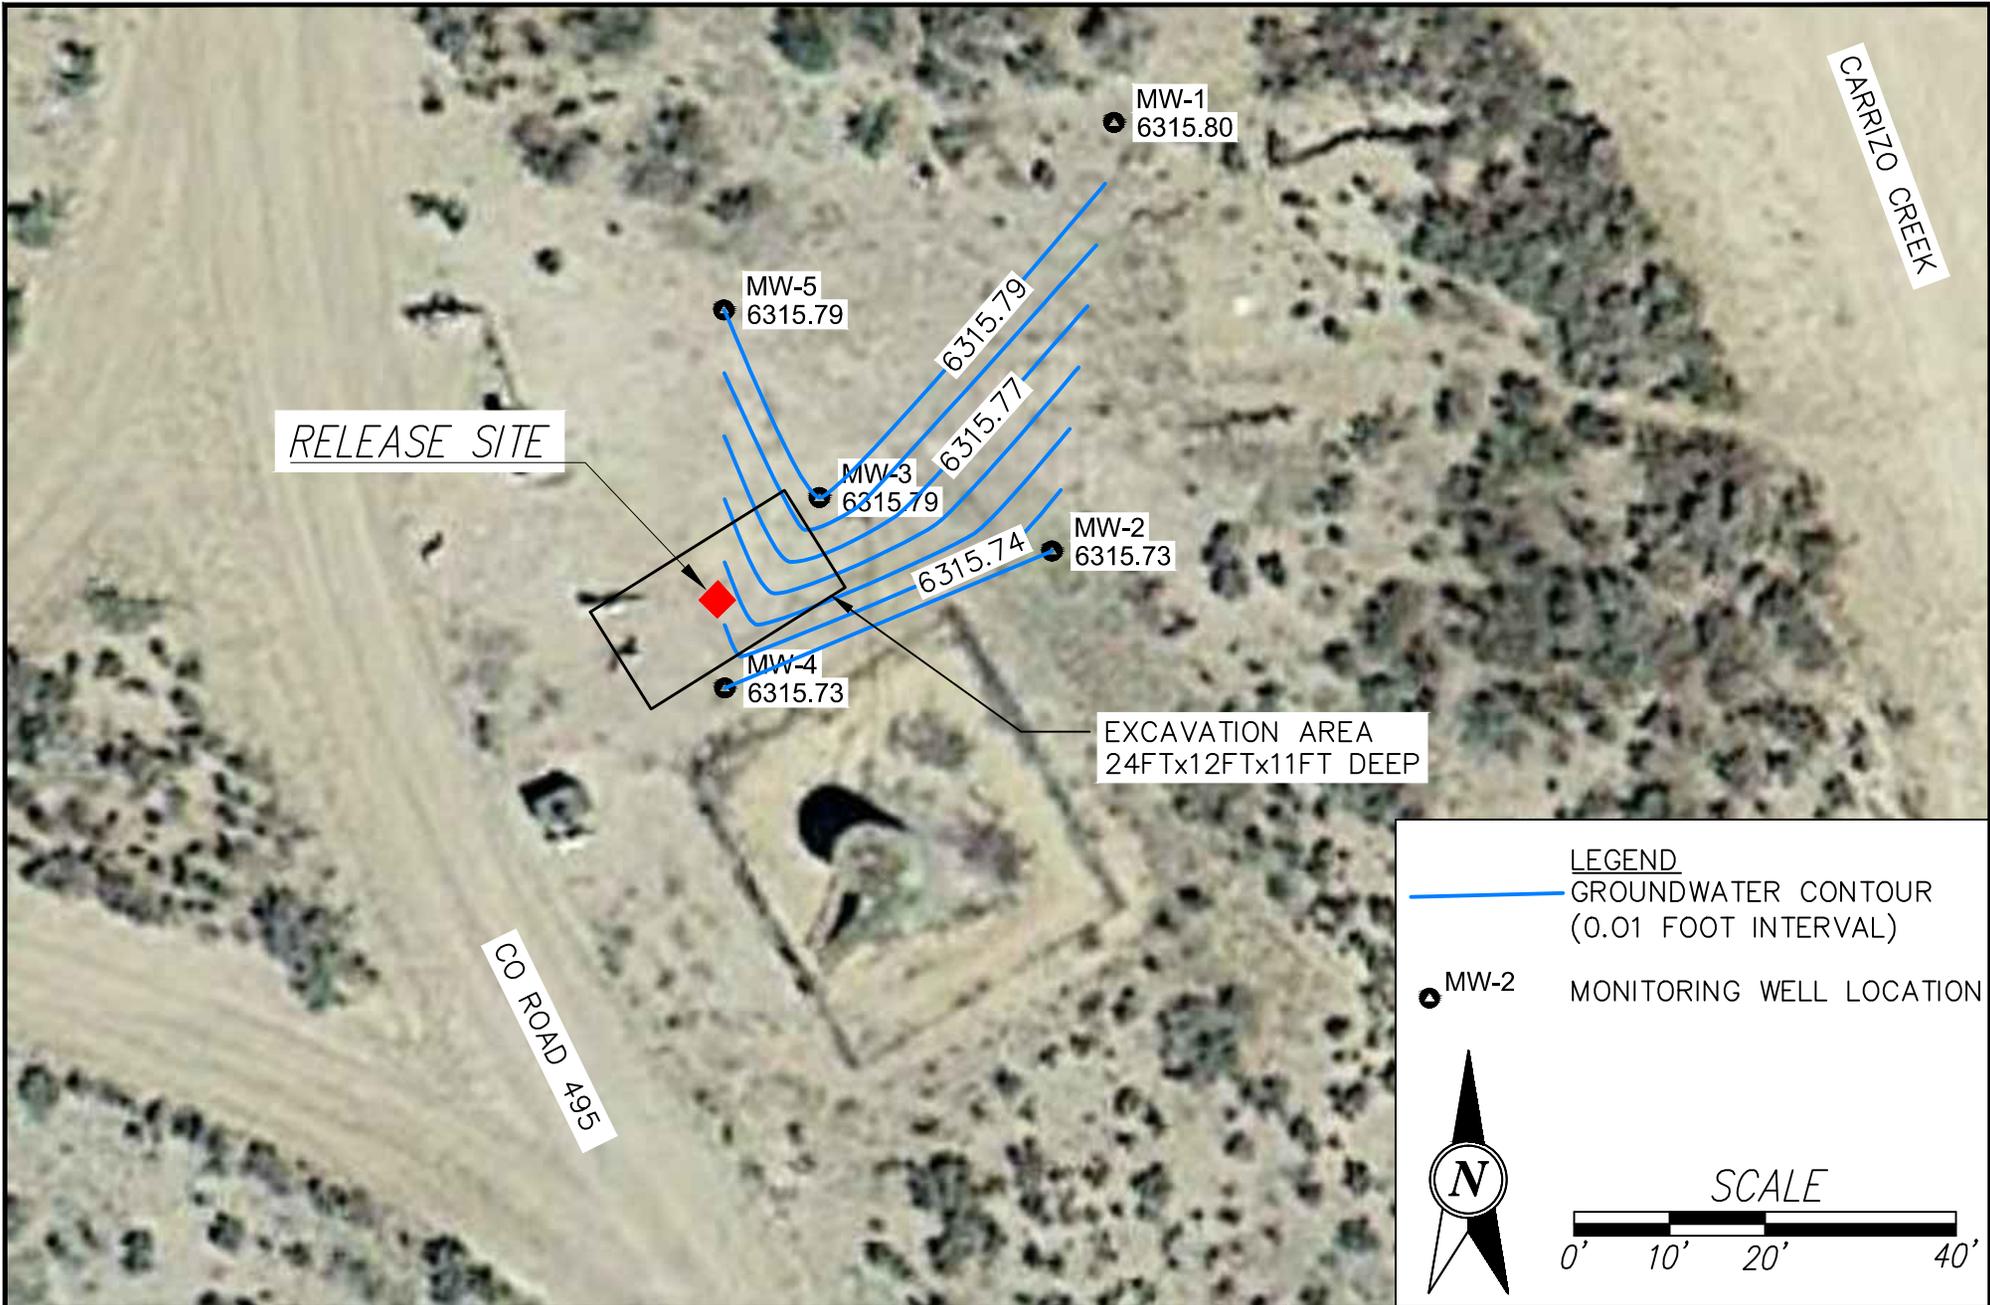
Designed JES	Drawn DJB	Checked RSA
Date: APRIL, 2015		
Scale: Horiz: 1"=40' Vert: N/A		
Project No: 5123699		
Figure: 9

GROUNDWATER CONTOUR MAP
 LATERAL C-64
 SECTION 24, T27N, R6W

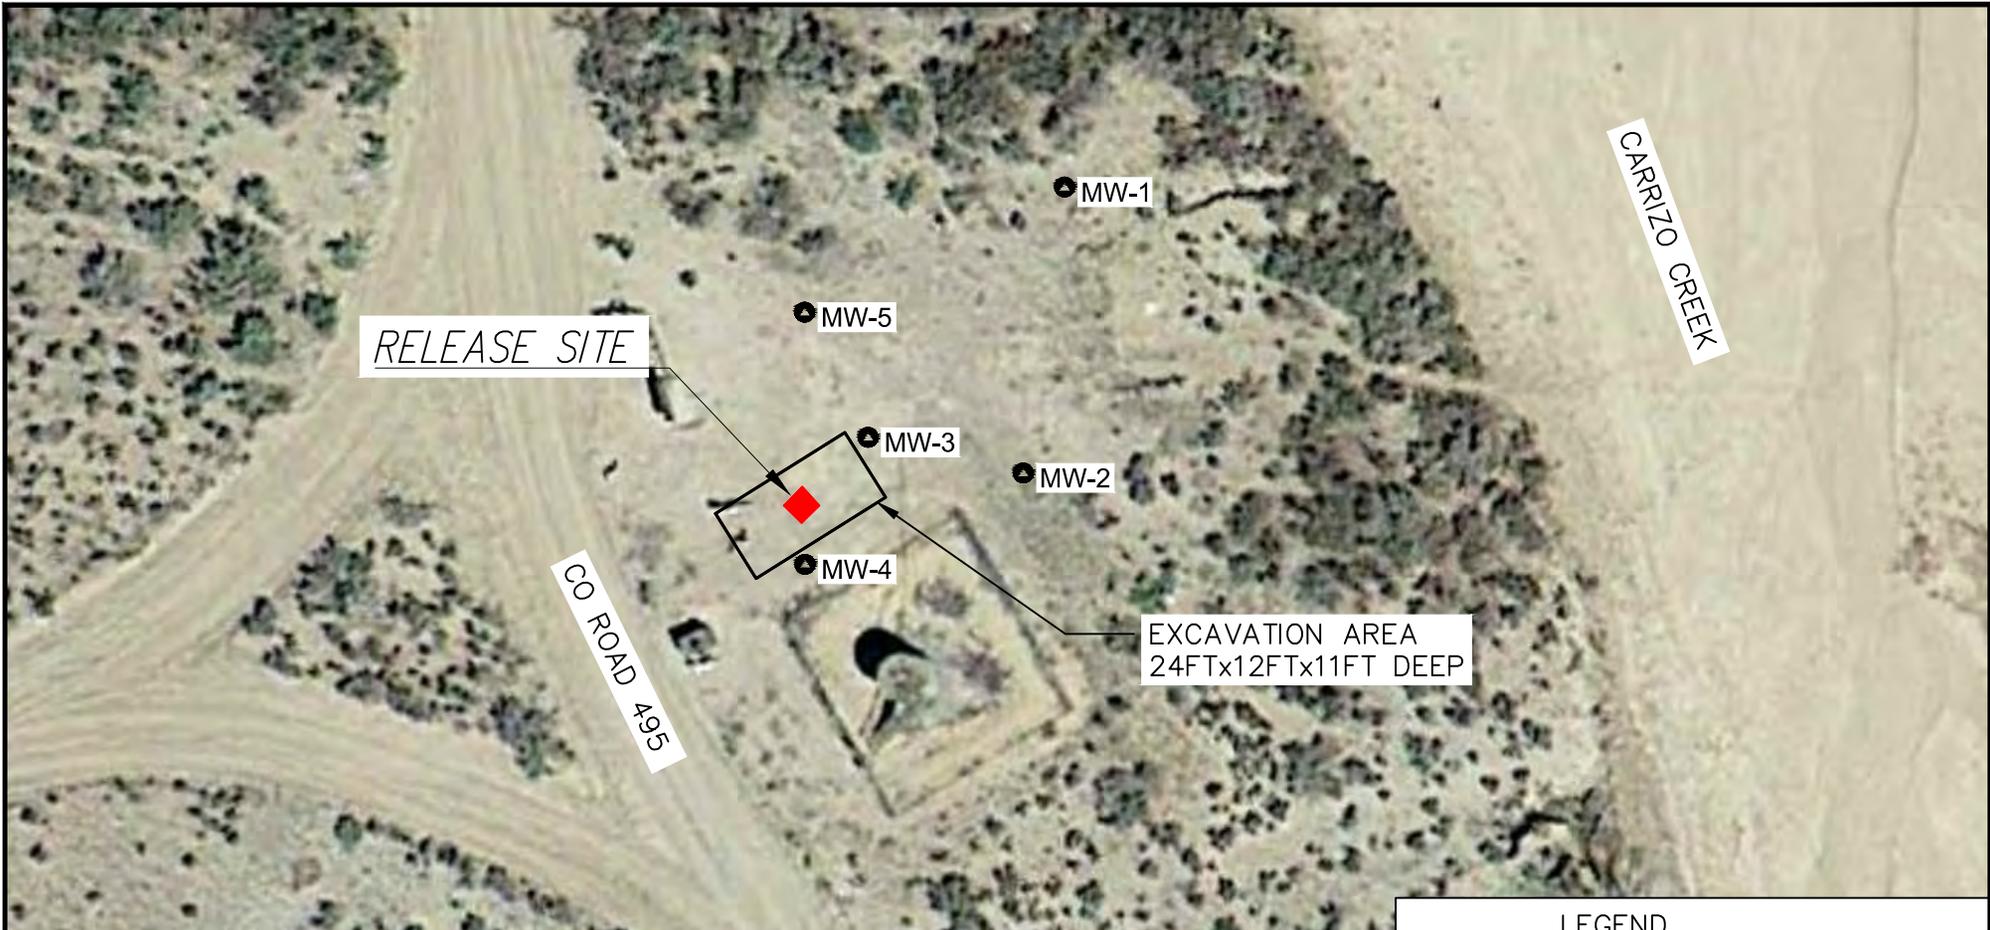
Date	Time	Sample ID	Method 8021				Method 300.0	
			Benzene	Toluene	Ethylbenzene	Total Xylenes	Chloride	Sulfate
			(µg/l)				(mg/L)	
NMWQCC/EIB/PSTB Standards			10	750	750	620	250	600
3/5/2015	10:30	MW-1	<2.0	<2.0	<2.0	<4.0	12	1300
3/5/2015	11:40	MW-2	39	37	15	110	12	1400
3/5/2015	12:10	MW-3	140	420	87	1400	14	1400
3/5/2015	11:05	MW-4	37	38	12	190	16	1700
3/5/2015	9:53	MW-5	<2.0	<2.0	<2.0	<4	14	1500

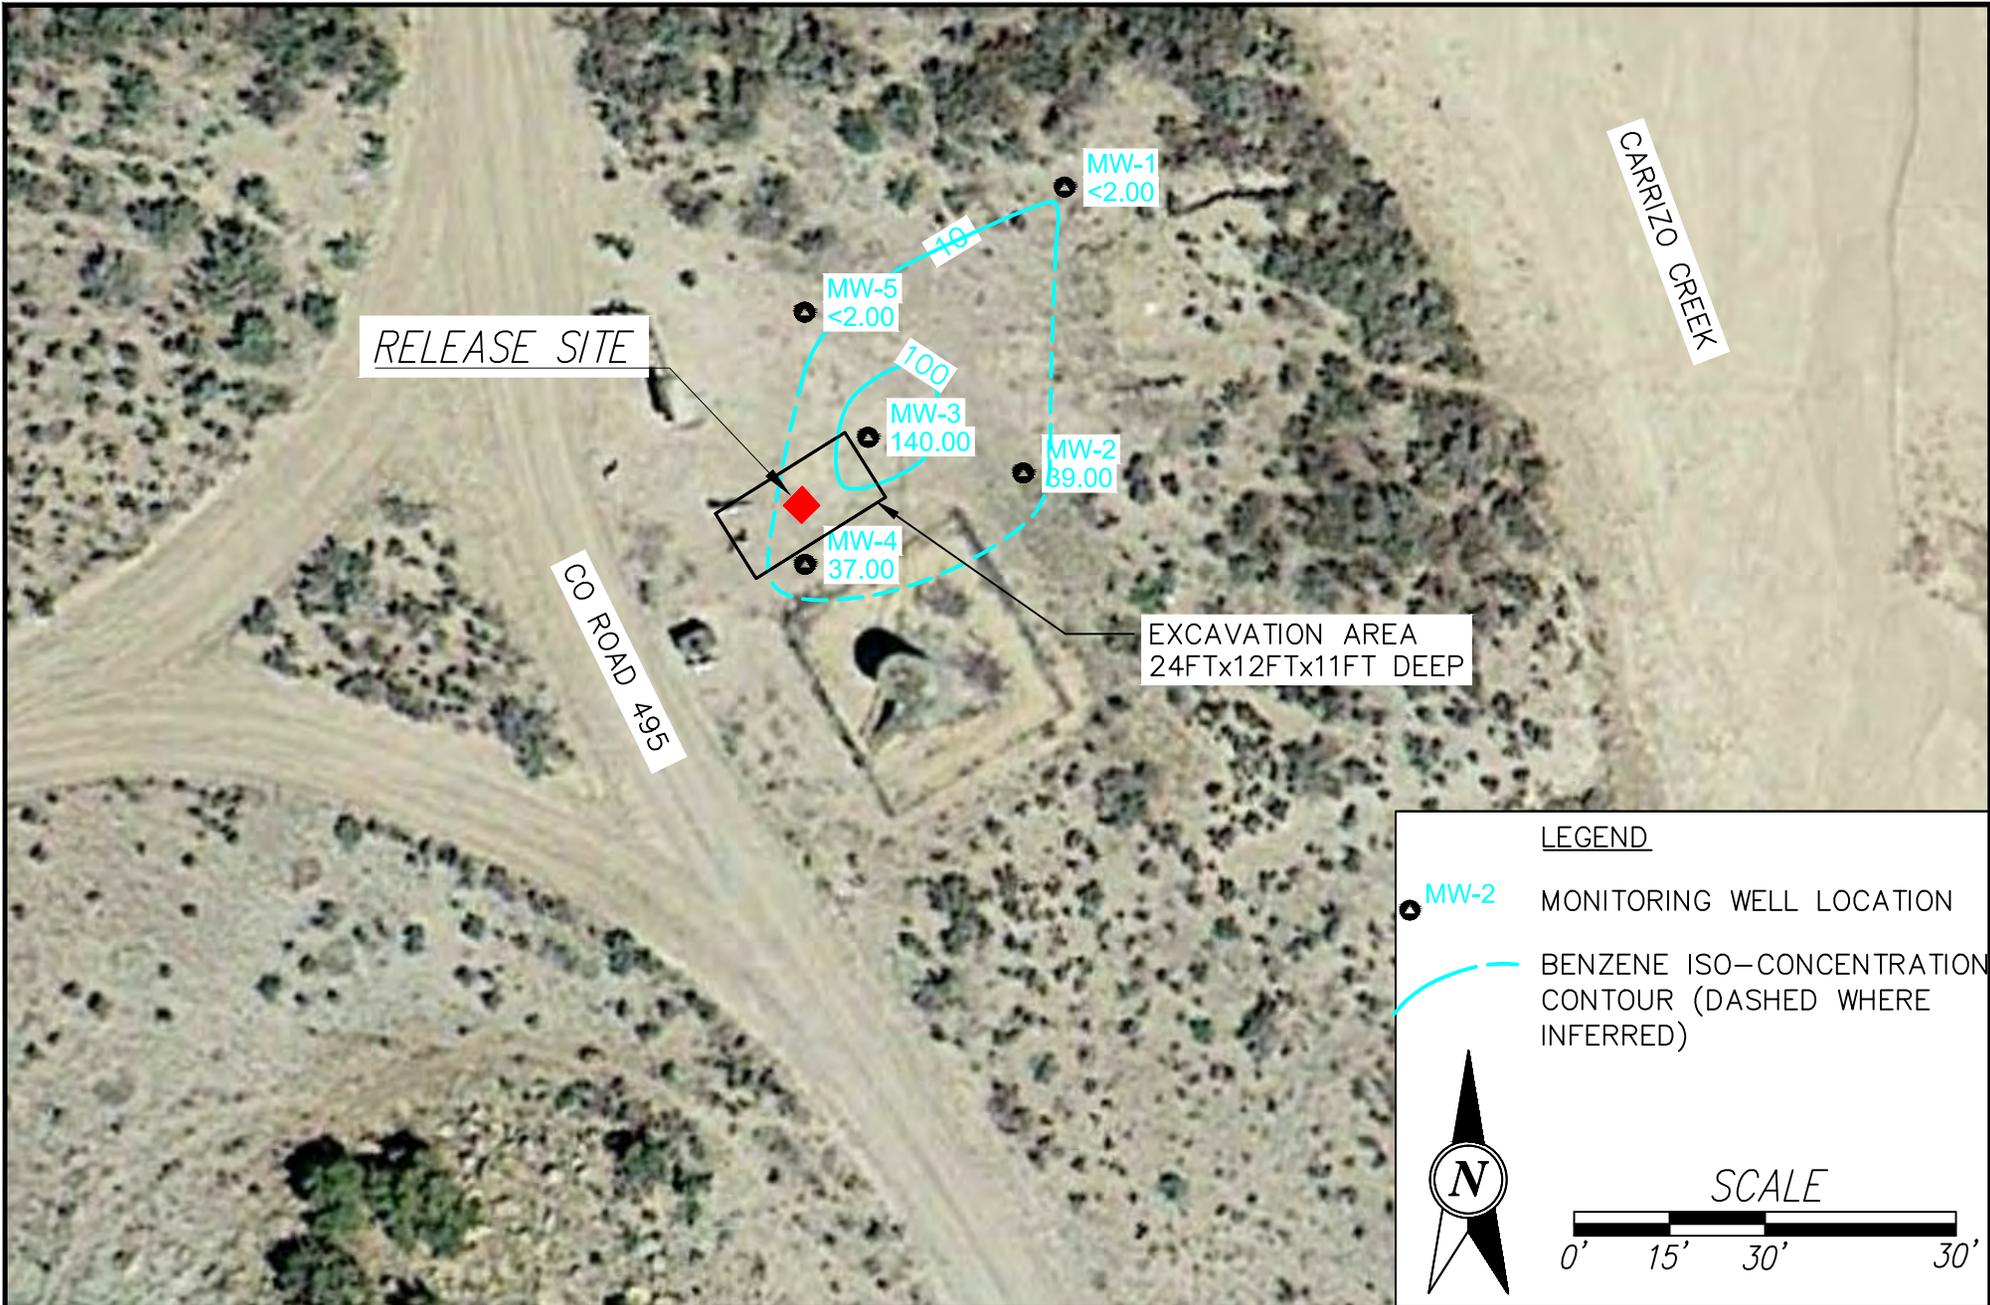
Designed JES	Drawn GJF	Checked RSA
Date: APRIL, 2015		
Scale: Horiz: 1"=30' Vert: N/A		
Project No: 5123699		
Figure: 11

GROUNDWATER BENZENE ISO-CONCENTRATION MAP
LATERAL C-64
SECTION 24, T27N, R6W

Groundwater Sampling Results: Laboratory analytical results of the groundwater samples collected from the five monitor wells are above standard for benzene in 3 samples, MW-2 with 39 µg/L, MW-3 with 140 µ/L, and MW-4 with 37 µg/L. Total xylenes were below standard in all samples except for MW-3 with 1,400 µg/L. Chloride was below standard in all samples and Sulfate was above standard in all samples. A summary of laboratory results is included as Table 2, and a summary of groundwater elevations is included in Table 3. A copy of the laboratory report is included in Appendix C.

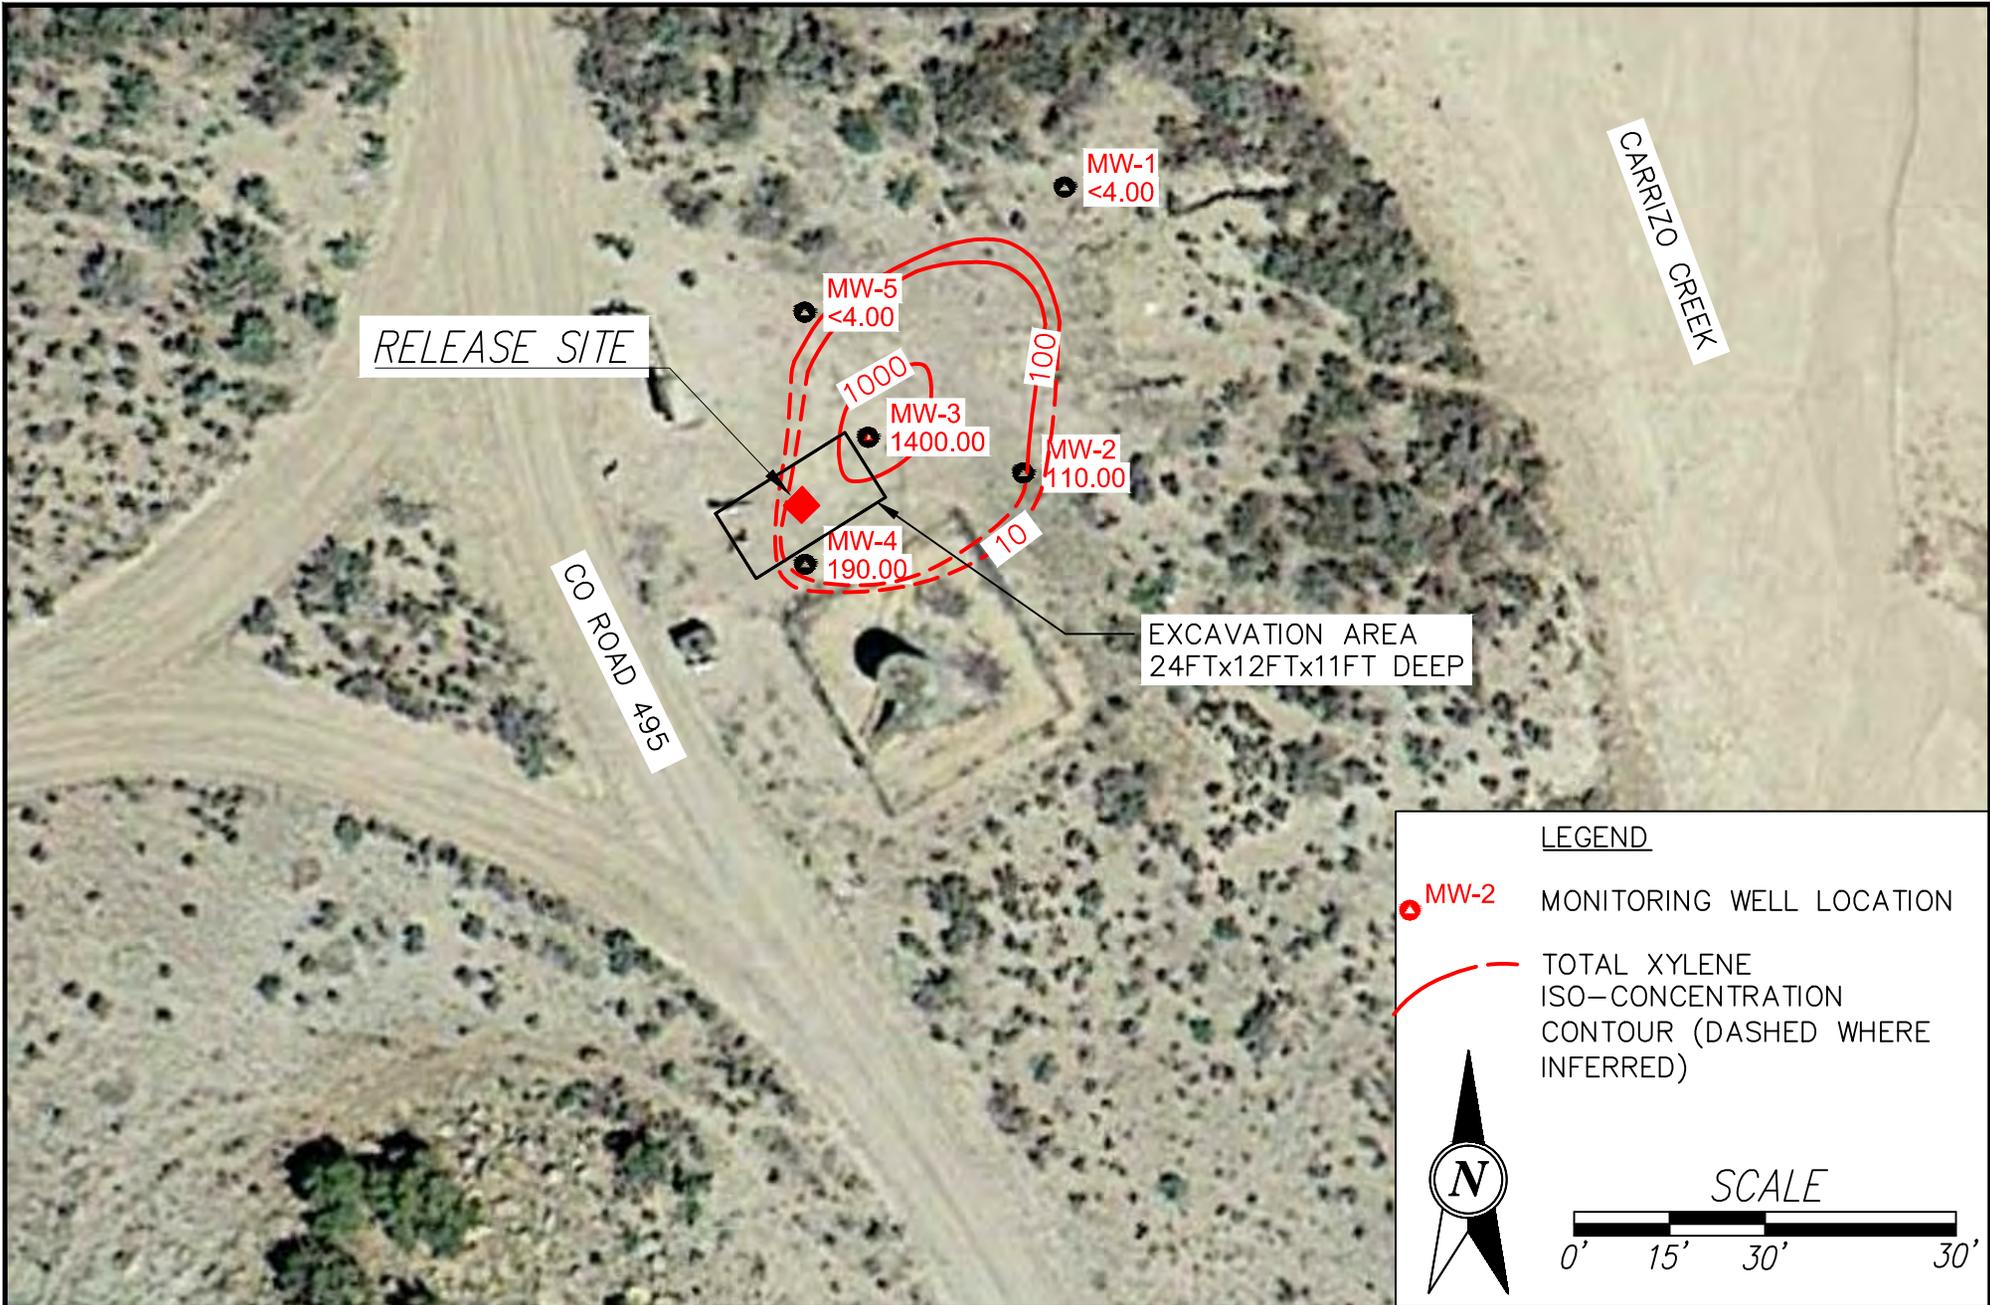
Designed JES	Drawn GJF	Checked RSA
Date: APRIL, 2015		
Scale: Horiz: 1"=30' Vert: N/A		
Project No: 5123699		
Figure: 12

GROUNDWATER TOTAL XYLENE ISO-CONCENTRATION MAP
LATERAL C-64
SECTION 24, T27N, R6W

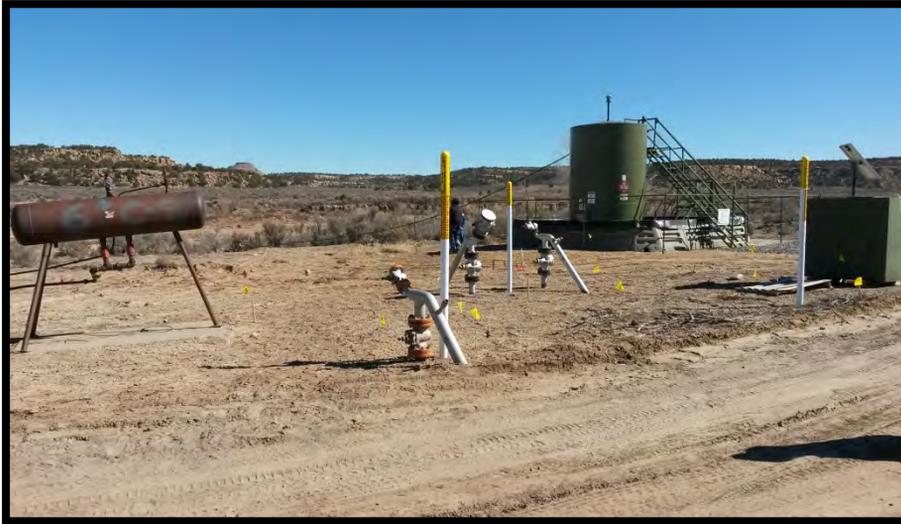
Photo 1: Lateral C-64 pipeline release site. The density of utilities and pipeline infrastructure on site constrained the well construction to proceed from farthest to closest to the road.

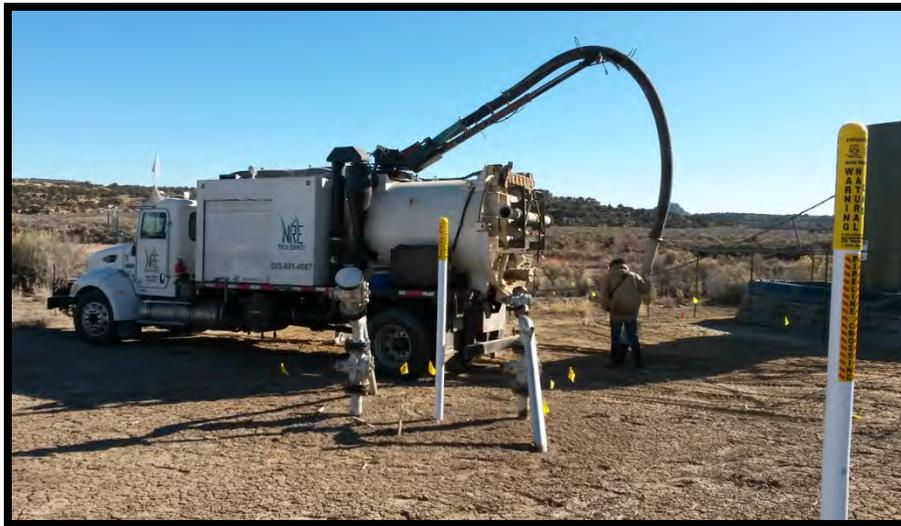
Photo 2: NRE Field Services hydro excavated the pipeline and advanced the borehole locations beyond the depth of any possible buried infrastructure. .

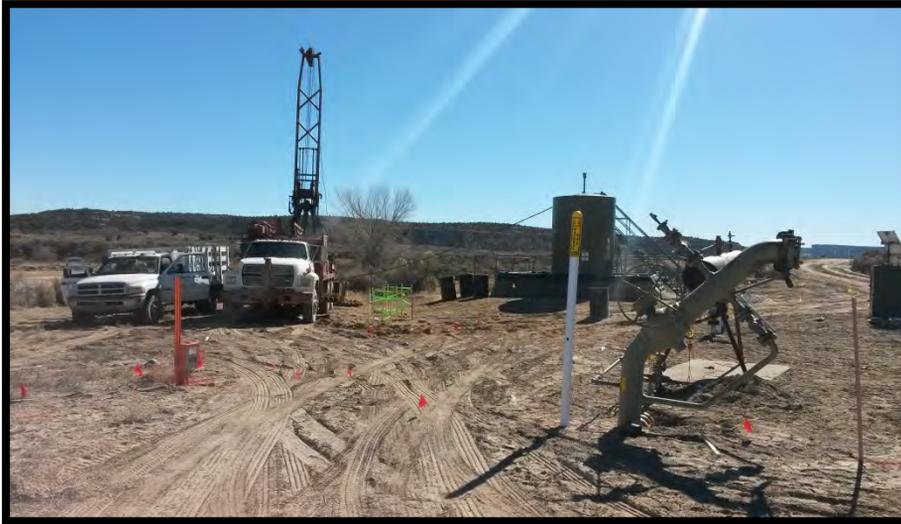
Photo 3: Enviro-Drill Inc. from Albuquerque installed the boreholes and monitor wells on site using a CME-75 drill rig with Hollow Stem Auger tooling and a split spoon sampler.

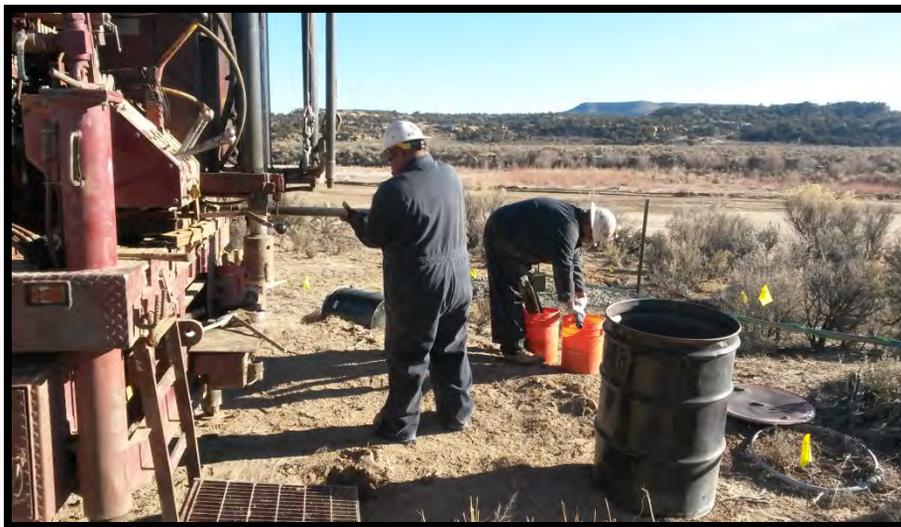
Photo 4: Split spoon sampler was decontaminated between each sample. All cuttings were drummed on site and disposed of by Envirotech.

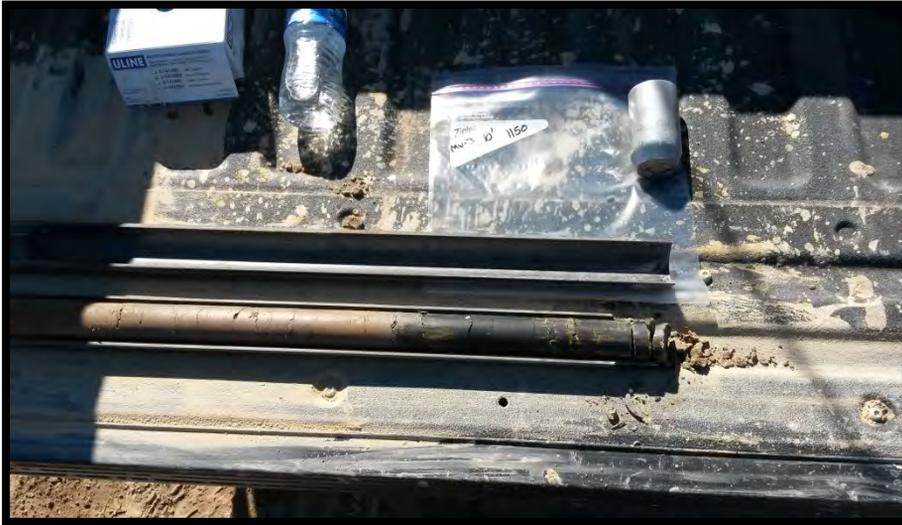
Photo 5: MW-3 is located closest to the location of the release, pictured is the split spoon sample driven from 10 to 12 feet. The black interval is between 11 and 12 feet bgs and had a noticeable hydrocarbon odor.

Recommendations: Because soil contaminant concentrations are above OCD and New Mexico Water Quality Control Commission standards, SMA recommends the excavation of remaining contaminated soils. A target layer of contaminated soil exists between 12 and 25 feet in varying thicknesses across the site. Based on lab analysis and field screening of the soil borings SMA anticipates the overburden soil can be stockpiled and sampled for use as backfill material. SMA also recommends removal of any infiltrating water during the excavation to be collected and hauled off for disposal to further remove any contamination.

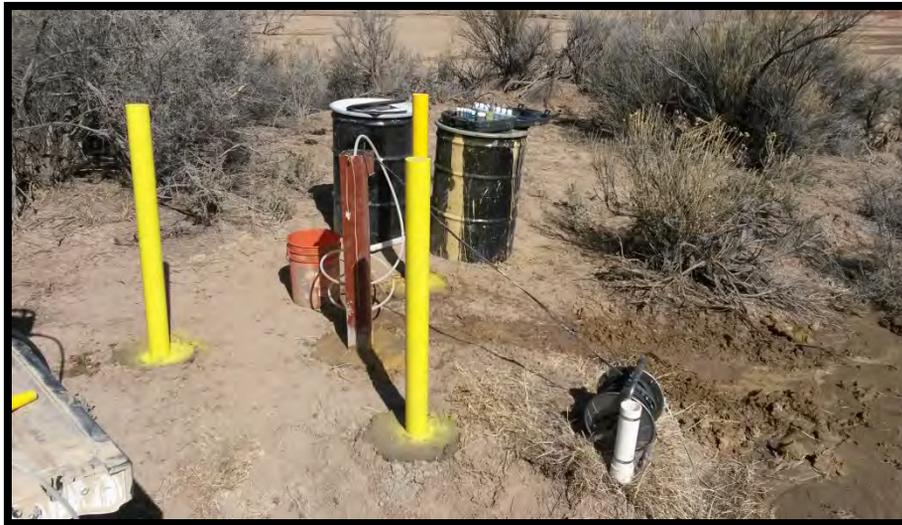
Photo 6: Purging the completed monitor well (MW-1) with a Grunfos submersible electric pump, after wells where surged with a PVC slug. Field parameters where measured with a calibrated HACH meter (on barrel) to monitor stabilization of pH, Temperature and Conductivity.
