CORRECTIVE ACTION REPORT AND SITE INVESTIGATION WORK PLAN

Gallegos #2 Well Tie Pipeline Release (9/18/2014) NE 1/4, S29 T26N R11W San Juan County, New Mexico

> December 2, 2014 Apex Project No. 7030414G035

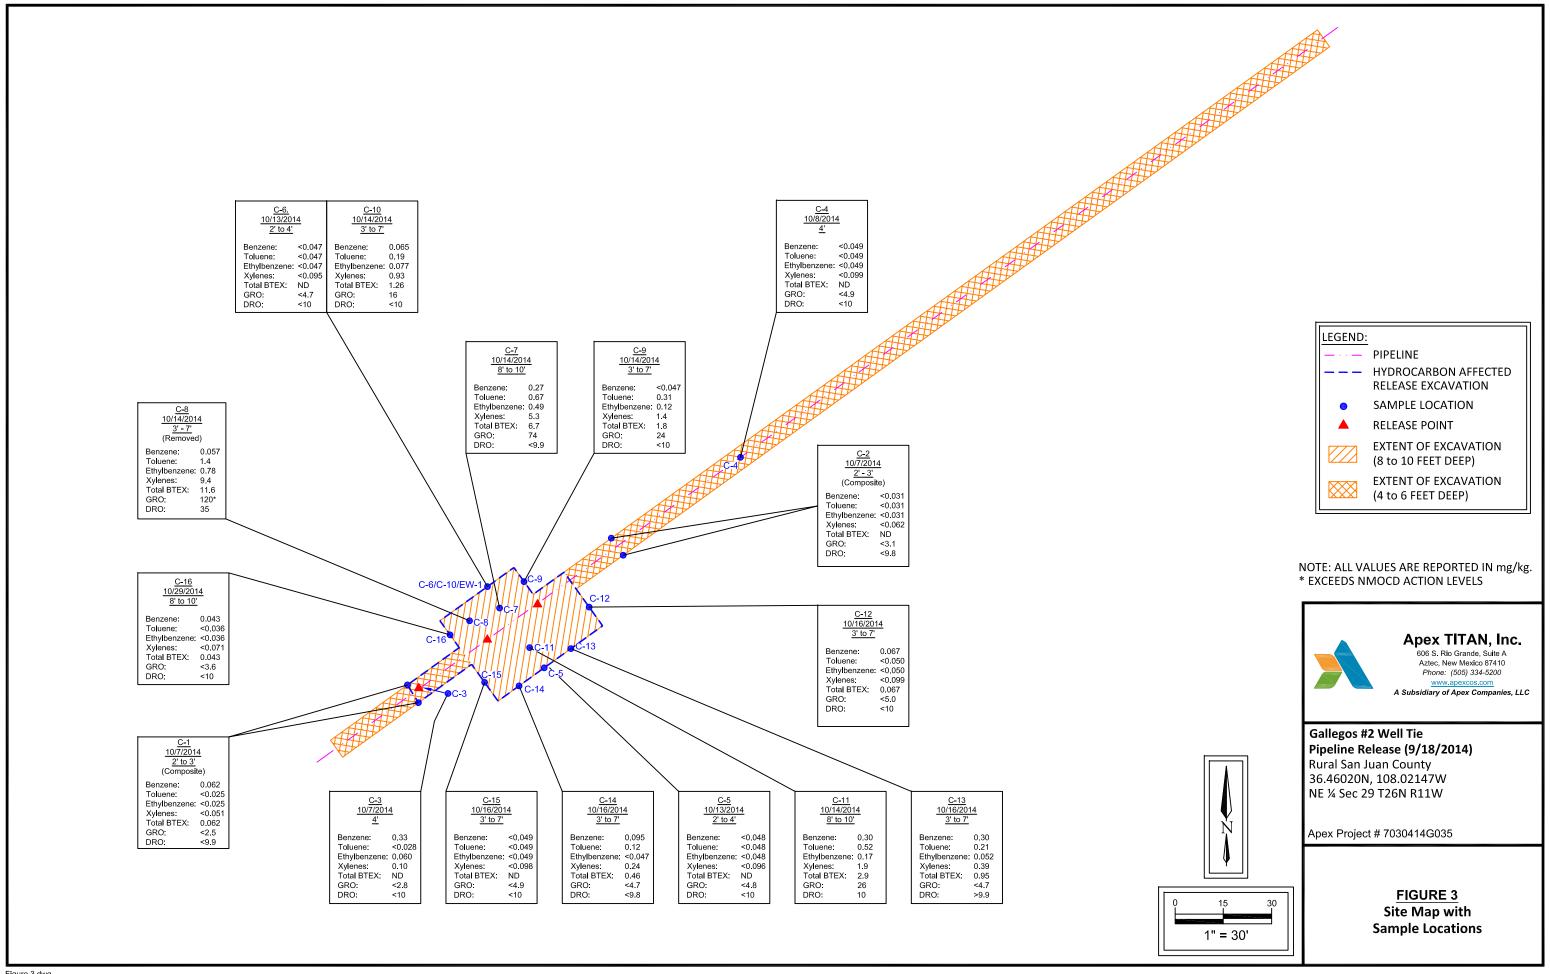
Figure 3 – Site Map with Sample Locations

Figure 3 is a site map that indicates the approximate location of the final excavated area in relation to pertinent land features (Appendix A). Photographic documentation of the field activities is included in Appendix C.

Apex's soil sampling program included the collection of sixteen (16) confirmation samples (C-1 through C-16) from the resulting excavation for laboratory analysis. Additionally, twelve (12) composite samples (SP-1 through SP-12) were collected from the remaining unaffected stockpiled soils to determine the potential to reuse these soils as excavation backfill. Figure 3 depicts the approximate location of the excavated areas and shows the final confirmation sample locations in relation to the final excavation dimensions (Appendix A).

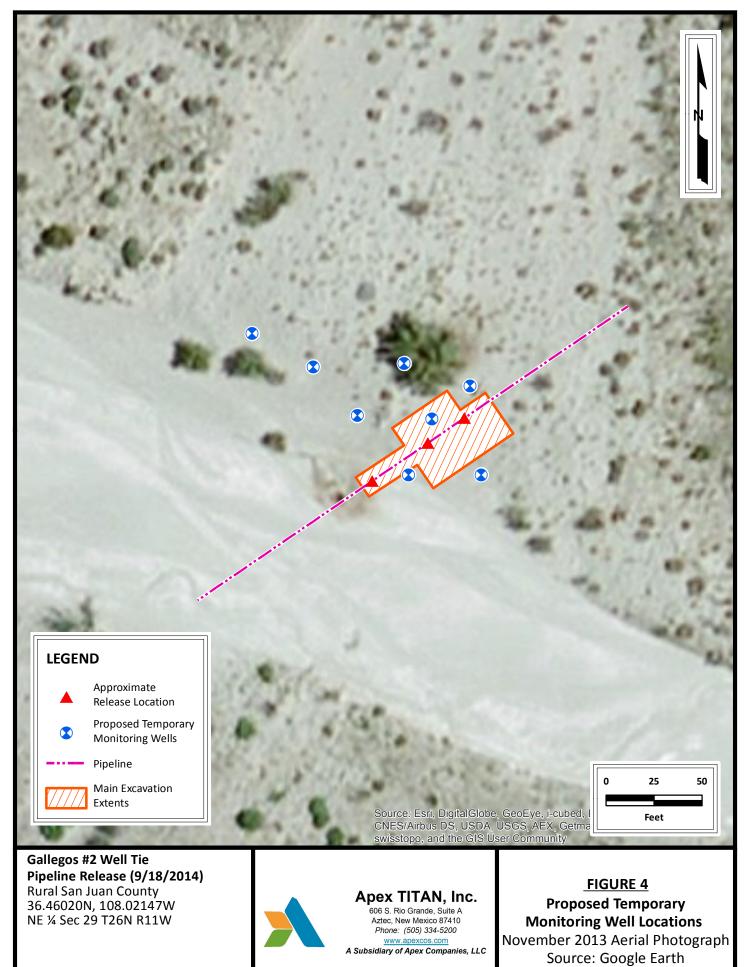
Figure 4 – Proposed Temporary Monitoring Well Locations

Eight (8) soil borings will be advanced and completed as temporary monitoring wells utilizing a direct push Geoprobe[®] drilling rig. The soil borings will be placed in selected locations to further evaluate potential petroleum hydrocarbon soil and groundwater impacts. The soil borings will be advanced to a depth of approximately ten (10) feet bgs, three to four feet below the initial groundwater table elevation, or equipment refusal, whichever is more shallow. Figure 4 is a site map that indicates the approximate locations of the proposed temporary monitoring wells (Appendix A).

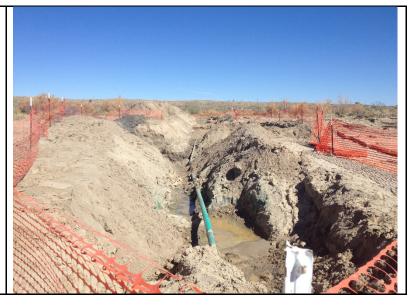
Photograph 1

View of the excavation facing northeast.

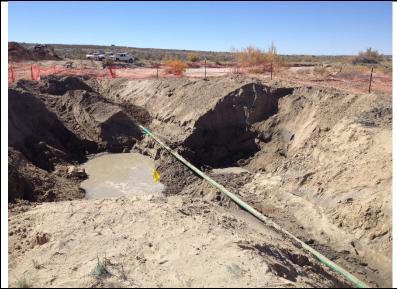
Photograph 2

View of the hydrocarbon affected release excavation facing southwest.

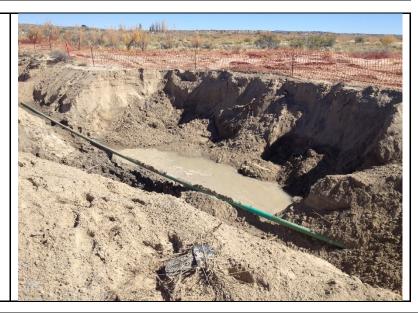
Photograph 3

View of the hydrocarbon affected release excavation facing east.

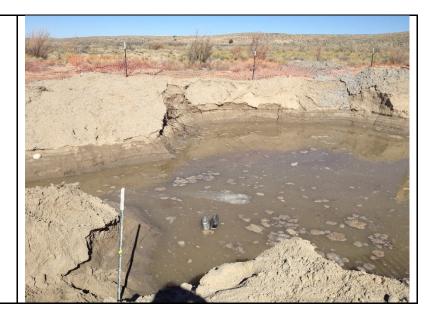
Photograph 4

View of the hydrocarbon affected release excavation facing northwest.
