2014 Annual Groundwater Monitoring Report

ConocoPhillips Flora Vista No. 1
San Juan County, New Mexico
API# 30-045-20073
NMOCD# 3R-173

March 2015 • 074926 • Report No. 6

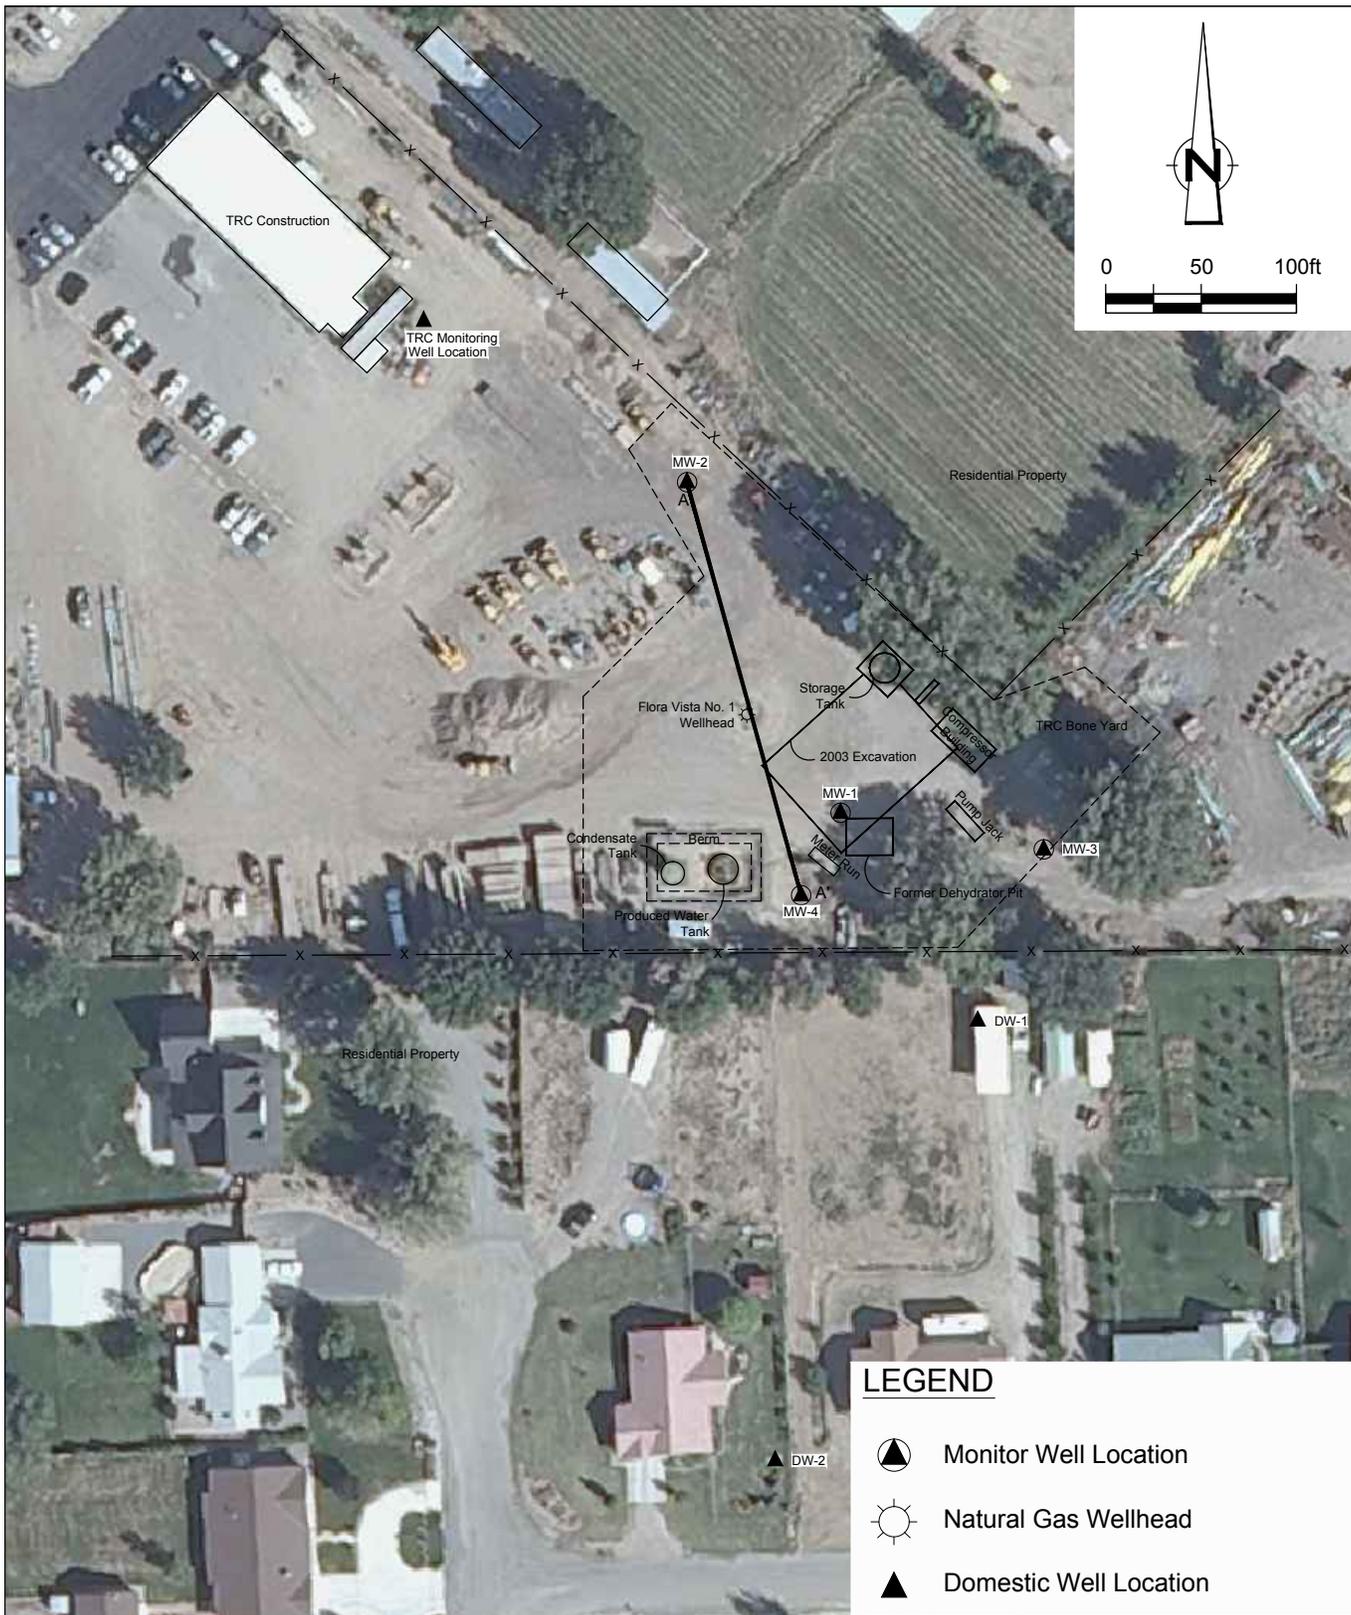
Figure 2

SITE PLAN
FLORA VISTA NO. 1 NATURAL GAS WELL SITE
SECTION 22, T30N-R12W, SAN JUAN COUNTY, NEW MEXICO
ConocoPhillips Company

This annual report presents the results of the quarterly groundwater monitoring events conducted by Conestoga-Rovers & Associates (CRA) during 2014 at the Flora Vista No. 1 natural gas well site (Site), operated by Burlington Resources Oil & Gas Company LP (Burlington), a wholly-owned subsidiary of ConocoPhillips Company (ConocoPhillips) (**Figure 1**). The Site is located on private property in Unit Letter F, Section 22, Township 30N, Range 12W, of San Juan County, New Mexico. The Site consists of a gas well and associated equipment and installations. A detailed Site layout map is provided as **Figure 2**.

In September 2003, Envirotech installed a groundwater monitoring well (MW-1) slightly down-gradient from the center of the excavation (**Figure 2**). Subsequent monitoring included analyses for benzene, toluene, ethylbenzene, and total xylenes (BTEX), as well as total petroleum hydrocarbons (TPH). Groundwater analyses indicated the presence of benzene and total xylenes above regulatory standards. Monitoring wells MW-2, MW-3, and MW-4 were installed at the Site in August 2008 in response to an April 2008 request from NMOCD for Site characterization and enhanced laboratory analyses.

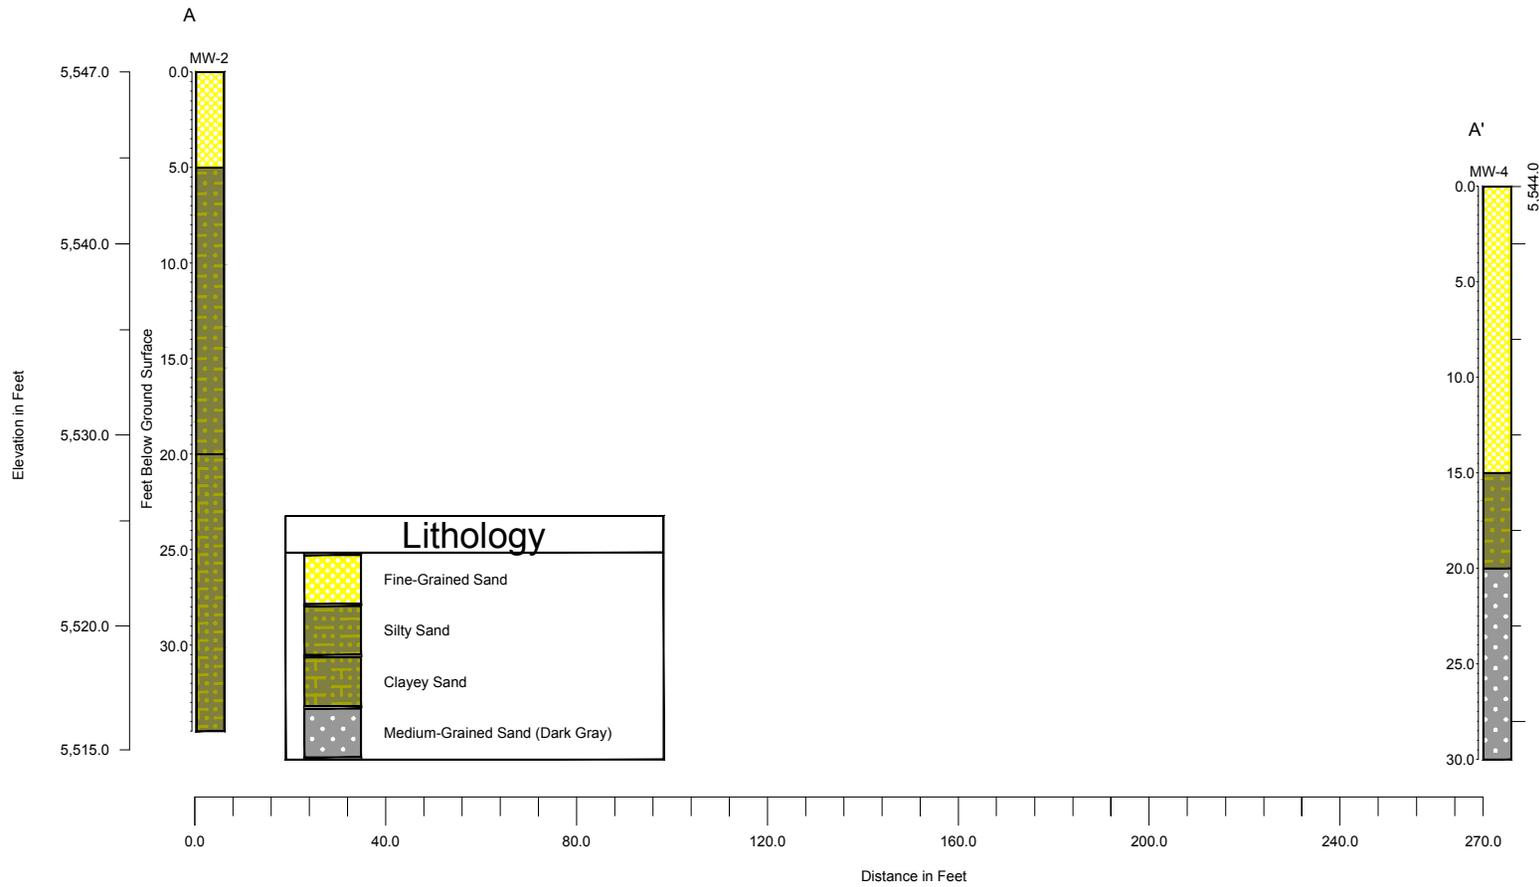
Figure 3
 GEOLOGICAL CROSS SECTION
 FLORA VISTA NO. 1 NATURAL GAS WELL SITE
 SECTION 22, T30N-R12W, SAN JUAN COUNTY, NEW MEXICO
ConocoPhillips Company

Flora Vista No. 1 - Cross-Section A-A'

A generalized geologic cross section was prepared using boring logs from the August 2008 monitoring well installation and is presented as **Figure 3**. In an attempt to actively remediate soil and groundwater at the Site, mobile dual phase extraction (MDPE) was conducted on August 21st and 22nd, 2013. The Flora Vista No. 1 Site history is summarized in **Table 1**.

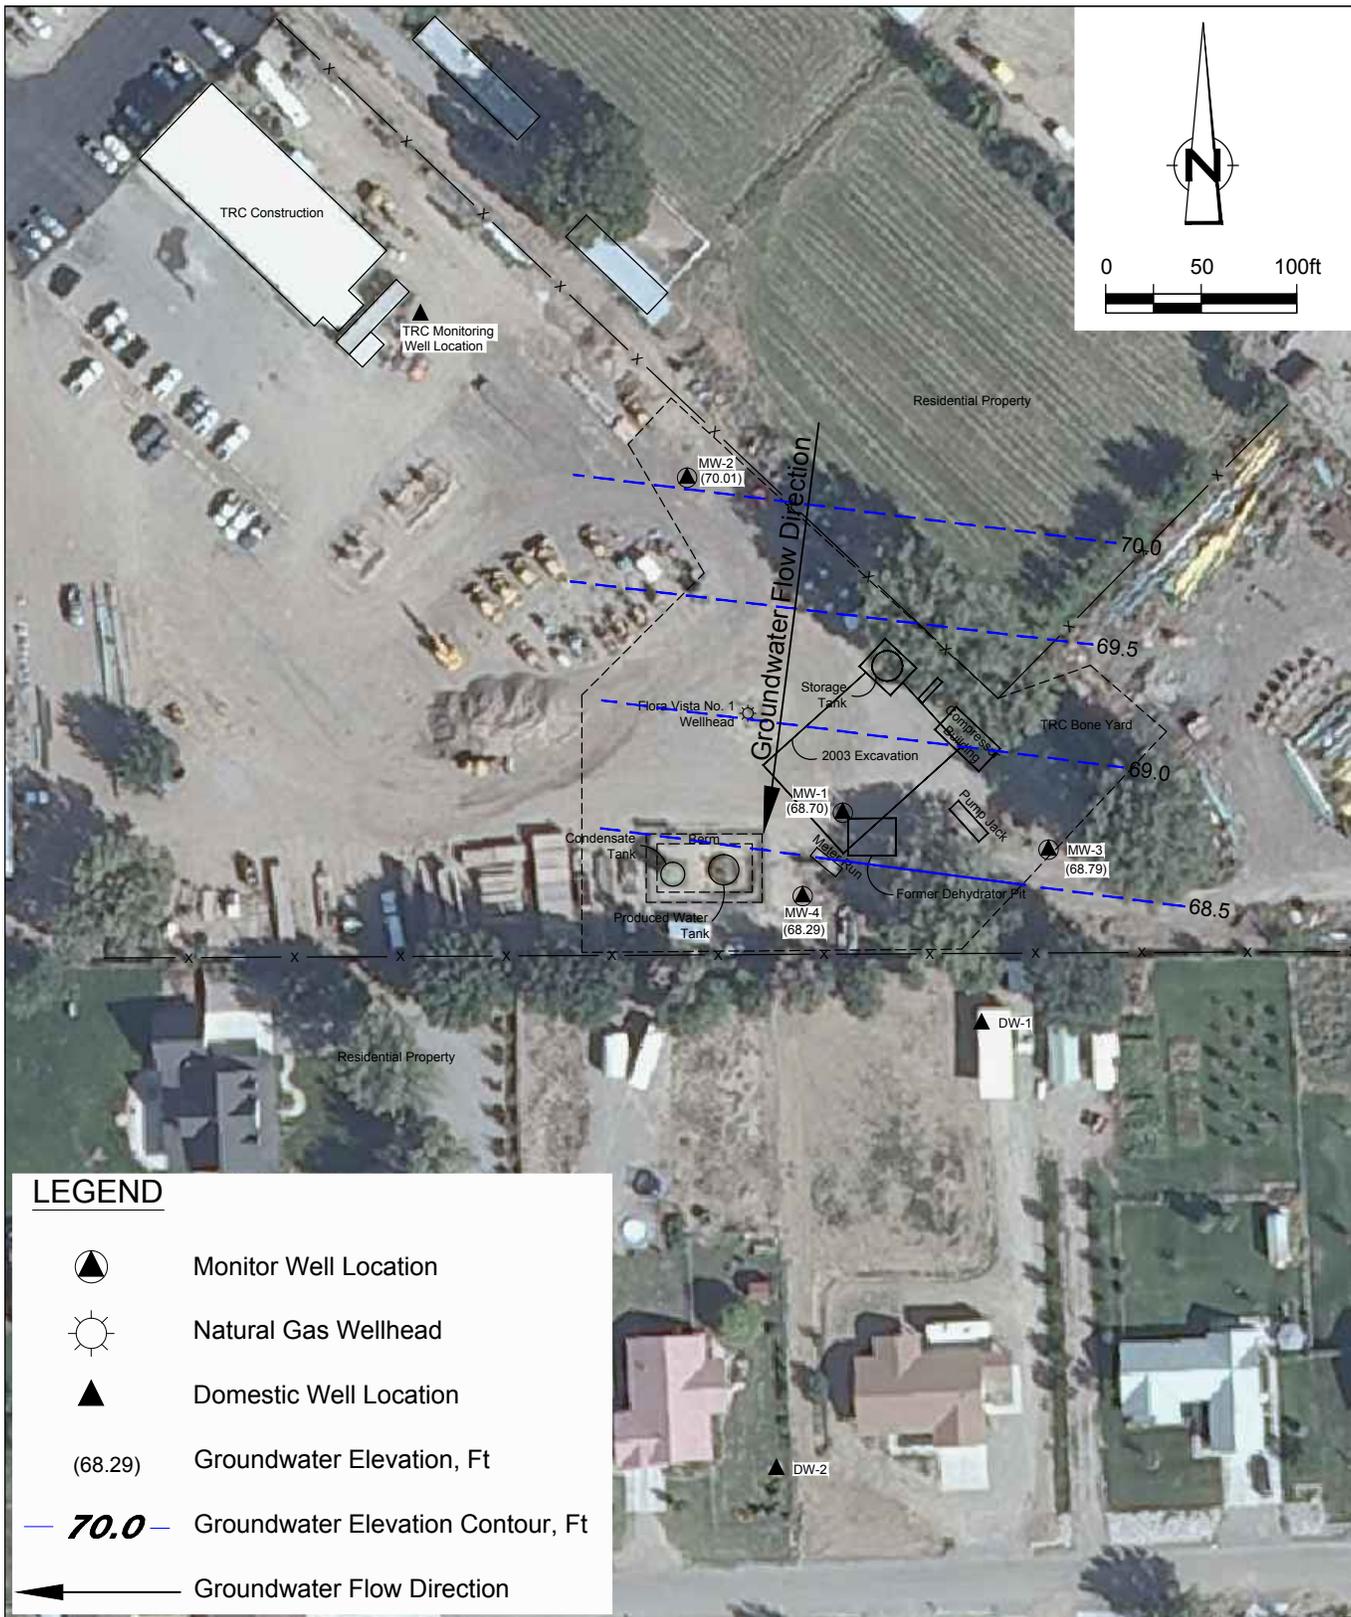
Figure 4

MARCH 2014 GROUNDWATER POTENTIOMETRIC SURFACE MAP
 FLORA VISTA NO. 1 NATURAL GAS WELL SITE
 SECTION 22, T30N-R12W, SAN JUAN COUNTY, NEW MEXICO
ConocoPhillips Company

During 2014 quarterly sampling events conducted on March 19, June 17, September 18, and December 18, groundwater elevation measurements were recorded in monitoring wells MW-1, MW-2, MW-3, and MW-4 using an oil/water interface probe. The only exception was during the December 2014 monitoring event when MW-1 and MW-3 were not able to be located beneath newly added gravel and asphalt in the area of the wells. Groundwater elevations are detailed in **Table 2**. Groundwater potentiometric surface maps created from 2014 data are presented as **Figures 4, 5, 6, and 7**. Based on data collected during the 2014 monitoring events, groundwater flow is to the southwest, consistent with historical data for this Site.

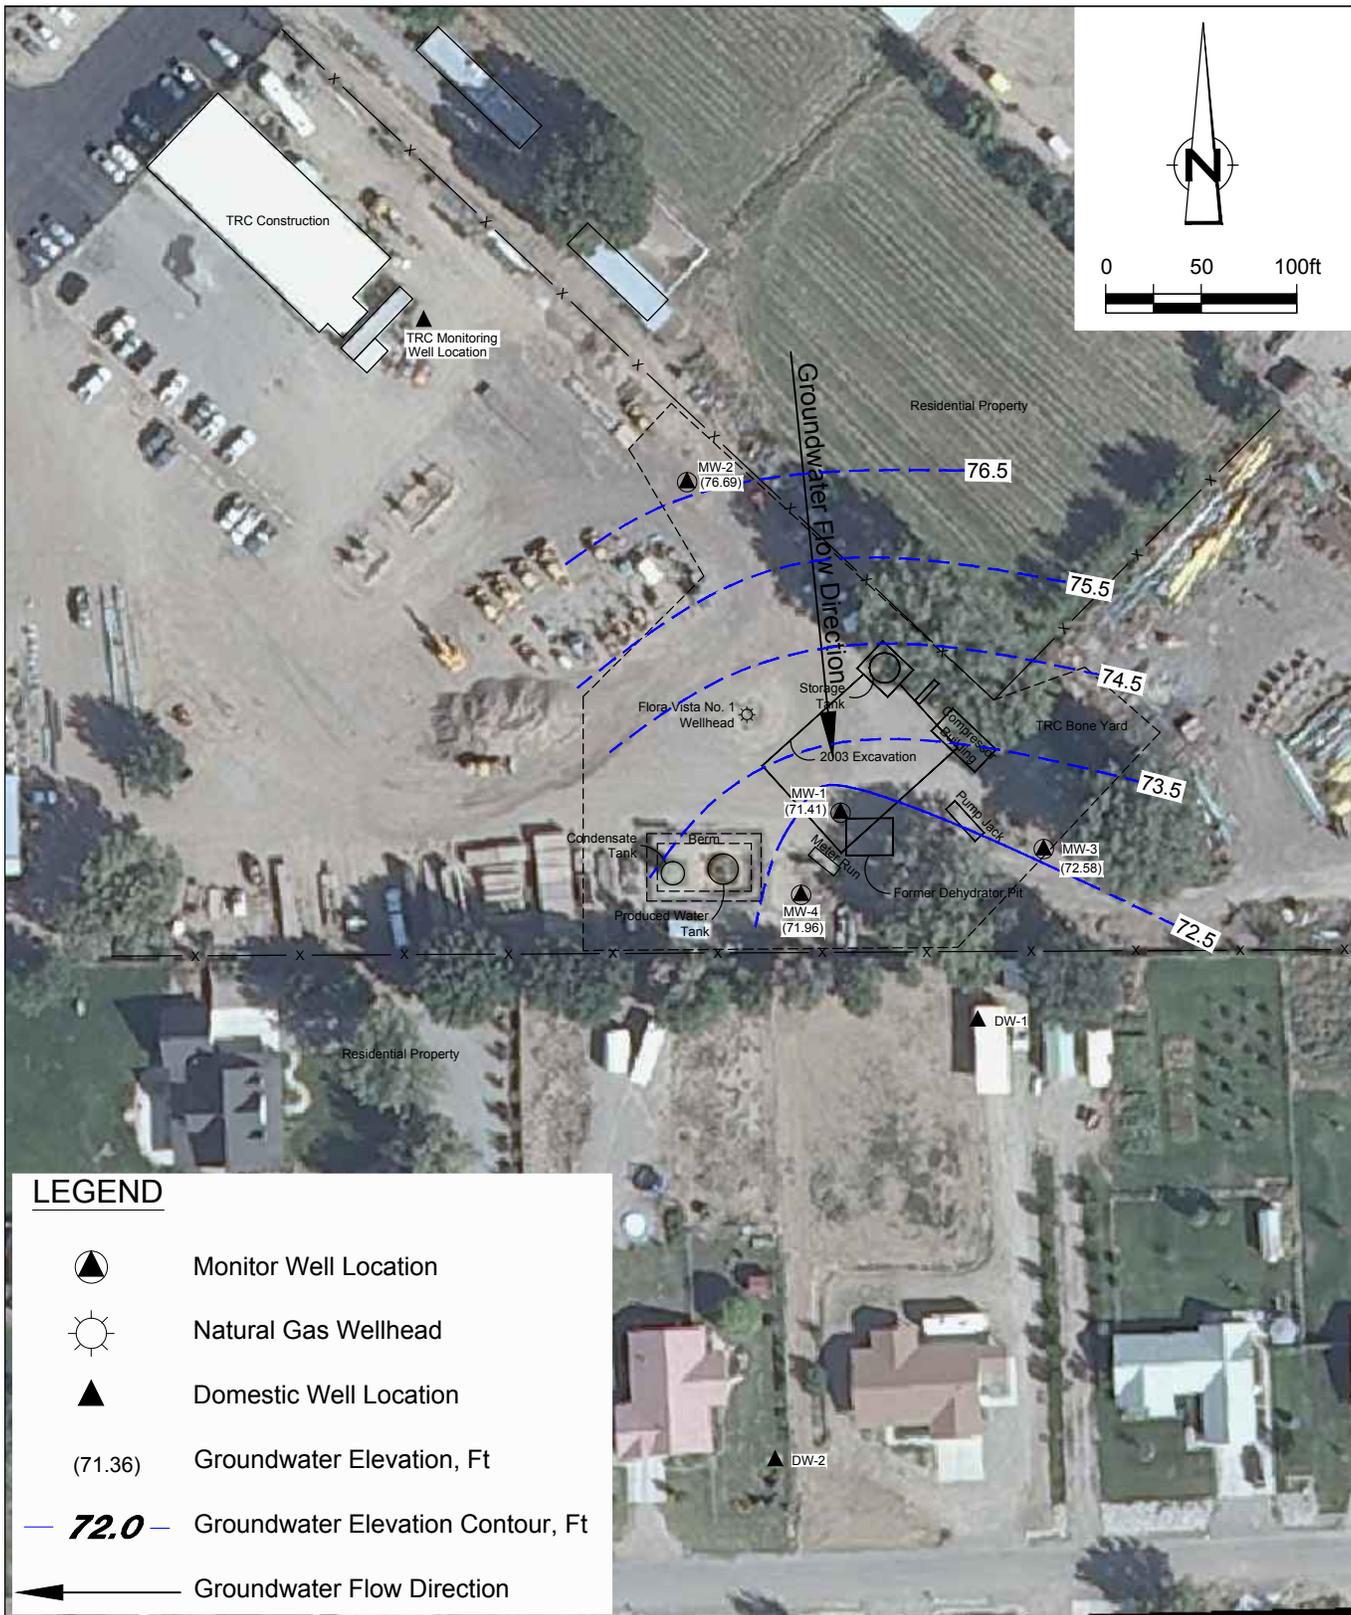
Figure 5

JUNE 2014 GROUNDWATER POTENTIOMETRIC SURFACE MAP
 FLORA VISTA NO. 1 NATURAL GAS WELL SITE
 SECTION 22, T30N-R12W, SAN JUAN COUNTY, NEW MEXICO
ConocoPhillips Company

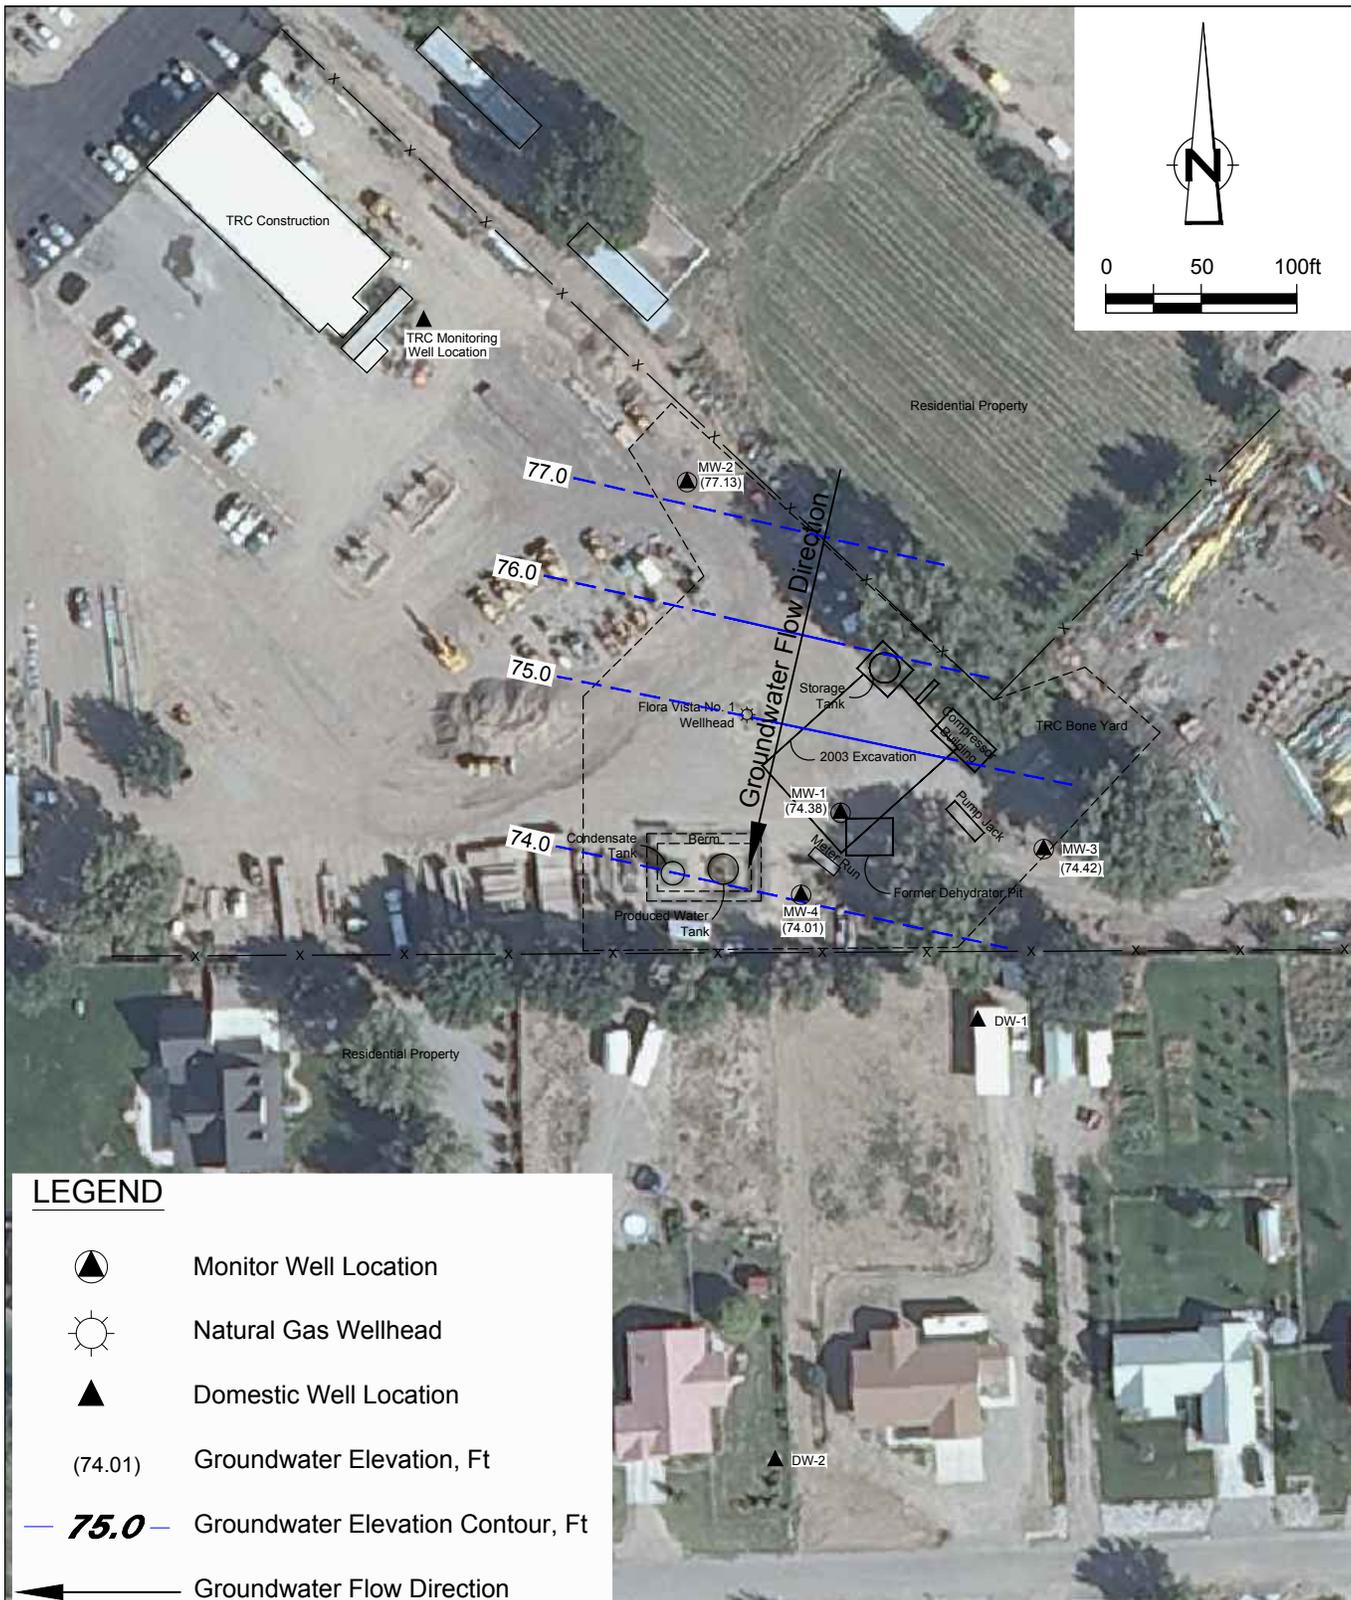
Figure 6

SEPTEMBER 2014 GROUNDWATER POTENTIOMETRIC SURFACE MAP
 FLORA VISTA NO. 1 NATURAL GAS WELL SITE
 SECTION 22, T30N-R12W, SAN JUAN COUNTY, NEW MEXICO

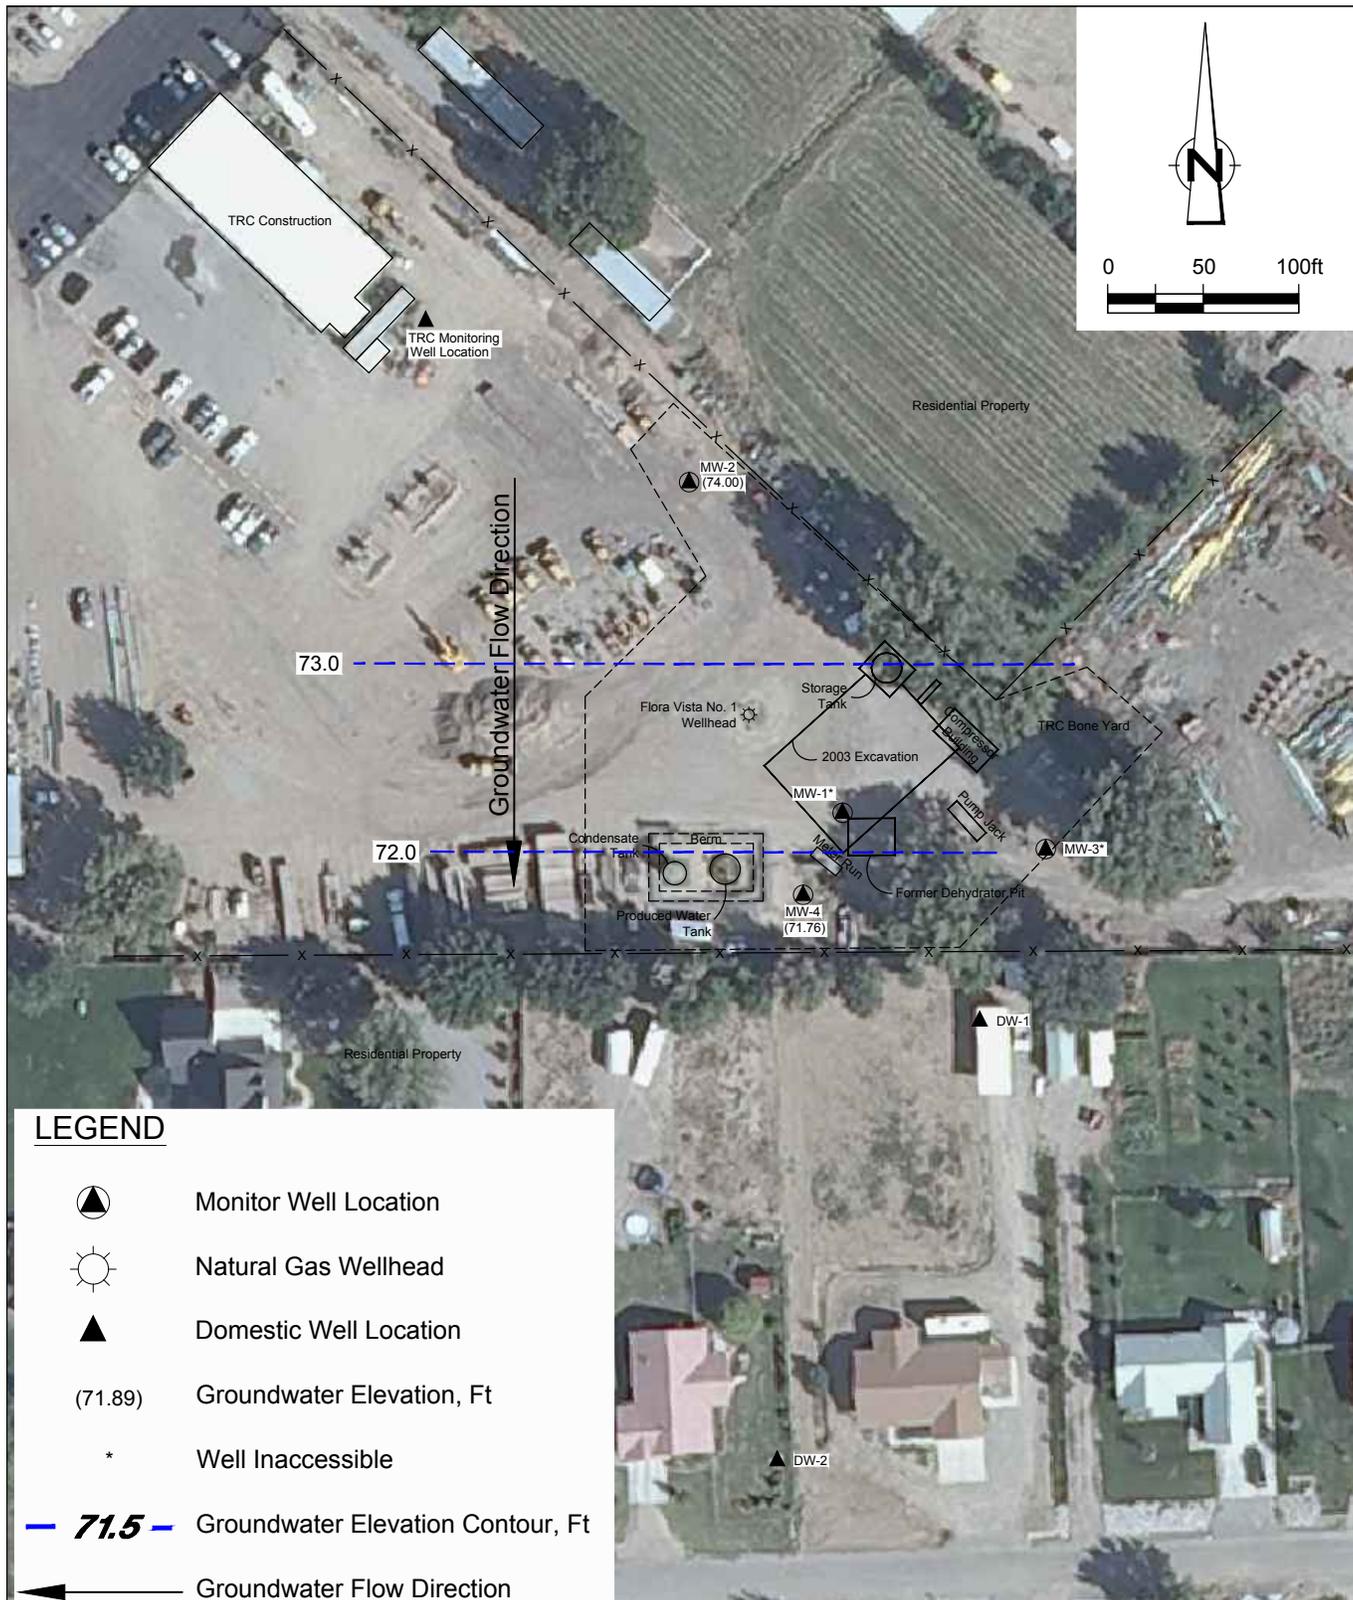
Figure 7

DECEMBER 2014 GROUNDWATER POTENTIOMETRIC SURFACE MAP
 FLORA VISTA NO. 1 NATURAL GAS WELL SITE
 SECTION 22, T30N-R12W, SAN JUAN COUNTY, NEW MEXICO

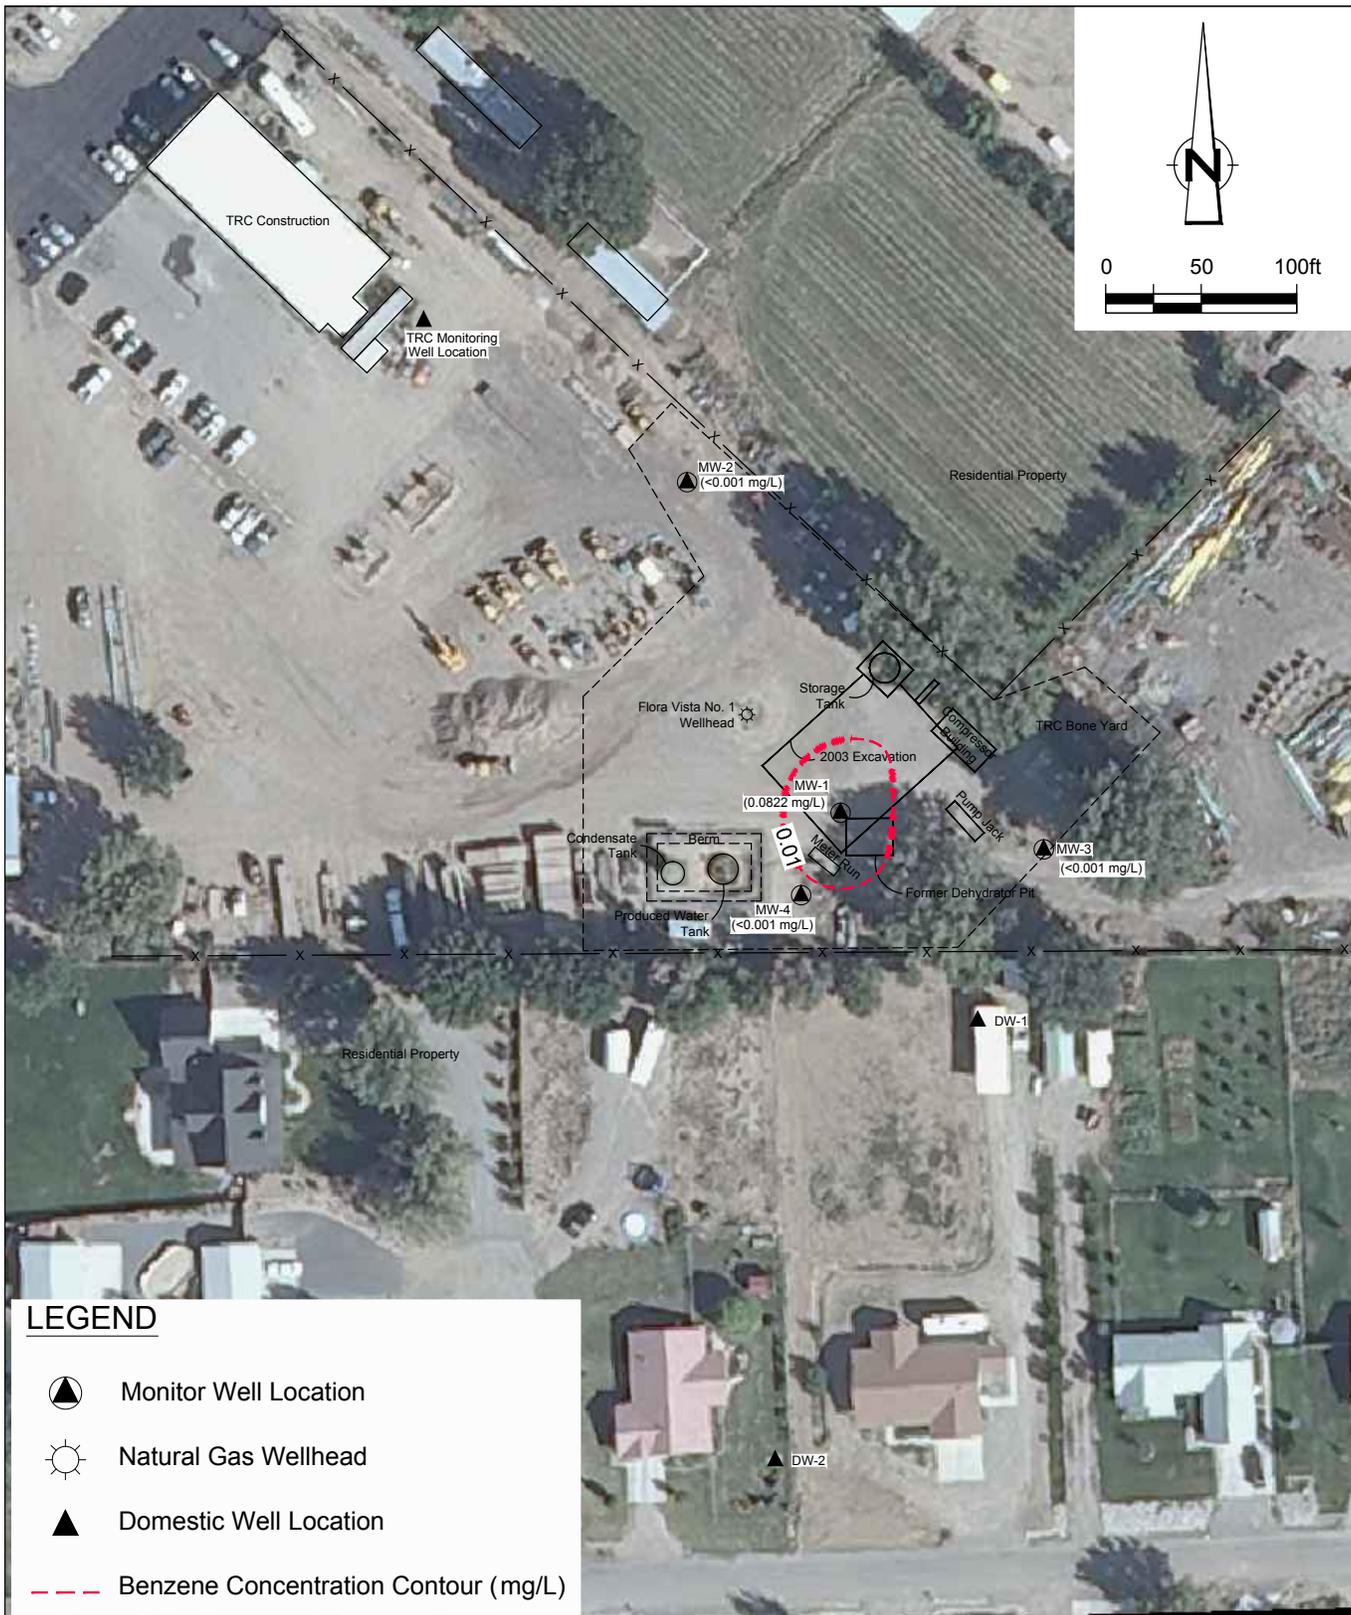
Figure 8

- **Benzene** – The NMWQCC standard for benzene is 0.010 milligrams per liter (mg/L). The concentration of benzene in the groundwater sample collected from MW-1 was 0.0822 mg/L.
- **Dissolved Iron** – The NMWQCC standard for dissolved iron is 1 mg/L. The concentration of dissolved iron in the groundwater sample collected from MW-4 was 1.33 mg/L. Insufficient water was present in MW-1 this quarter to allow for metals analysis.
- **Dissolved Manganese** – The NMWQCC standard for dissolved manganese is 0.2 mg/L. The concentration of dissolved manganese in the groundwater sample collected from MW-4 was 4.19 mg/L. Insufficient water was present in MW-1 this quarter to allow for metals analysis.

MARCH 2014 BENZENE CONCENTRATION MAP
 FLORA VISTA NO. 1 NATURAL GAS WELL SITE
 SECTION 22, T30N-R12W, SAN JUAN COUNTY, NEW MEXICO
ConocoPhillips Company

Benzene concentration maps for the 2014 quarterly groundwater monitoring events are presented in **Figures 8, 9, 10, and 11**. A summary of the historical groundwater laboratory analytical results is presented in **Table 4**. The 2014 laboratory analytical reports are included in **Appendix A**.

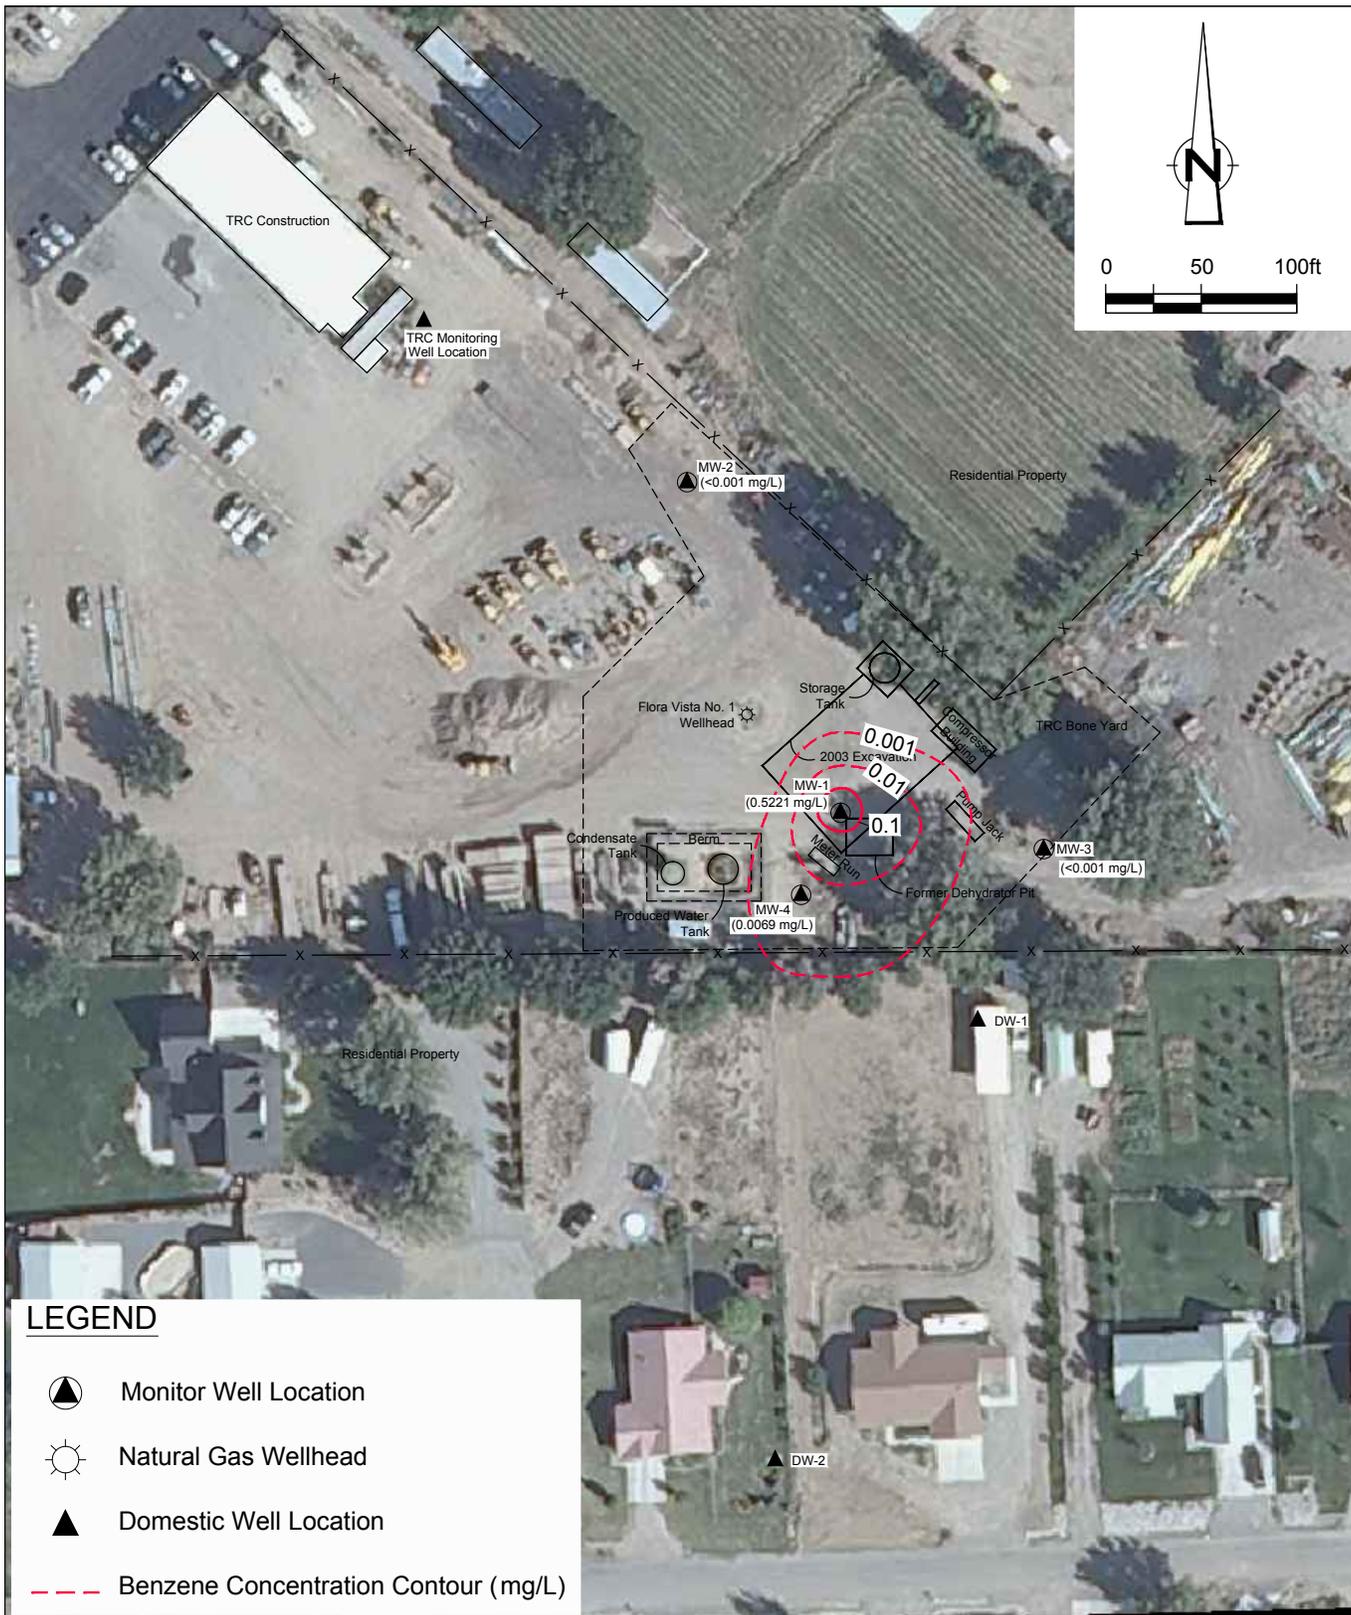
Figure 9

- **Benzene** – The concentration of benzene in the groundwater sample collected from MW-1 was 0.522 mg/L.
- **Dissolved Iron** – The concentrations of dissolved iron in groundwater samples collected from MW-1 and MW-4 were 17.4 mg/L and 2.68 mg/L, respectively.
- **Dissolved Manganese** – The concentrations of dissolved manganese in groundwater samples collected from MW-1 and MW-4 were 0.896 mg/L and 4.01 mg/L, respectively.

JUNE 2014 BENZENE CONCENTRATION MAP
 FLORA VISTA NO. 1 NATURAL GAS WELL SITE
 SECTION 22, T30N-R12W, SAN JUAN COUNTY, NEW MEXICO
ConocoPhillips Company

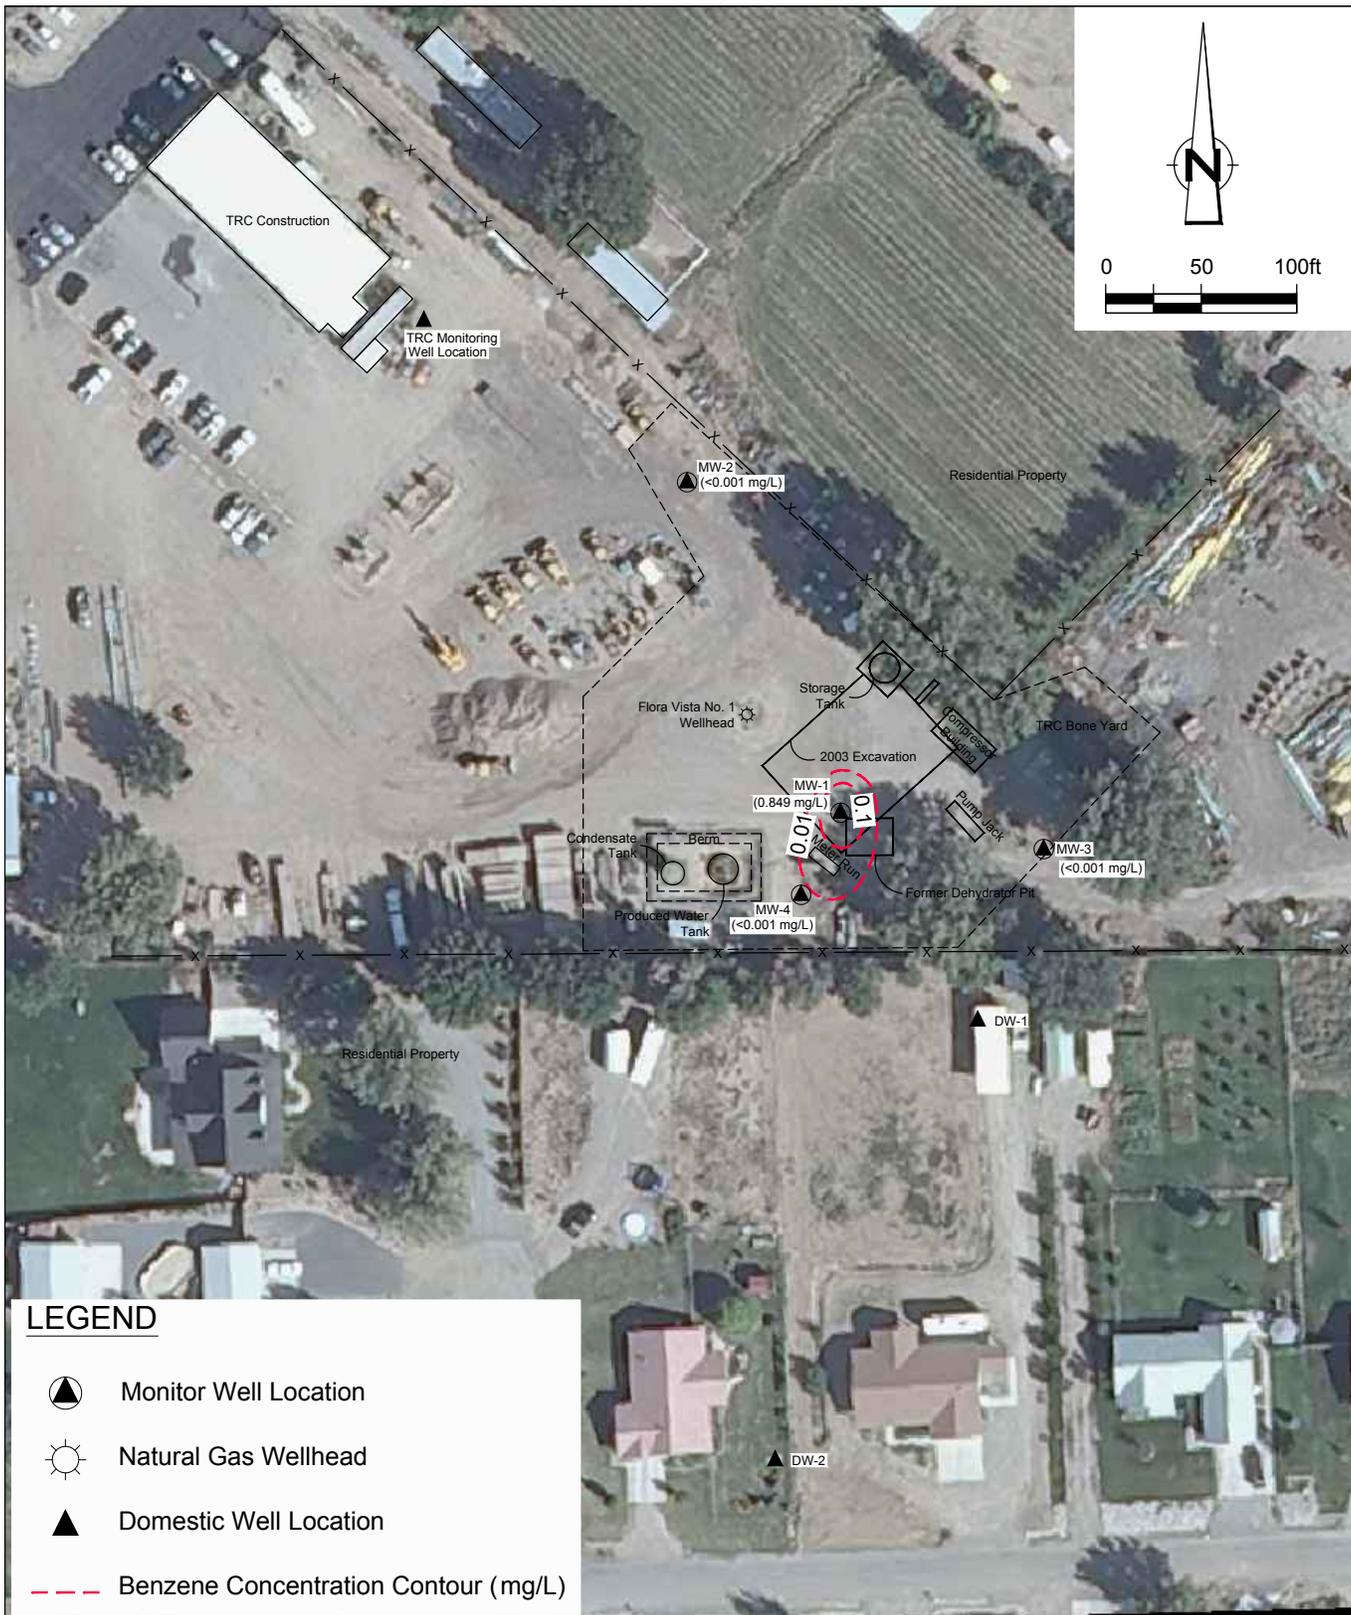
Figure 10

- **Benzene** – The concentration of benzene in the groundwater sample collected from MW-1 was 0.849 mg/L.
- **Xylenes** – The NMWQCC standard for total xylenes is 0.62 mg/L. The concentration of xylenes in the groundwater sample collected from MW-1 was 1.23 mg/L.
- **Dissolved Iron** – The concentrations of dissolved iron in groundwater samples collected from MW-1 and MW-4 were 23.4 mg/L and 3.43 mg/L, respectively.

SEPTEMBER 2014 BENZENE CONCENTRATION MAP
 FLORA VISTA NO. 1 NATURAL GAS WELL SITE
 SECTION 22, T30N-R12W, SAN JUAN COUNTY, NEW MEXICO
ConocoPhillips Company

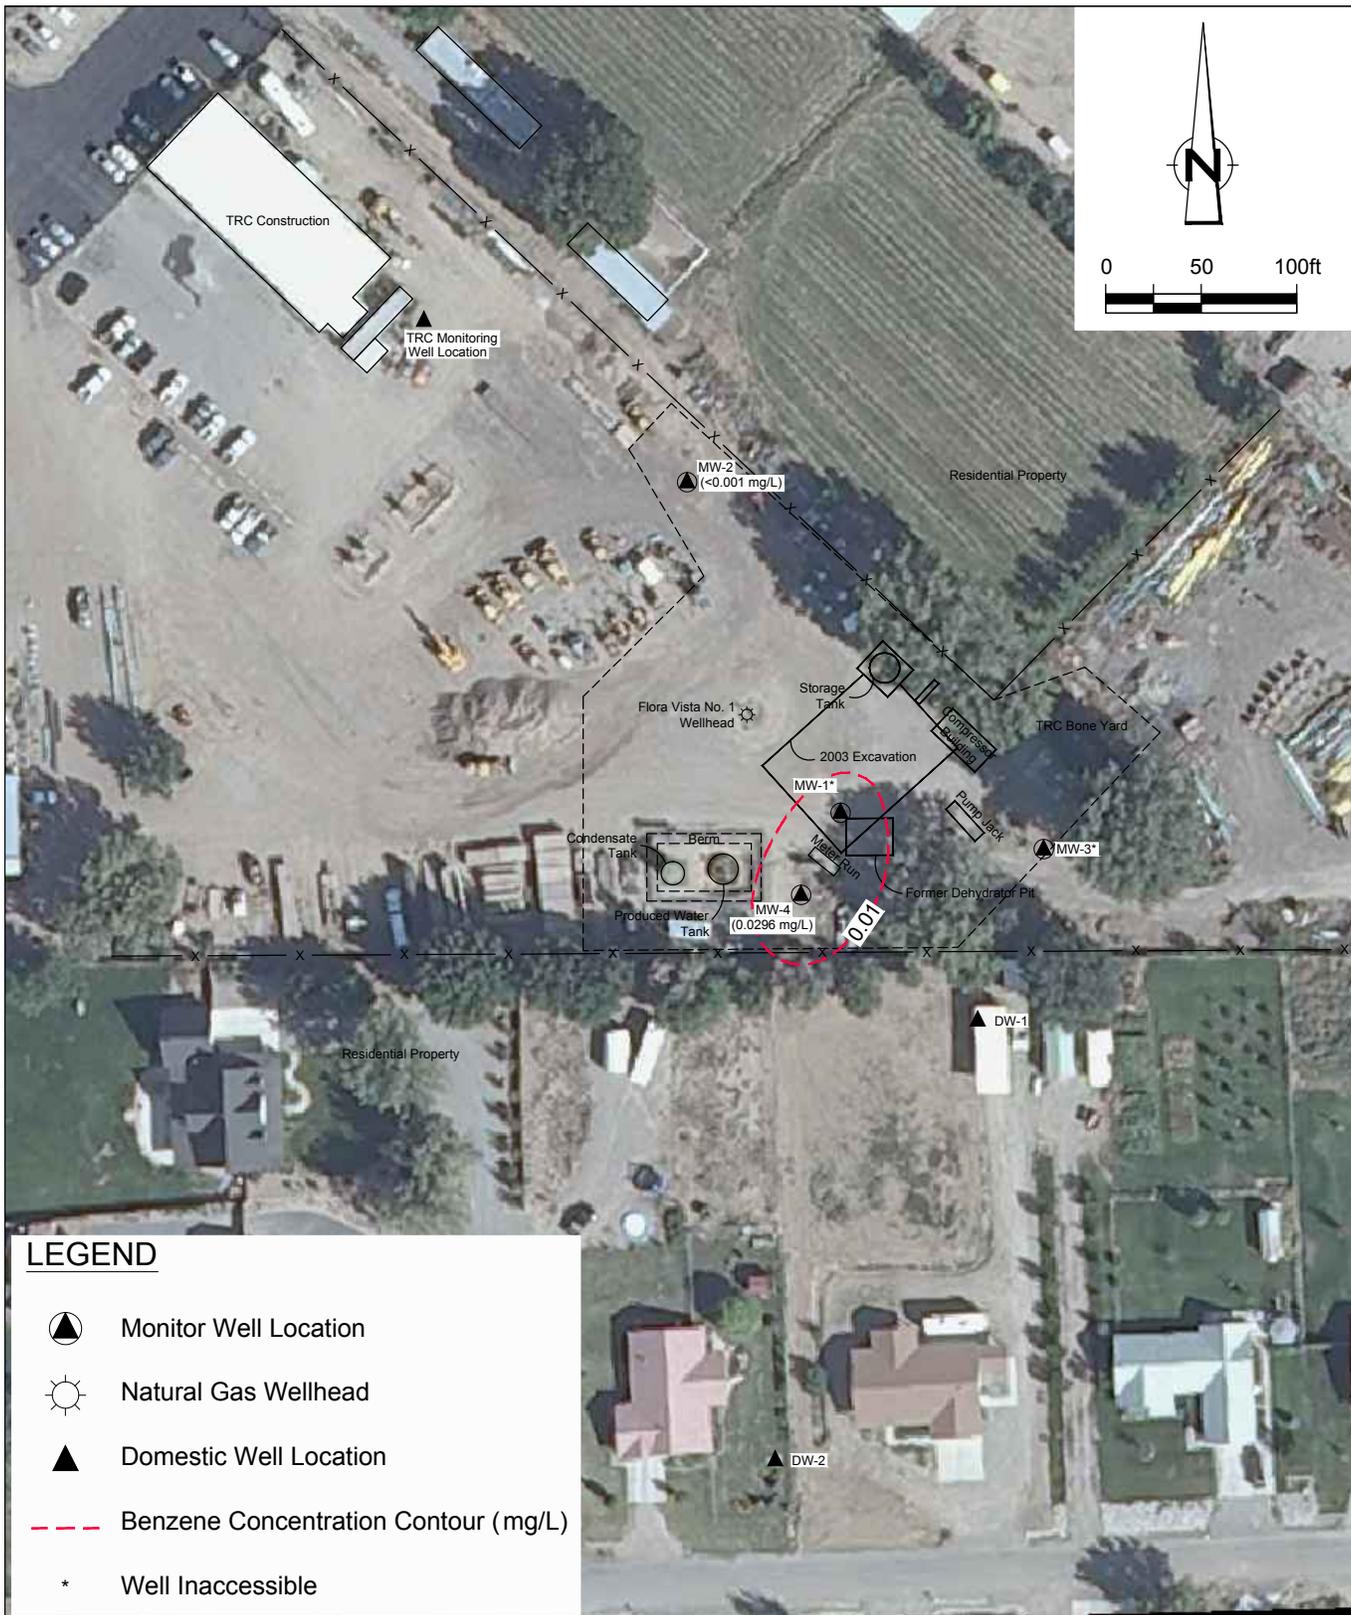
Figure 11

- **Benzene** – The concentration of benzene in the groundwater sample collected from MW-4 was 0.0296 mg/L.
- **Dissolved Iron** – The concentration of dissolved iron in the groundwater sample collected from MW-4 was 4.02 mg/L.
- **Dissolved Manganese** – The concentrations of dissolved manganese in the groundwater sample collected from MW-4 was 4.46 mg/L.

DECEMBER 2014 BENZENE CONCENTRATION MAP
 FLORA VISTA NO. 1 NATURAL GAS WELL SITE
 SECTION 22, T30N-R12W, SAN JUAN COUNTY, NEW MEXICO
ConocoPhillips Company
