2014 Annual Groundwater Monitoring Report

ConocoPhillips Flora Vista No. 1
San Juan County, New Mexico
API# 30-045-20073
NMOCD# 3R-173

March 2015 • 074926 • Report No. 6

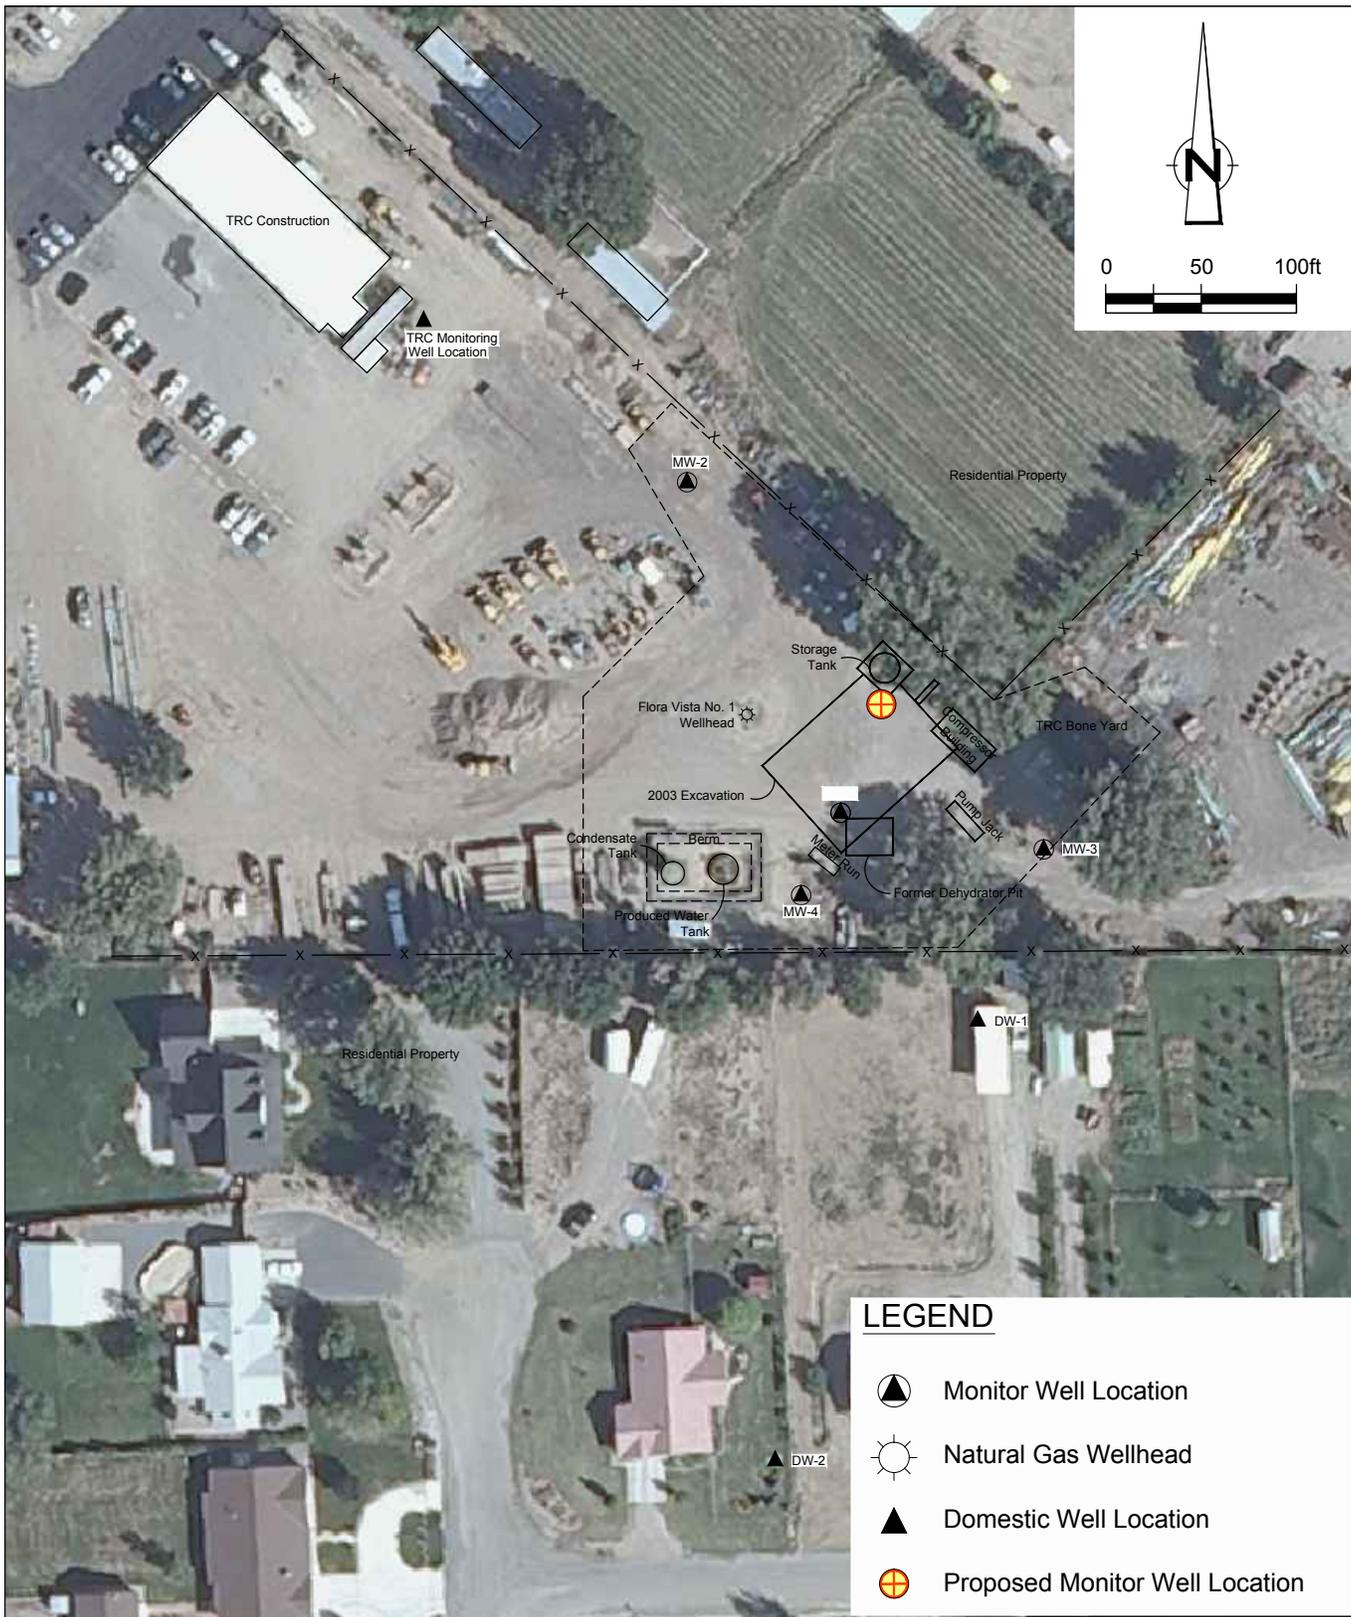
Figure 12

PROPOSED MONITOR WELL LOCATION MAP
FLORA VISTA NO. 1 NATURAL GAS WELL SITE
SECTION 22, T30N-R12W, SAN JUAN COUNTY, NEW MEXICO
ConocoPhillips Company

CRA recommends an assessment be made of subsurface soil and groundwater conditions north of monitoring well MW-1, between it and the on-Site storage tank, to attempt to determine

whether this tank is a source of released hydrocarbons (**Figure 12**). An additional monitoring well, MW-5, is proposed for this location. Soil and groundwater samples collected during drilling would be analyzed for hydrocarbons.
