**Re: Continued Site Assessment Workplan
Lateral C-64 July 2013 Line Drip Release
NW ¼ NE ¼, Sec 24, T27N, R6W
Rio Arriba County, New Mexico**

**RE: Continued Site Assessment Workplan
Lateral C-64 July 2013 Line Drip Release
NW¼ NE¼, Section 24, T27N, R6W
Rio Arriba County, New Mexico**

Animas Environmental Services, LLC (AES) has completed an initial release assessment and a workplan for continued assessment at the Lateral C-64 line drip release that was discovered by Enterprise Field Services, LLC (Enterprise) in July 2013. On July 31, 2013, AES completed an initial assessment associated with a release of unknown volume of natural gas and petroleum hydrocarbons from the Enterprise Lateral C-64 line drip. The release resulted from a leak caused by corrosion and was discovered by Enterprise personnel on July 24, 2013.

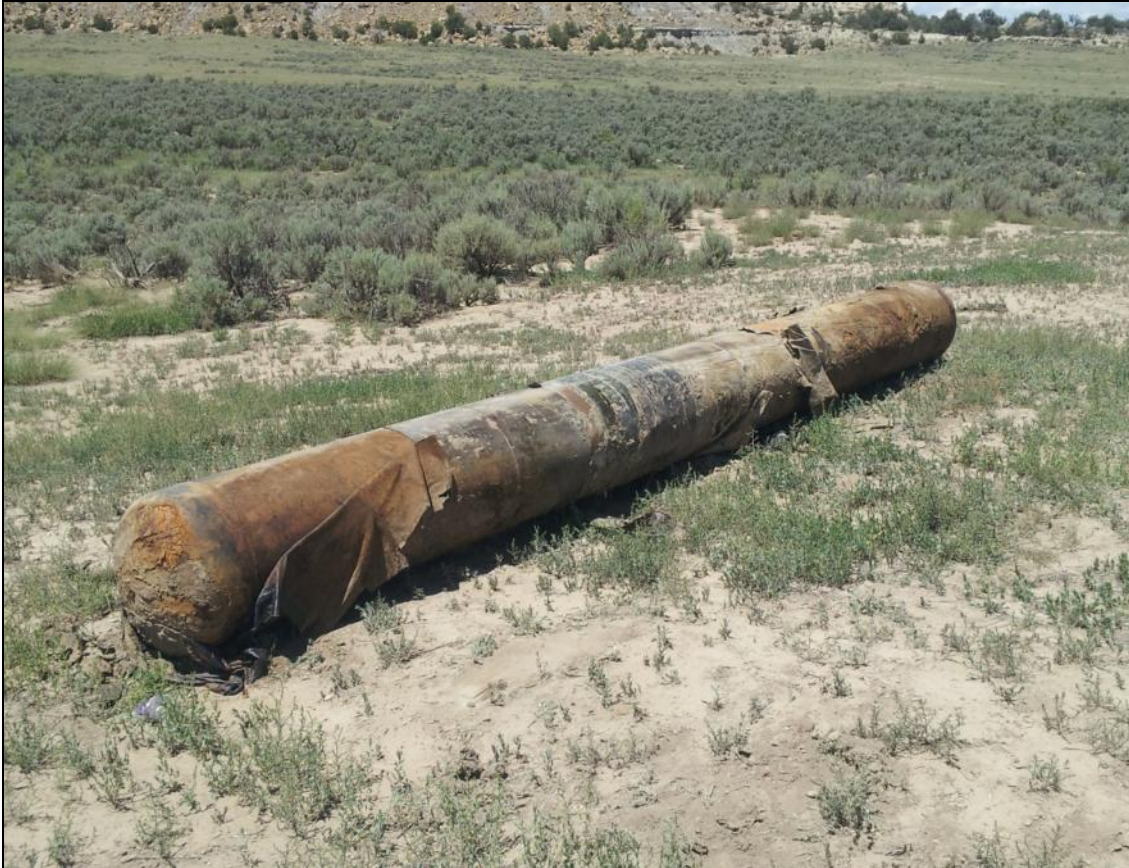
Photo #1

Description: Removed line drip.

On July 31, 2013, Enterprise contractors completed the excavation and removal of the line drip. The line drip was not replaced, and 6-inch pipeline was used to repair the Lateral C-64 pipeline. During the excavation work, AES collected six discrete soil samples (S-1 at 6 feet and 11 feet, and S-2 through S-5 from 2.5 feet) from the four walls and base of the excavation for field screening of volatile organic compounds (VOCs). The final excavation dimensions measured approximately 24 feet by 12 feet by 11 feet in depth. A photograph log is included in the Appendix.

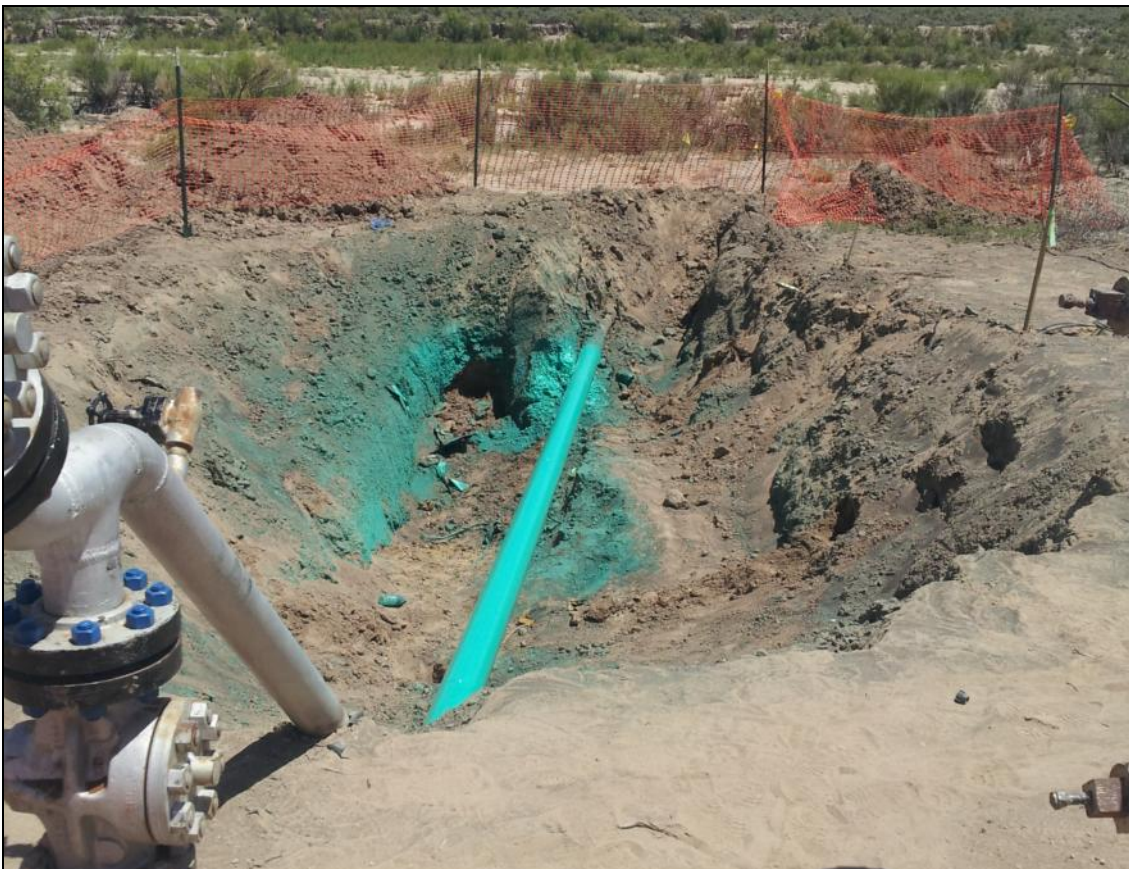
Photo #2

Description: View looking east of repaired pipeline.

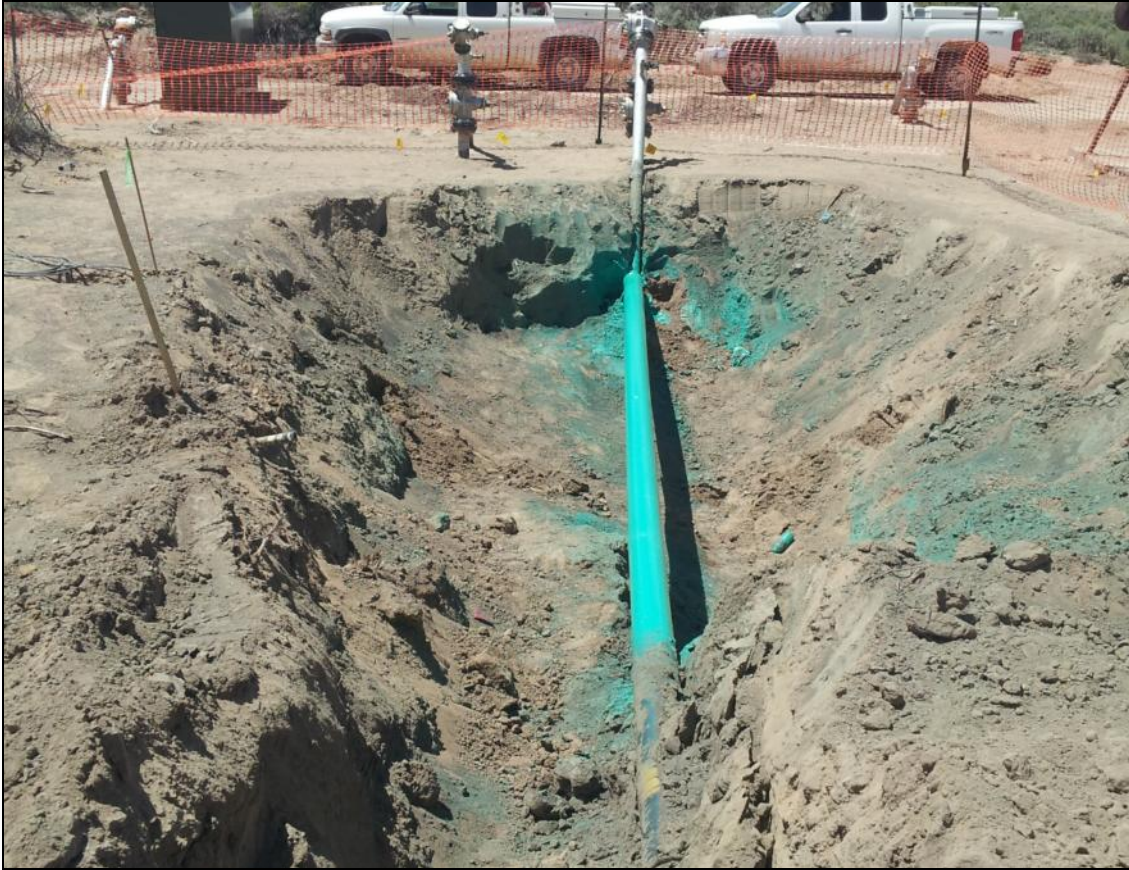
Photo #3

Description: View looking west of repaired pipeline.
