Re: Central Vacuum Unit 47H Soil Assessment and Delineation Activities Report

Soil Assessment and Delineation Activities Report

Central Vacuum Unit No. 47H

Unit A, Section 31, Township 17 South, Range 35 East Lovington, New Mexico

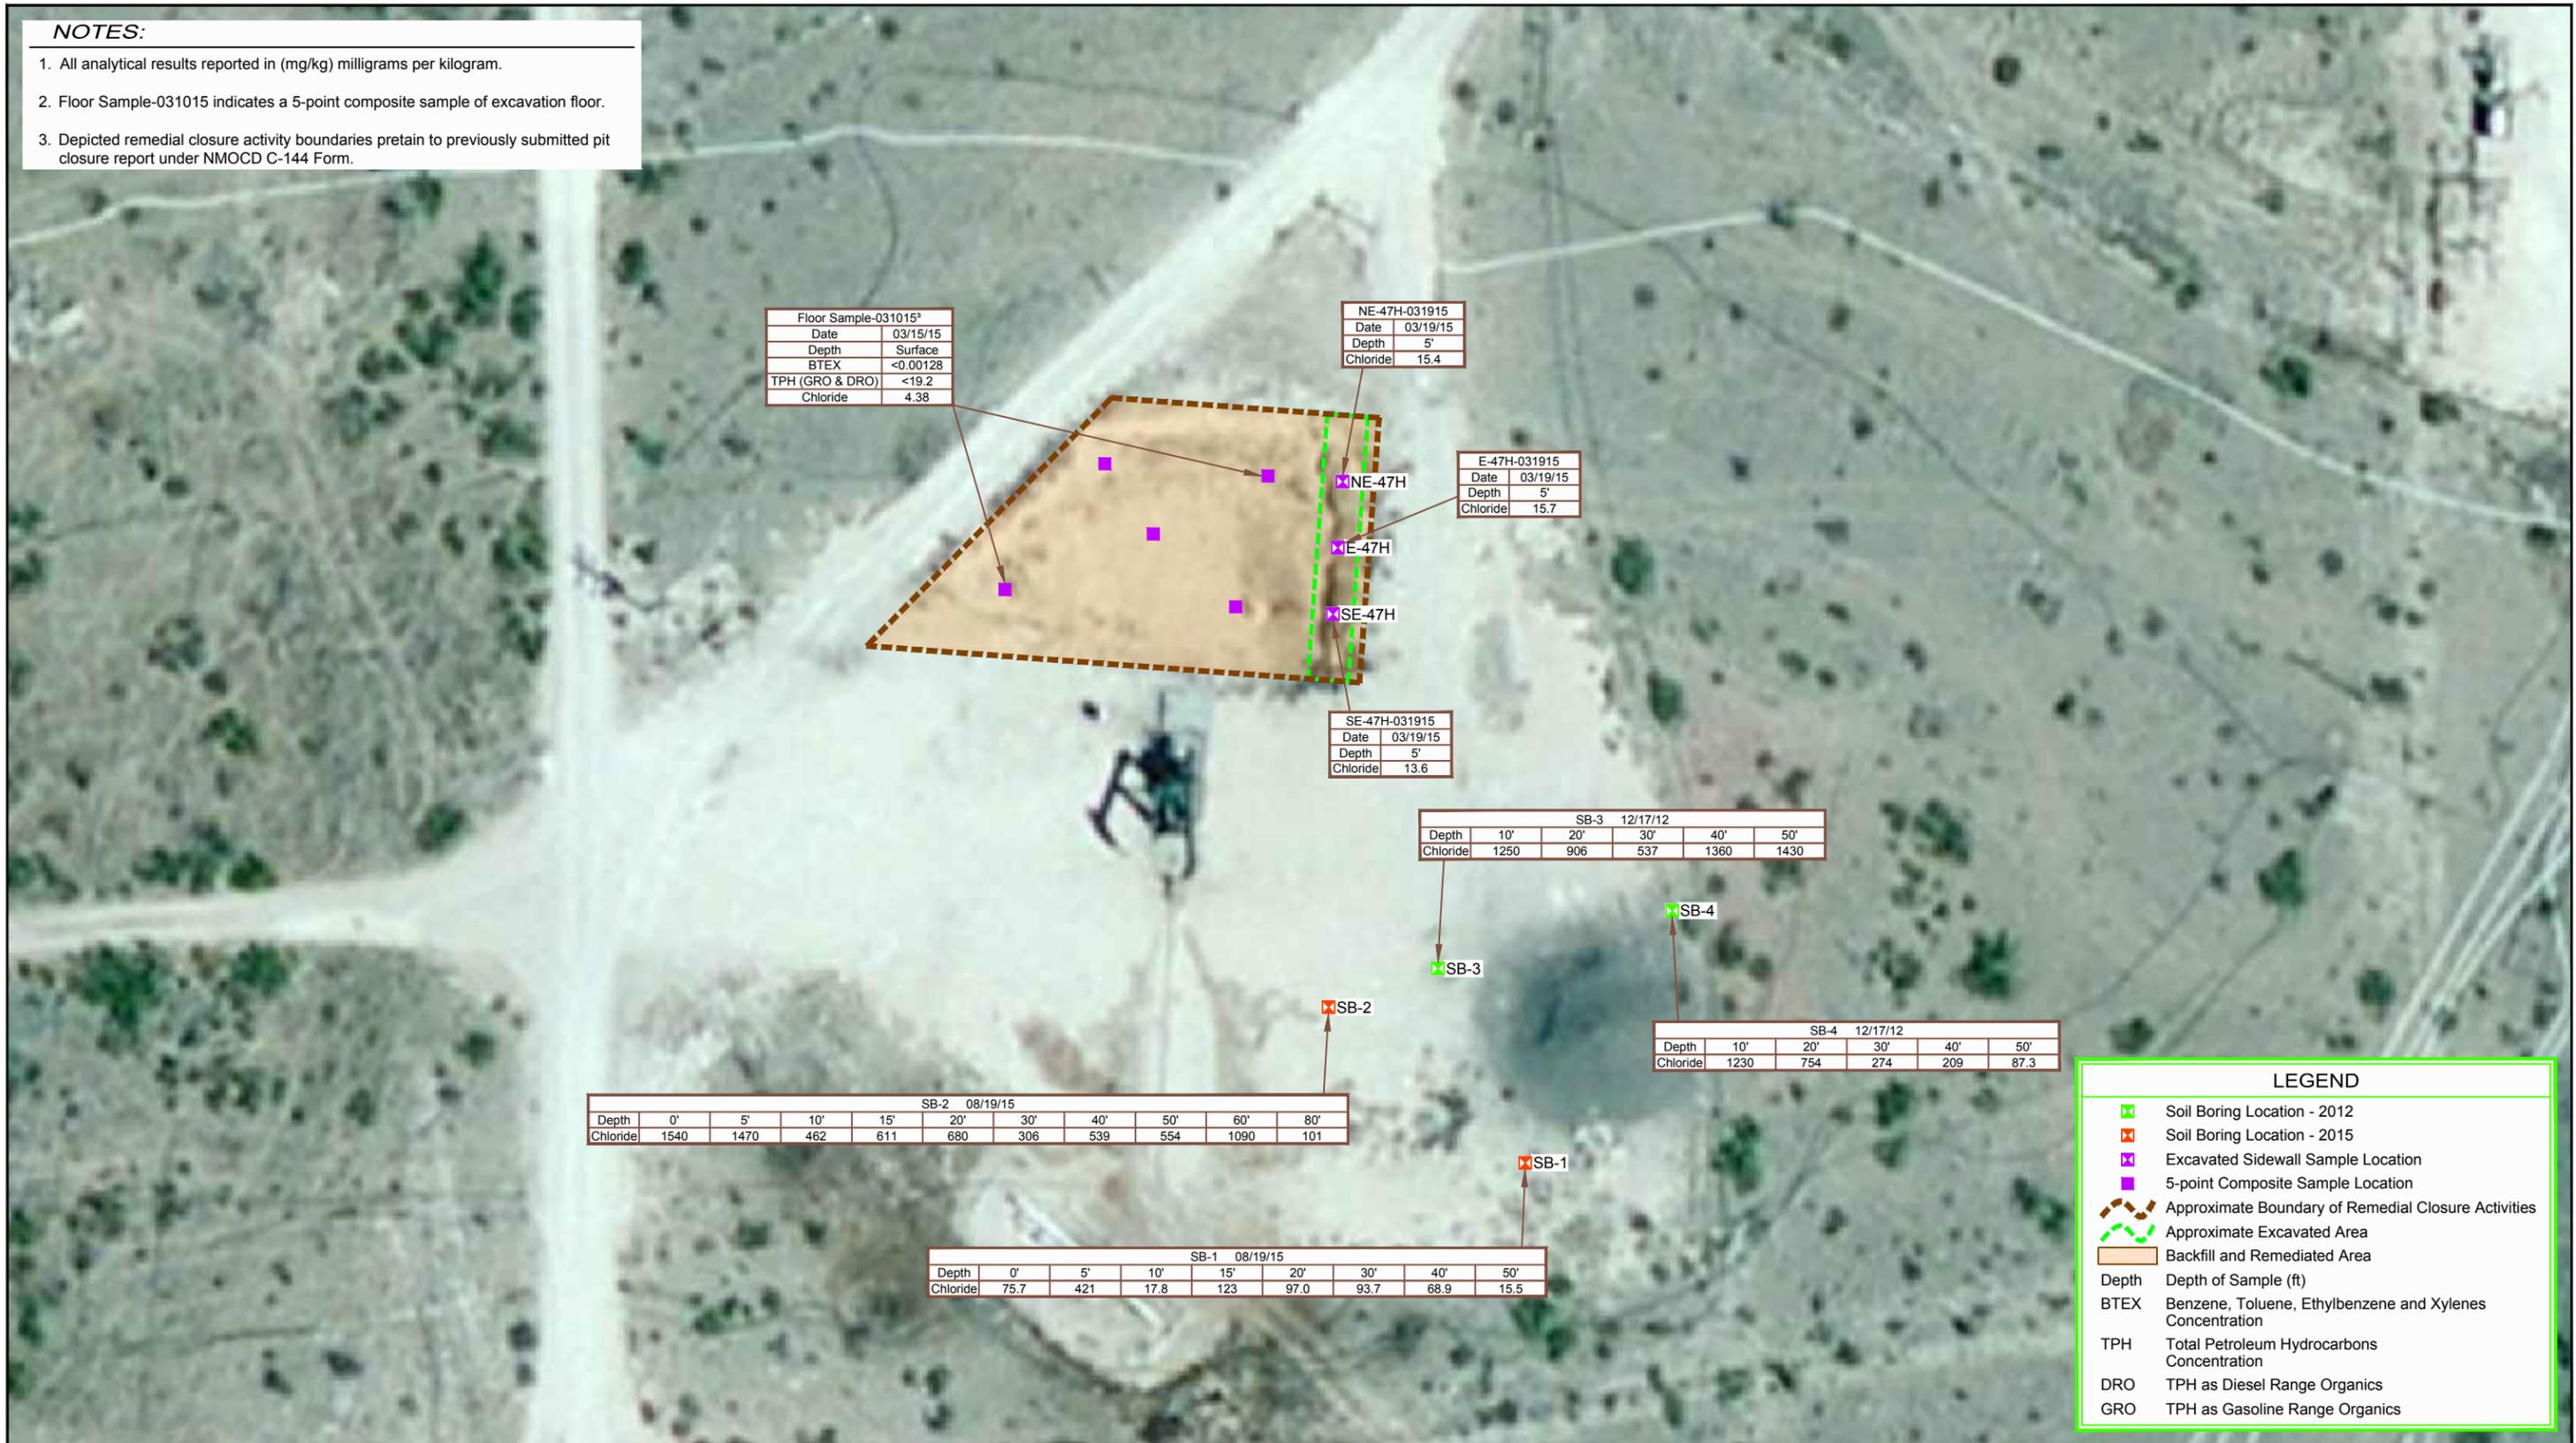
Sample ID	Sample Date	Depth (bgs)	Chlorides (mg/kg)
NMOCD Recommended Remediation Action Levels			250 (mg/kg)
SB-3	12/17/12	10'	1,250
SB-3	12/17/12	20'	906
SB-3	12/17/12	30'	537
SB-3	12/17/12	40'	1,360
SB-3	12/17/12	50'	1,430
SB-4	12/17/12	10'	1230
SB-4	12/17/12	20'	754
SB-4	12/17/12	30'	274
SB-4	12/17/12	40'	209
SB-4	12/17/12	50'	87.3

<i>Sample ID</i>	<i>Sample Date</i>	<i>Depth (bgs)</i>	<i>Chlorides (mg/kg)</i>
NMOCD Recommended Remediation Action Levels			250 (mg/kg)
SB-1	8/19/15	0'	75.7
SB-1	8/19/15	5'	421
SB-1	8/19/15	10'	17.8
SB-1	8/19/15	15'	123
SB-1	8/19/15	20'	97.0
SB-1	8/19/15	30'	93.7
SB-1	8/19/15	40'	68.9
SB-1	8/19/15	50'	15.5
SB-2	8/19/15	0'	1540
SB-2	8/19/15	5'	1470
SB-2	8/19/15	10'	462
SB-2	8/19/15	15'	611
SB-2	8/19/15	20'	680
SB-2	8/19/15	30'	306
SB-2	8/19/15	40'	539
SB-2	8/19/15	50'	554
SB-2	8/19/15	60'	1090
SB-2	8/19/15	80'	101

The soil type observed in soil samples collected during the 2015 drilling program consisted of dense, weathered, dull yellow to orange caliche from the surface to approximately 18-feet bgs. Light gray very fine grained sand interbedded with poor to moderately cemented very fine grained sandstone was noted to approximately 25-feet bgs becoming yellowish orange at 28-feet bgs and continuing to a total depth of approximately 90-feet bgs. Moisture content observed in the soil samples was dry in all instances with the exception of soil boring (SB-2) at the 70-foot interval; which was noted as being moist.
