**RE: CAP Report and Termination Request
Rice Operating Company – EME SWD System
EME L-20 AD (1R-1159): UL/L, Sec. 20, T19S, R37E**

CAP Report

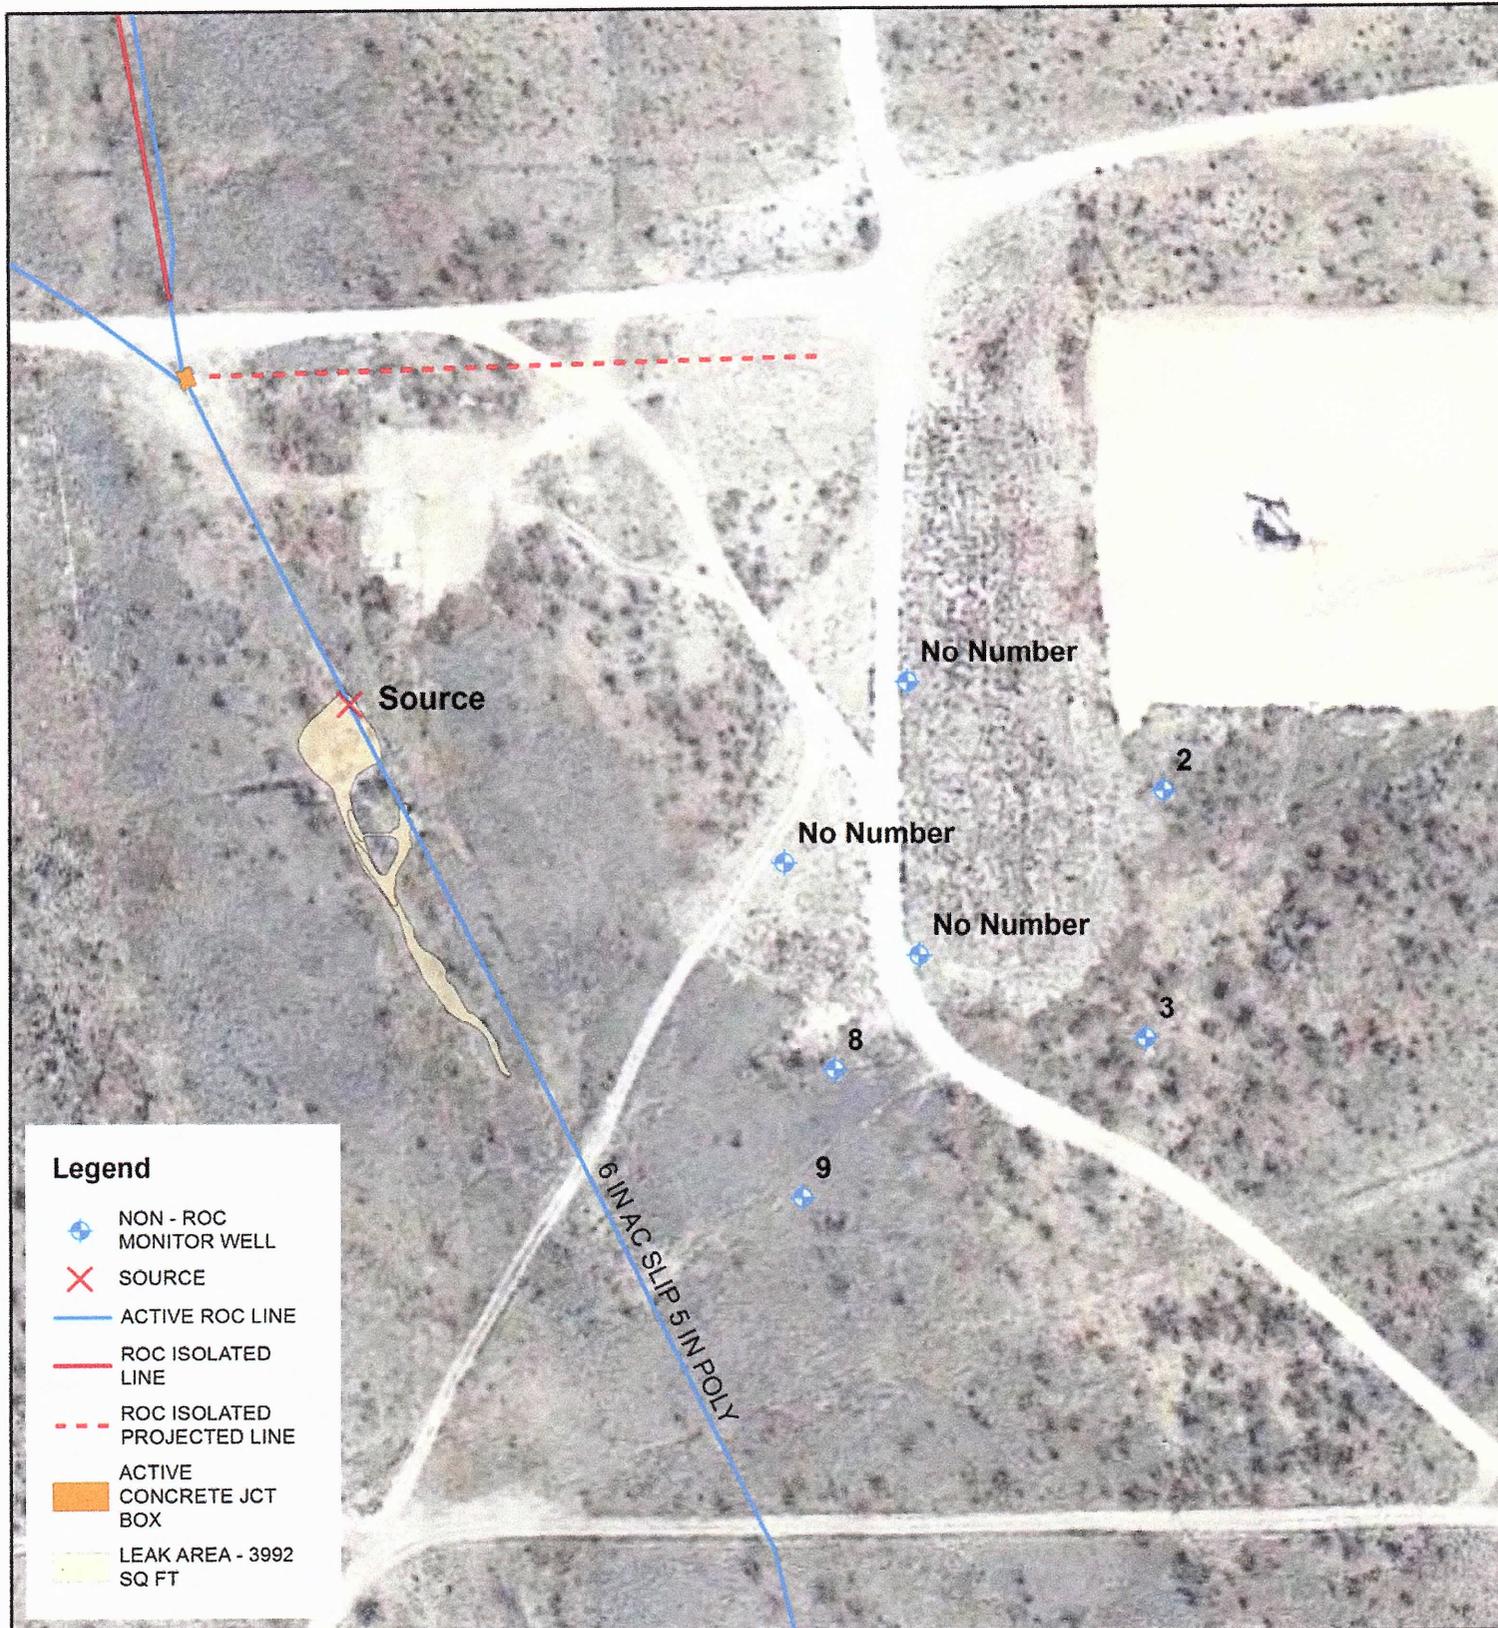
Figure 3

The site is located approximately 1.6 miles northwest of Monument, New Mexico at UL/L, Sec. 20, T19S, R37E as shown on the Geographical Location Map (Figure 1) and Area Map (Figure 2). NM OSE records indicate that groundwater will likely be encountered at a depth of approximately 31 feet below ground surface (bgs); however, non-ROC monitor wells in the area indicate that groundwater will be encountered at a depth of approximately 23 feet bgs (Figure 3).

Non - ROC Monitor Wells

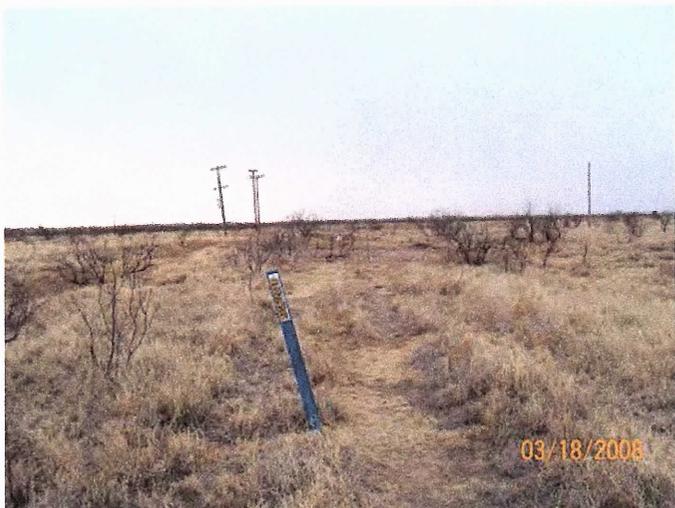
Site prior, facing south 3/18/2008

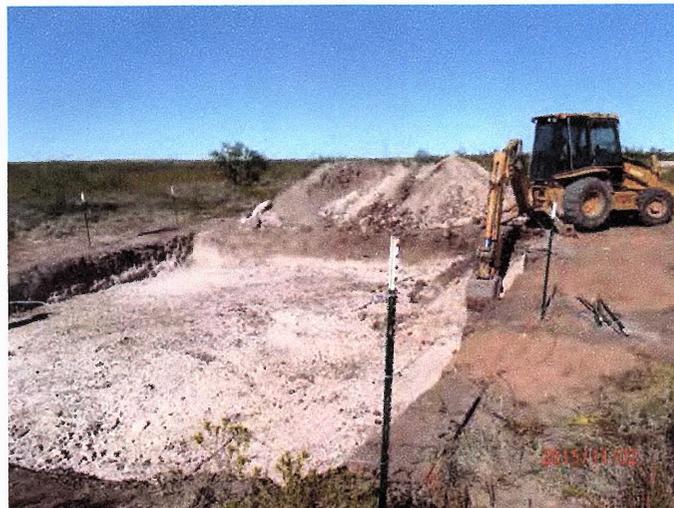
Excavating the north half of the site, facing northwest 11/2/2015

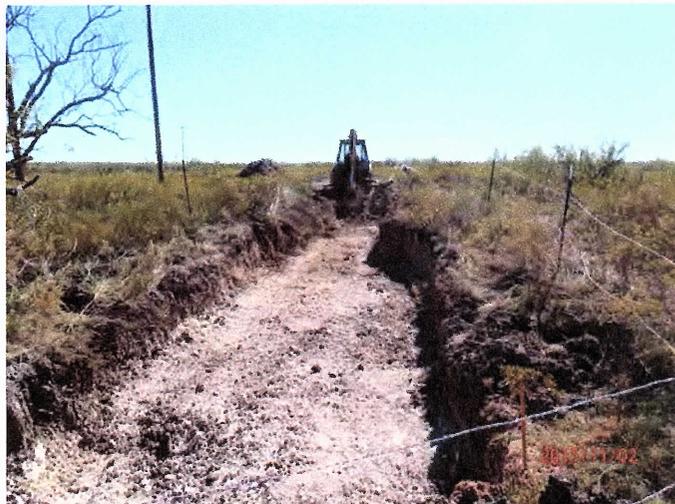
Excavating the south half of the site, facing southeast 11/2/2015

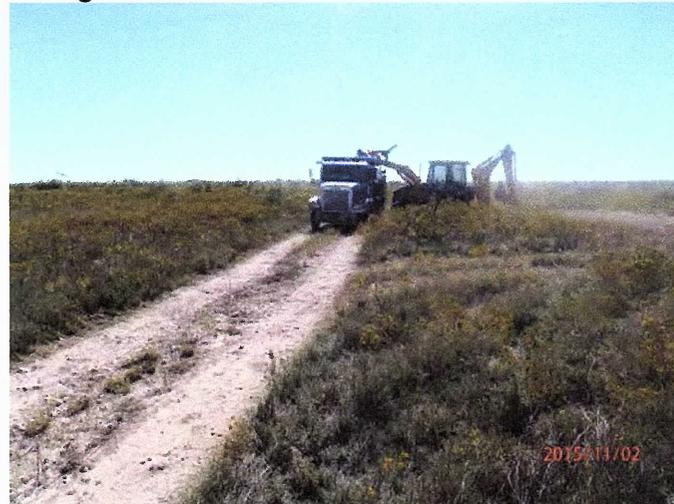
Exporting excavated soil, facing south 11/2/2015

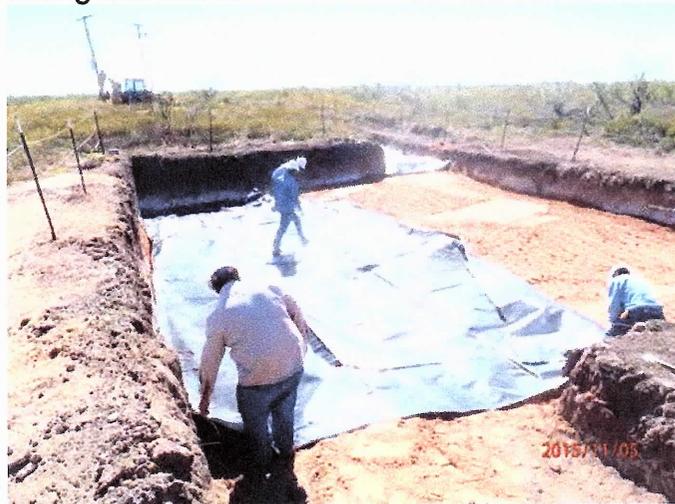
Installing a 20-mil, reinforced liner above a 6 inch pad of blow sand, facing south 11/5/2015

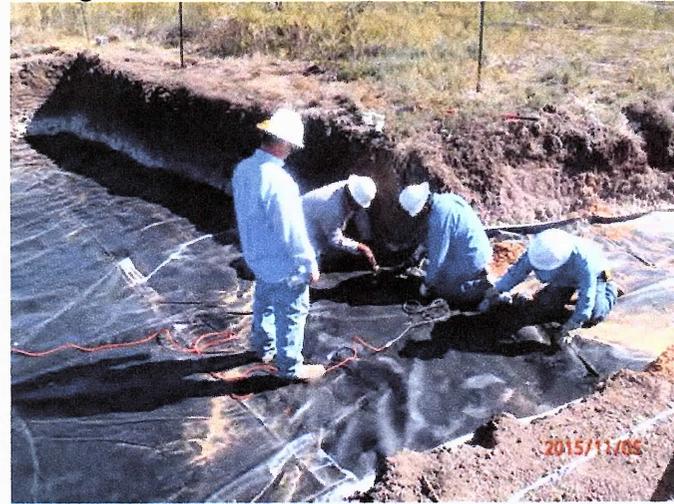
Seaming the liner, facing east 11/5/2015

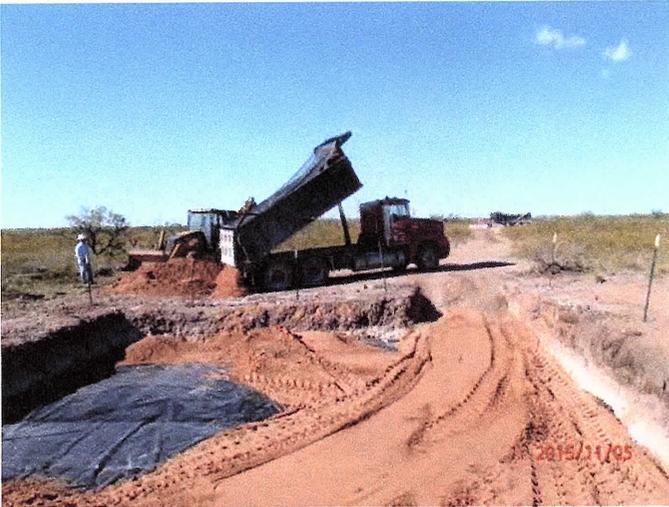
Padding above the liner with imported blow sand, facing northwest 11/5/2015

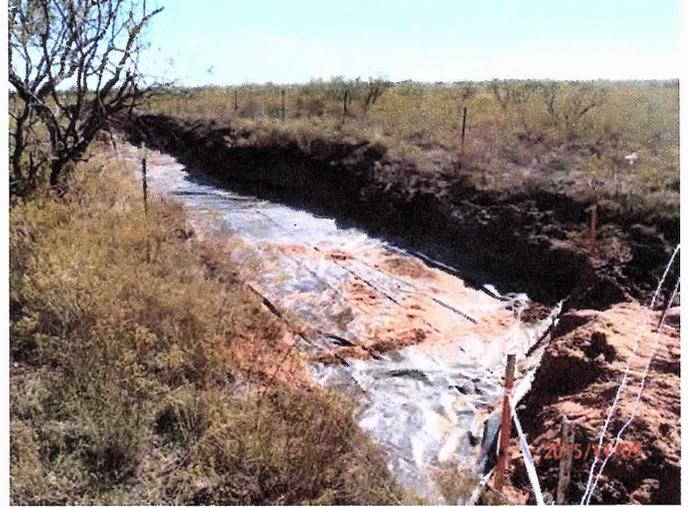
20-mil, reinforced liner installed in the south half of the site, facing south 11/9/2015

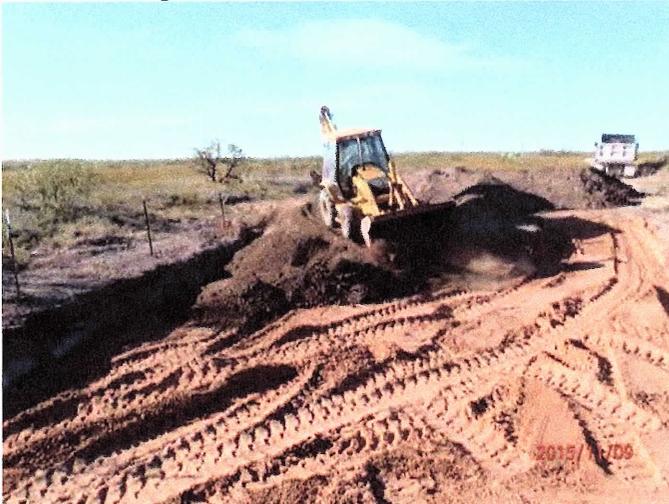
Backfilling with imported top soil, facing northwest 11/9/2015

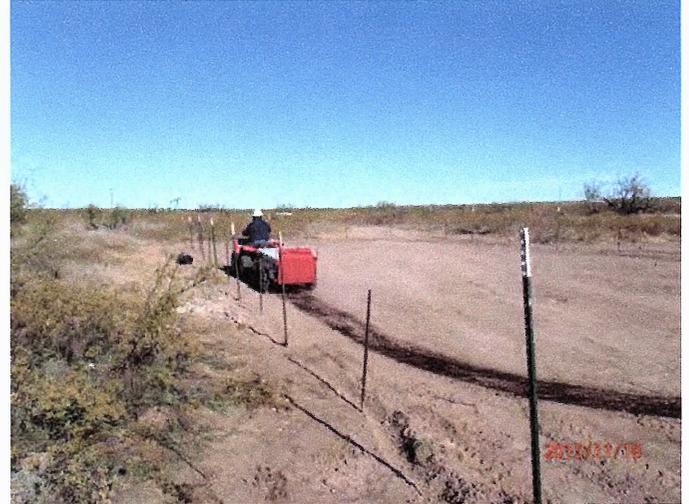
Spreading amendments, facing northeast 11/18/2015

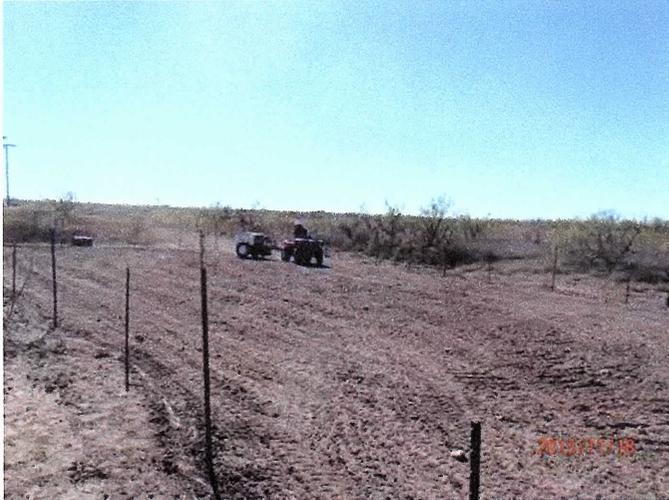
Seeding the site, facing southwest 11/18/2015

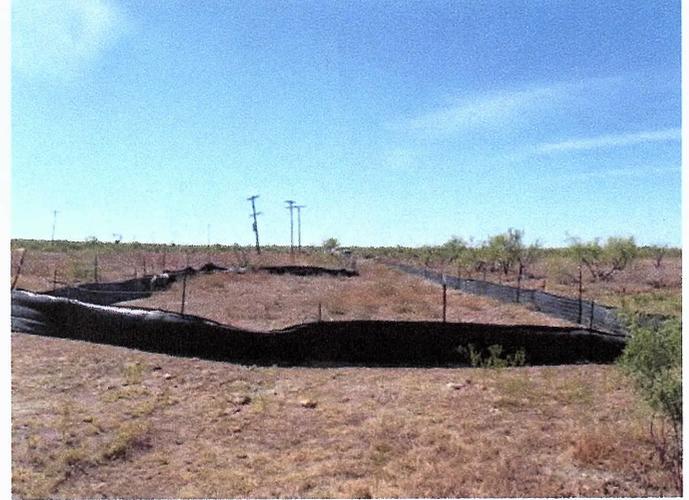
Site complete with vegetation beginning to establish, facing south 7/21/2016
