SUBJECT: SOIL REMEDIATION WORK PLAN FOR INCIDENT 1RP-4197 STATE "S" BRINE AND WATER STATION (BW-028), LEA COUNTY, NEW MEXICO

SOIL REMEDIATION WORK PLAN FOR INCIDENT 1RP-4197

KEY ENERGY SERVICES, LLC

STATE "S" BRINE AND WATER STATION (BW-028)
API# 30-025-33547
SECTION 15, T21S R37E, NMPM
LEA COUNTY, NM

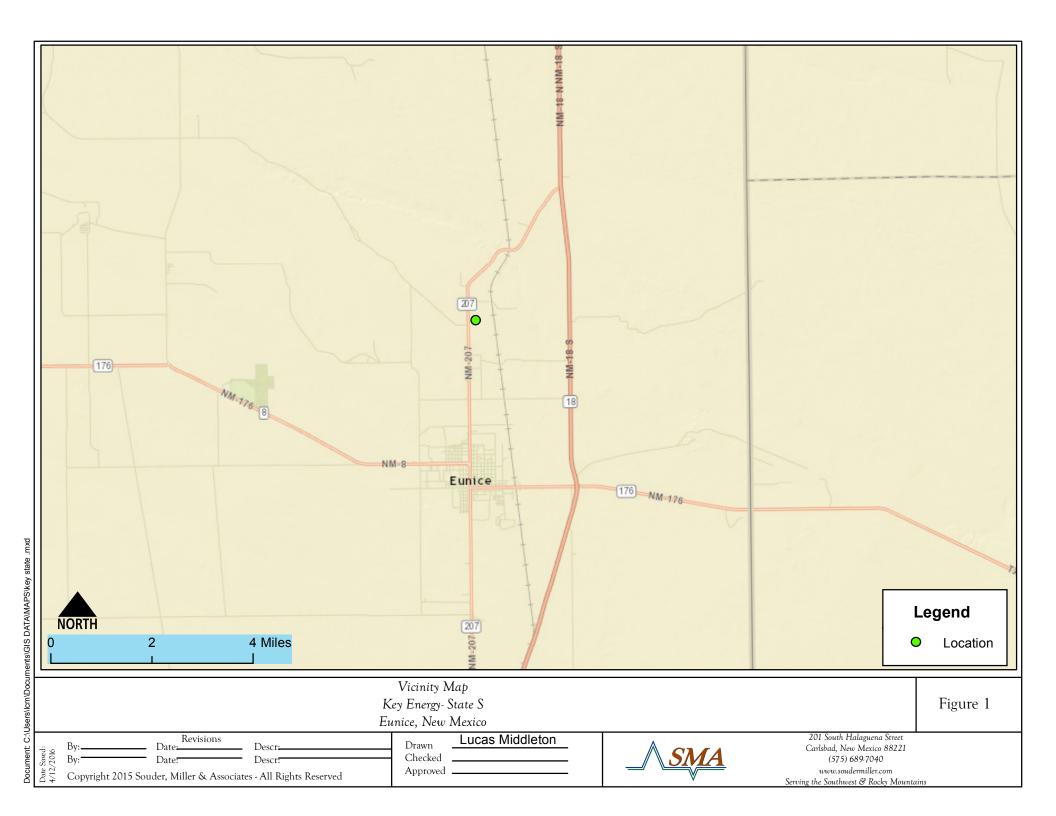
FIGURE 1 VICINITY MAP

On behalf of Key Energy Services (Key) Souder Miller & Associates (SMA) has prepared this report that describes the assessment and initial delimitation of the releases associated with the State "S" Brine And Water Station (BW-028) in Lea County, New Mexico on land owned by the Millard Deck Trust. Figure 1 illustrates the vicinity and location of the site.

The release site is located approximately 46 miles (> 1,000 feet) west of Salt Lake, in an area owned by Millard Deck Trust with an elevation of approximately 3,460 feet above sea level. After evaluation of the site using aerial photography and topographic maps, depth to groundwater is estimated to be greater less 100 feet but greater than 50 feet below ground surface (bgs). Figure 1 depicts the site vicinity and Figure 2 depicts the site details and sample locations.

SMA searched the New Mexico State Engineer's Office online water well database for water wells in the vicinity of the release. No well is located within a 1000 foot radius of the site. Figure 1 depicts the site vicinity and Figure 2 shows the site itself. The physical location of this release is within the jurisdiction of NMOCD.

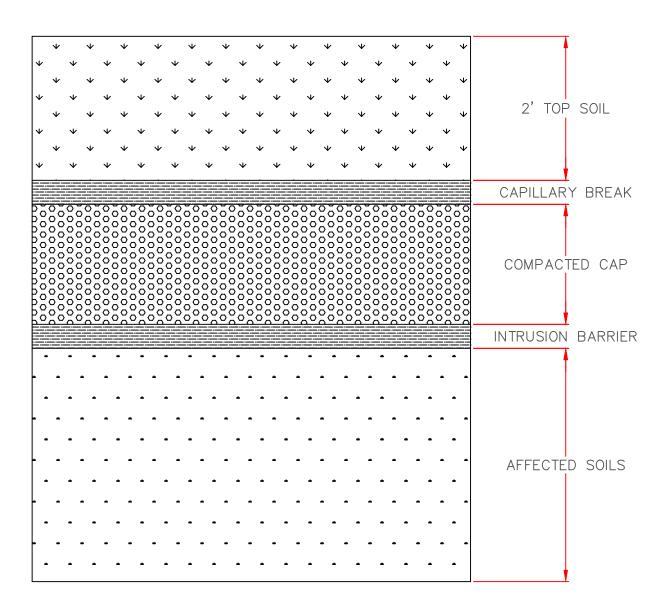
FIGURE 3 IN-SITU CAP AND BIO BARRIER DESIGN

samples will be collected at final depth of excavation, where an in-situ cap will be placed within the excavation. The construction of the in-situ cap (Figure #3) has been designed to prevent both capillary and leaching movement of the brine affected soils. Starting from three ft. below surface grade, bentonite layer will be added to the bottom of the excavation. Then a plastic liner will be added as a capillary break between the affected soils and the proposed caliche cap. The caliche cap will consist of two feet of contaminant-free material placed, and compacted. Then, hay will be added above the caliche cap to form an intrusion barrier. This barrier will prevent leaching and formation of deep root systems into the cap itself. Topsoil will then be placed on top of the cap. The plastic liner on both sides of the caliche cap will effectively break the communication of precipitation through the compacted cap. After excavation, installation of insitu cap and backfill occurs topsoil will be added as over burden to help with contouring of the area. Final samples will be collected at the maximum depths of the excavation. Approximately 2,680 cubic yards of contaminated soil will excavated. The contaminated soil was transported for proper disposal at New Mexico permitted Sundance facility in New Mexico.

IN-SITU CAP
AND BIOBARRIER DESIGN
Key Station- State 1 Brine Station
