Re: Remediation Summary Report  
Howse 1 (API 30-025-36226)  
RP No. 4311

This report documents the results of the remediation and final site closure activities performed at the former tank battery location associated with the plugged Howse 1 well location (API 30-025-36226). This report was prepared for CEMC by GHD Services, Inc. (GHD, formerly Conestoga-Rovers & Associates). This report is submitted as an attachment to the included final C-141 for the site.

**Re: Remediation Summary Report  
Howse #1 (API #30-025-36226)  
OCD RP #4311  
Section 17, Township 20-S, Range 39-E  
Latitude N 32.571190°, Longitude W -103.075300°  
Lea County, New Mexico**

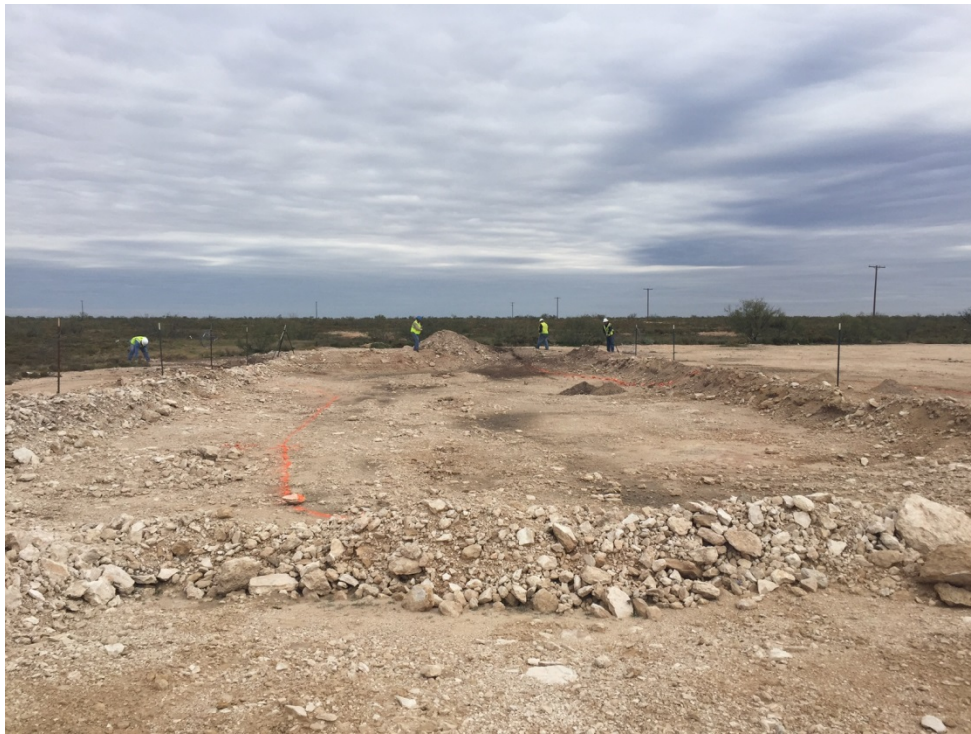
Photo 1 - View of planned excavation area facing north

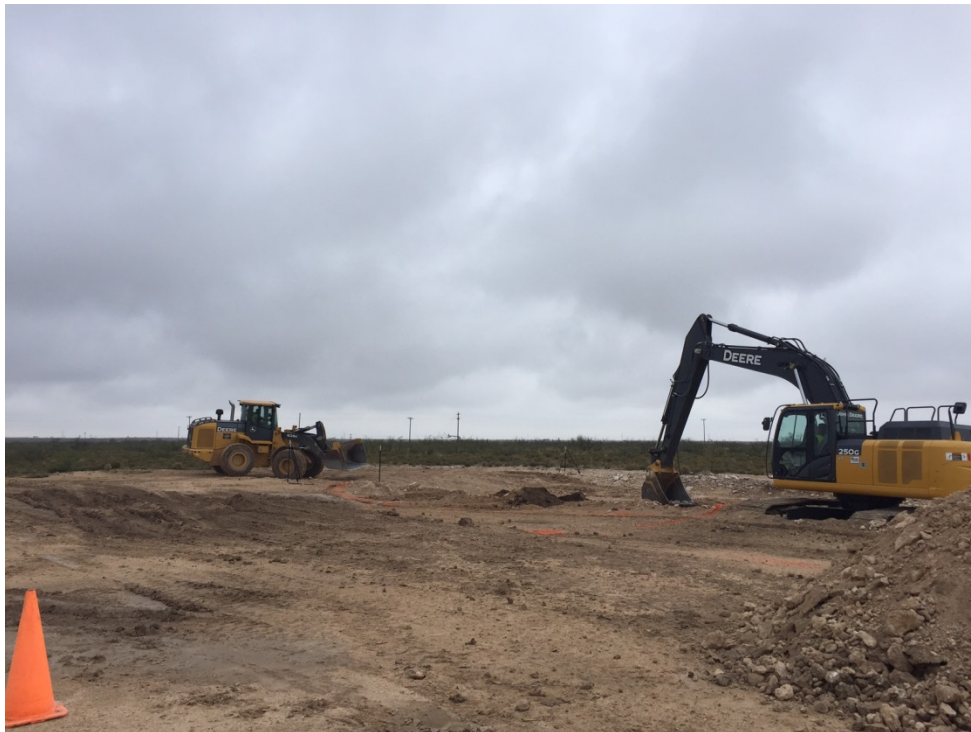
Photo 2 - View of excavation activities facing southwest

Excavation activities were initiated on November 7 and completed on November 10, 2016. The excavation limits were based upon the results of the April and June 2016 investigations. Soils were excavated to a depth of 4 ft bgs within the approximate limits of the former tank battery pad and additional areas to the north, northwest, and southeast of the pad. The final excavation limits are included on Figure 2. Approximately 325 cubic yards (cy) of soil was excavated from the former tank battery area. Photographic documentation of excavation activities is included as Attachment A.

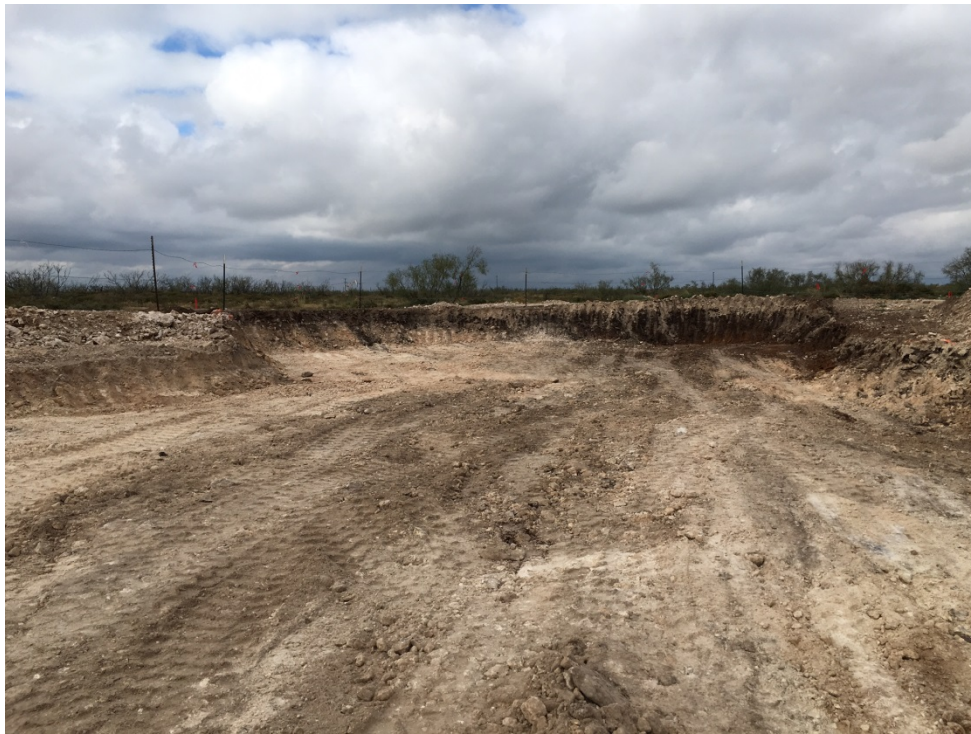
Photo 3 - View of final excavation limits facing north

Two side wall confirmation samples, SW-1 and SW-2, were collected at 4 ft bgs from the north and southeast walls of the excavation, respectively, to confirm excavation limits had been met. These samples were collected from the two perimeter locations that exhibited chlorides exceedances during the April 2016 soil investigation. Six soil samples, #1A, #2, #3, #4, #6A, and #7, collected during the

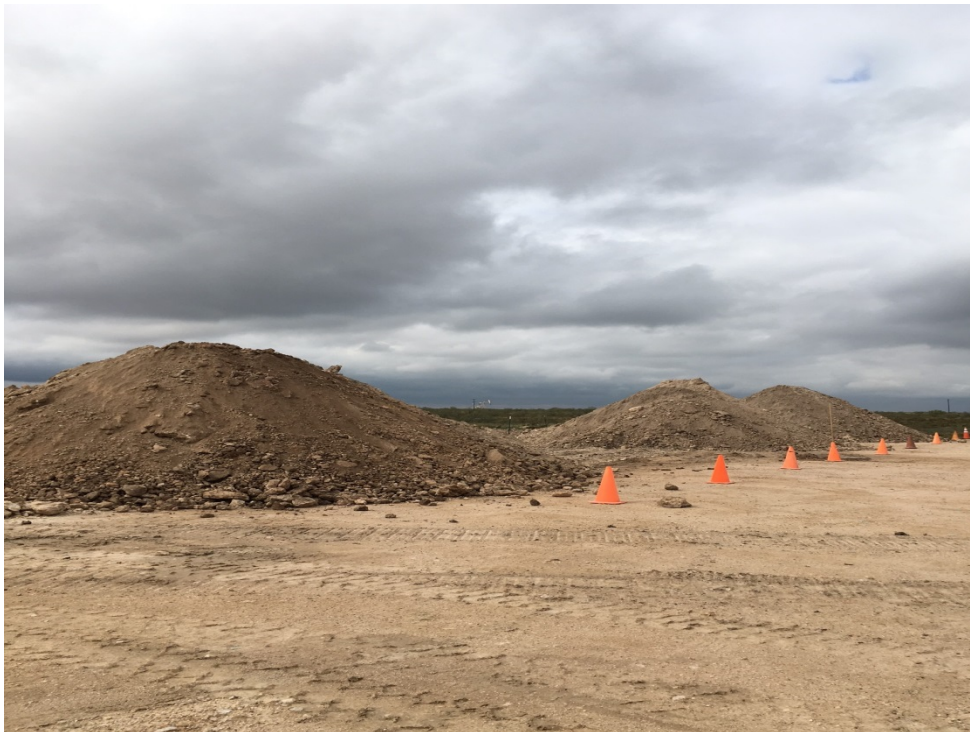
Photo 4 - View of excavated soil stockpiles facing northwest

The excavated soils were placed into three stockpiles located adjacent to the excavation. Each stockpile contained approximately 100 cy of soil. One 5-point composite sample was collected from each of the stockpiles, identified as SP-1 through SP-3, and analyzed for chlorides by EPA Method 300 and moisture by EPA Method SW3550.

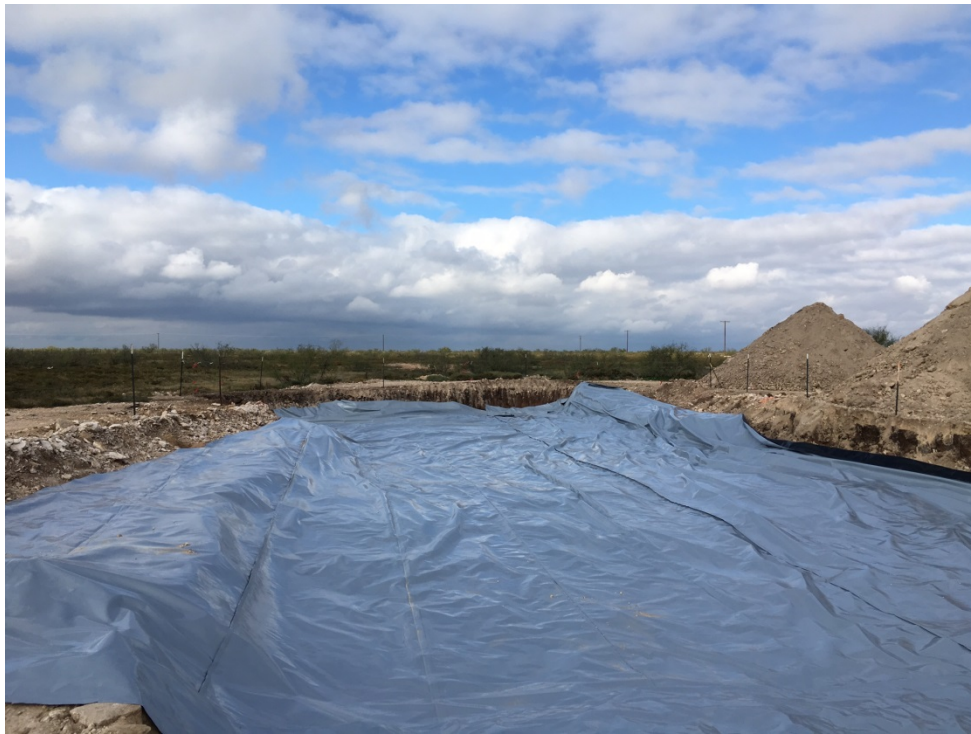
Photo 5 - View of liner following completing of excavation activities facing north

Lining activities were completed on November 10, 2016 once analytical results from both of the confirmation wall samples indicated that the excavation limits had been met. A 20-mil polyethylene liner was placed in the bottom of the excavation at a depth of 4 ft bgs. Photographic documentation of lining activities is included in Attachment A.

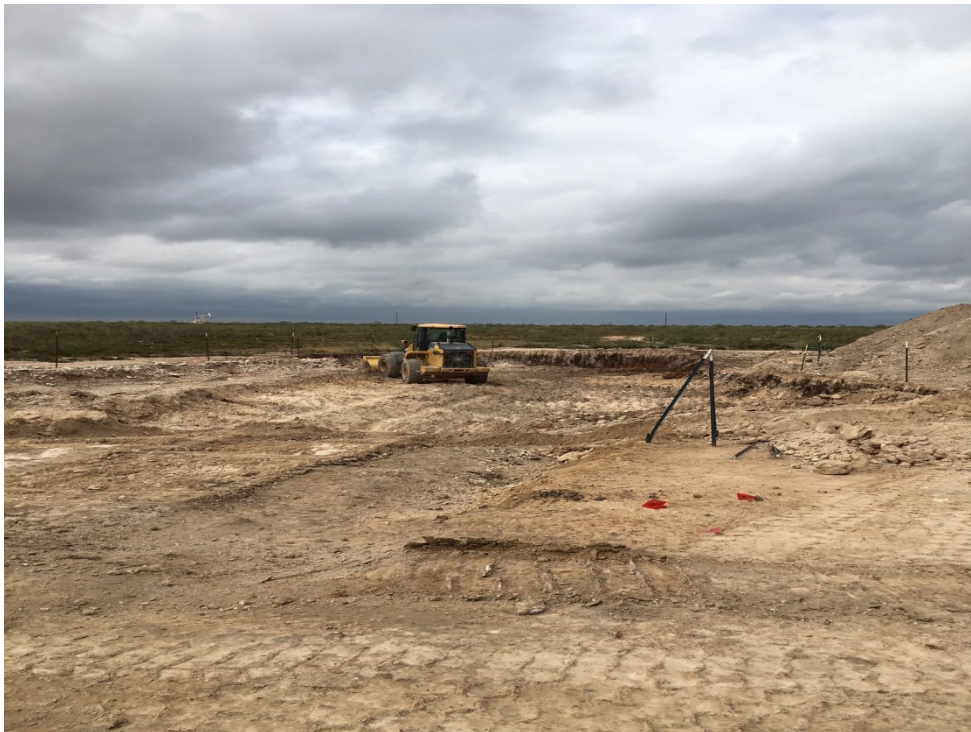
Photo 6 - View of backfilling activities facing northwest

Backfilling activities were conducted November 11 through 14, 2016. The stockpiled material was placed back into the excavation, above the liner. In order to bring the former tank battery area up to surface grade, an additional 760 cy of clean fill material was transported to the site from a Chevron borrow pit located in Eunice, Lea County, New Mexico, and used to backfill the remainder of the excavation. Once completed, the backfilled material was compacted with heavy equipment and the Site was graded to match existing topography. Following completion of backfilling and grading, the disturbed area was fertilized and reseeded with BLM #2 and #3 seed mix. Photographic documentation of backfilling activities is included as Attachment A.

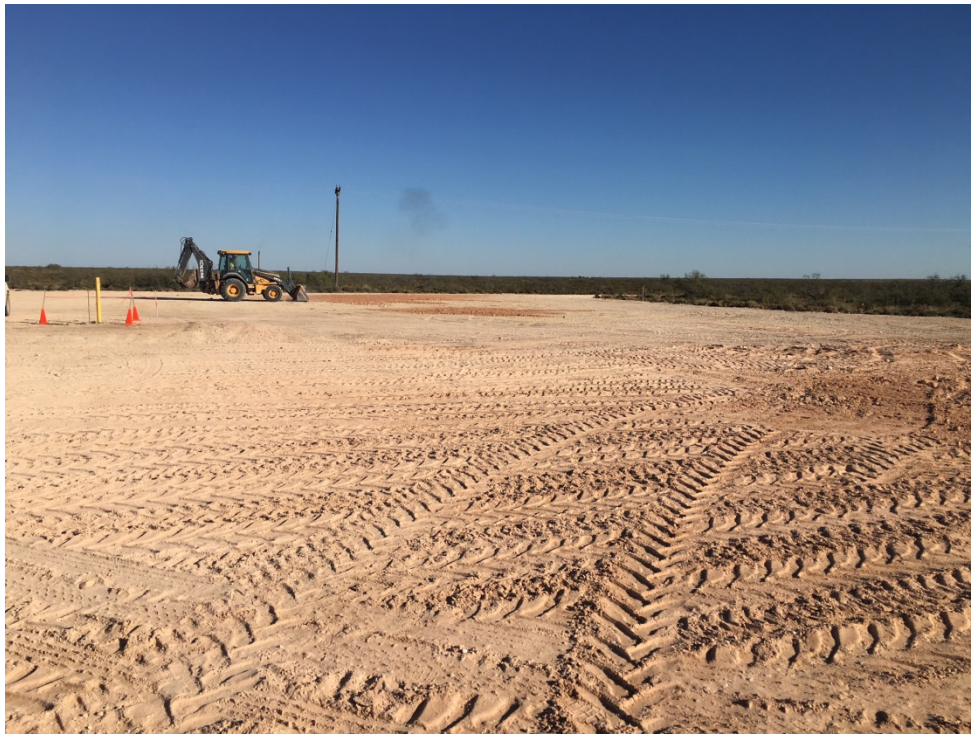
Photo 7 - View of Site during wheel compacting and grading facing northwest

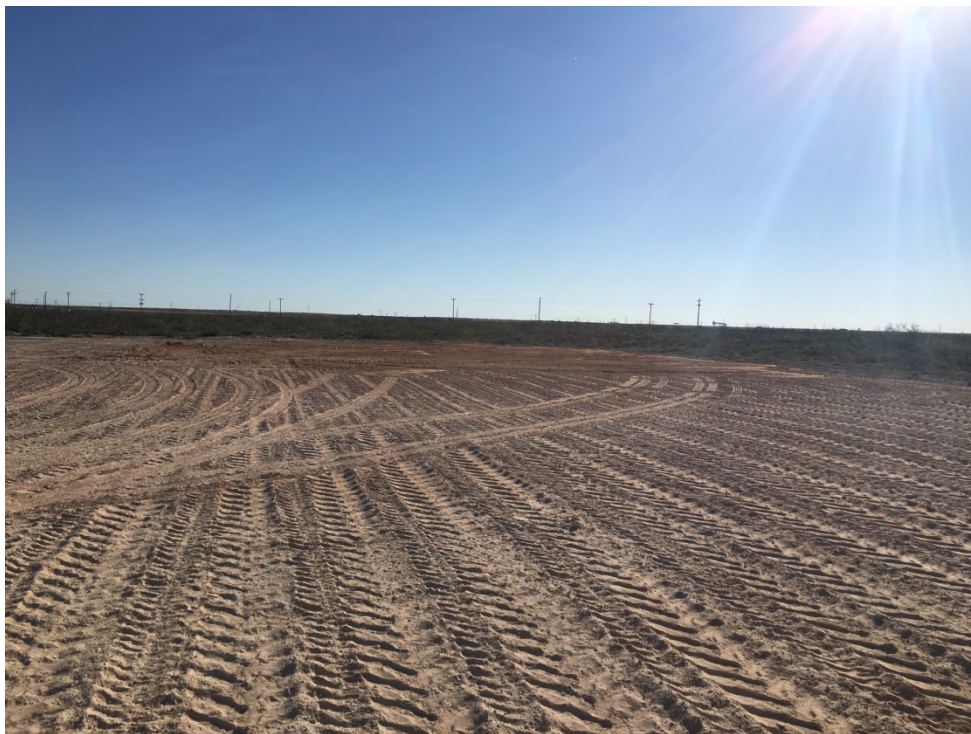
Photo 8 - View of Site following completion of backfilling and grading facing south

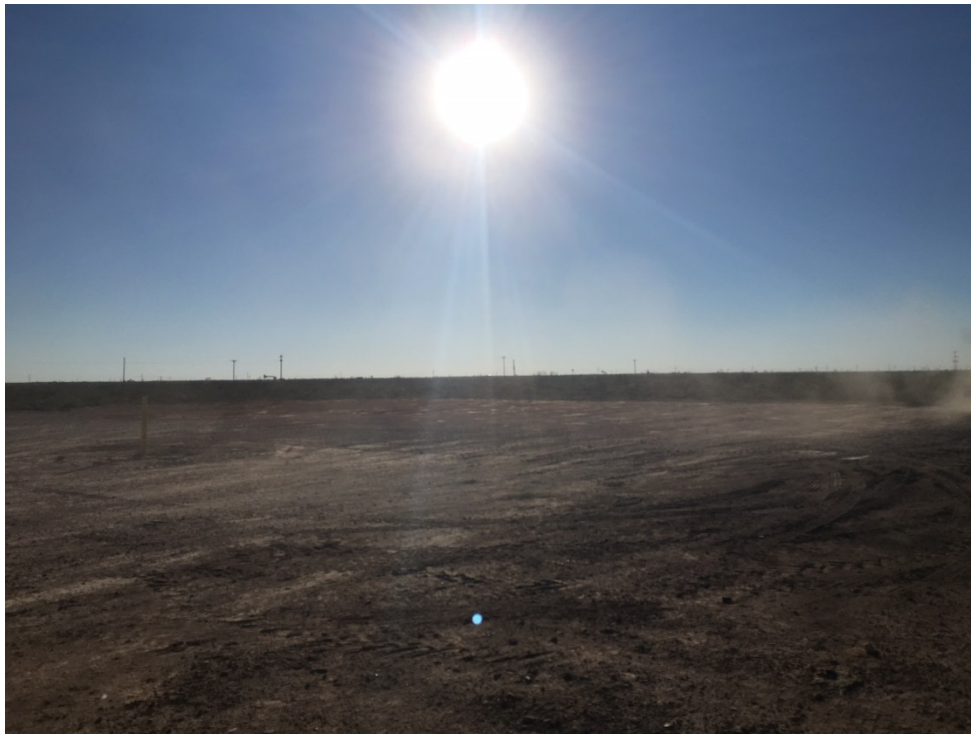
Photo 9 - View of Site following completion of backfilling and grading facing southwest
