CMU B Battery

CLOSURE REQUEST

RP# 1RP-3847

RE: Linn CMU B Battery – Closure Request
UL/K, Section 19, T17S, R33E
API No. 30-025-01483
NMOCD Case #: 1R-3487
NMOCD Score: 0

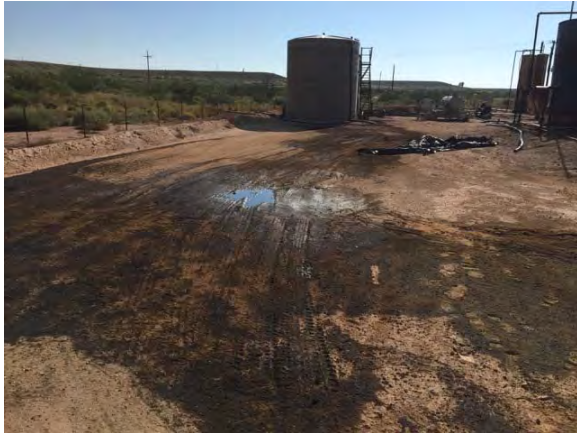
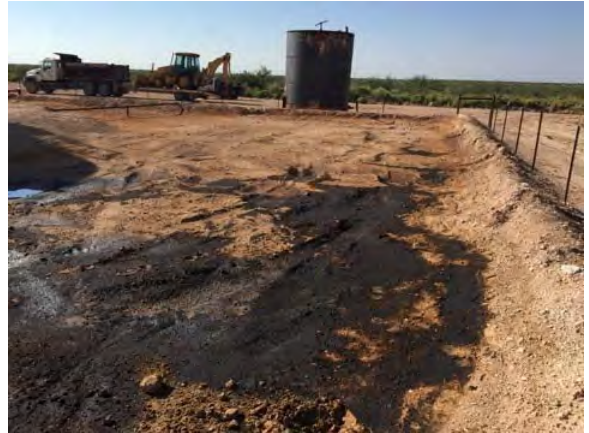
Site prior

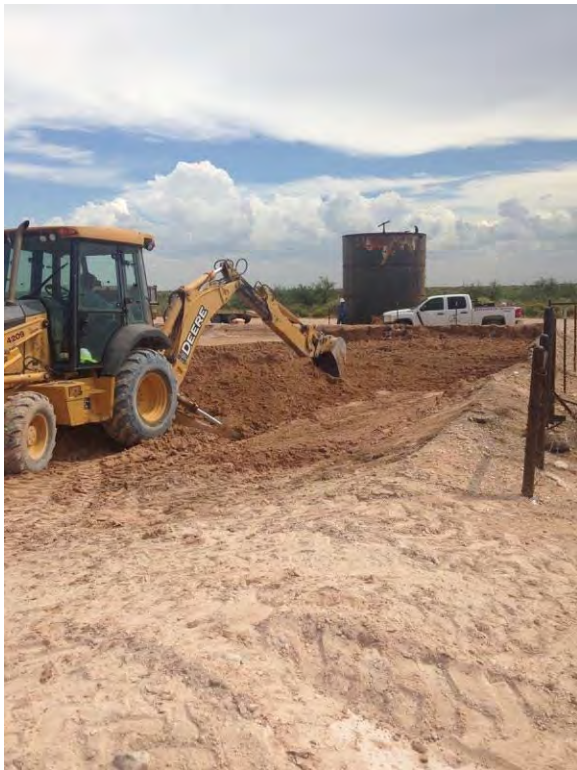
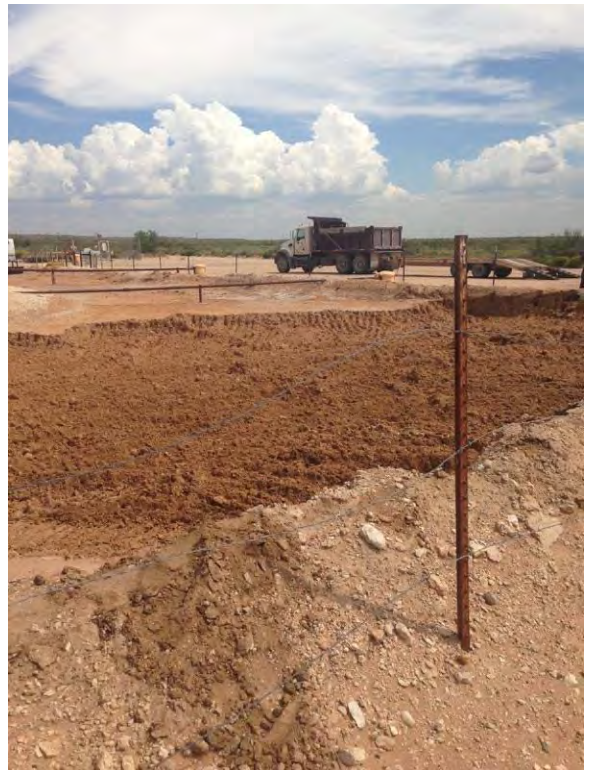
Excavating site

DFSI personnel were on site to excavate the release area to 2' bgs (Appendix III). Impacted soil was properly removed and disposed of at a NMOCD approved facility. The excavation was backfilled with clean, imported soil. Any remaining constituents will be addressed at site abandonment.

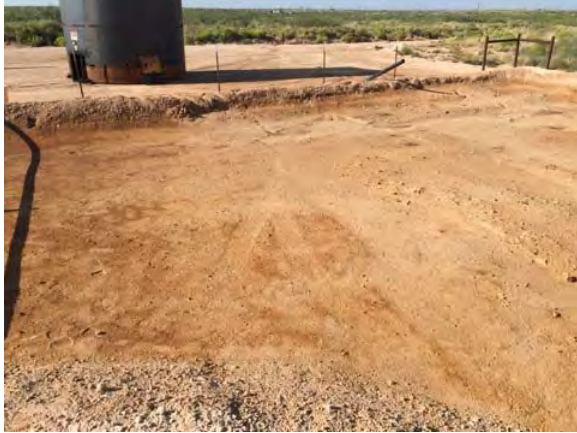
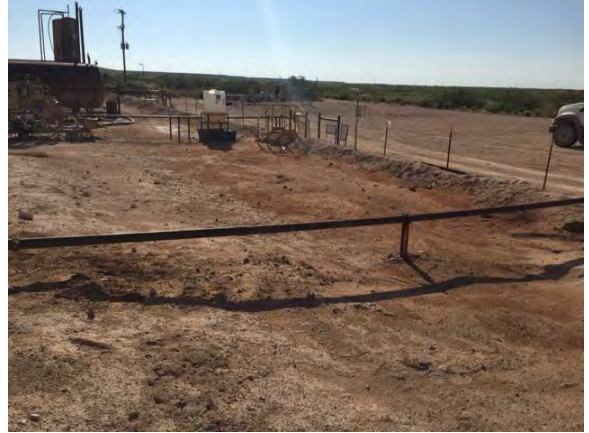
Excavation completed

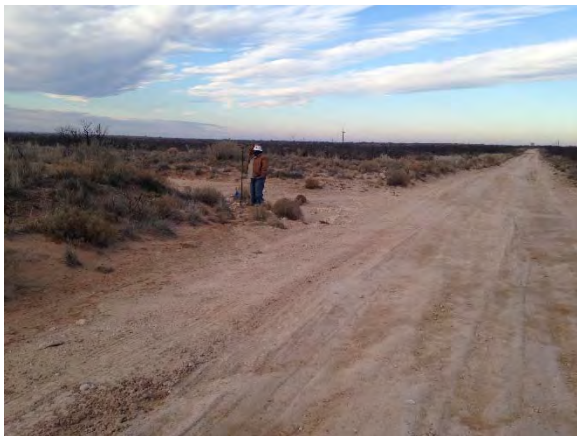
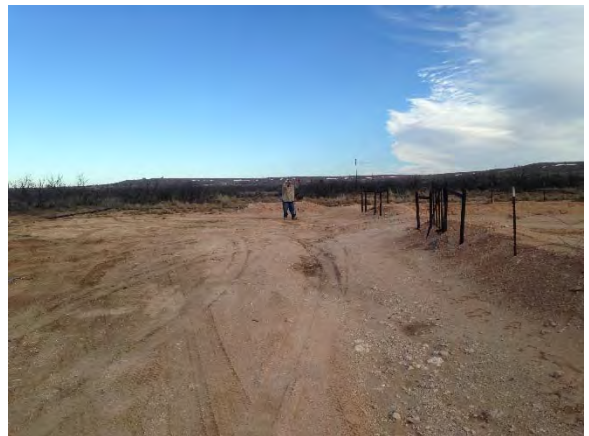
Collecting sample

To provide laboratory analysis on the remaining constituents, on January 20, 2016, DFSI personnel were on site to obtain samples within the leak area (Figure 1). Nine samples were obtained and field sampled for chloride levels, as well as BTEX. The BTEX samples were performed using a Mini Rae Photoionization Detector (PID). Field samples for five sample points, SP1 through SP5, were submitted for analysis at Cardinal Laboratories of Hobbs, NM to obtain confirmation (Appendix IV). Samples

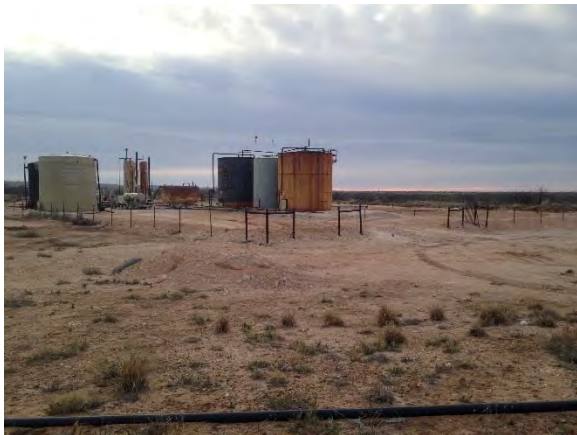
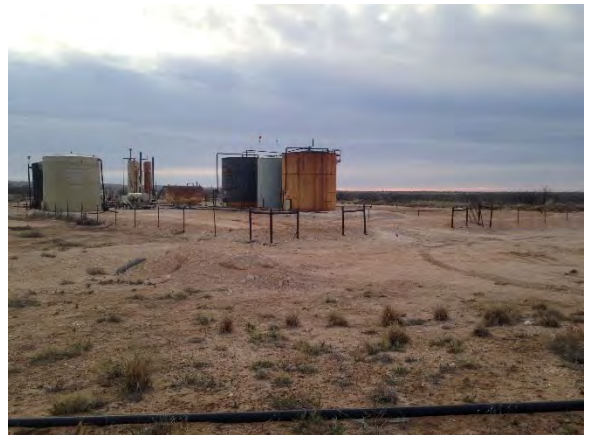
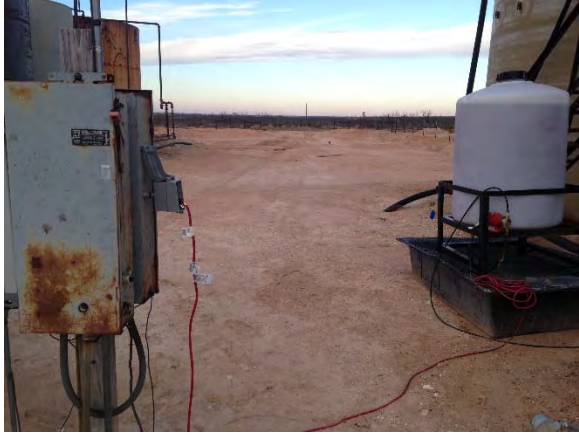
Site completed
