**Re: Closure Report
COG Operating
Boone 16 State Com 3H (12/29/18)
API #: 30-025-41432
GPS: 32.470531, -103.578689
RP#: 1RP-5327
Unit Letter O, Section 16, Township 21 South, Range 33 East
Lea County, New Mexico**

COG Operating, LLC (COG) is pleased to submit the following closure report in response to a release that occurred at the Boone 16 State Com 3H located in Unit Letter O, Section 16, Township 21 South, Range 33 East in Lea County, New Mexico.

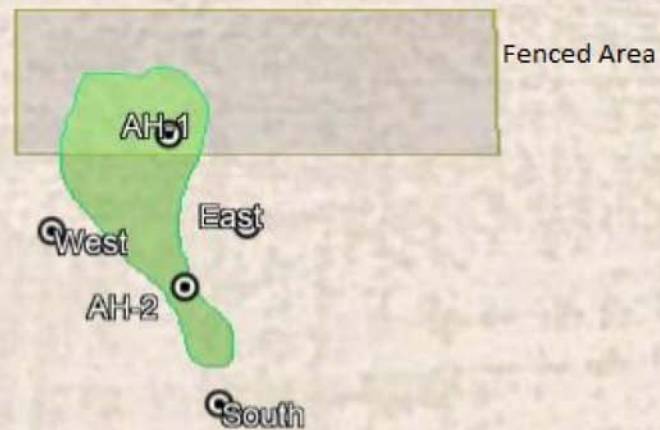
- Auger hole
- Fenced Area
- Spill Area

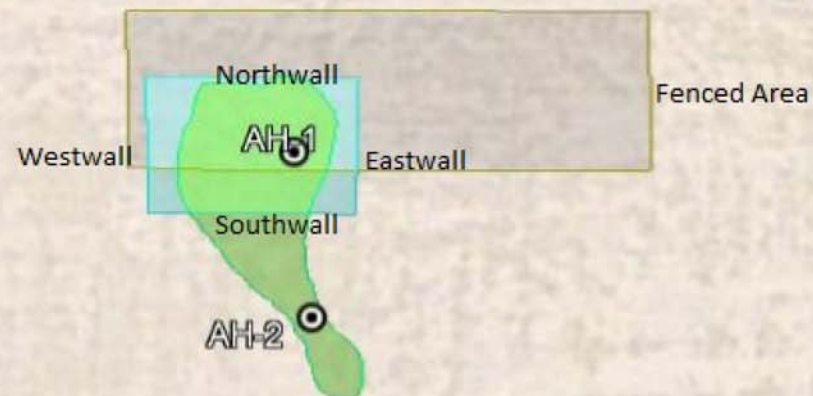
Excavation Area
-

Auger hole
-

FencedArea
-

Spill Area

The impacted area of AH-1 was excavated to a depth of 1.0' below surface. Once excavated, confirmation samples were collected from the bottom and sidewalls. Based on the results, all of the samples were below the Table 1 closure criteria.

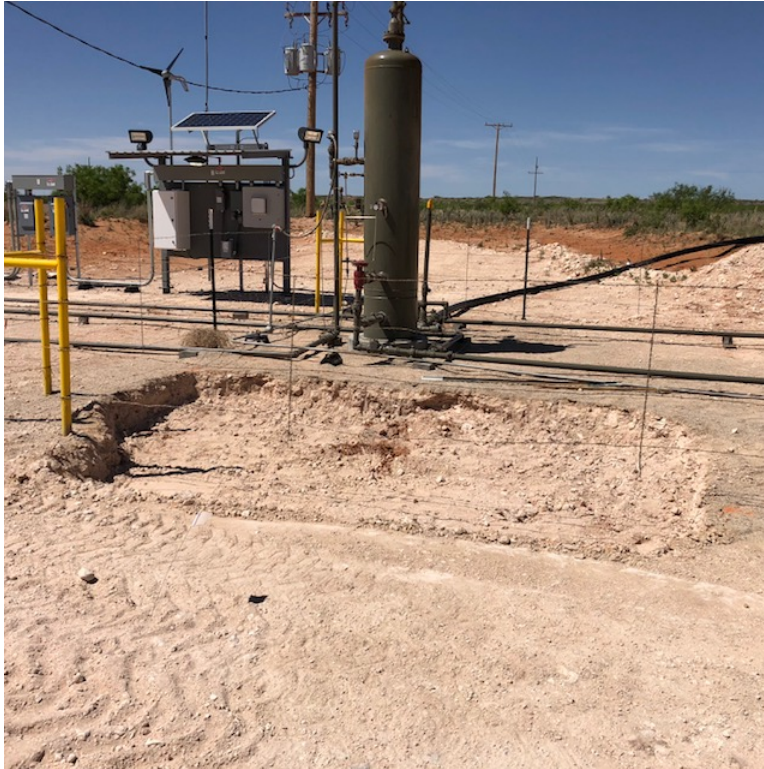
View of Excavation Area

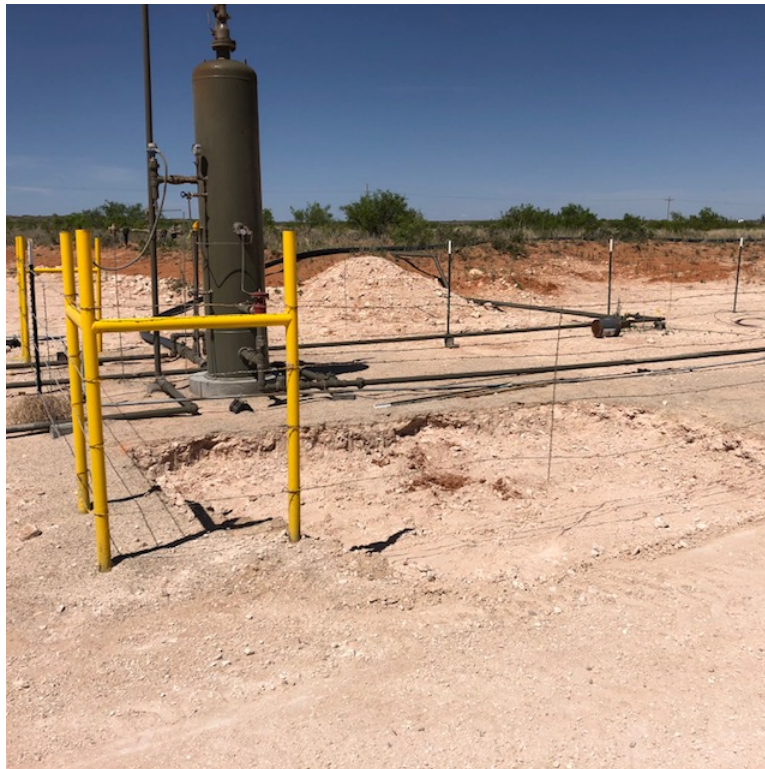
View of Excavation Area –
