January 7, 2019

**Re: Remedial Action Report and Closure Request
Godfather 36 State Com No. 1H (API No. 3002540830000)
1RP-5227
Centennial Resource Development
Site Location: Unit C, Sec. 36, T 22-S, R 34-E
(Lat 32.3551254°, Long -103.4268036°)
Lea County, New Mexico**

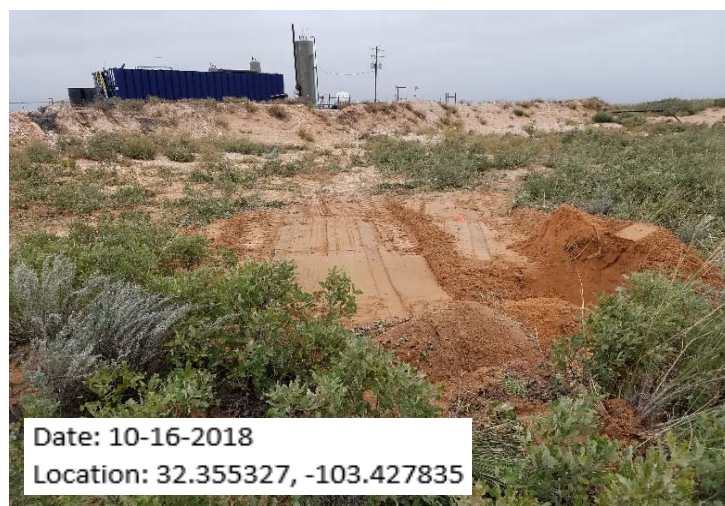
Photograph No. 3

View of TP1, TP6, and TP7 sample locations looking east.

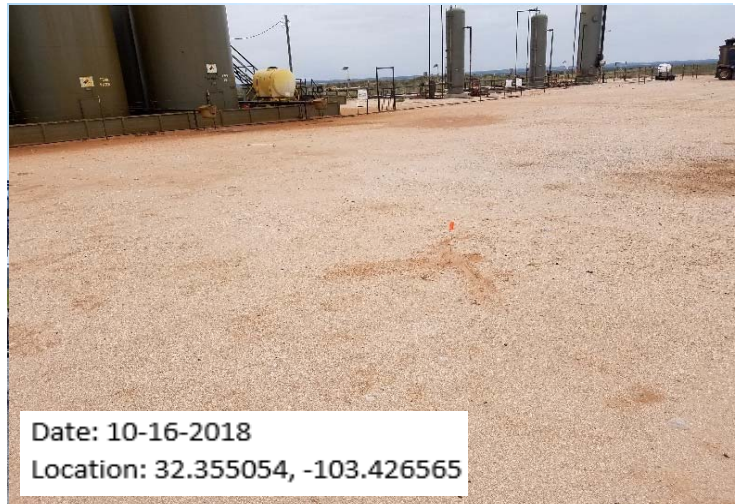
Photograph No. 4

View of TP2 sample location looking south.

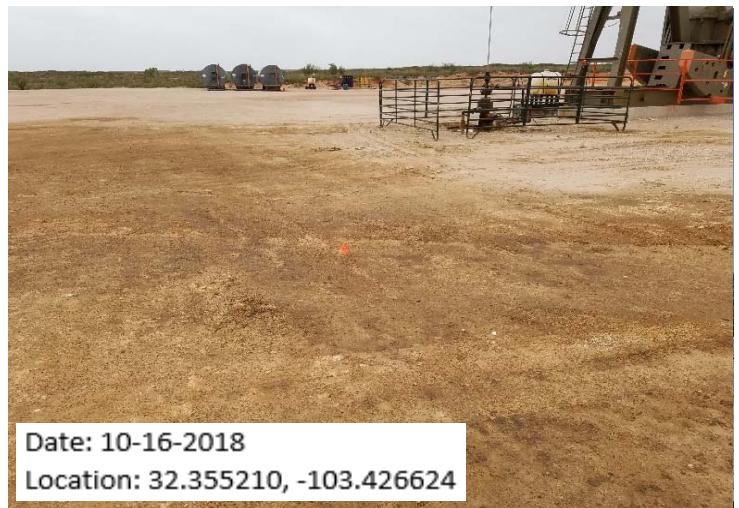
Photograph No. 5

View of TP3 sample location looking north.

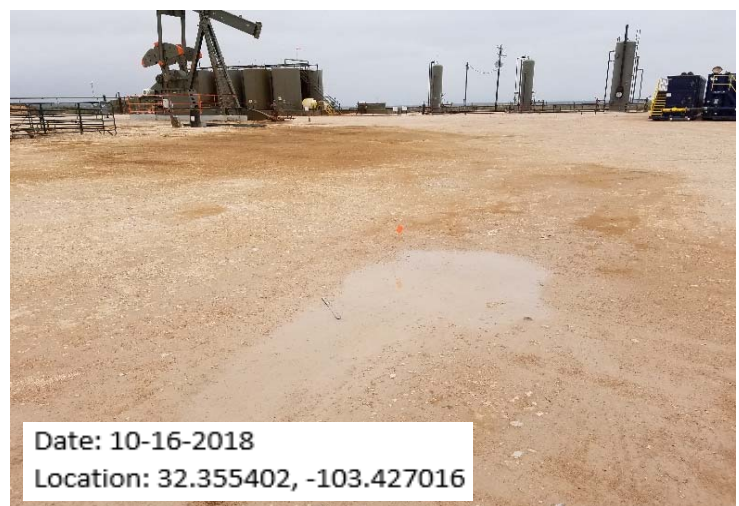
Photograph No. 6

View of TP4 sample location looking south.

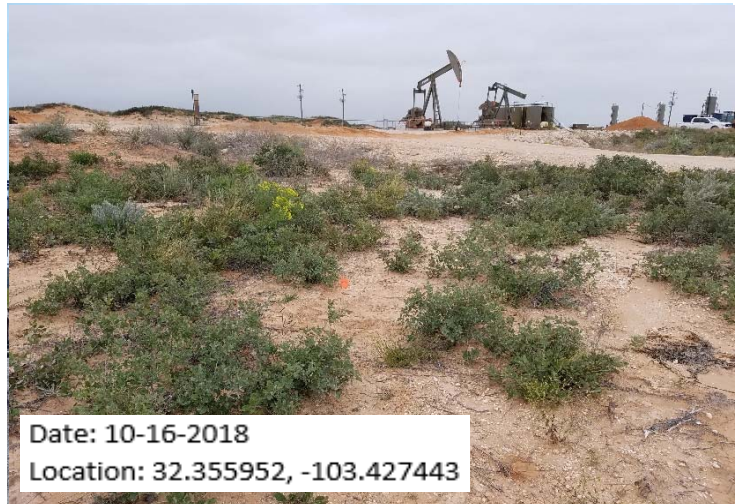
Photograph No. 7

View of TP5 sample location looking south.

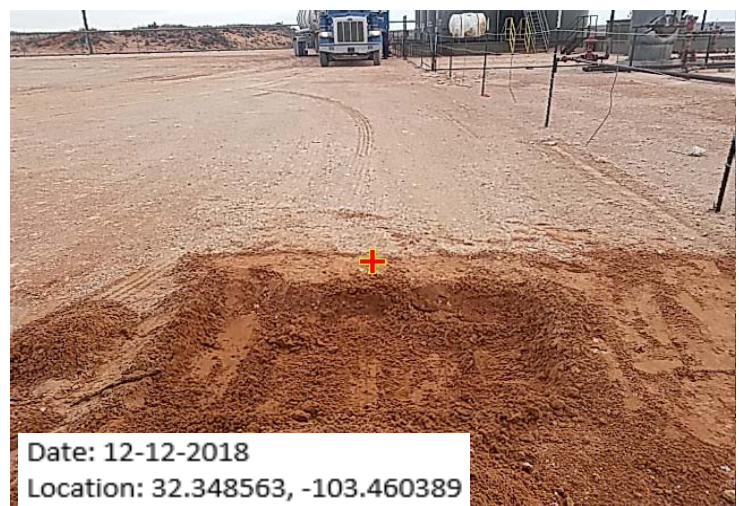
Photograph No. 9

View of excavation at TP10.

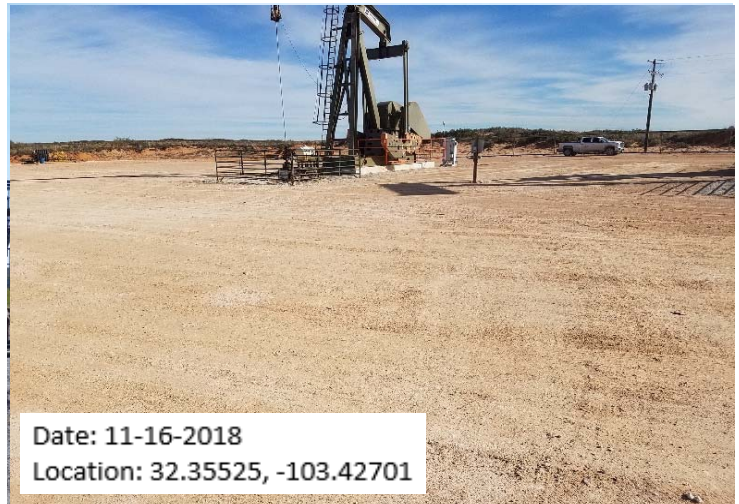
Photograph No. 10

View of completed remedial activities looking northwest.

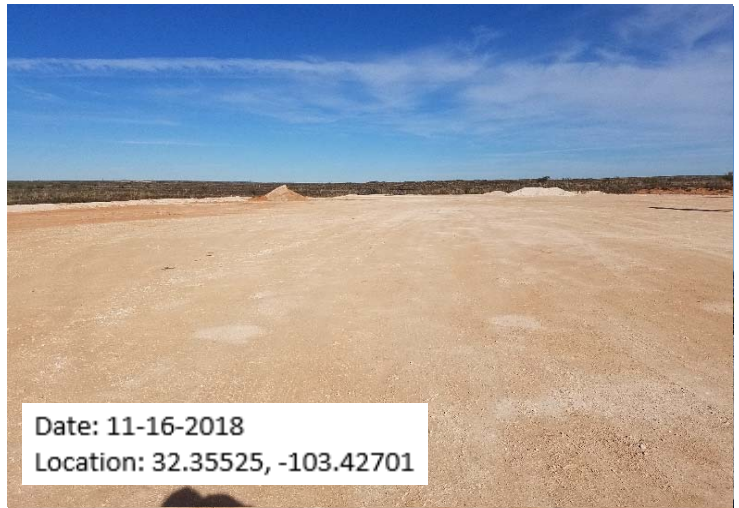
Photograph No. 11

View of completed remedial activities looking north.
