## **Closure Report**

West Red Lake Unit Water Station #001  
Talon Project # 701307.120.01, \*2RP-5440

Subject: **Site Assessment & Closure Report**  
WRLU Water Station #001  
Eddy County, NM  
2RP-5440

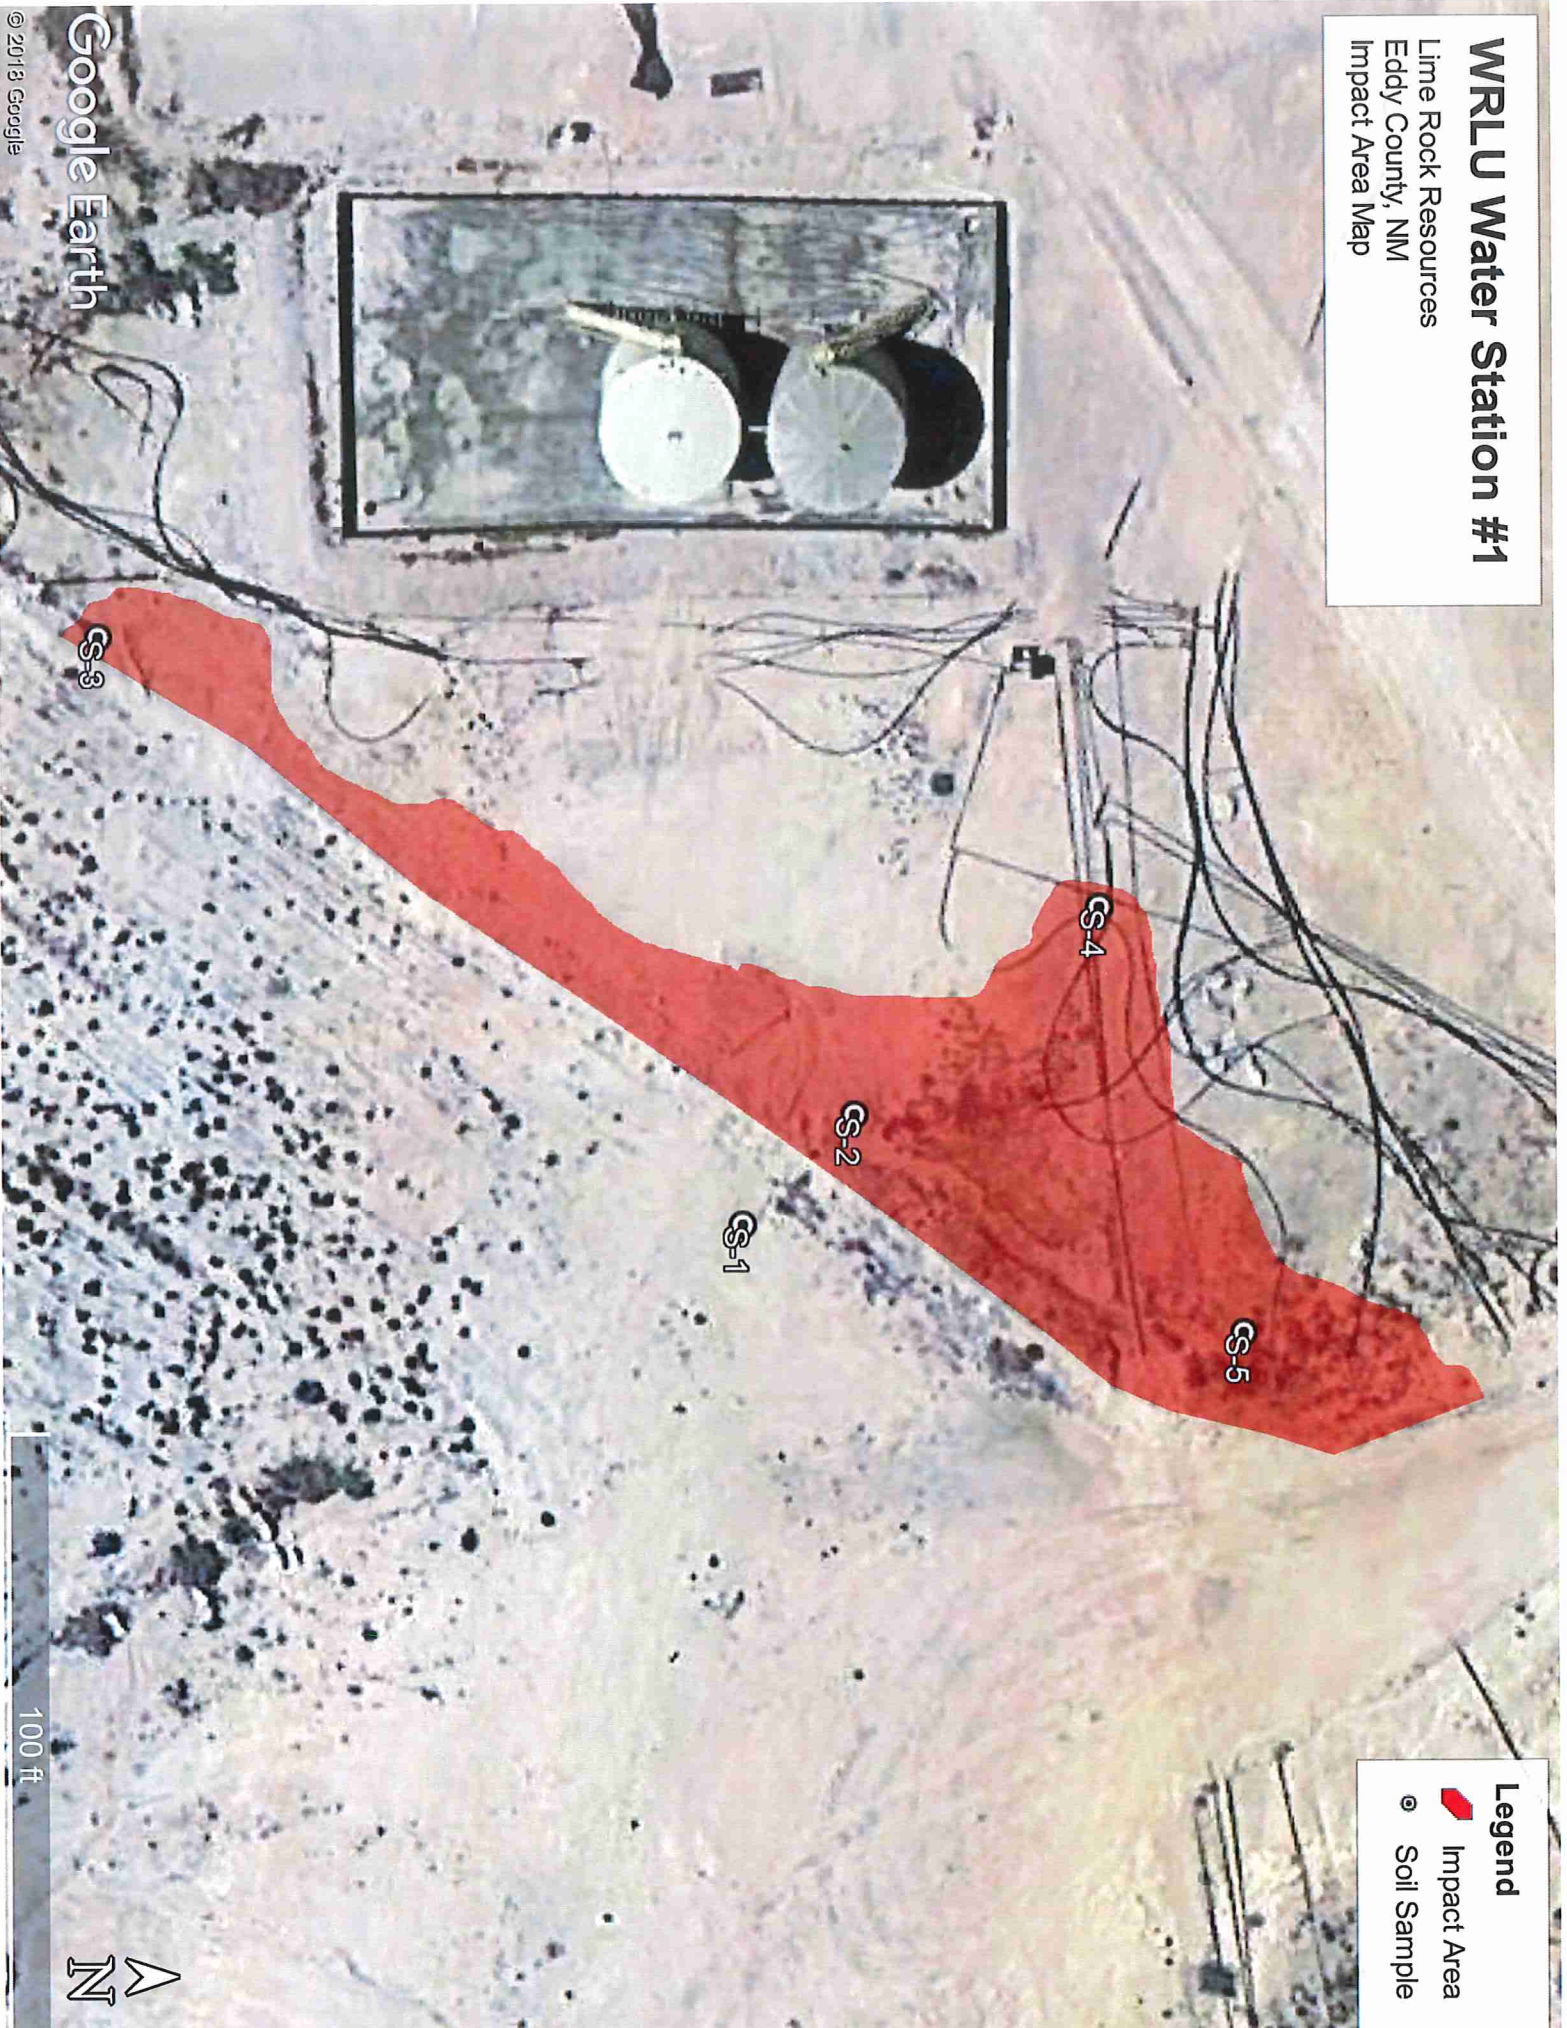
Lime Rock Resources  
Eddy County, NM  
Impact Area Map

-   Impact Area
-

Soil Sample

- The impacted area in the vicinity of S-2 through S-3 was excavated to a depth of 5.0-feet BGS where the excavation was met with hard rock refusal. Once the excavation was complete, a hydrovac was used and the rock surface washed off. A bentonite clay liner was then installed at the bottom of the excavation. Two feet of backfill was placed over the bentonite liner and a 40 mil-liner was then installed at the bottom and over the newly reconstructed berm. The liner was installed to capture future releases and facilitate vac truck recovery efforts.

- The impacted area in the vicinity of S-4 through S-5 was hand-excavated to a depth of 2.0-feet BGS until it was met with hard rock refusal. This area was hand-excavated due to presence of multiple flow lines and inaccessibility of heavy equipment.

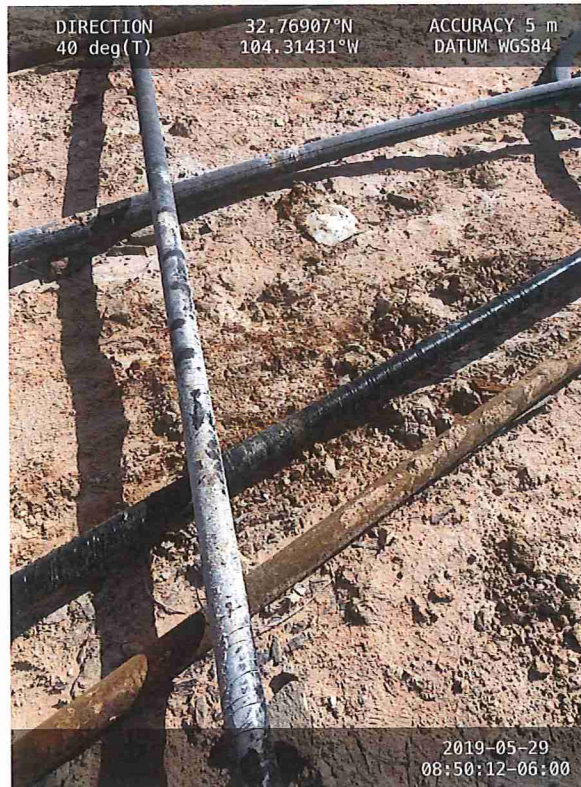
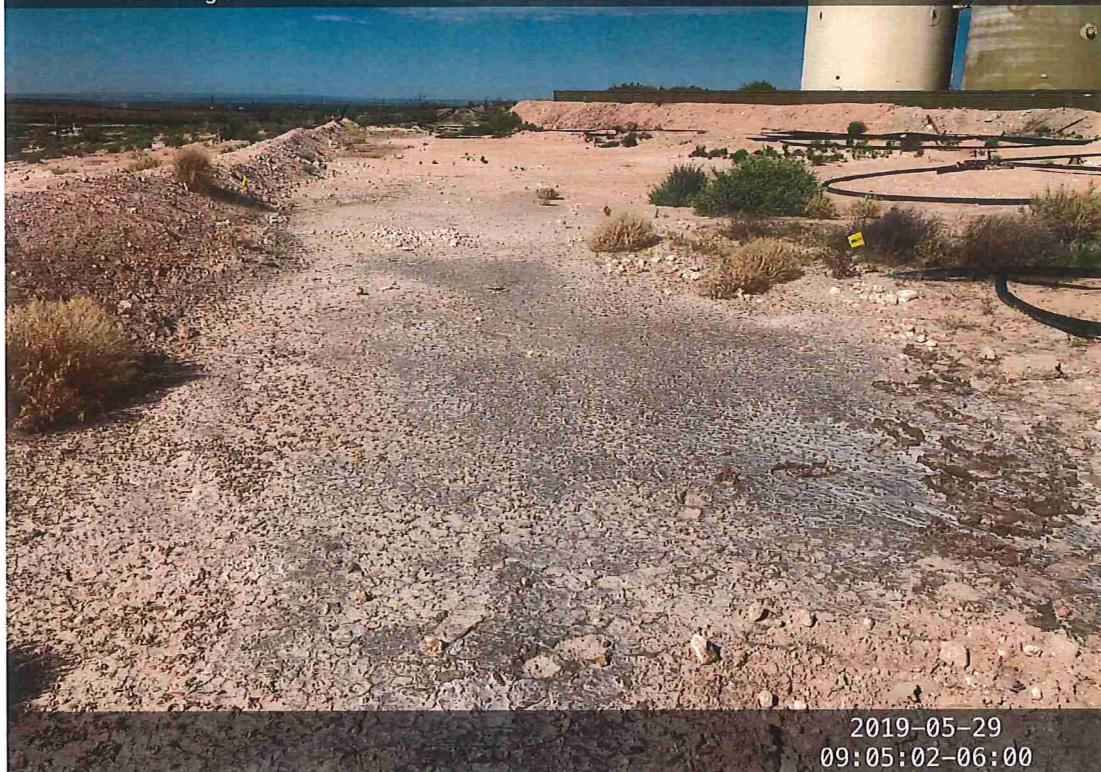
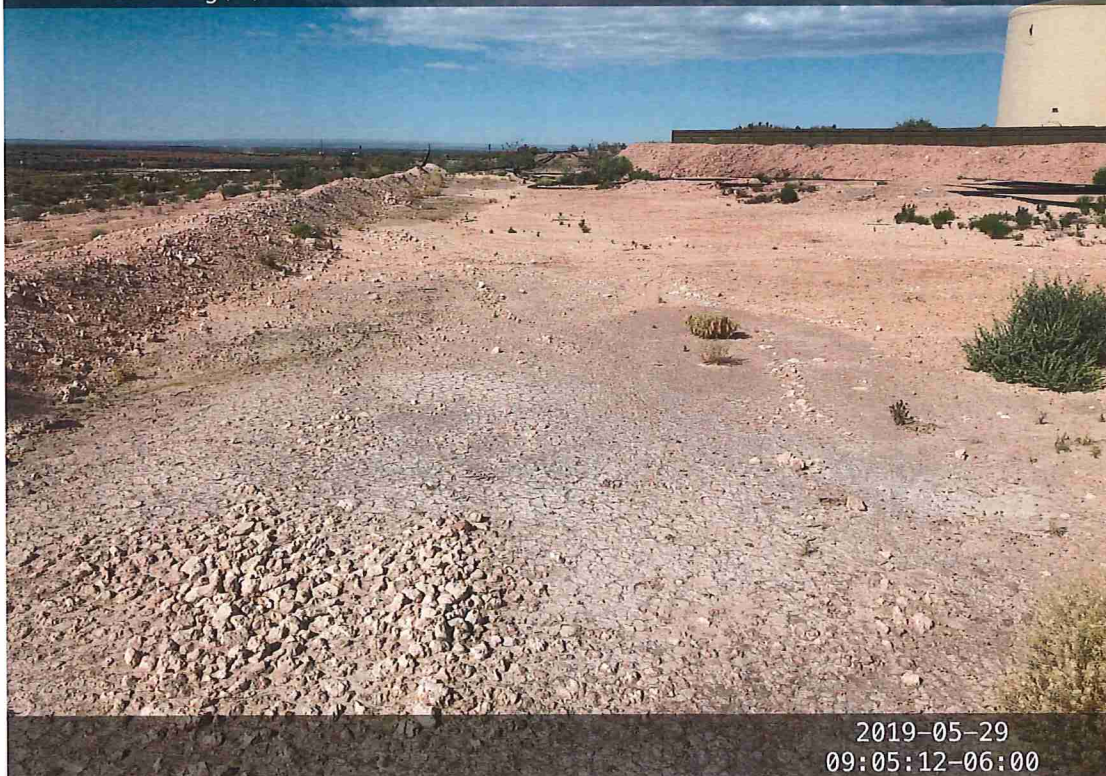
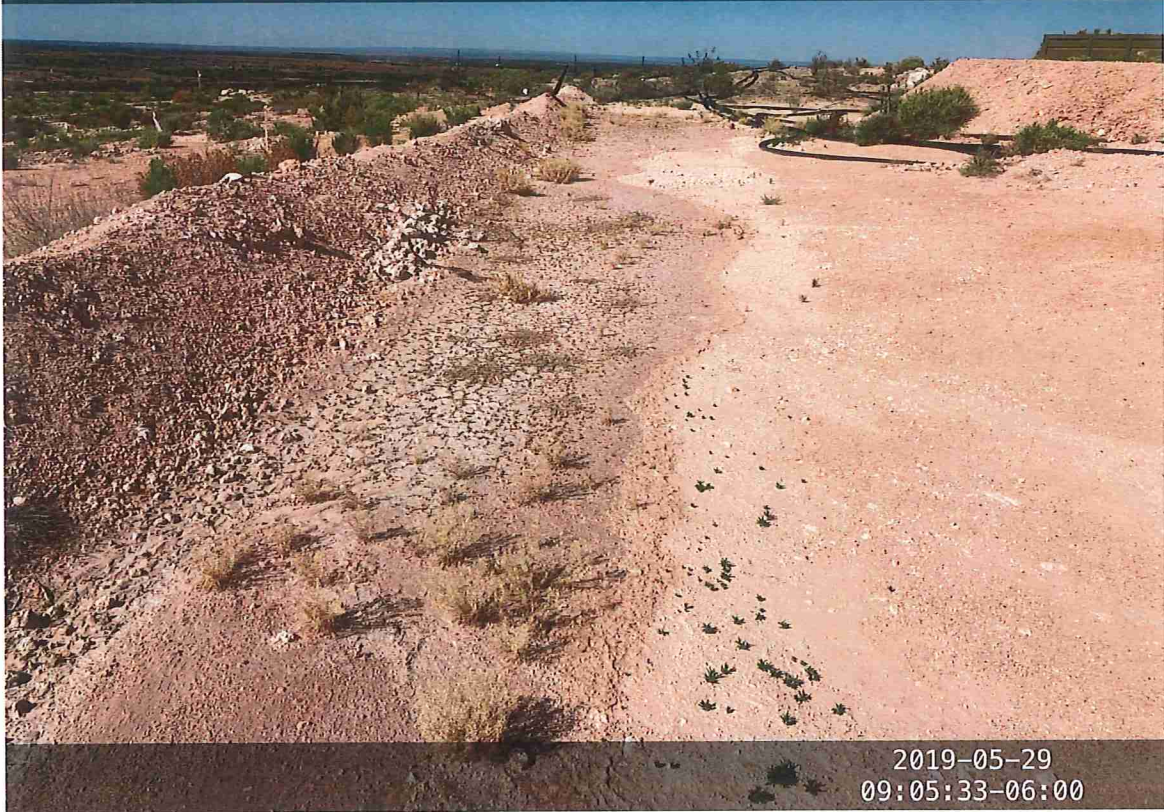
## Spill Area

On May 18, 2019, a 2 7/8" IPC injection line was discovered to be leaking due to corrosion. A total of 135 barrels (bbls) of produced water were released inside the previously constructed bermed area off location. Vac trucks were dispatched and recovered 115 bbls of water.

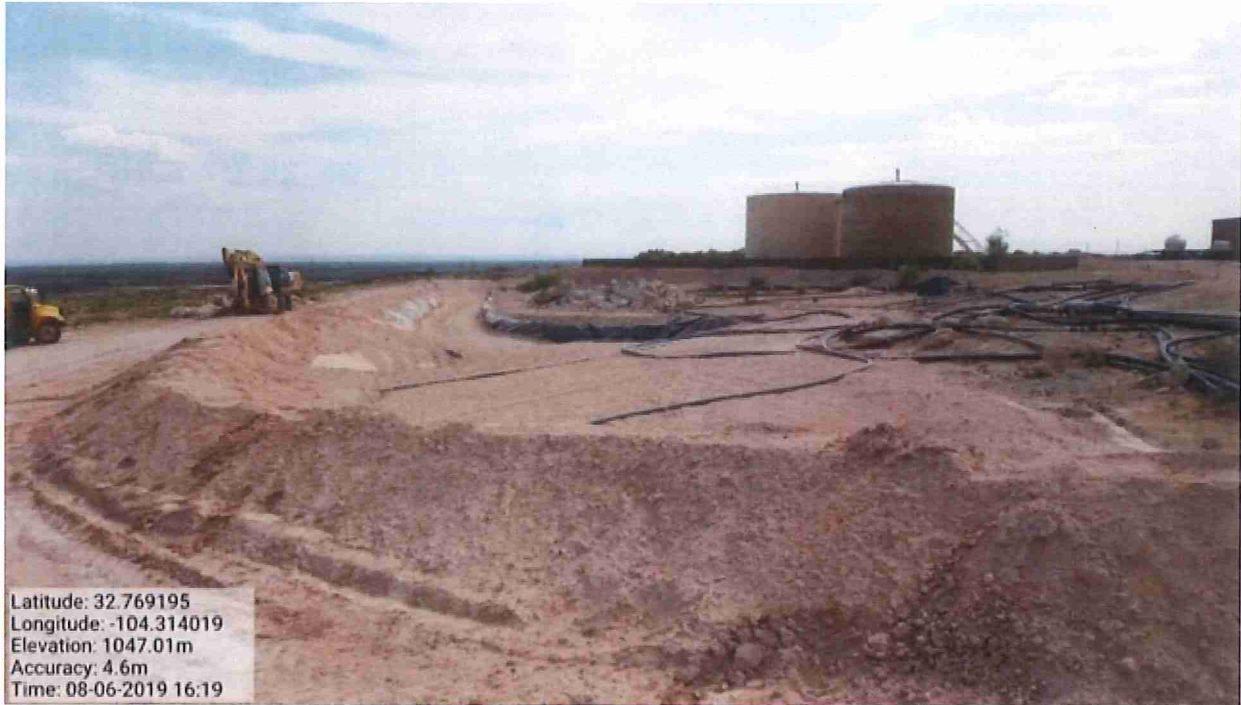
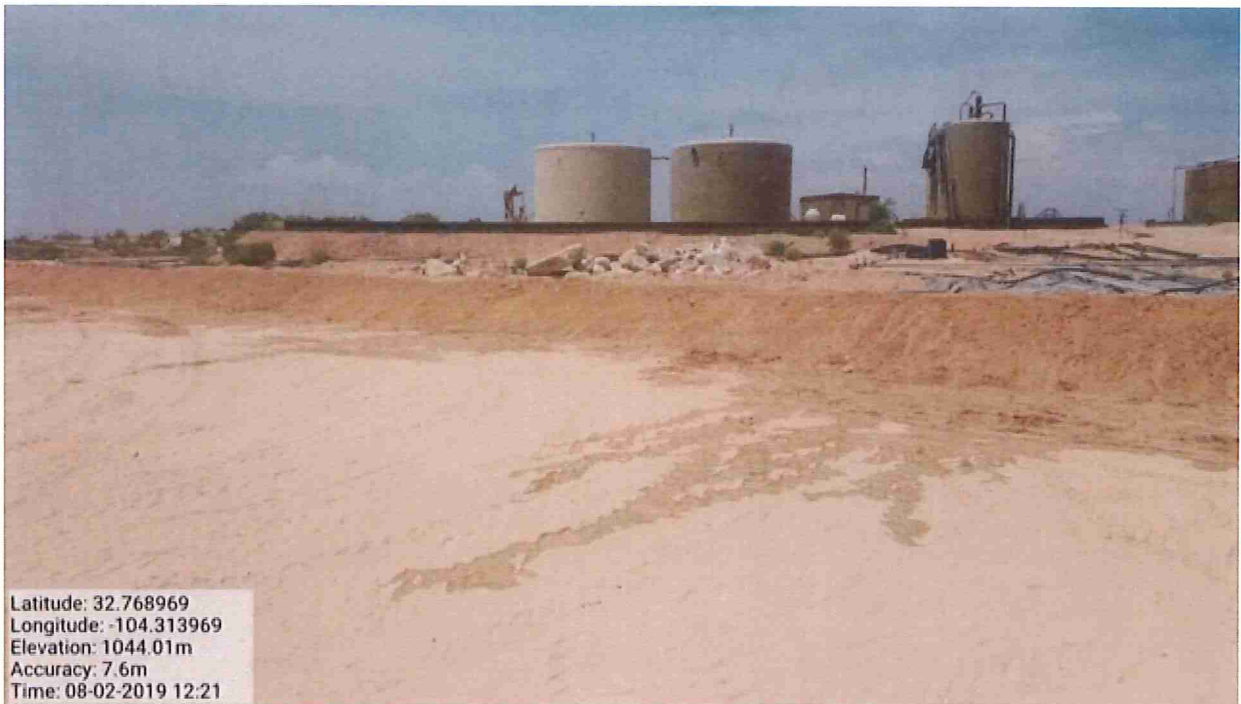
## Completed

- All contaminated soil was transported to Lea Land, LLC, a NMOCD approved soil waste disposal facility.
- The excavated area was backfilled with clean caliche, machine compacted and contoured to match the surrounding location.

- The work area was contoured and sloped to funnel potential spills into the lined and bermed collection area in order to mitigate future incidents of this nature.
