SUBJECT: Remediation Closure Report for the 1009 Pipeline Release (2RP-5570), Eddy County, New Mexico

On behalf of Enterprise Field Services LLC (Enterprise), Souder, Miller & Associates (SMA) has prepared this Remediation Closure Report that describes the remediation of a release of liquids related to oil and gas production activities at the 1009 pipeline release site. Contaminated soil has been removed and remaining soil meets NMOCD Closure Criteria set forth by 19.15.29.13(D)(1). On behalf of Enterprise, SMA requests closure for release 2RP-5570.

## **1.0 Background**

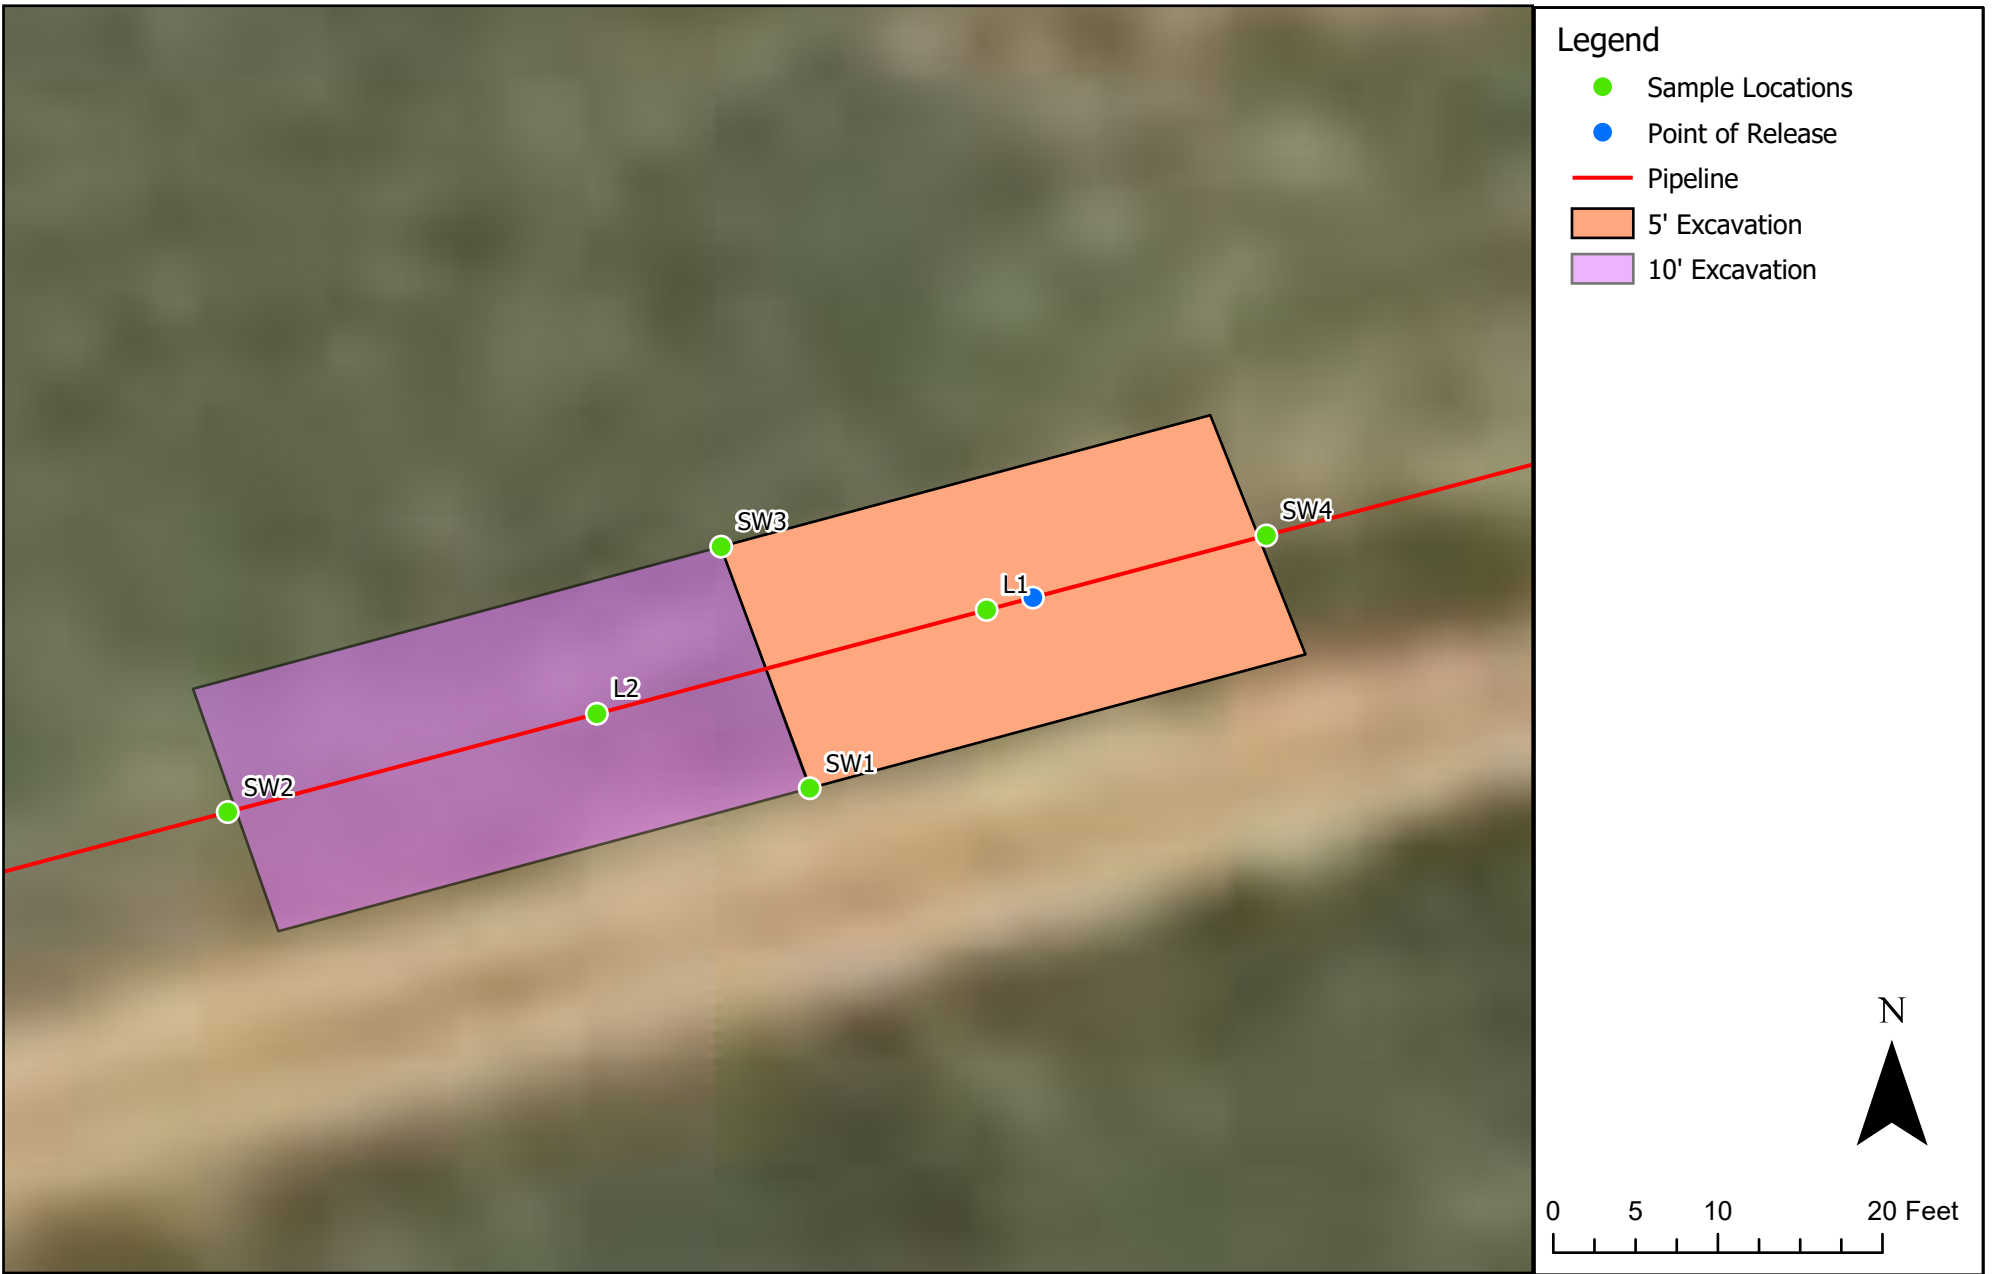
On September 6, 2019, SMA conducted confirmation sampling of the walls and base of the excavation, which measured approximately 50 x 25 feet. The area around sample location (L2) was excavated to a depth of ten (10) feet bgs, while the area around L1 remained at five (5) feet bgs.

Figure 3 shows the extent of the excavation and sample locations. Analytical laboratory results are summarized in Table 3. Laboratory reports are included in Appendix D.

Site and Sample Location Map  
1009 Pipeline - Enterprise  
UL: E S: 27 T: 22S R: 30E Eddy County, New Mexico
