**RE: LINER INSPECTION REPORT
GRAMA 8817 JV-P TANK BATTERY (1RP-5464)**

Souder, Miller & Associates (SMA) is pleased to submit this letter report on behalf of BTA Oil Producers, LLC (BTA) summarizing the liner inspection that occurred due to the Grama 8817 JV-P Tank Battery release. The site is located in Section 16, T22S, R34E (N32.38615/W-103.48183) Lea County, New Mexico, on State land.

Souder, Miller & Associates
Liner Inspection Form

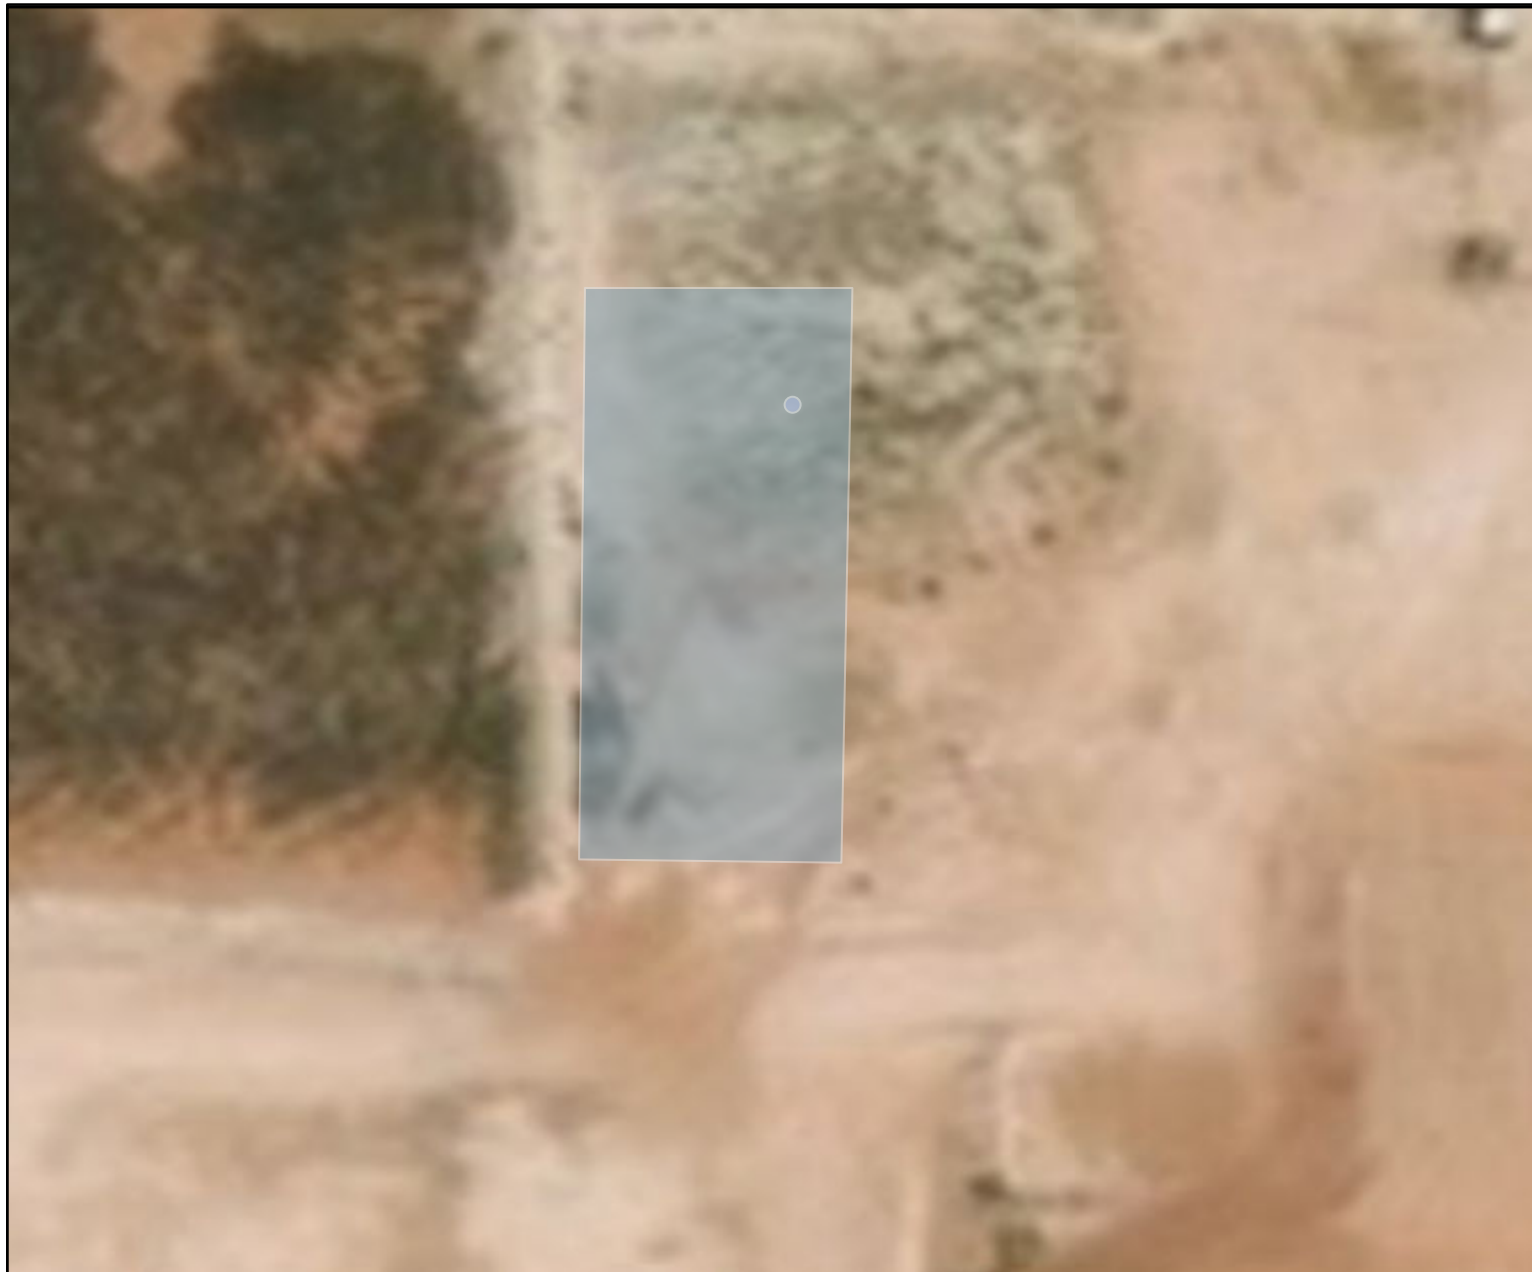
Figure 2

- Point of Release
- Lined Containment

Site and Sample Locations
Grama Tank Battery - BTA Oil Producer, LLC
Lea County, New Mexico

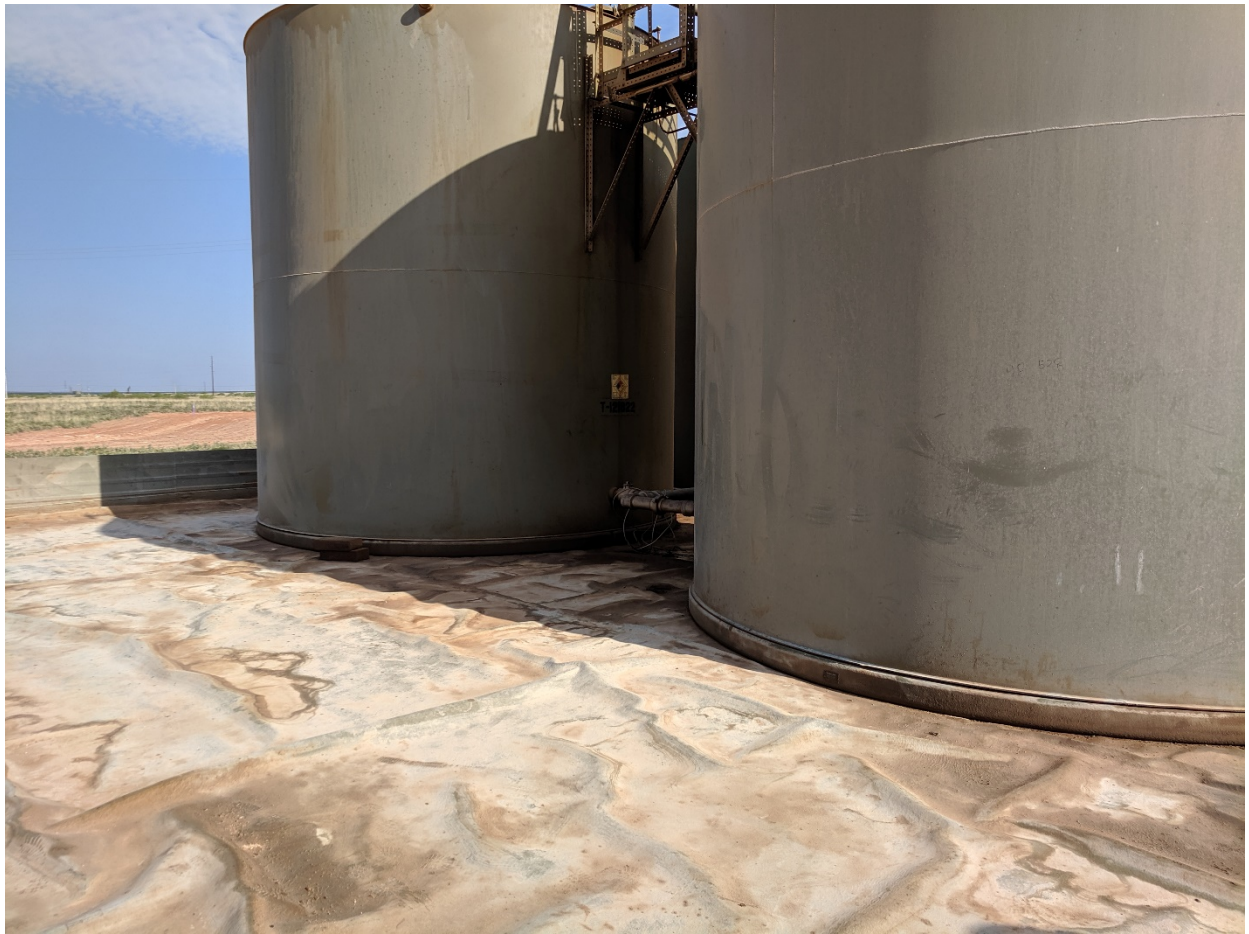
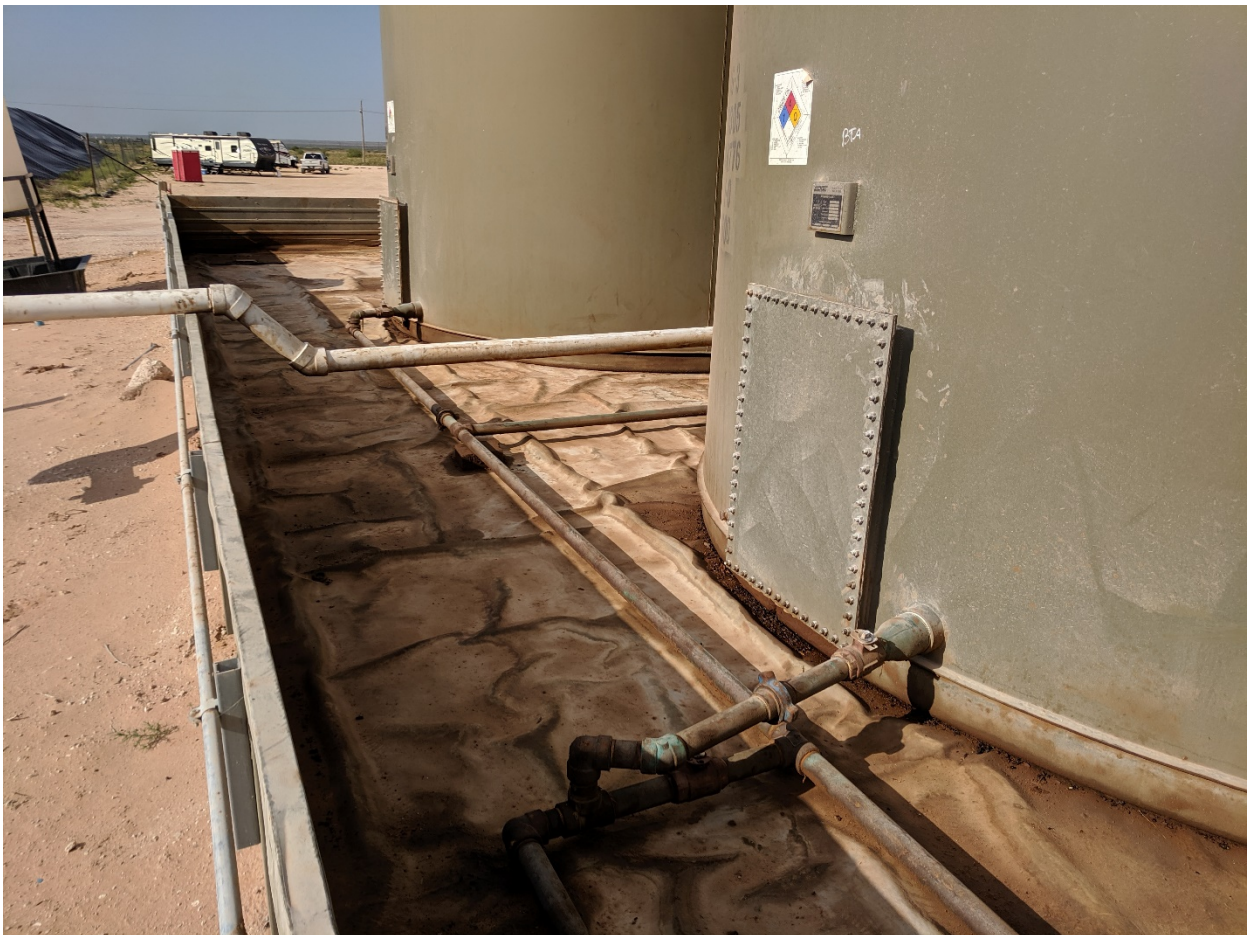
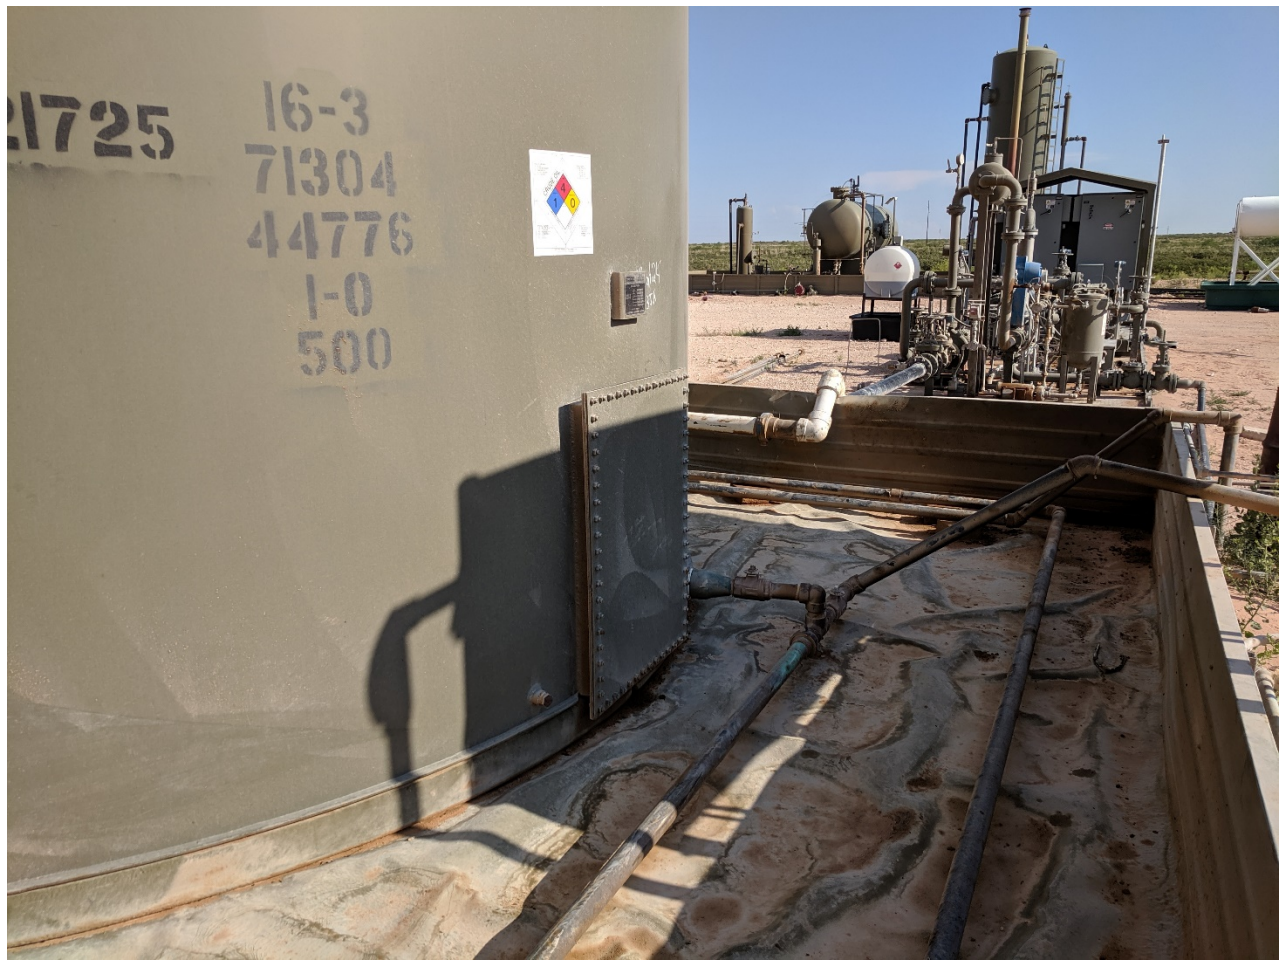
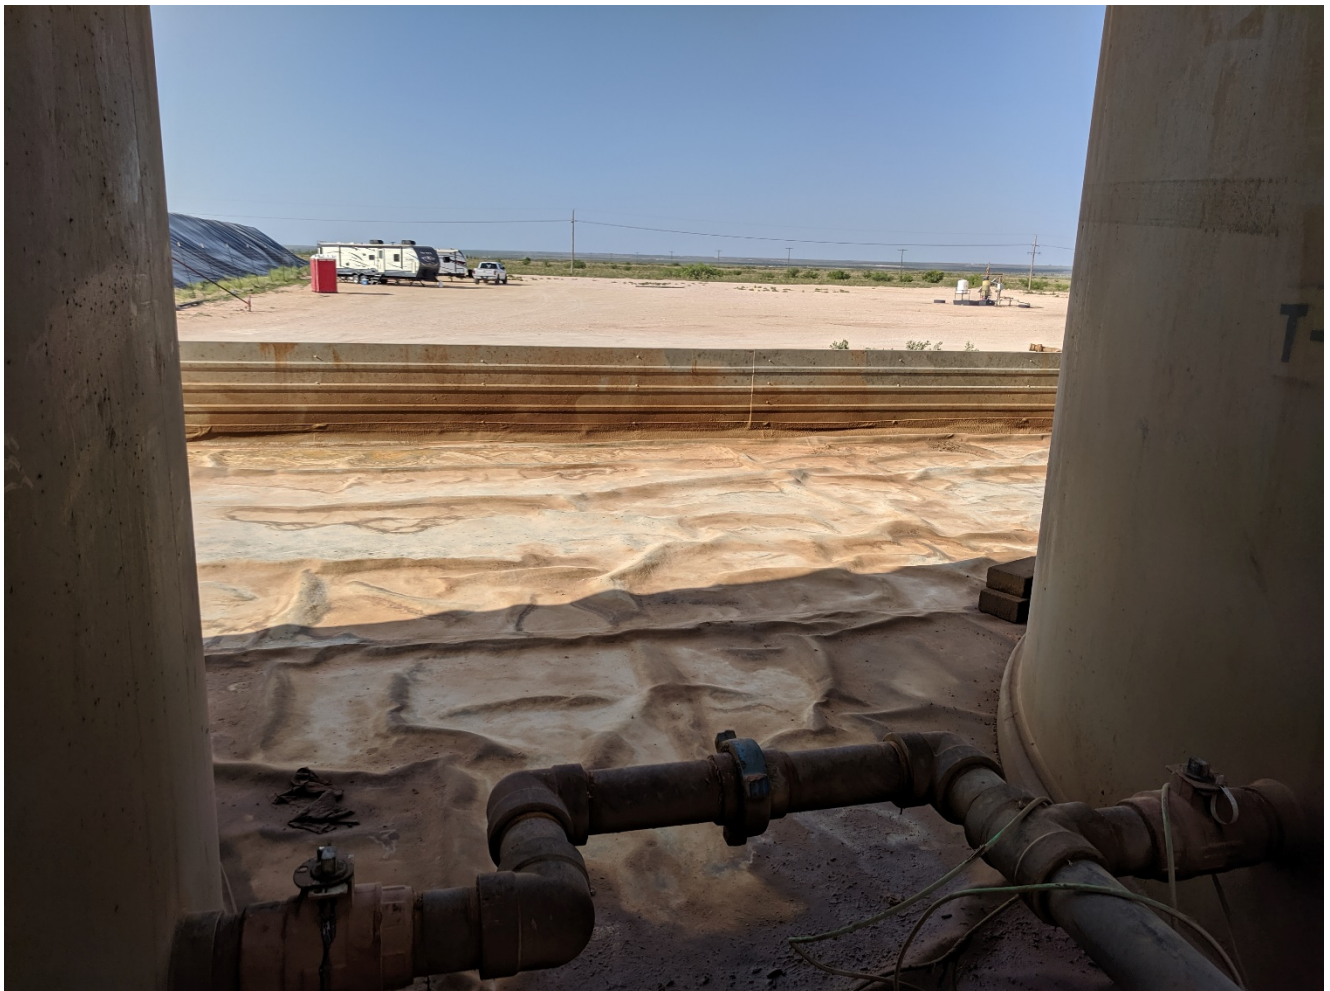
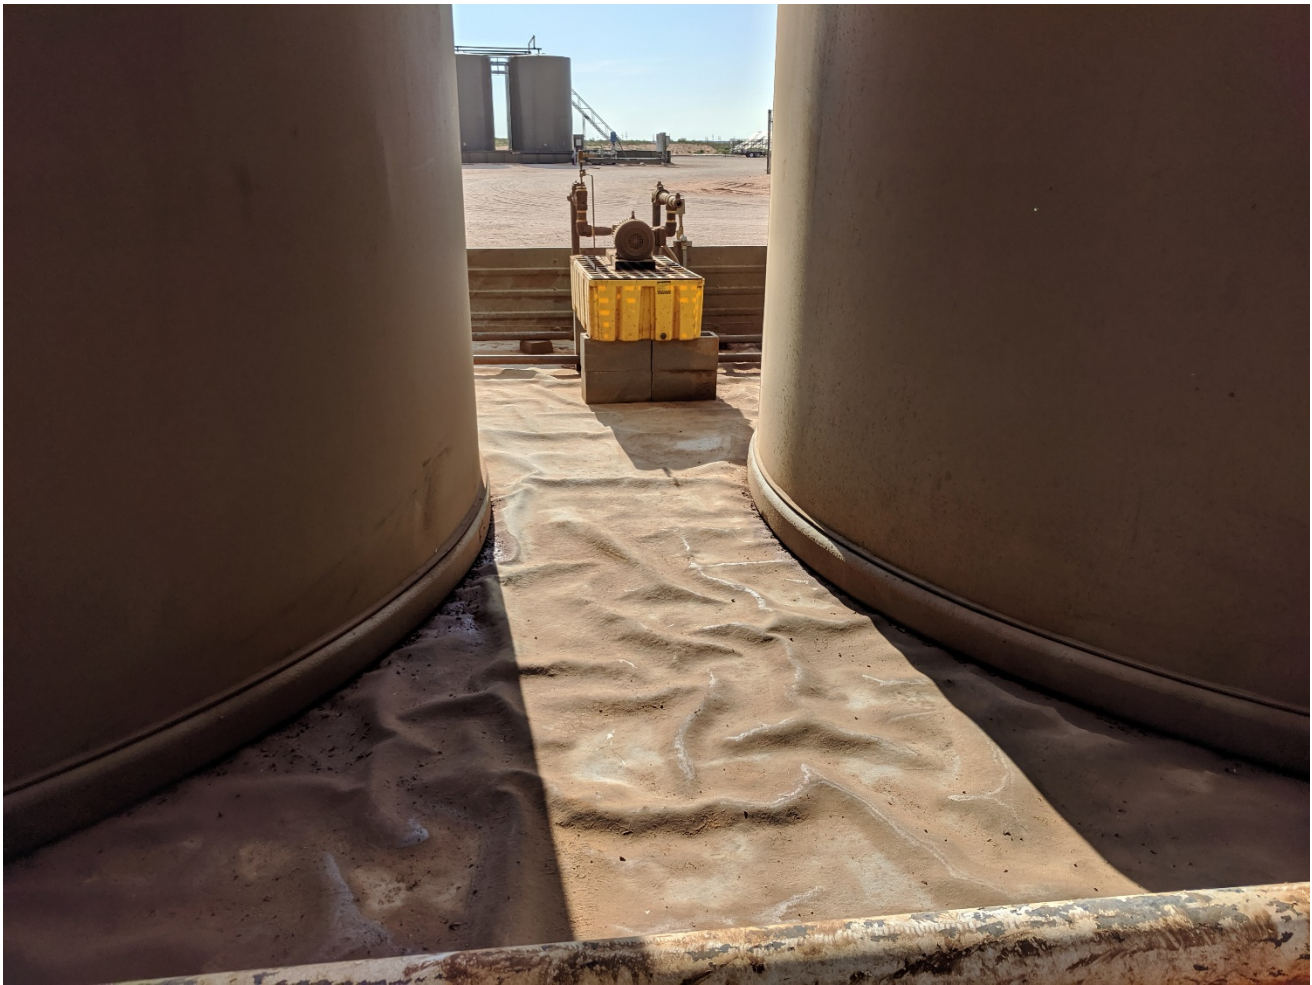
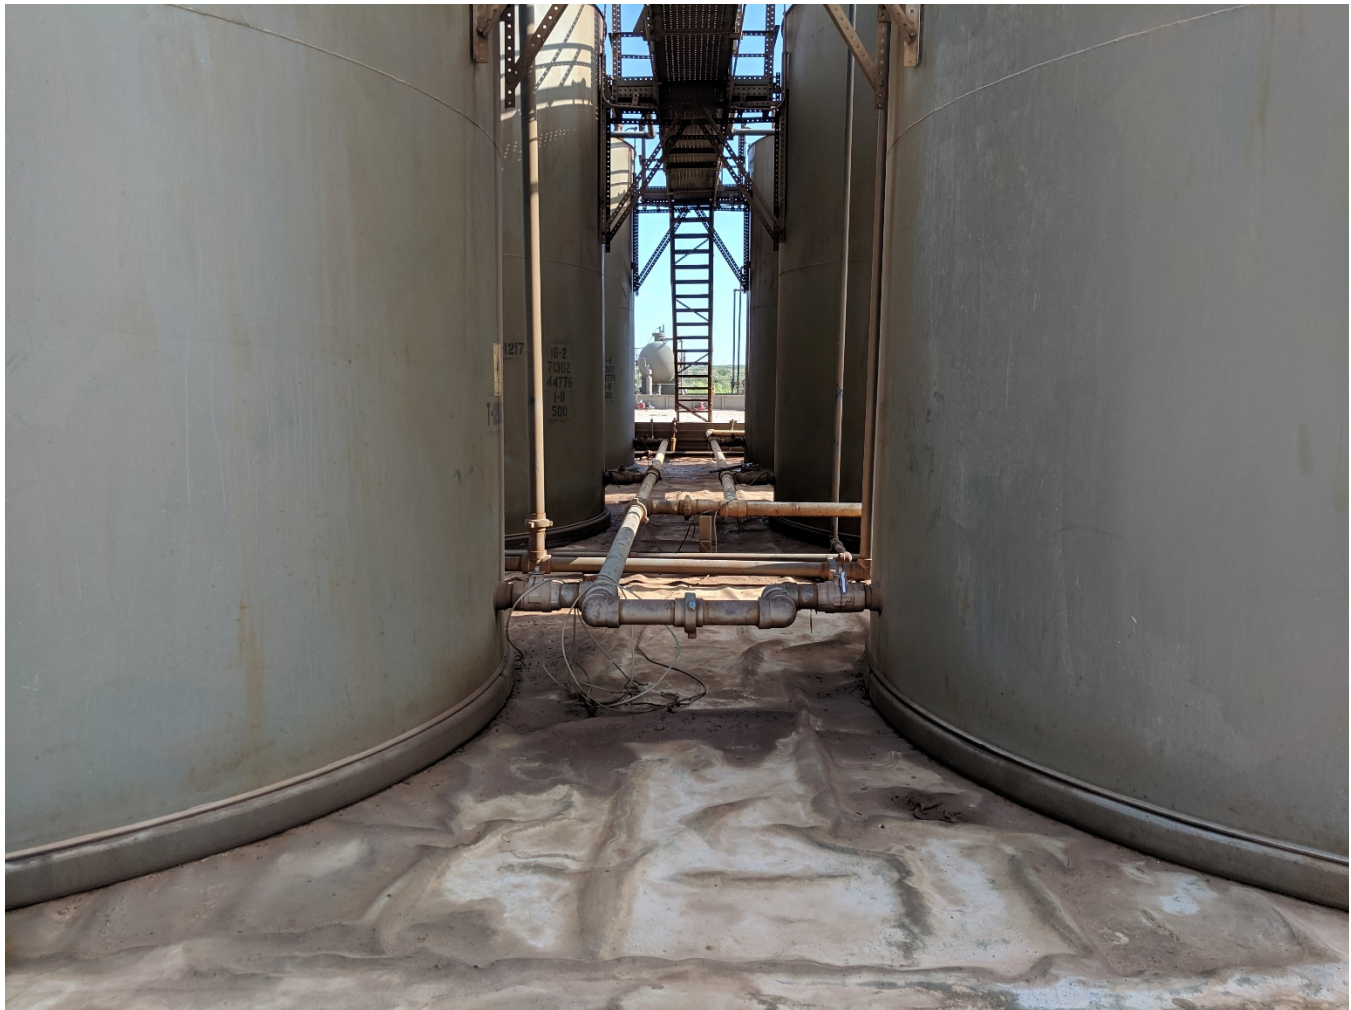
Appendix A
PHOTO LOG & FIELD NOTES

At the request of BTA, SMA conducted a liner integrity inspection per requirements of 19.15.29.11.A(5)(a) NMAC. NMOCD was notified on July 8, 2019 that the liner inspection was to occur, and SMA conducted the inspection on July 11, 2019. After a thorough visual inspection of the liner within the tank battery containment, the liner appeared to be intact and had the ability to contain the leak in question. The tank from which the release occurred was identified, and SMA verified that the release did not occur outside of the lined containment. A photo log and field notes of the inspection is included in Appendix A.

SMA recommends no further action for this release.
