**N. DRAINAGE  
DITCH**

**RE: Response to Approval with Modifications – Comment No. 6**  
**[Revised] Investigation Report North Drainage Ditch and OW-29 & OW-30 Areas**  
**Marathon Petroleum Company LP, Gallup Refinery**  
**(dba Western Refining Southwest, Inc.)**  
**EPA ID# NMD000333211**  
**HWB-WRG-18-008**

The purpose of this investigation is to; (1) further characterize impacts to soils observed in and near the ditch, (2) characterize the area up-gradient of the ditch to help identify potential sources of the observed groundwater impacts, and (3) determine the down-gradient extent of groundwater impacts. The investigation activities proposed in this work plan include sampling of soils at 2 locations along the North Drainage Ditch with groundwater samples to be collected at temporary well completions. Six temporary wells are proposed down-gradient of the North Drainage Ditch and two up-gradient permanent monitoring wells are also proposed.

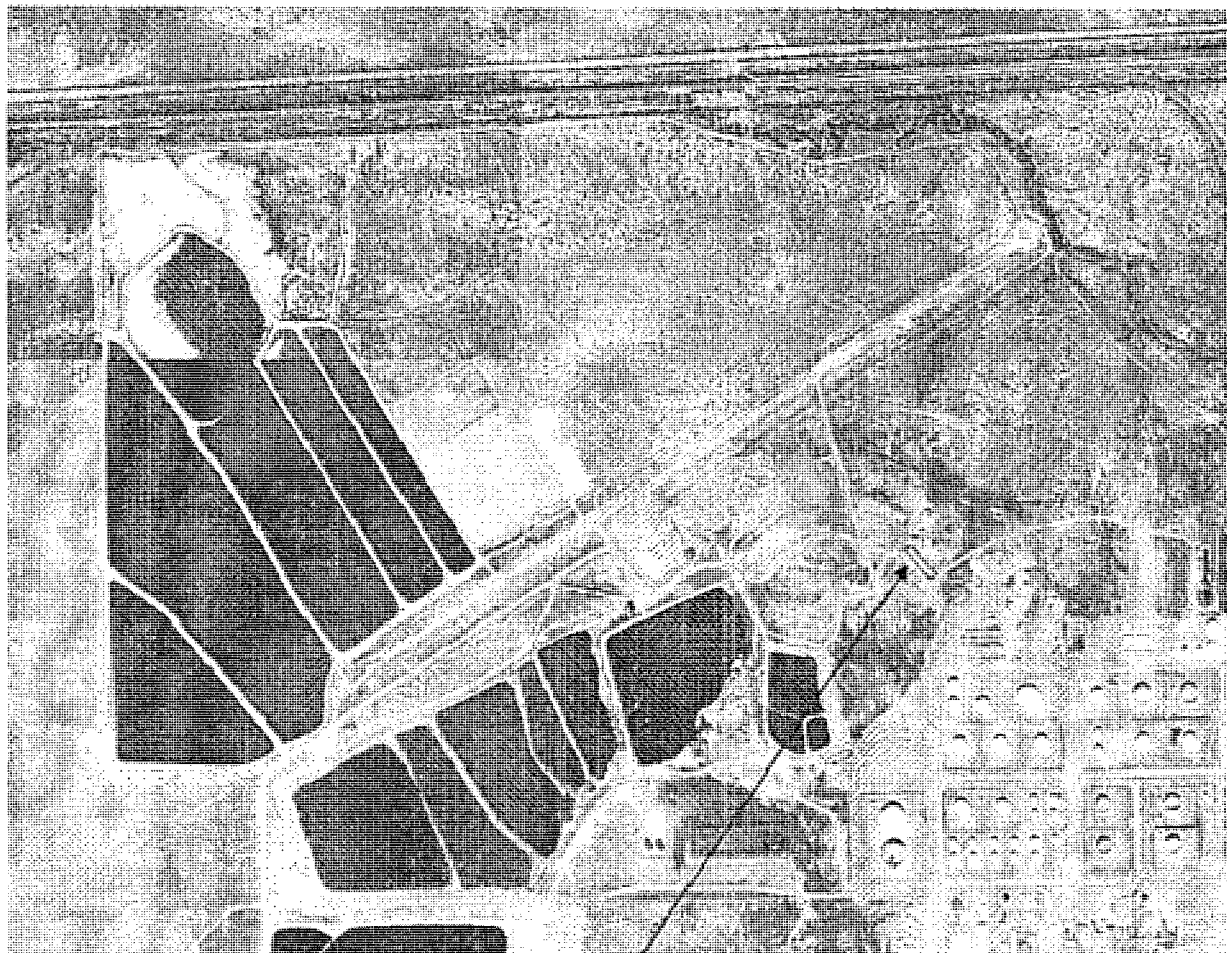
Approximate location of ditch – not to scale

Describe Cause of Problem and Remedial Action Taken.\* At approximately 1:30 pm on 10/19/2009, during a routine walk-through of arroyos and ditches in a field that lies immediately north of the hill on which the refinery is located, a ditch containing non-moving water was found to have some possible hydrocarbon staining – suspected from color of the water and smell of diesel.
