**RE: Deferral Request
Big Eddy Unit 039
Remediation Permit Number 2RP-5294
Eddy County, New Mexico**

FIGURE 1
SITE LOCATION MAP
BIG EDDY UNIT 039
UNIT G SEC 29 T21S R28E
EDDY COUNTY, NEW MEXICO
XTO ENERGY, INC.

Project: 012919036	XTO Energy, Inc. Big Eddy Unit 039

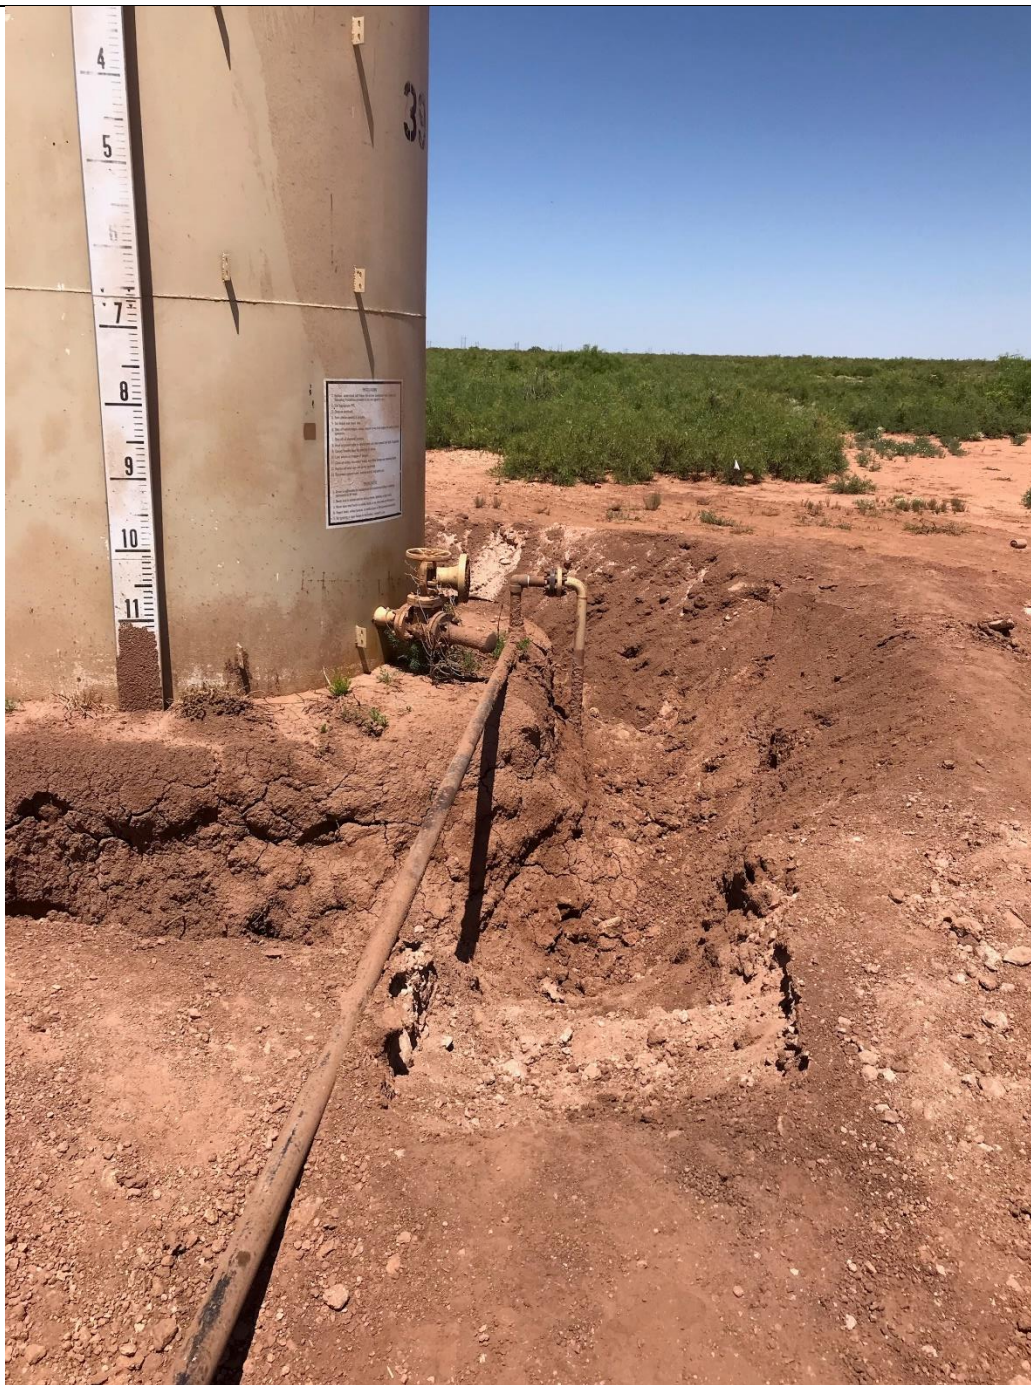
Eastern view of release area south of the tank battery during excavation activities.

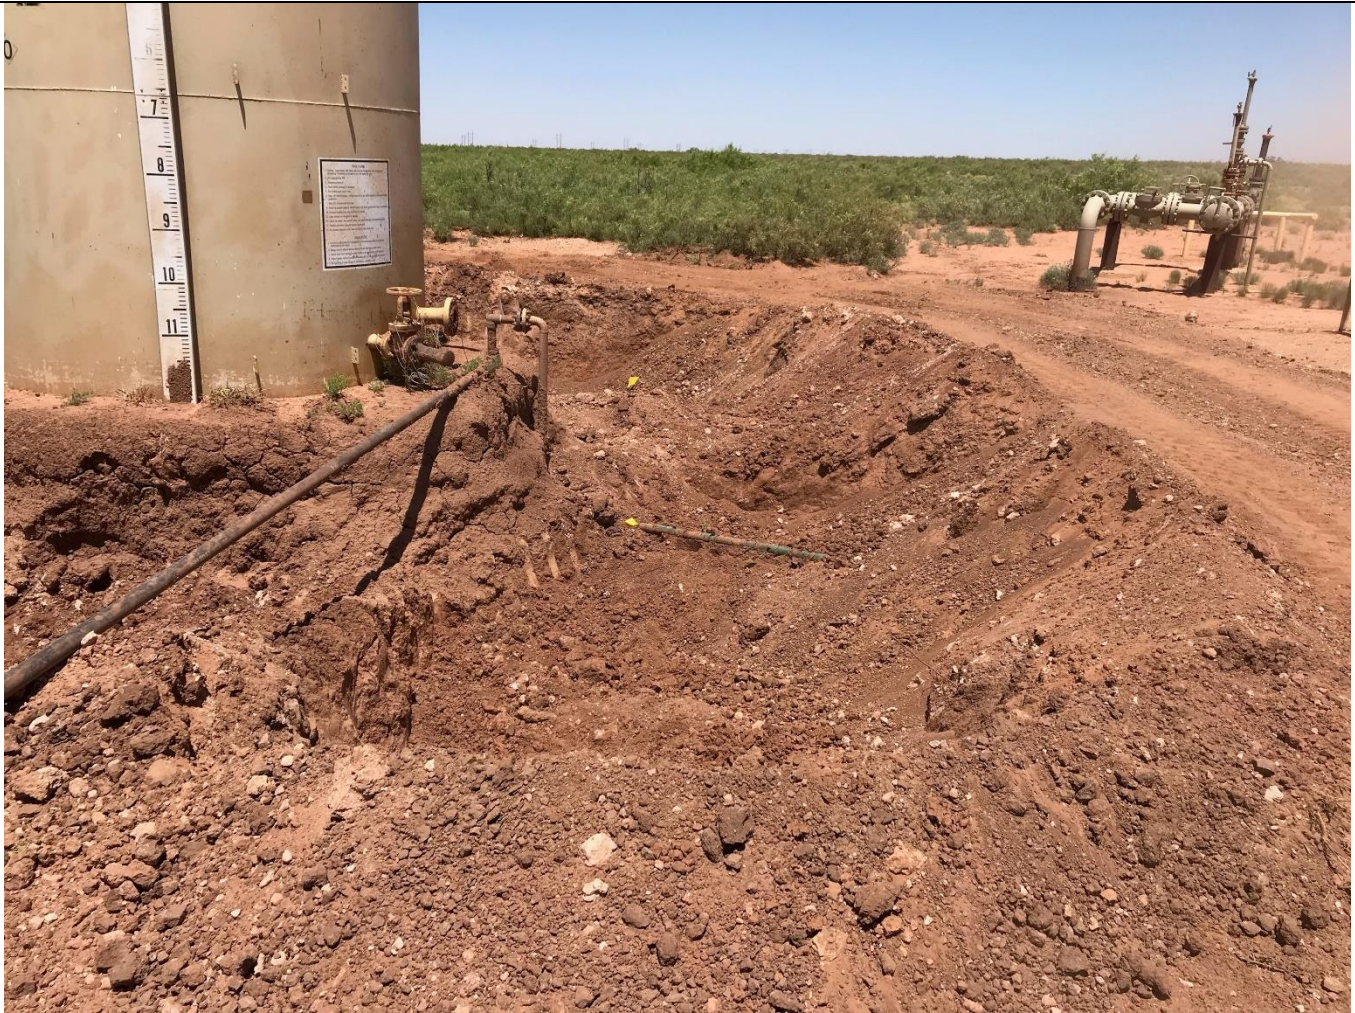
Eastern view of the final excavation extent on the south side of the tank battery.

A total of approximately 100 cubic yards of impacted soil were excavated from the Site; however, residual impacted soil was left in place for compliance with the XTO safety policy regarding earth-moving activities within 2-feet of active production equipment. Laboratory analytical results for excavation soil sample SW03, collected from the interior sidewall of the final excavation extent, indicated that soil with TPH and chloride concentrations exceeding the NMOCD Table 1 closure criteria was left in place within two feet of an active oil tank. The excavation was advanced to within 2 feet from the oil tank to remove as much impacted soil as possible. An estimated 30 cubic yards of impacted soil remain in place around and beneath the oil tank, assuming a maximum 5-foot depth based on soil samples FS03 and FS04 that were compliant with the NMOCD Table 1 closure criteria. The impacted soil remaining in place is delineated laterally and vertically by soil samples FS03, FS04, SW04, and SW05.

XTO requests to backfill the existing excavation and complete remediation during any future major well pad construction/alteration or final plugging and abandonment, whichever occurs first. LTE and XTO do not believe deferment will result in imminent risk to human health, the environment, or groundwater. The free-standing fluids were recovered during initial response activities, and no saturated soil remains in place. XTO requests deferral of final remediation for RP Number 2RP-5294. Upon approval of this deferral request, XTO will backfill the excavation with material purchased locally and recontour the Site to match pre-existing conditions. An updated NMOCD Form C-141 is included in Attachment 1. A photographic log of the Site is included in Attachment 3.
