## Release Notification

Site Name Big Eddy Unit 039	Site Type Production Well and Storage Facility
Date Release Discovered 2/21/2019	API# (if applicable) 30-015-20945

Excavation of impacted soil have mitigated impacts at this Site. XTO requests no further action for RP Number 2RP-5294. Upon approval of this closure request, XTO will backfill the excavation with material purchased locally and recontour the Site to match pre-existing site conditions. An updated NMOCD Form C-141 is included as Attachment 1 and a Photographic Log is included as Attachment 4.

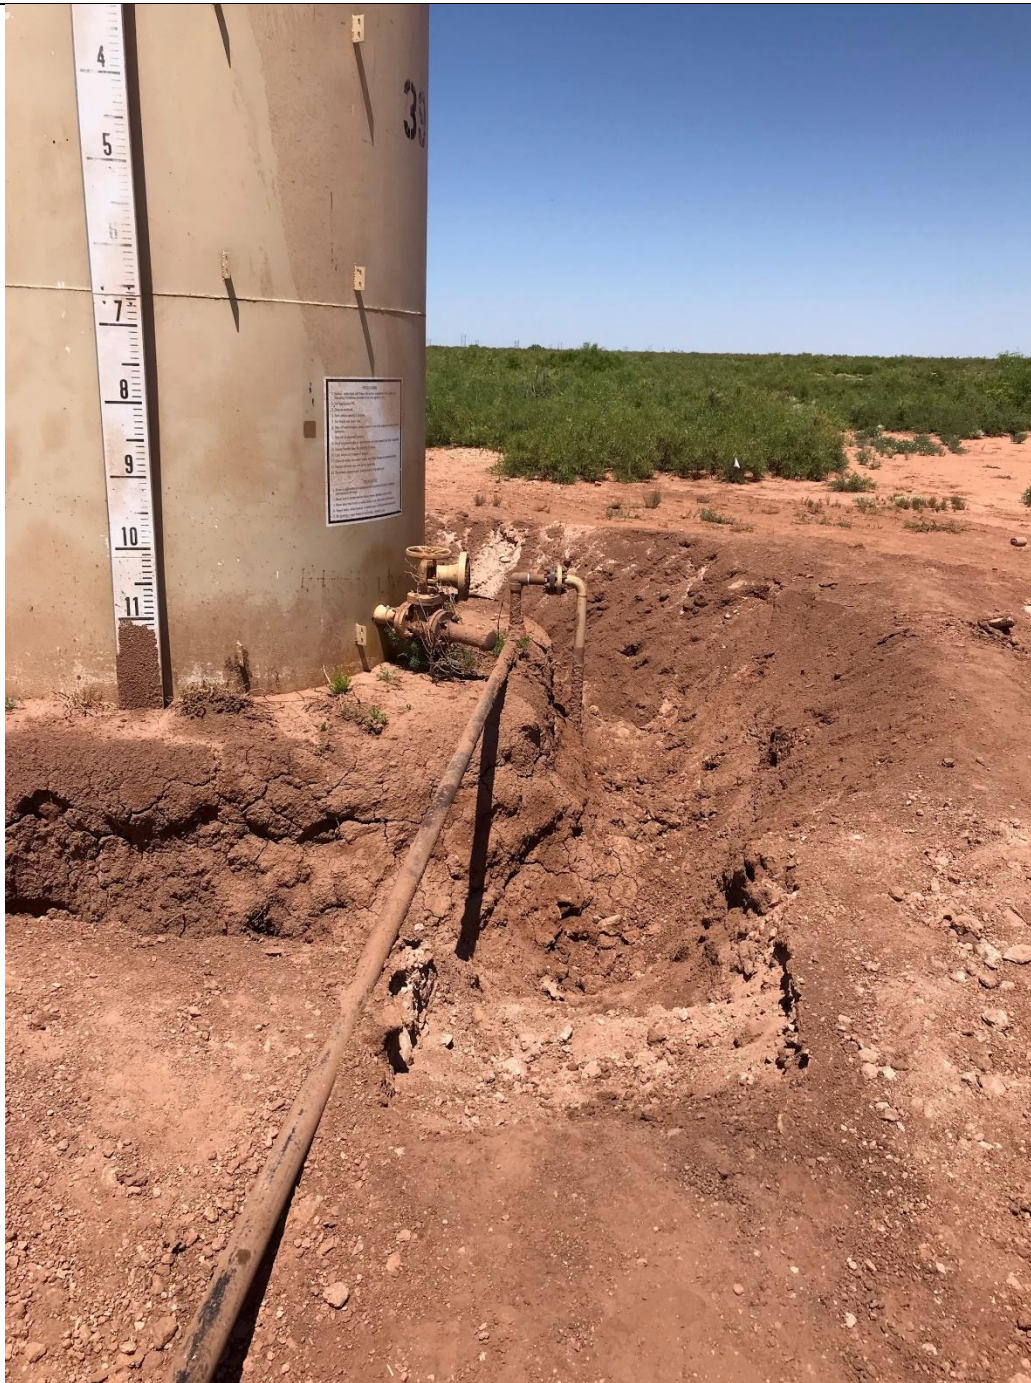
**Eastern view of release area south of the tank battery during excavation activities.**

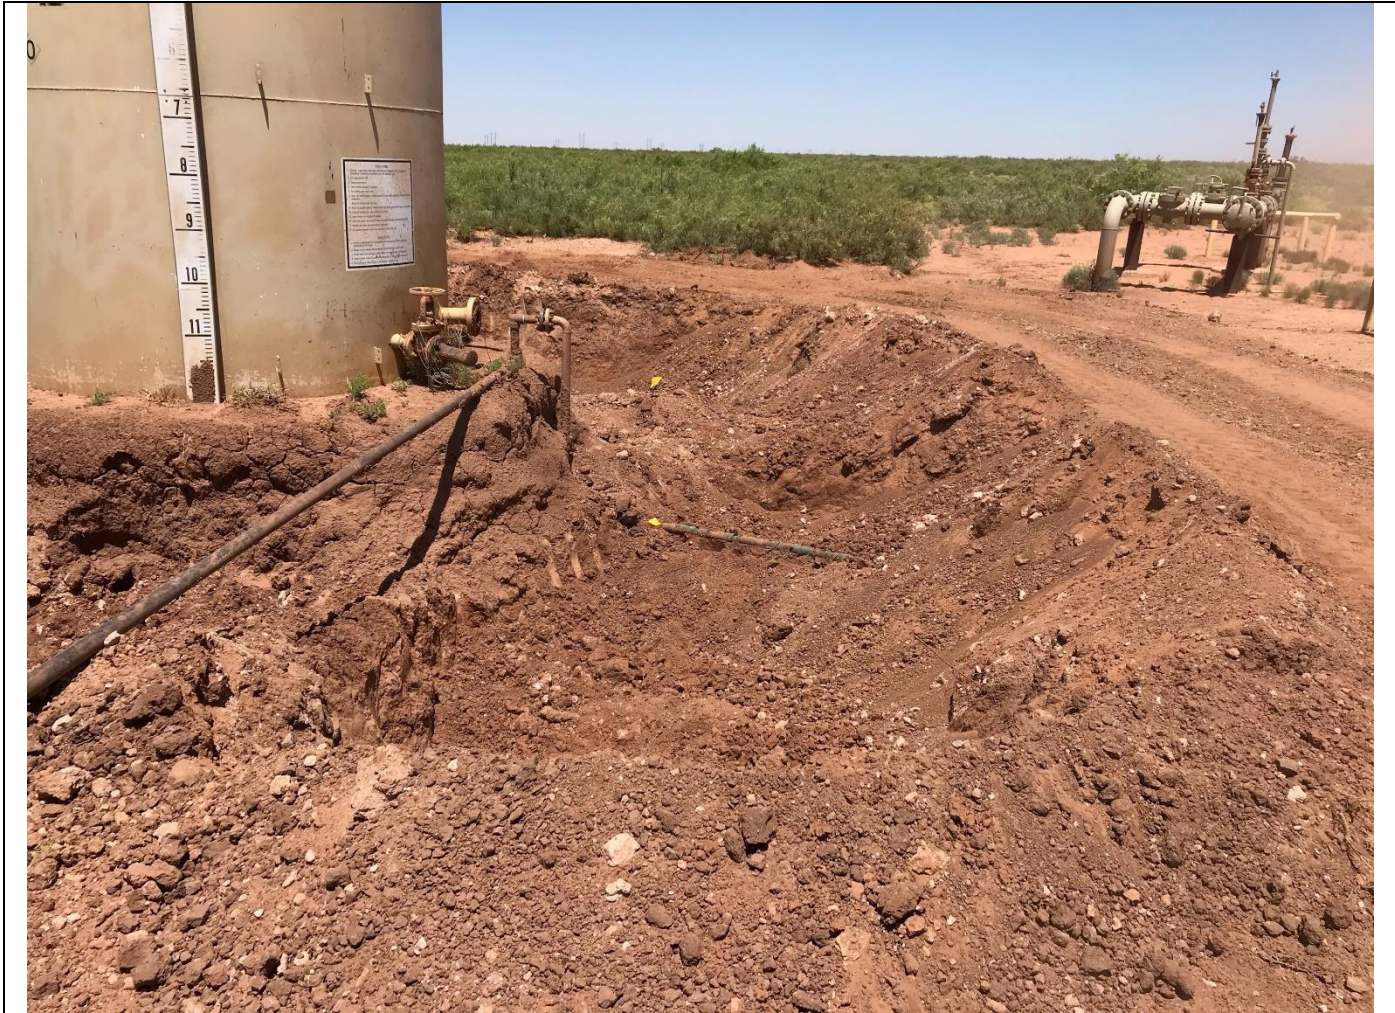
Eastern view of the excavation extent on the south side of the tank battery during excavation activities.
