**RE: 2019 Annual Groundwater Report**

**Rice Operating Company – BD SWD System**

**BD F-29 (1R426-16) and F-29-1 (1R426-15): UL/F, Sec. 29, T21S, R37E**

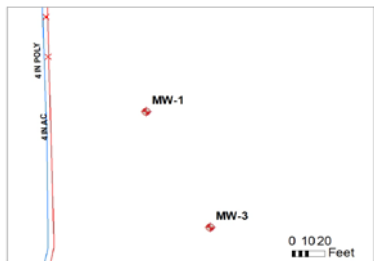
Logger:	Nick Kopiasz

Driller:	HCI Drilling					
Drilling Method:	Air rotary					
Start Date:	11/13/2018					
End Date:	11/16/2018					
Comments: Located approximately 70 ft southeast of the former junction boxes. Soil samples were collected from drill cuttings at specified intervals.  DRAFTED BY: N.Kopiasz TD = 116 ftGW = 99 ft			Project Name:BD F-29/F-29-1Well ID:MW-1 Project Consultant: Tasman Location:Unit F, Section 29, T21S, R37E Lat: 32.450441County: Lea Long: -103.184960 (NAD83)State: NM			
Depth (feet)	Chloride field tests	LAB	PID	Description	Lithology	Well Construction
				SM-dark red, silty sand

Concrete
SS						
				SC-dark red, clayey silt		4 in. PVC
5 ft						
				SM-tan, silty sand, caliche		
10 ft						Bentonite Seal
				SM-reddish tan, silty sand, occasional caliche		
15 ft						
				SM-reddish tan, silty sand		
20 ft						
				SM-tan, silty sand		
25 ft						
				SM-tan, silty sand, caliche

40 ft										
				SM-SAA						
45 ft										
				SM-tan, silty sand						
50 ft										
				SM-SAA						
55 ft										
				SM-SAA						
60 ft										
				SM-tan, silty sand, sandstone						
65 ft										
				SM-SAA						
70 ft										
				SM-SAA						
75 ft										
				SM-SAA						
80 ft										
				SM-reddish tan, silty sand, sandstone, slight moisture						
85 ft

<div>10' Sump</div> <div>Sand Pack</div>
90 ft								
				SM-reddish tan, silty sand, moist				
95 ft								
				SM-SAA				
100 ft								
				SM-SAA				
105 ft								
				SM-SAA				
110 ft								
				SM-SAA				
115 ft

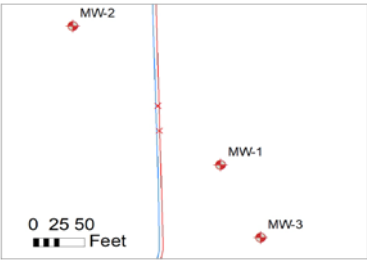
Logger:	Nick Kopiasz

Driller:	HCI Drilling						
Drilling Method:	Air Rotary			Project Name: BD F-29/F-29-1 Well ID: MW-2 Project Consultant: Tasman			
Start Date:	12/10/2018						
End Date:	12/10/2018	Comments: Located approximately 133 ft northwest of the former junction boxes. Soil samples were collected from drill cuttings at specified intervals.  DRAFTED BY: N.Kopiasz TD = 102 ft                      GW = 99 ft			Location: Unit F, Section 29, T21S, R37E  Lat: 32.450860                      County: Lea Long: -103.185424 (NAD83)      State: NM		
Depth (feet)	Chloride field tests	LAB	PID	Description	Lithology	Well Construction	
				SM-reddish brown, silty sand			Concrete
SS							
				SC-reddish brown, clayey silt			
5 ft							
				SC-Same As Above (SAA)			
10 ft							
				GM-light tan, gravelly silt, caliche		2 in. PVC	
15 ft							
				SM-light tan, silty sand, occasional caliche			Bentonite Seal

20 ft							
				SM-SAA			
25 ft							
				GM-light tan, gravelly silt, caliche			
30 ft							
				GM-SAA			
35 ft

40 ft										
				SM-SAA						
45 ft										
				SM-SAA						
50 ft										
				SM-tan, silty sand, occasional caliche						
55 ft										
				SM-SAA						
60 ft										
				GM-tan, gravelly silt, caliche						
65 ft										
				SM-tan, silty sand, occasional caliche						
70 ft										
				SM-reddish tan, silty sand, occasional caliche and sandstone						
75 ft										
				SM-SAA						
80 ft										
				SM-SAA						
85 ft

90 ft								
				Not Sampled (NS)				
95 ft								
				NS				
100 ft								
				NS				
105 ft

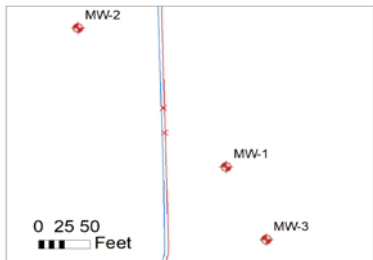
Logger:	Nick Kopiasz

Driller:	HCI Drilling				<b>Project Name:</b> BD F-29/F-29-1 <b>Well ID:</b> MW-3 <b>Project Consultant:</b> Tasman		
Drilling Method:	Air Rotary						
Start Date:	12/10/2018						
End Date:	12/11/2018				<b>Location:</b> Unit G, Section 29, T21S, R37E <b>Lat:</b> 32.450223 <b>Long:</b> -103.184836 (NAD83) <b>County:</b> Lea <b>State:</b> NM		
<b>Comments:</b> Located approximately 170 ft southeast of the former junction boxes. Soil samples were collected from drill cuttings at specified intervals. <b>DRAFTED BY:</b> N.Kopiasz TD = 108 ft                      GW = 99 ft							
Depth (feet)	Chloride field tests	LAB	PID	Description	Lithology	Well Construction	
				SM-dark red, silty sand

Concrete
SS							
				SC-dark red, clayey silt			
5 ft							
				SM-tan , silty sand			
10 ft							
				SM-Same As Above (SAA)			
15 ft							
				SM-tan, silty sand, occasional caliche

40 ft										
				SM-tan, silty sand, occasional sandstone						
45 ft										
				SM-reddish tan, silty sand						
50 ft										
				SM-tan, silty sand						
55 ft										
				SM-tan, silty sand, occasional caliche						
60 ft										
				GM-tan , gravelly silt, caliche						
65 ft										
				SM-reddish tan, silty sand, occasional caliche						
70 ft										
				SM-SAA						
75 ft										
				SM-SAA						
80 ft										
				SM-reddish tan, silty sand, occasional sandstone						
85 ft

90 ft								
				Not Sampled (NS)				
95 ft								
				NS				
100 ft								
				NS				
105 ft								
				NS				
110 ft

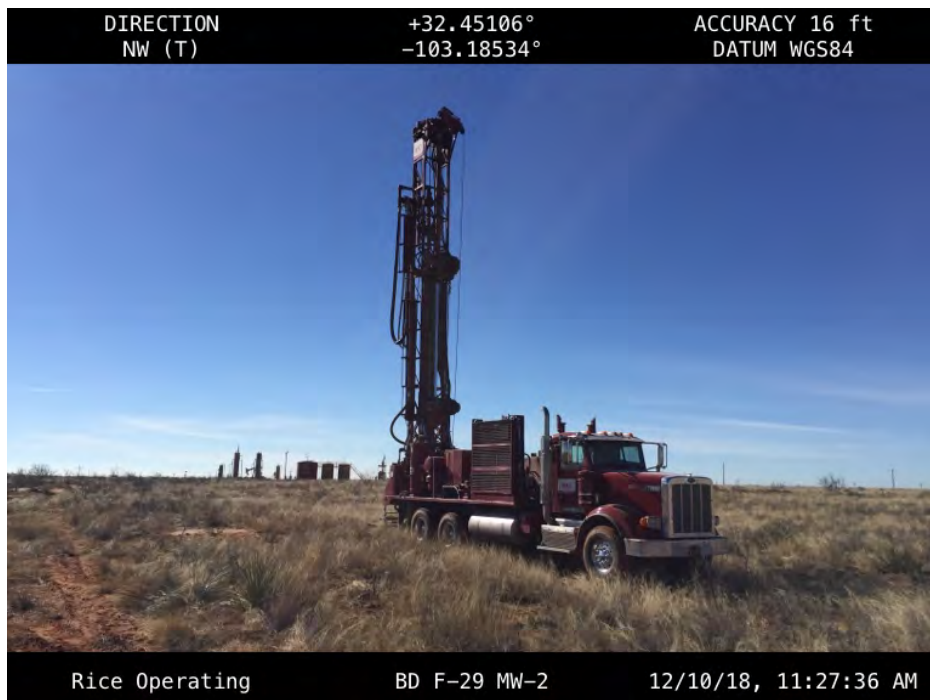
MW-2 overview

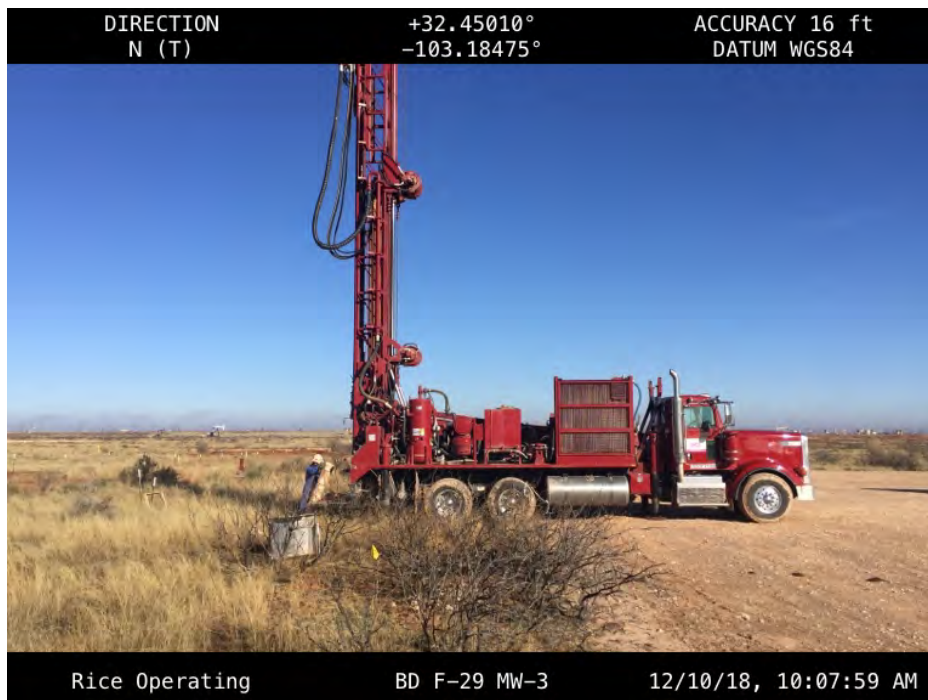
MW-3 overview

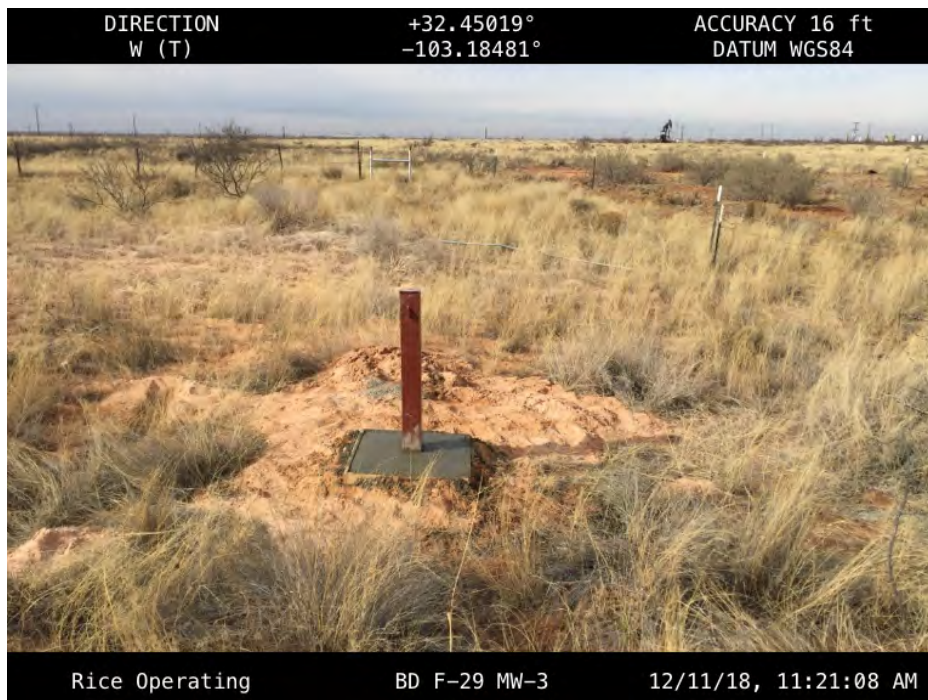
**MW-3 completed**
