RE: 2019 Annual Groundwater Report

Rice Operating Company – BD SWD System

BD Jct. B-4-2 (1R426-204): UL/B, Sec. 4, T22S, R37E

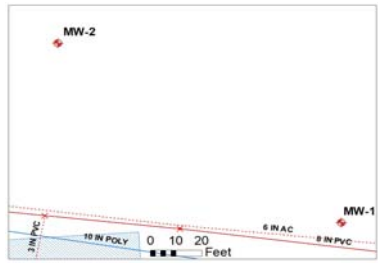
Logger:	Nick Kopiasz

Driller:	Harrison & Cooper, Inc.					
Drilling Method:	Air rotary					
Start Date:	11/13/2018					
End Date:	11/14/2018					
Project Name: BD Jct. B-4-2			Well ID: MW-1			
Project Consultant: Tasman						
Location: Unit B, Section 4, T22S, R37E						
Lat: 32.424620			County: Lea			
Long: -103.164110 (NAD83)			State: NM			
Comments: Located approximately 45 ft east of the former junction box site. Soil samples were collected from drill cuttings at specified intervals.						
DRAFTED BY: N.Kopiasz						
TD = 137 ft GW = 92 ft						
Depth (feet)	Chloride field tests	LAB	PID	Description	Lithology	Well Construction
				SM-red, silty sand		Concrete
SS						
				CL-red, silty clay		4 in. PVC
5 ft						
				GW-light tan, sandy dravel, caliche		Bentonite Seal
10 ft						
				SW-tan, well graded sand, caliche		
15 ft						
				SW-Same As Above (SAA)		
20 ft						
				SW-SAA		
25 ft						
				GM-light tan, gravelly silt, caliche

30 ft						
				SM-tan, silty sand, caliche		
35 ft

Depth (feet)	Chloride field tests	LAB	PID	Description		Lithology		Well Construction		
				SM-tan, silty sand, caliche and sandstone						
40 ft										
				SM-tan, silty sand, very fine grained sandstone						
45 ft										
				SM-SAA						
50 ft										
				SM-SAA						
55 ft										
				GM-tan, silty gravel, sandstone						Bentonite Seal
60 ft										
				SM-tan, silty sand, sandstone						
65 ft										
				SM-tan, silty sand						
70 ft										
				SM-tan, silty sand, sandstone						
75 ft										
				SM-SAA						
80 ft										
				SM-reddish tan, silty sand, sandstone						Sand Pack
85 ft

Depth (feet)	Chloride field tests	LAB	PID	Description		Lithology		Well Construction		
				SM-reddish tan, silty sand, sandstone, moist						
90 ft										
				SM-SAA						
95 ft										
				SM-light brown, silty sand, moist						
100 ft										
				SM-SAA						
105 ft										
				SM-SAA						
110 ft										
				Not Sampled (NS)						
115 ft										
				NS						
120 ft										
				NS						
125 ft										
				NS						
130 ft										
				NS						
135 ft

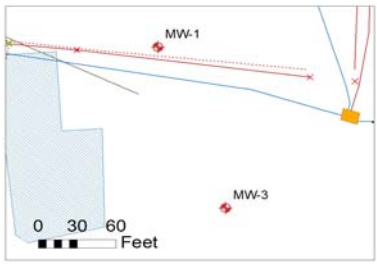
Logger:	Nick Kopiasz

Driller:	Harrison & Cooper, Inc.			
Drilling Method:	Air Rotary		Project Name:	Well ID:
Start Date:	11/15/2018		BD Jct. B-4-2	MW-3
End Date:	11/15/2018		Project Consultant: Tasman	
Comments: Located approximately 179 ft southeast of the former junction box site. Soil samples were collected from drill cuttings at specified intervals. <div style="text-align: center;"> DRAFTED BY: N.Kopiasz TD = 101 ft GW = 89 ft </div>			Location: Unit B, Section 4, T22S, R37E Lat: 32.424236 County: Lea Long: -103.163944 (NAD83) State: NM

Depth (feet)	Chloride field tests	LAB	PID	Description	Lithology	Well Construction
				SM-red, silty sand		Concrete
SS						
				CL-red, silty clay		
5 ft						
				SM-reddish tan, silty sand, caliche		2 in. PVC
10 ft						
				GM-reddish tan, silty gravel, caliche		
15 ft						
				SM-reddish tan, silty sand, caliche		Bentonite Seal
20 ft						
				GM-light tan, silty gravel, caliche		
25 ft						
				SM-light tan, silty sand, caliche		
30 ft						
				SM-Same As Above (SAA)		
35 ft

Depth (feet)	Chloride field tests	LAB	PID	Description		Lithology		Well Construction		
				SM-SAA						
40 ft										
				SM-tan, silty sand, sandstone and caliche						
45 ft										
				SM-SAA						
50 ft										
				SM-light tan, silty sand, sandstone						
55 ft										
				SM-SAA						
60 ft										
				SM-tan, silty sand, sandstone and caliche						
65 ft										
				SM-tan, silty sand						
70 ft										
				SM-tan, silty sand, sandstone						
75 ft										
				SM-SAA						
80 ft										
				SM-tan, silty sand						
85 ft

Depth (feet)	Chloride field tests	LAB	PID	Description		Lithology		Well Construction
				SM-tan, silty sand, moist

90 ft								
				SW-tan, well graded sand, caliche, moist				
95 ft								
				SM-light brown, silty sand, moist				
100 ft								
				SM-SAA				
105 ft
