# **RICE** *Operating Company*

**RE: 2019 Annual Groundwater Report  
Rice Operating Company – BD SWD System  
BD J-30 vent (1R426-217): UL/J, Sec. 30, T21S, R37E**

# Geographical Location Map

# Site Map

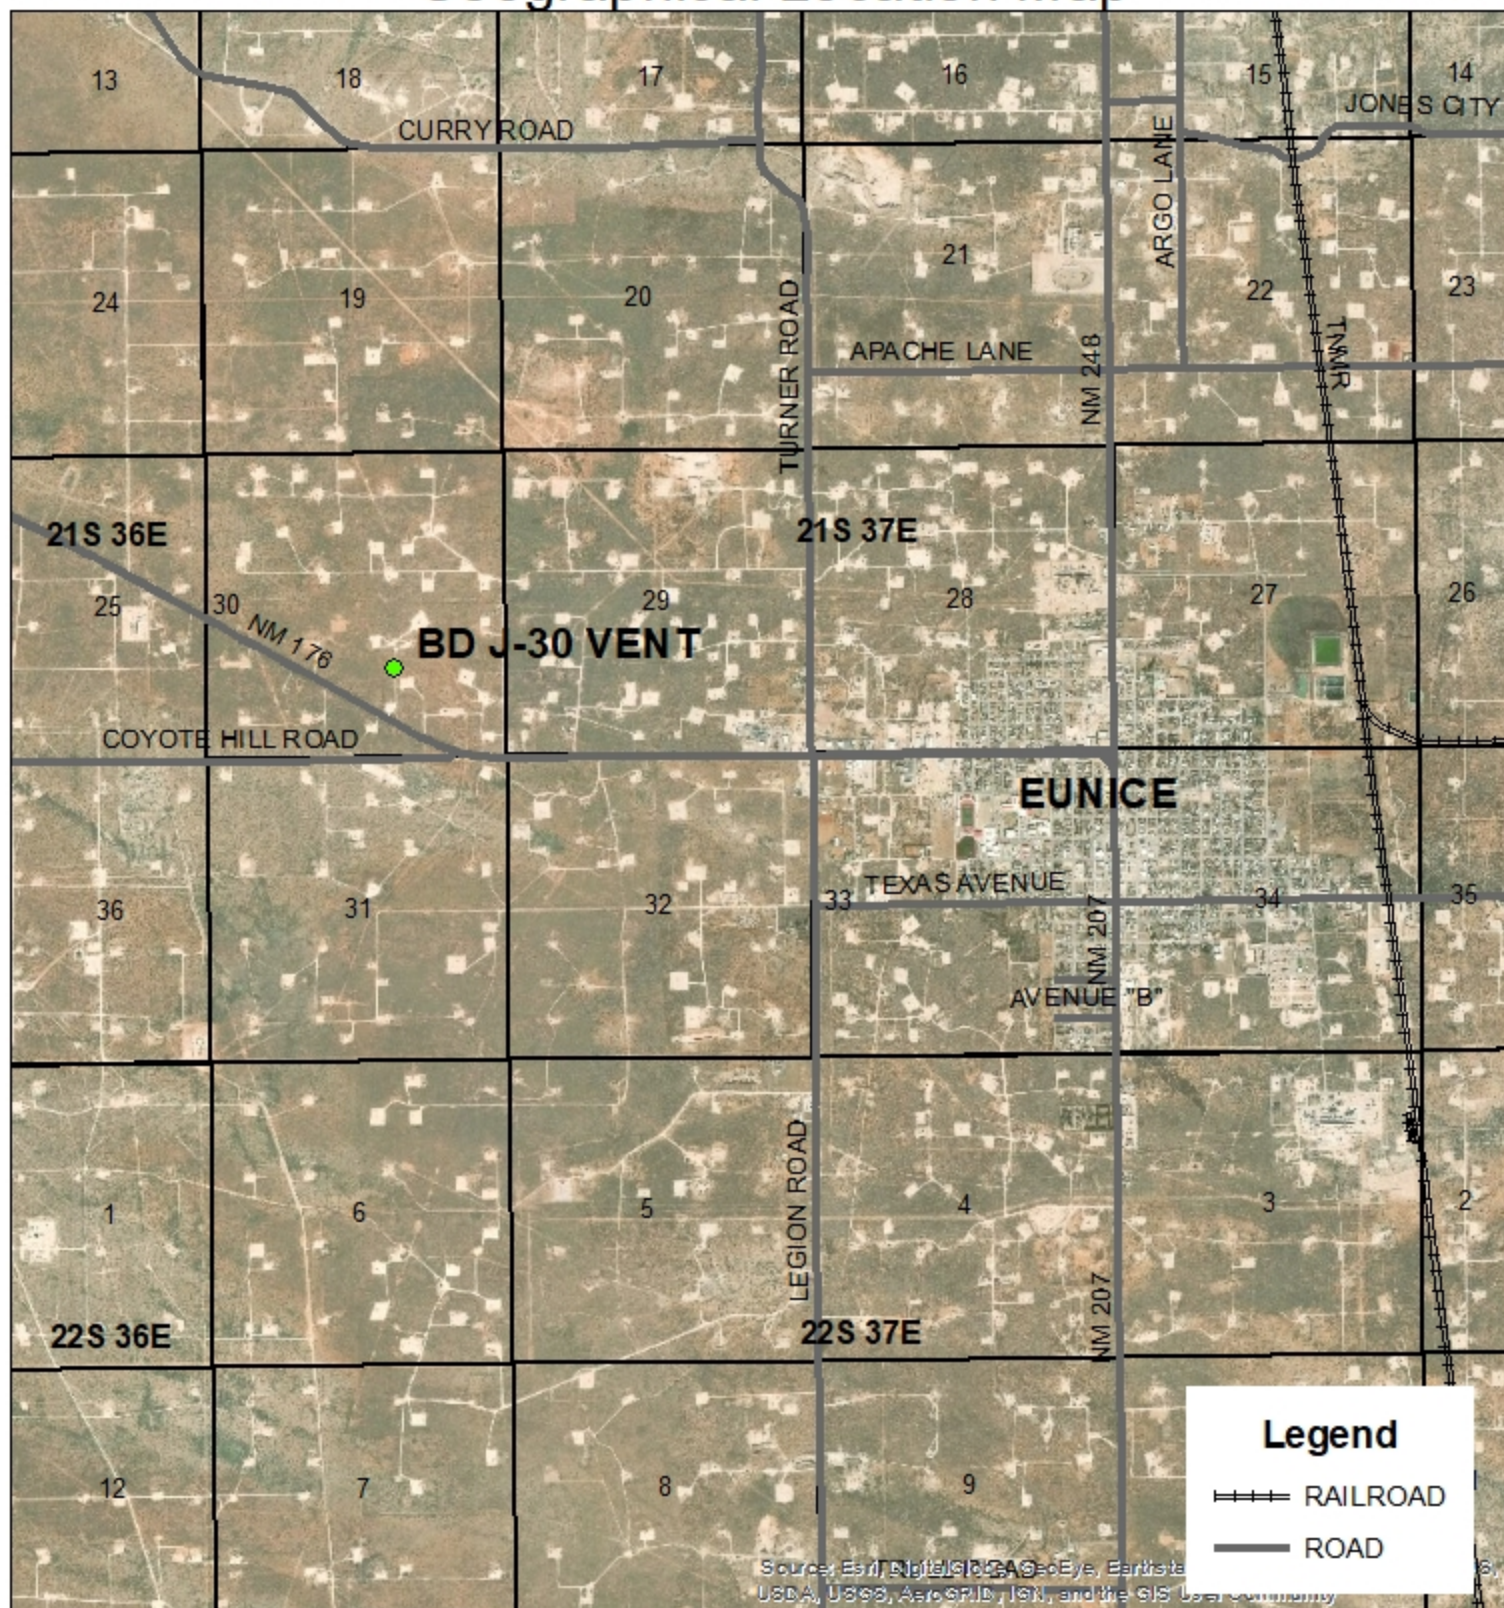
***BD J-30 VENT***

LEGALS: UL J SECTION 30  
T-21-S R-37-E  
LEA COUNTY, NM

GPS: 32.446879, -103.199905  
NAD 83 STATE PLANE PROJ  
NM EAST ZONE

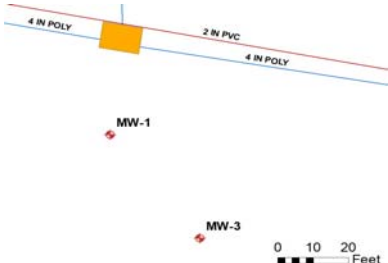
<b>Driller:</b>	Harrison & Cooper, Inc.						
<b>Drilling Method:</b>	Air rotary						
<b>Start Date:</b>	12/11/2018						
<b>End Date:</b>	12/11/2018			<b>Project Name:</b>	<b>Well ID:</b>		
				BD J-30 vent	MW-1		
				<b>Project Consultant:</b> Tasman			
<b>Comments:</b> Located approximately 75 ft southeast of the former junction box vent. Soil samples were collected from drill cuttings at specified intervals.				<b>Location:</b>			
				Unit J, Section 30, T21S, R37E			
<b>DRAFTED BY:</b> N.Kopiasz TD = 141 ft                      GW = 106 ft				<b>Lat:</b> 32.446749			
				<b>Long:</b> -103.199741 (NAD83)			
				<b>County:</b> Lea			
				<b>State:</b> NM			
<b>Depth (feet)</b>	<b>Chloride field tests</b>	<b>LAB</b>	<b>PID</b>	<b>Description</b>	<b>Lithology</b>	<b>Well Construction</b>	
				SM-reddish brown, silty sand			Concrete
SS							
				SC-reddish brown, clayey silt

5 ft							
				SC-Same As Above (SAA)			
10 ft							
				SM-reddish brown, silty sand			4 in. PVC
15 ft							
				GM-tan, gravelly silt, caliche			Bentonite Seal
20 ft							
				SM-reddish tan, silty sand			
25 ft							
				SM-tan, silty sand			
30 ft							
				SM-SAA			
35 ft

Bentonite Seal
40 ft										
				SM-light tan, silty sand, occasional caliche						
45 ft										
				SM-SAA						
50 ft										
				SM-SAA						
55 ft										
				SM-SAA						
60 ft										
				GM-reddish tan, gravelly silt, caliche						
65 ft										
				SM-reddish tan, silty sand, occasional caliche						
70 ft										
				SM-SAA						
75 ft										
				SM-light tan, silty sand						
80 ft										
				GM-light brown, silty gravel, caliche and sandstone						
85 ft

Sand Pack	
90 ft										
				GM-SAA						
95 ft										
				Not Sampled (NS)						
100 ft										
				NS						
105 ft										
				NS						
110 ft										
				NS						
115 ft										
				NS						
120 ft										
				NS						
125 ft										
				NS						
130 ft										
				NS						
135 ft

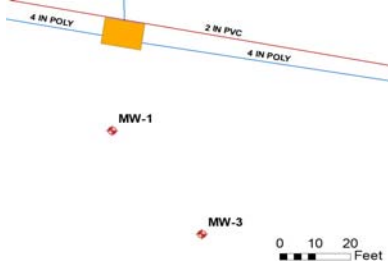
<b>Driller:</b>	Harrison & Cooper, Inc.							
<b>Drilling Method:</b>	Air Rotary				<b>Project Name:</b>		<b>Well ID:</b>	
<b>Start Date:</b>	12/12/2018				BD J-30 vent		MW-3	
<b>End Date:</b>	12/12/2018				<b>Project Consultant:</b> Tasman			
<b>Comments:</b> Located approximately 125 ft southeast of the former junction box vent. Soil samples were collected from drill cuttings at specified intervals.  DRAFTED BY: N.Kopiasz TD = 110 ft                      GW = 106 ft					<b>Location:</b>			
					Unit J, Section 30, T21S, R37E			
					<b>Lat:</b> 32.446657		<b>County:</b> Lea	
					<b>Long:</b> -103.199660 (NAD83)		<b>State:</b> NM	
<b>Depth (feet)</b>	<b>Chloride field tests</b>	<b>LAB</b>	<b>PID</b>	<b>Description</b>	<b>Lithology</b>	<b>Well Construction</b>		
				SM-reddish brown, silty sand

Concrete	
SS								
				SW-light brown, well graded sand, caliche

5 ft								
				SM-off-white, sandy silt, occasional caliche

Bentonite Seal	
20 ft								
				SM-off-white, sandy silt

Depth (feet)	Chloride field tests	LAB	PID	Description		Lithology		Well Construction		
				SM-light tan, sandy silt, occasional caliche						
40 ft										
				SM-light tan, sandy silt						
45 ft										
				Not Sampled (NS)						
50 ft										
				NS						
55 ft										
				NS						
60 ft										
				NS						
65 ft										
				NS						
70 ft										
				NS						
75 ft										
				NS						
80 ft										
				NS						
85 ft

Sand Pack	
90 ft									
				NS					
95 ft									
				NS					
100 ft									
				NS					
105 ft									
				NS					
110 ft

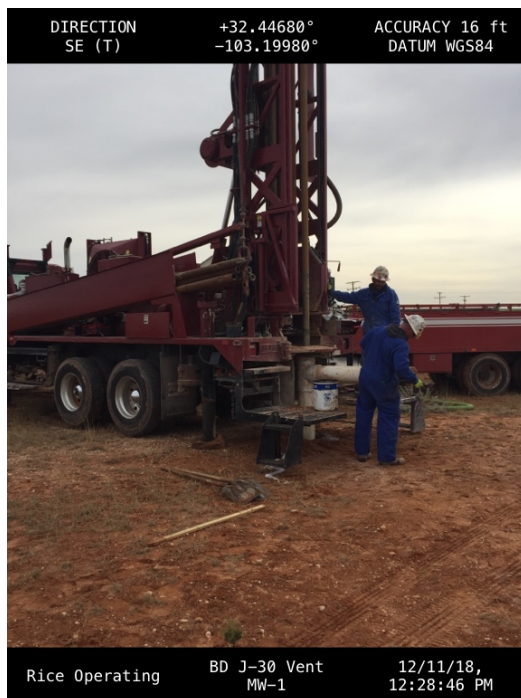
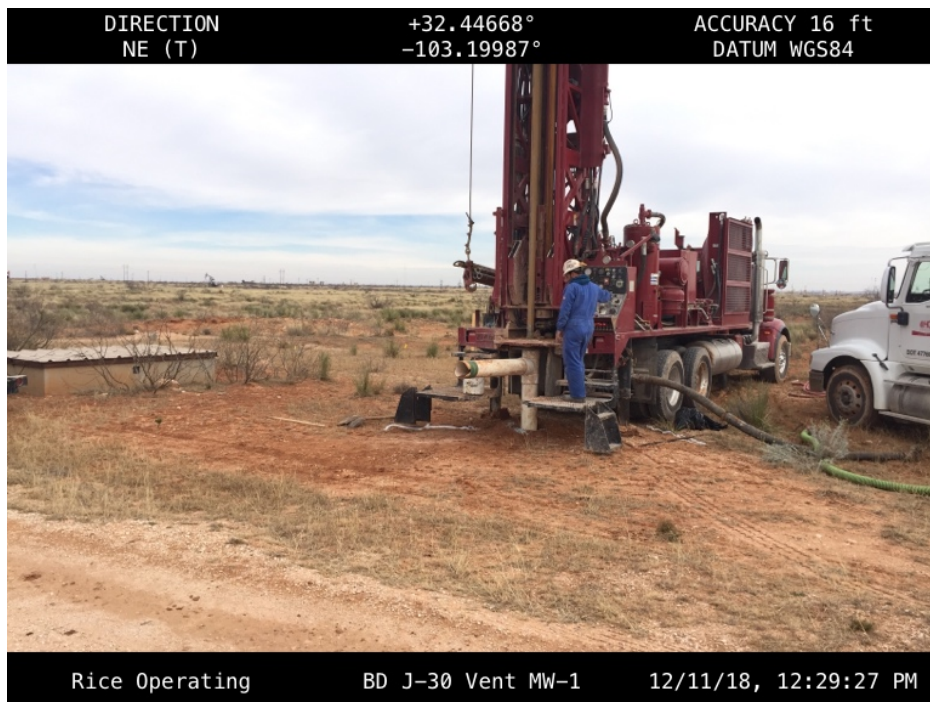
MW-1 drilling

Rice Operating Company  
BD J-30 Vent  
Drilling Photo Log

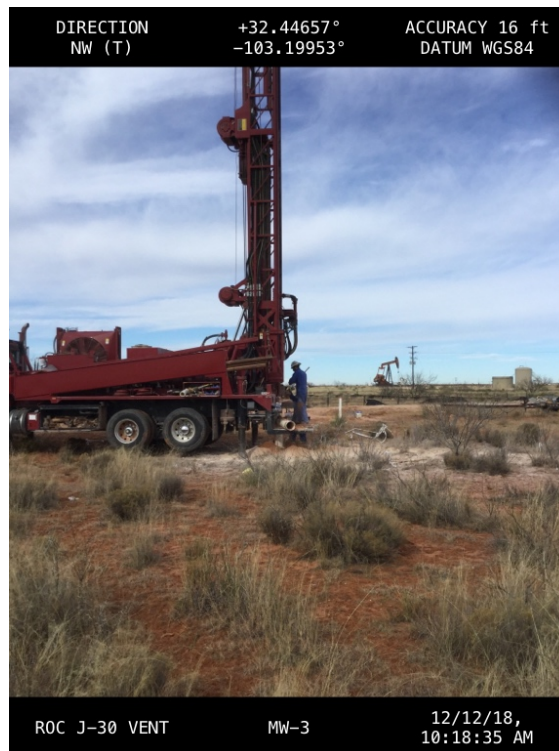
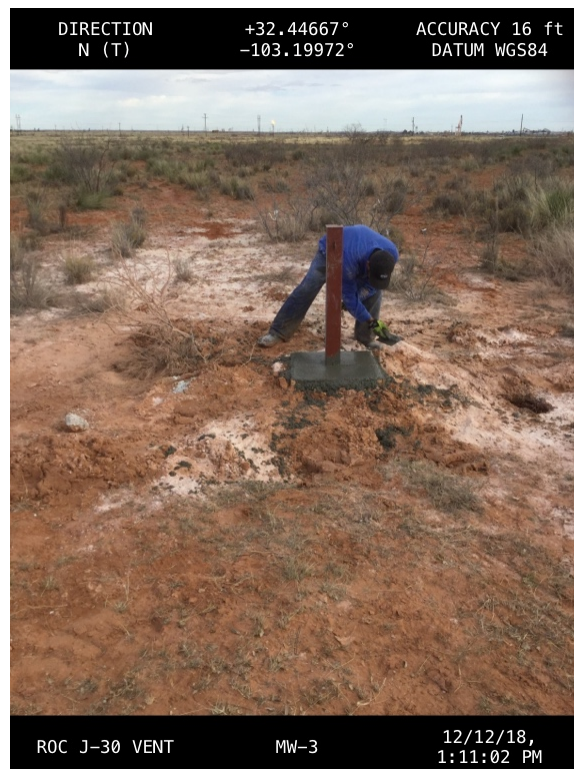
Rice Operating Company  
BD J-30 Vent  
Drilling Photo Log

Rice Operating Company  
BD J-30 vent  
Monitoring Well Drilling  
4/26/2019

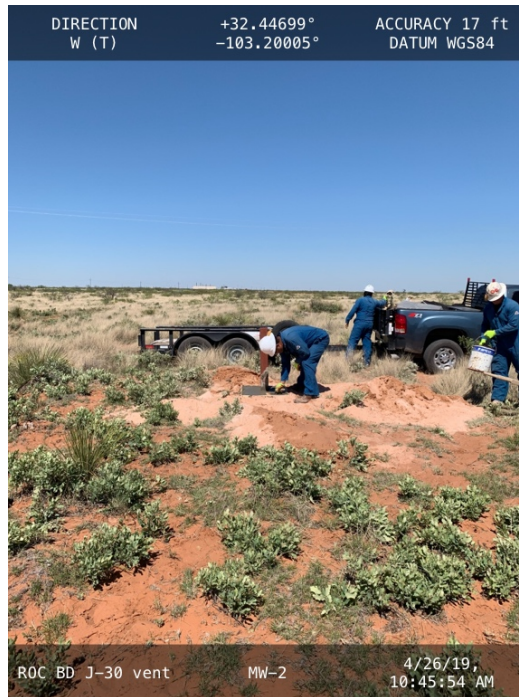
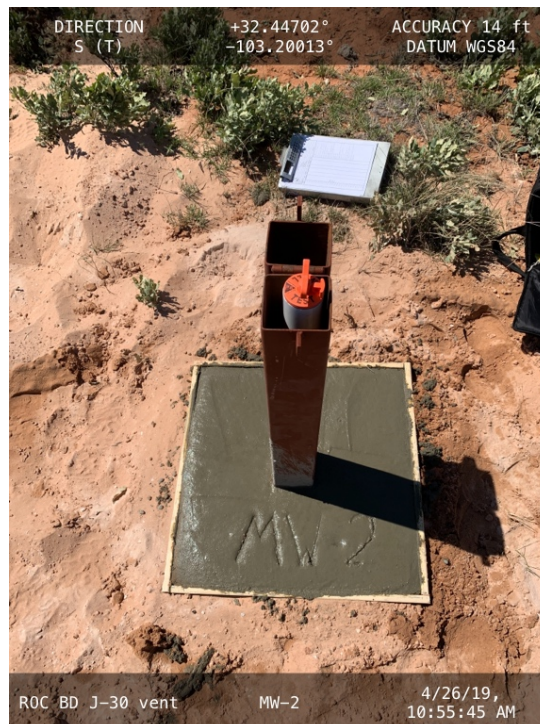
Set

Rice Operating Company  
BD J-30 vent  
Monitoring Well Drilling  
4/26/2019
