**Remediation and Closure Report:**

West Red Lake #41  
API # 30-015-28443  
Talon Project No. 701307.101.01

Subject: **Remediation and Closure Report**  
West Red Lake #41  
API # 30-015-28443

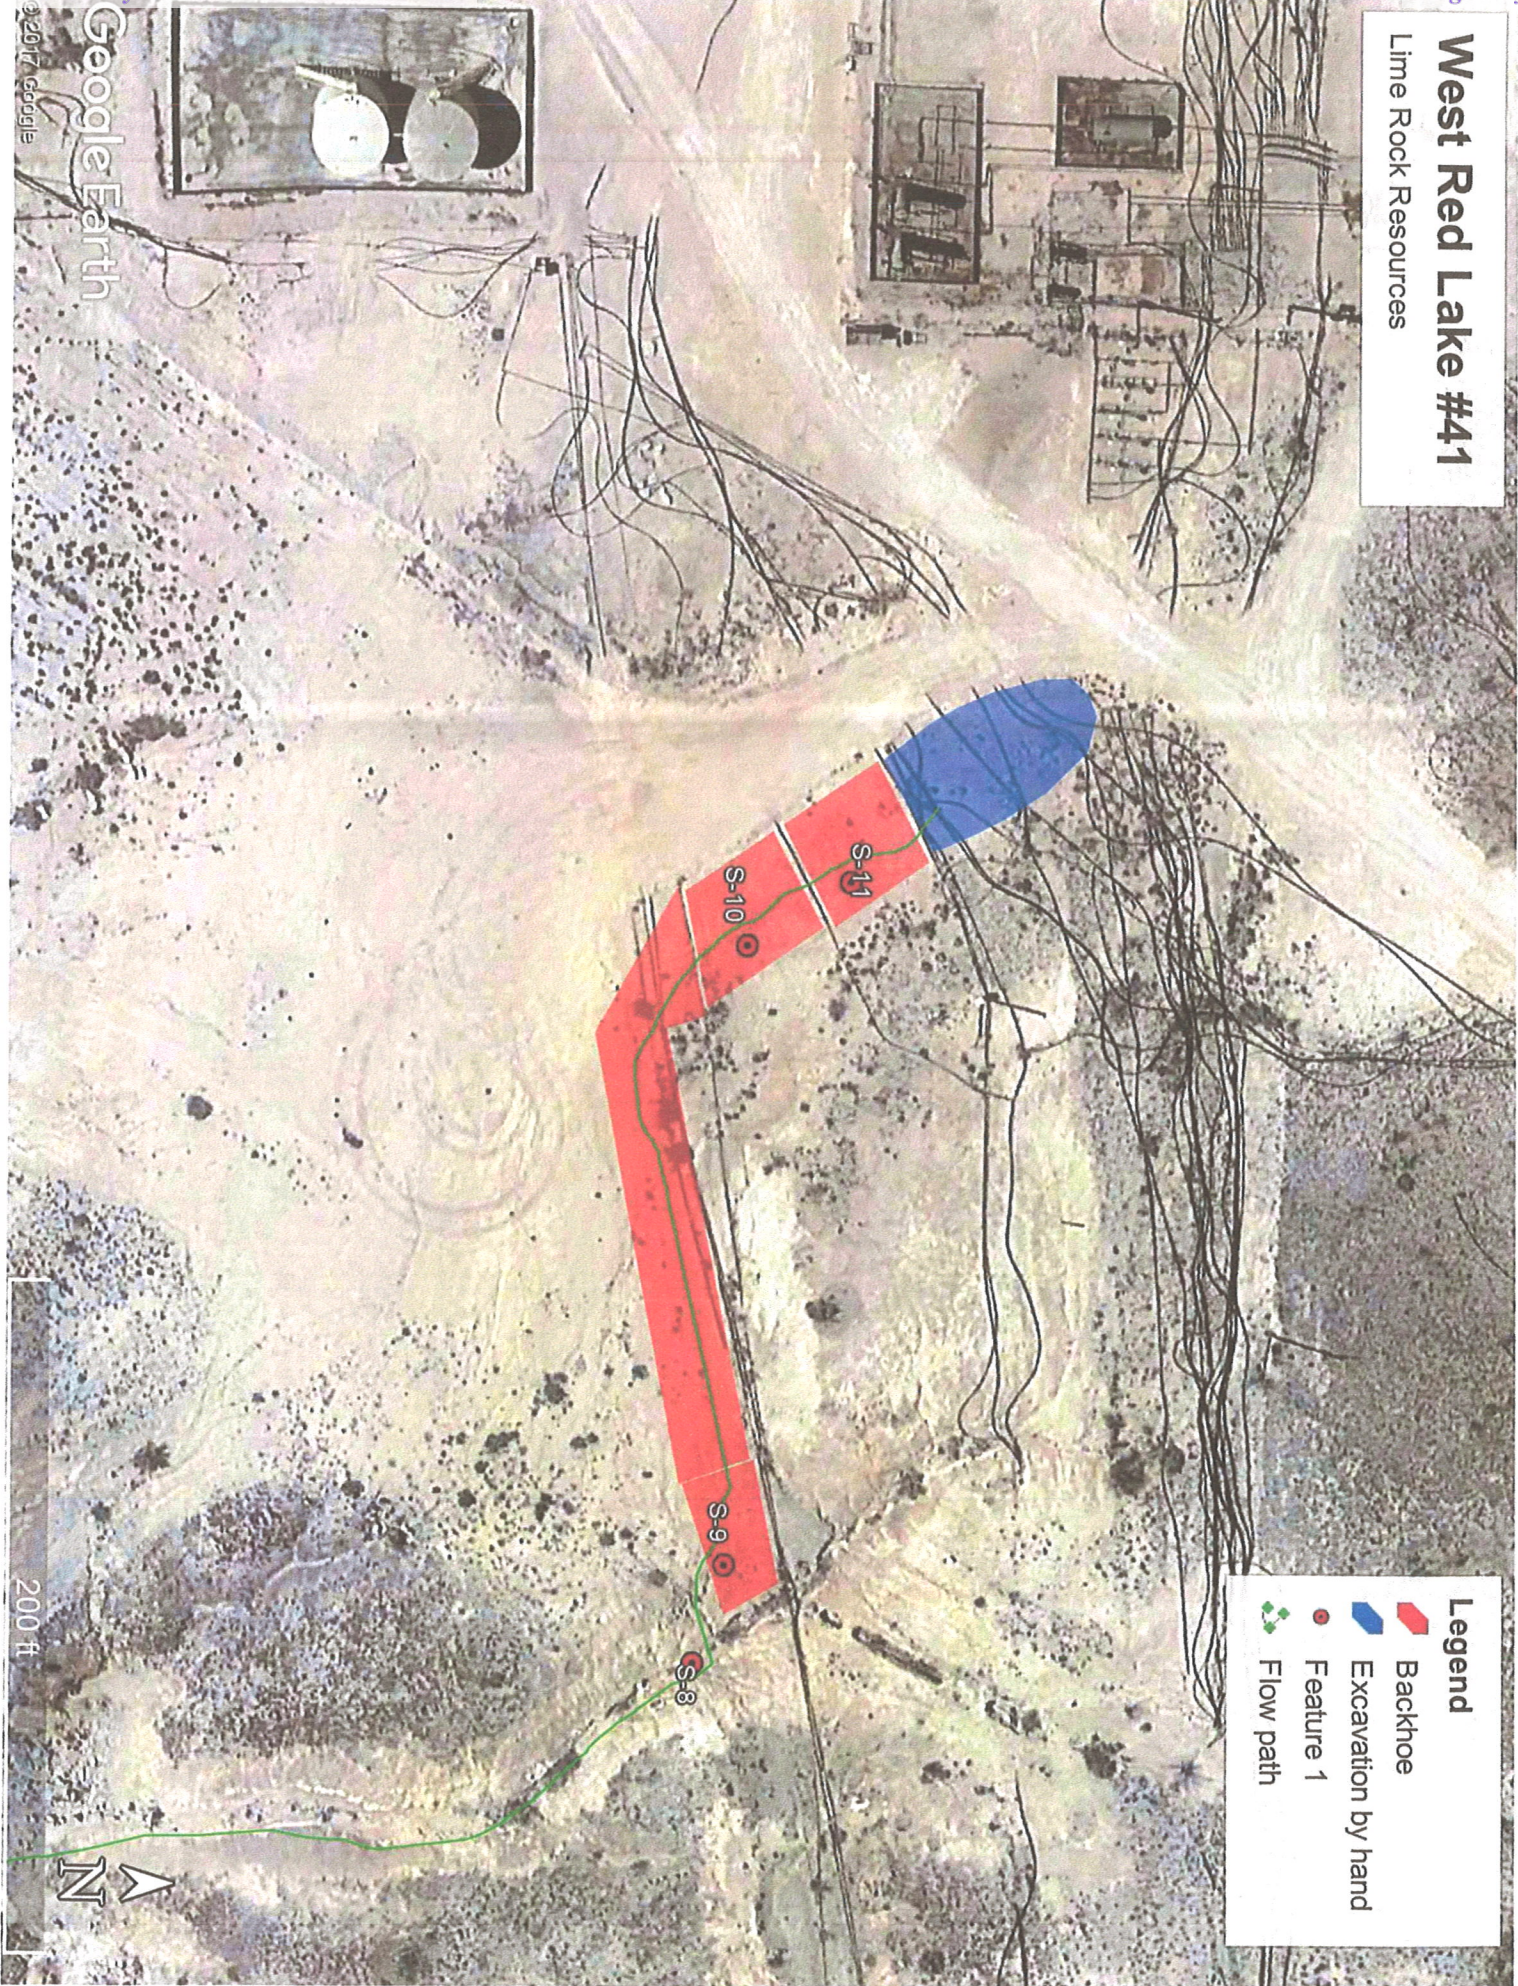
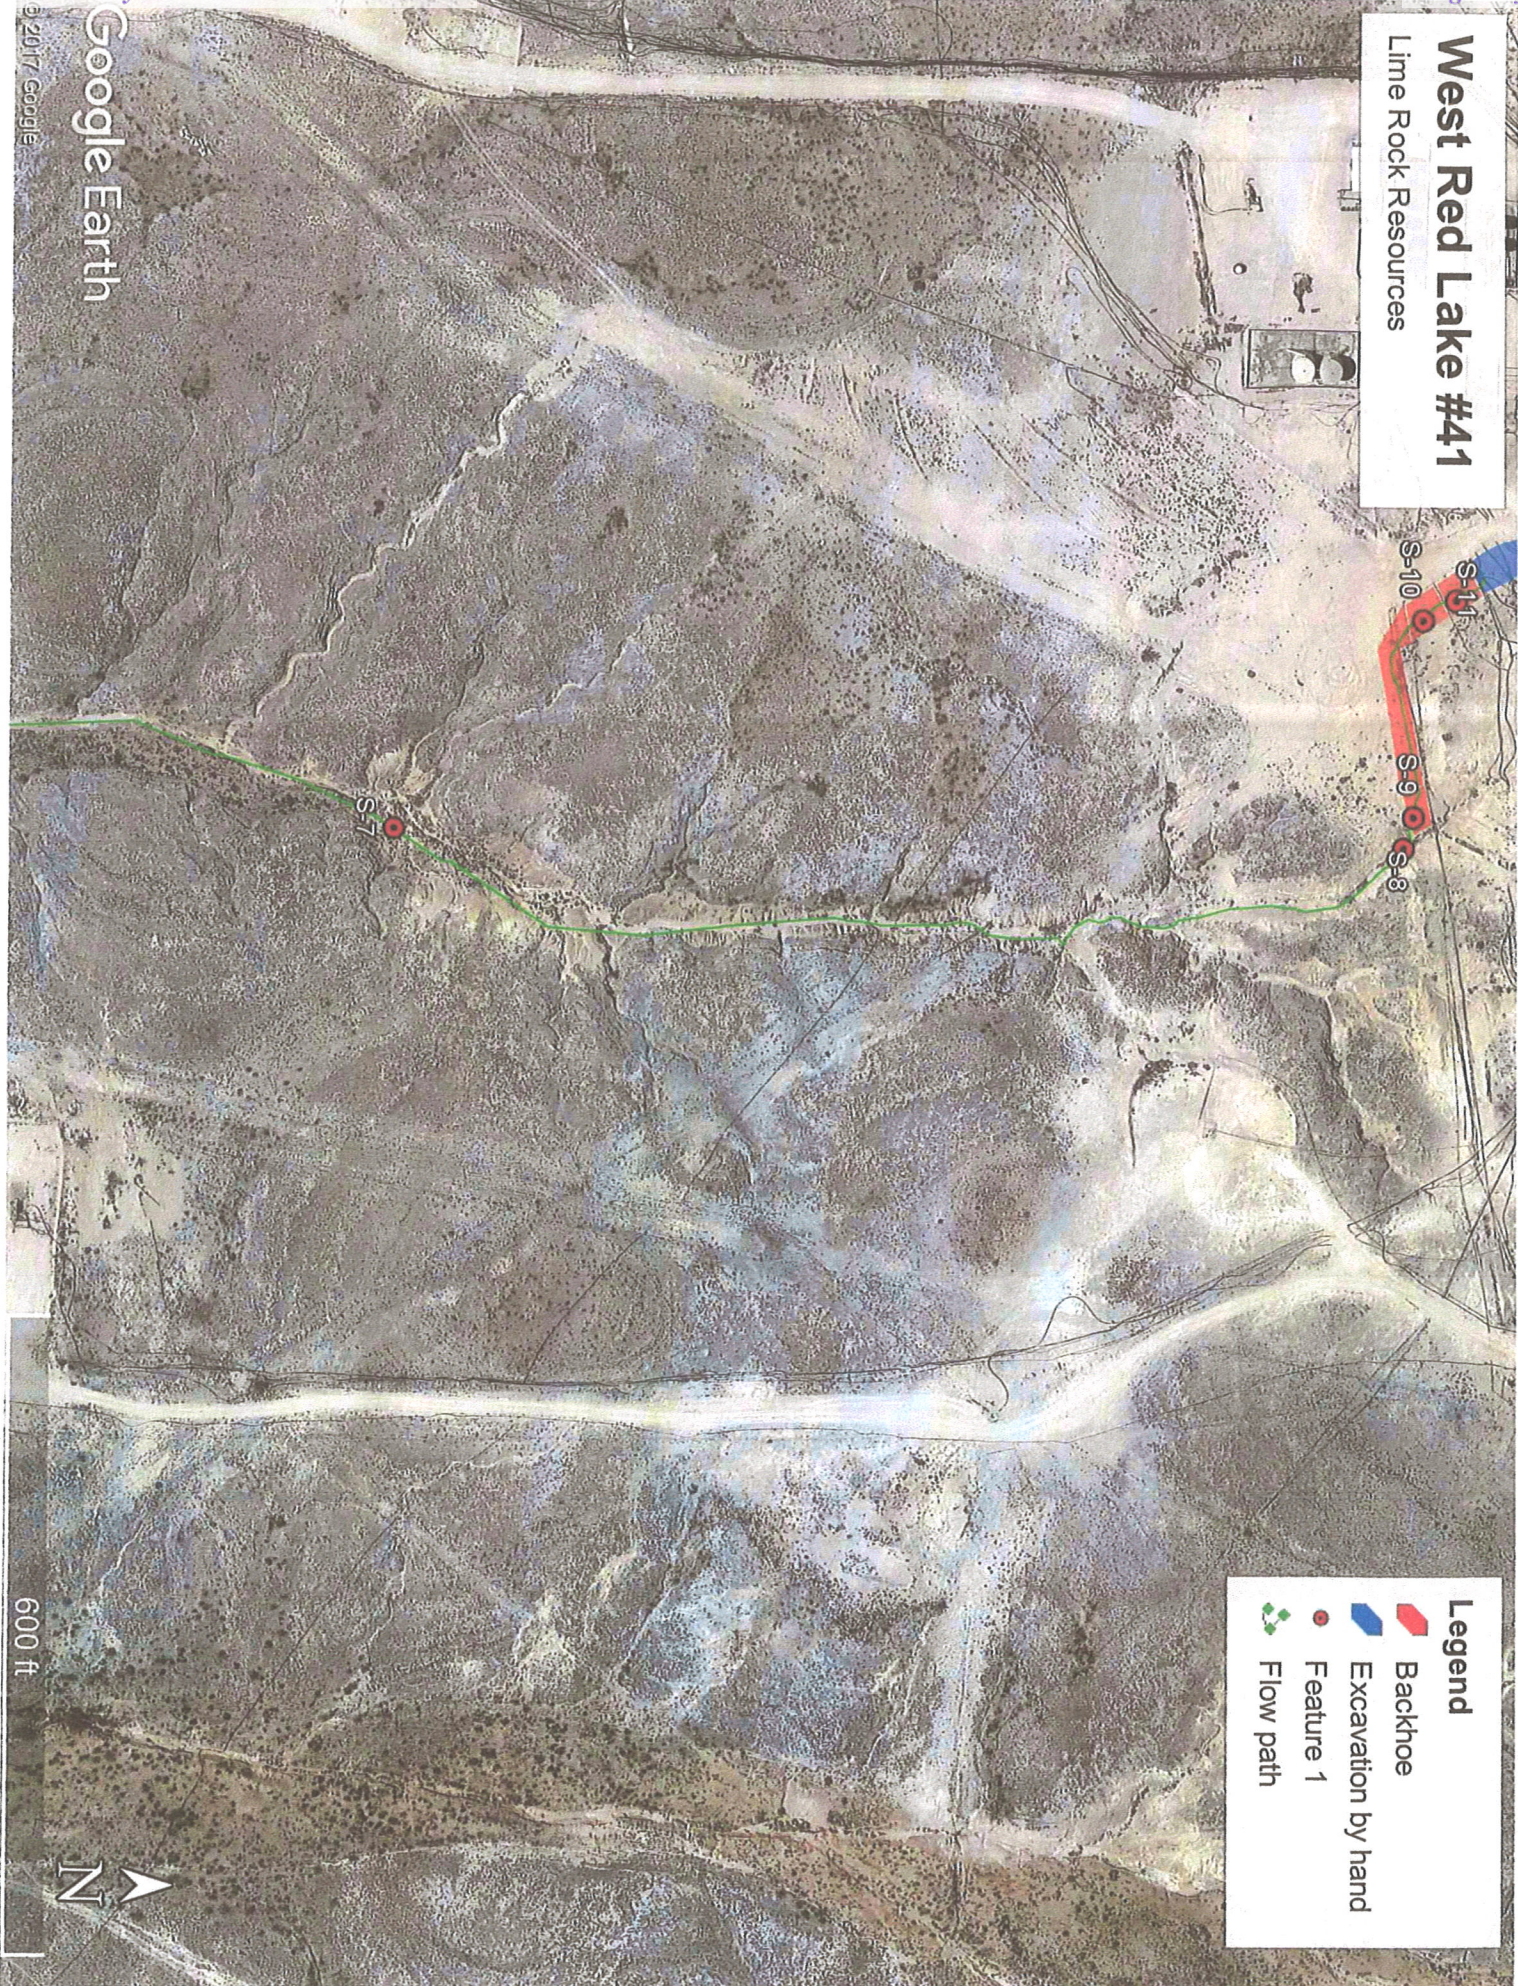
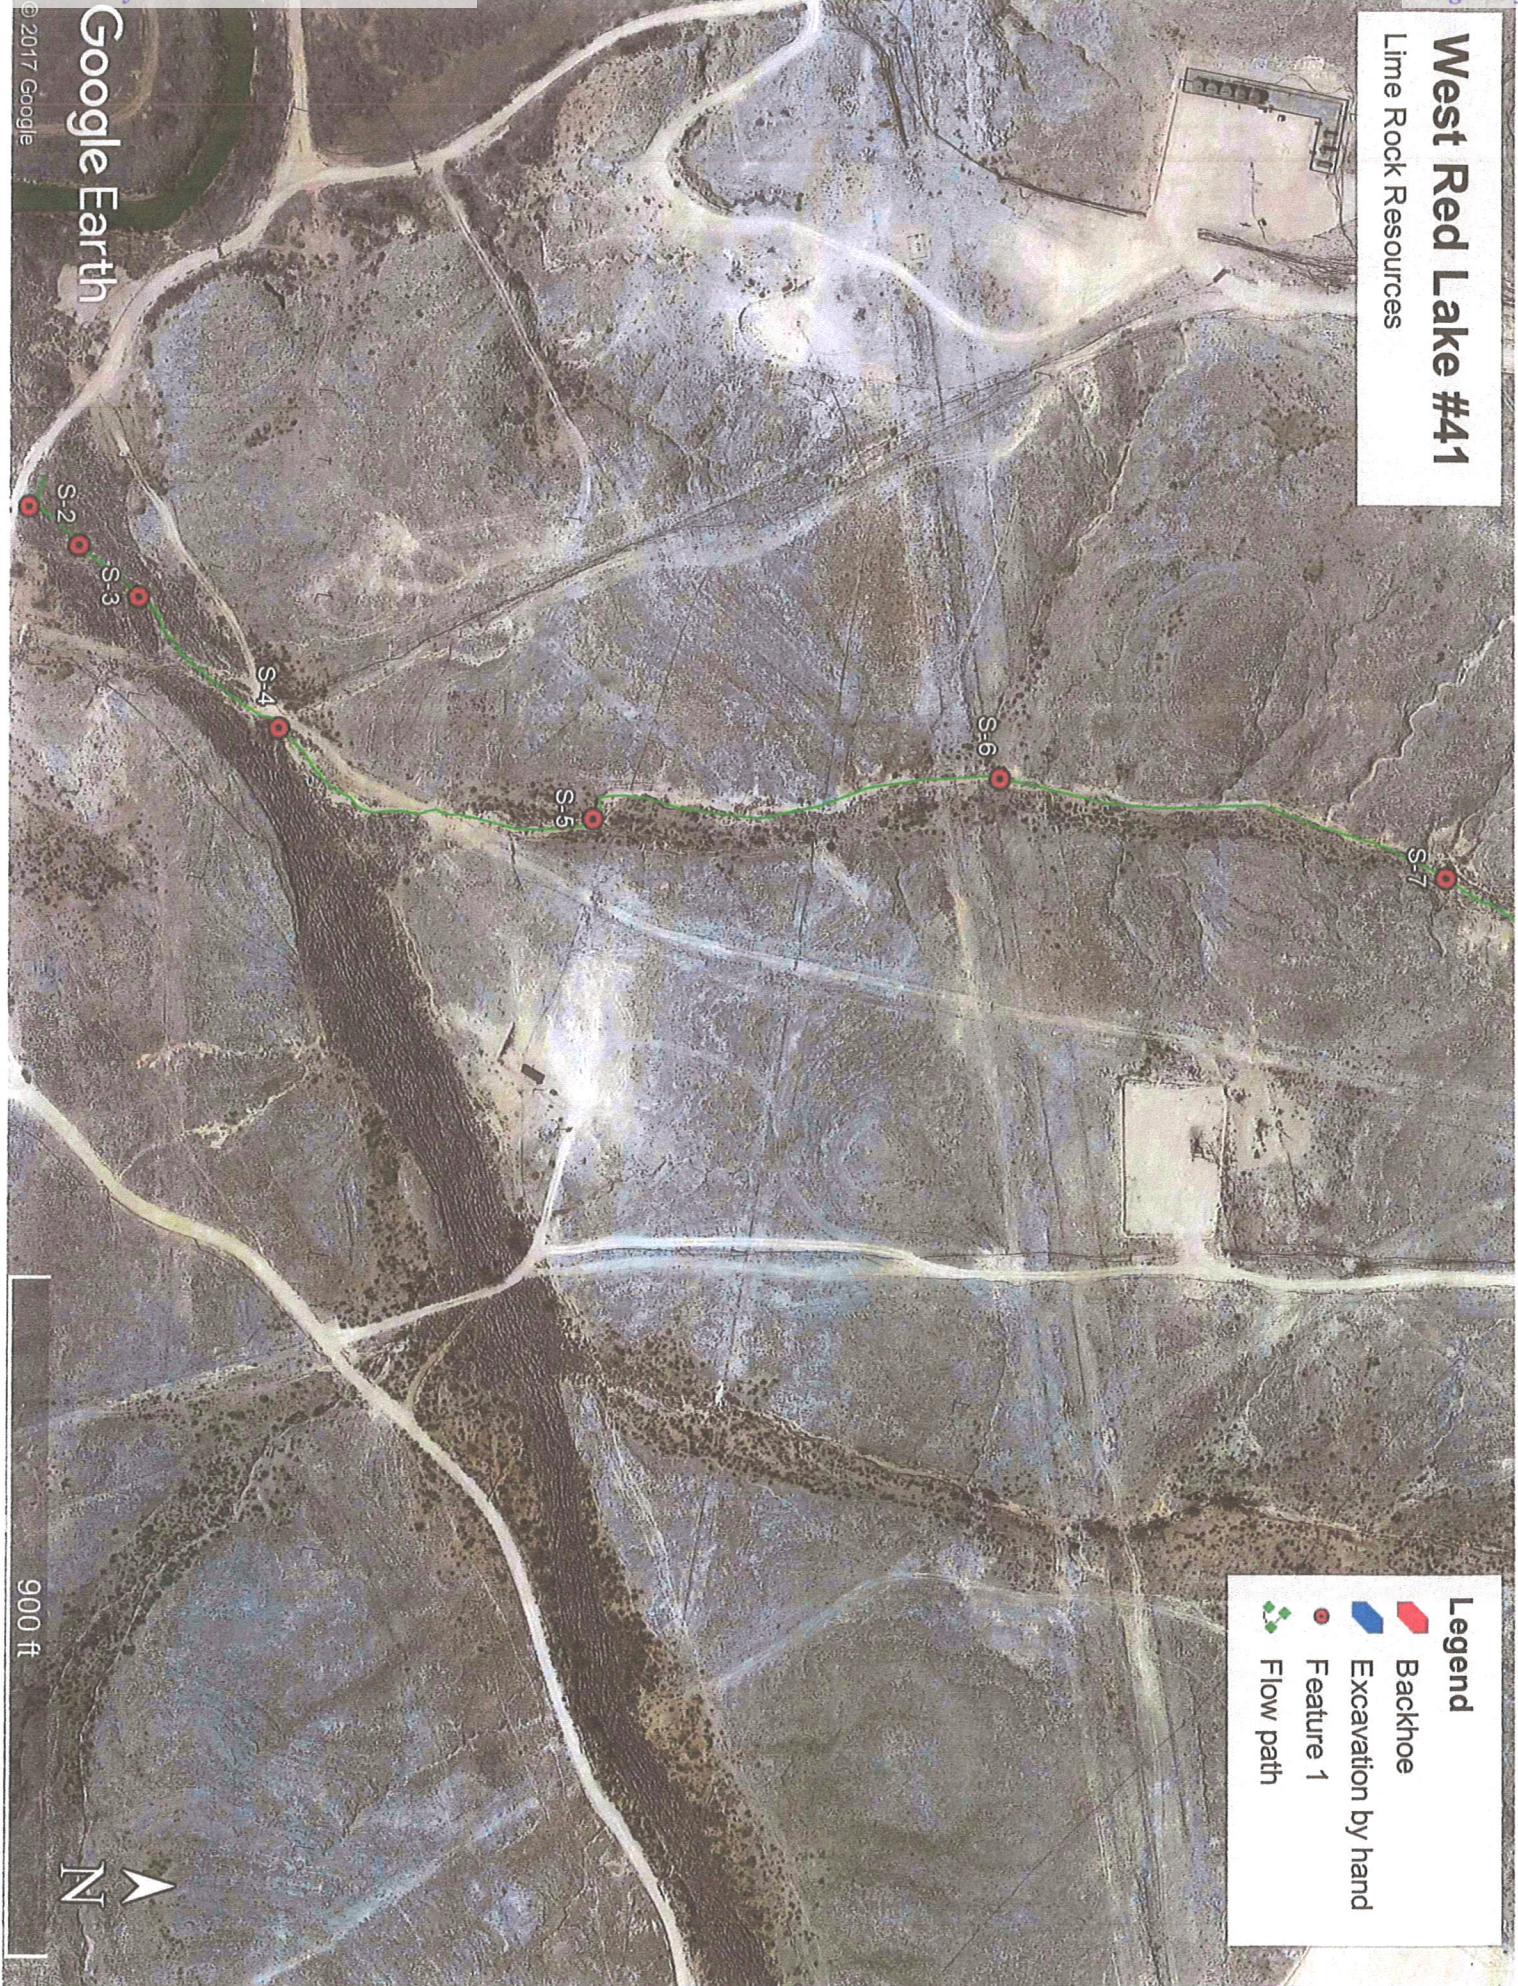
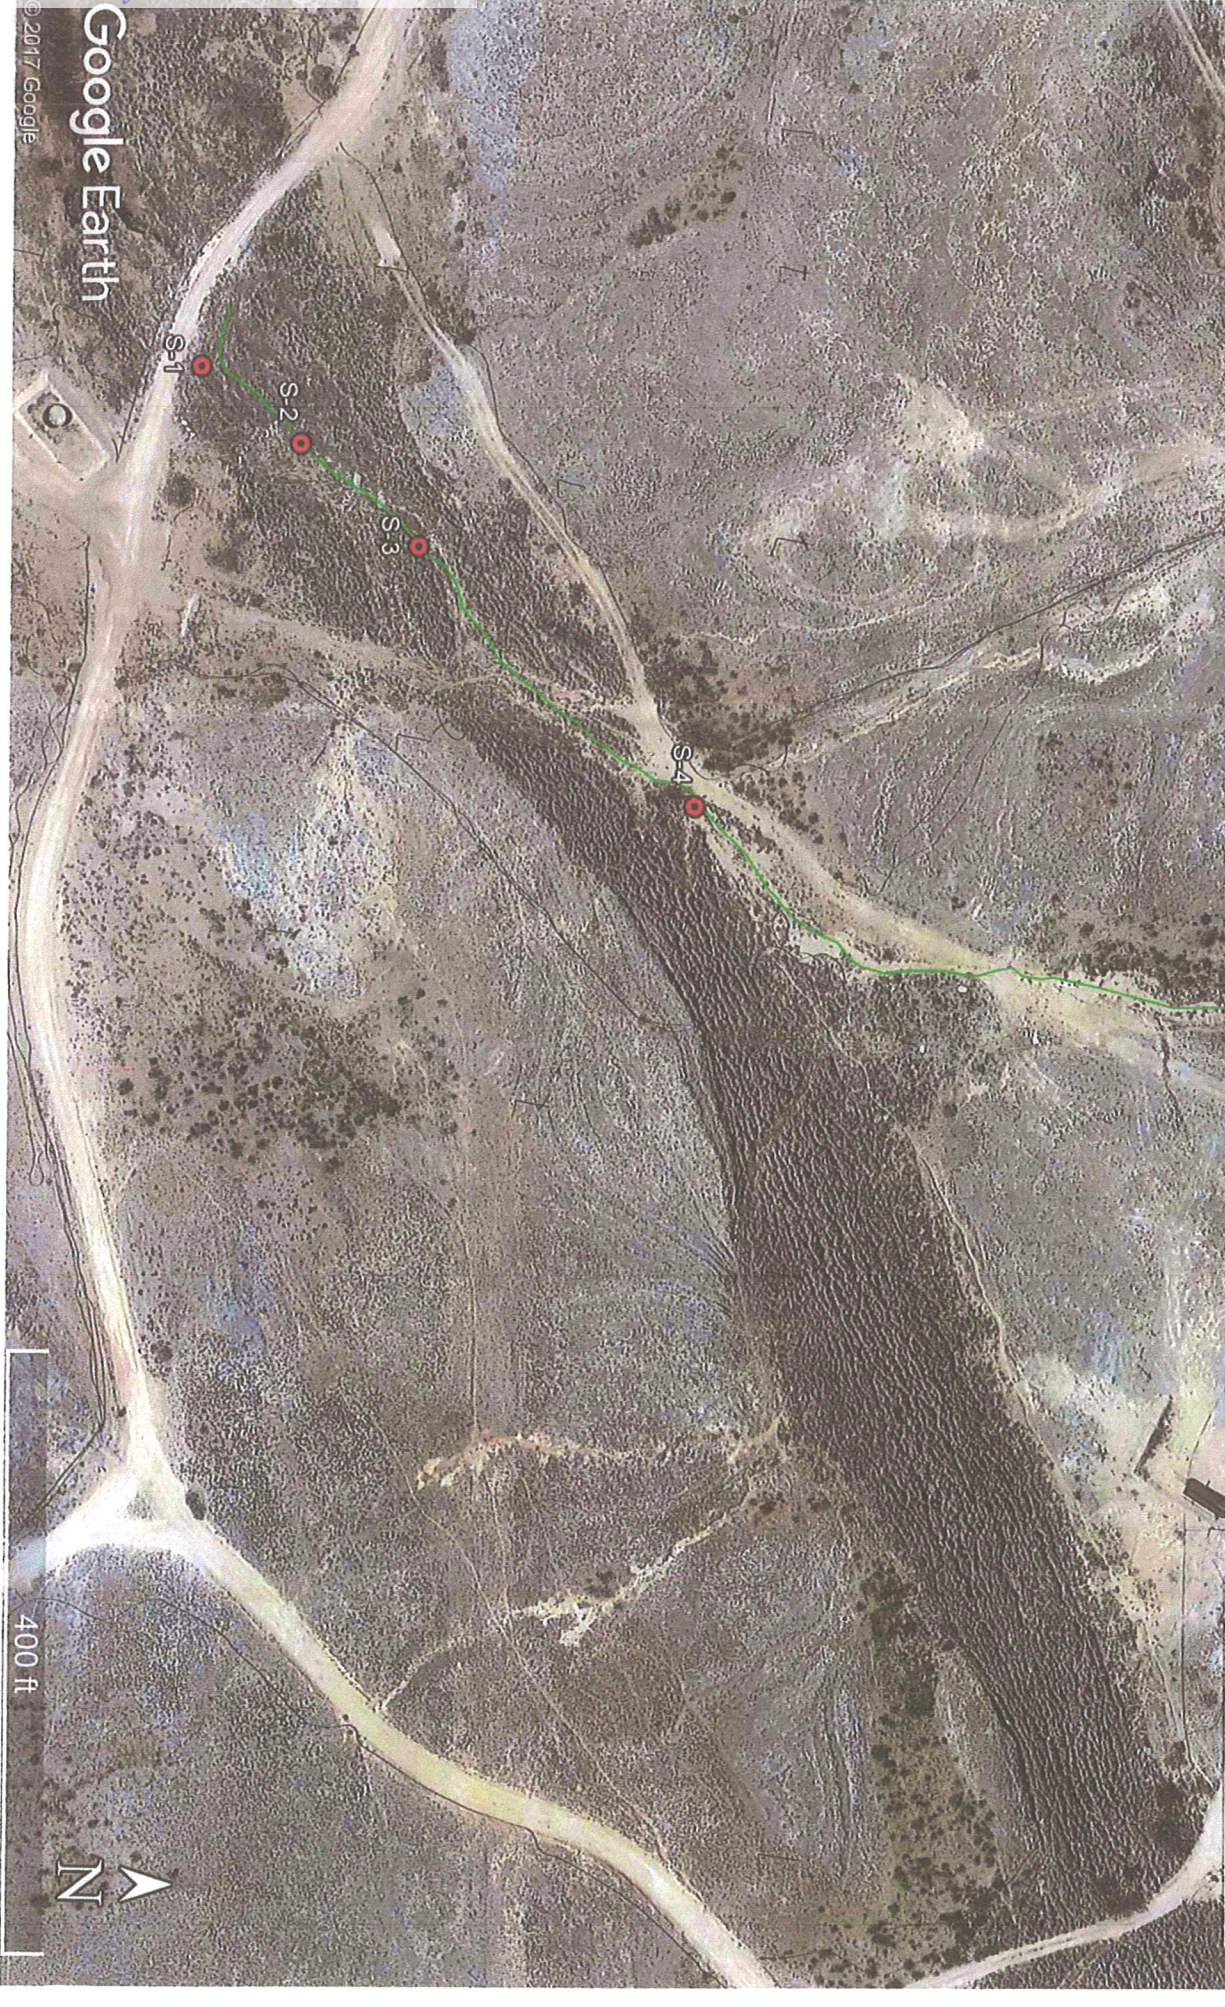
### **SITE MAP**

- Backhoe
- Excavation by hand
- Feature 1
- Flow path

- 8/24/17- The lower flow path of the draw was flushed with 1040 barrels of fresh water. 650 barrels of water was recovered from the lower sump.
- 11/28/17- Talon returned to the location with a backhoe and roustabout crew. Soil samples were collected and field titrated for total chlorides to guide the excavation process. The upper portion of the impacted area within the numerous flow lines present was excavated by hand to avoid damage to the lines. The remaining impacted areas and flow path leading to the draw were excavated with a backhoe to a depth of 1.5-feet below surface.

- The impacted areas within the draw were hand-excavated by roustabout crews.
- Confirmation samples were collected from locations within the draw and from the flow path between the release point and the draw. Sample locations are illustrated on the attached site plans ([Appendix I](#)) and the resulting data is summarized in the following table. The complete lab report is attached in [Appendix III](#).
