Kinder Morgan Former Deming Compressor Station Discharge Permit GW-147, Closure Report

September 28, 2020

AECOM Technical Services
6501 Americas Parkway
Albuquerque, NM 87110
aecom.com

Appendix D
Kinder Morgan NM UST Closure Report

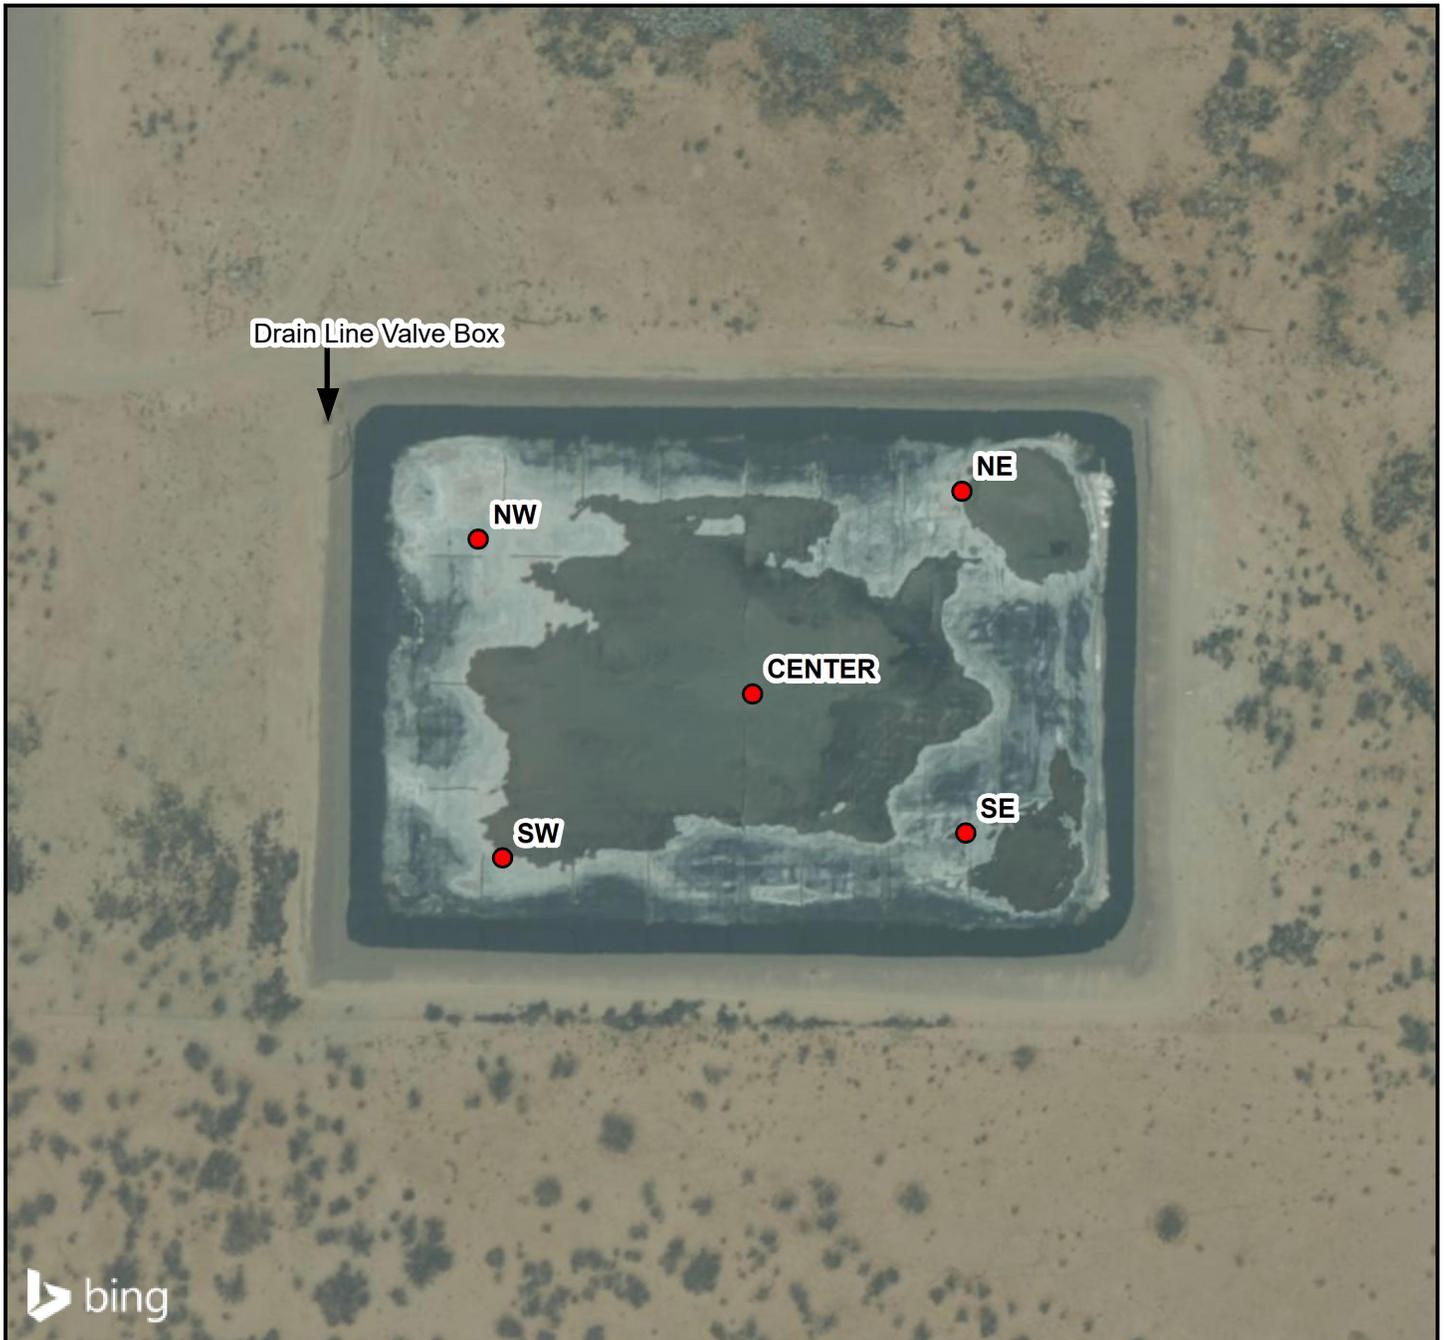
Figure 2

Five-Point Composite Sample Location Map

A five-point composite soil sample was collected from soil beneath the pond liner to determine if soils have been impacted from potential contaminants in compressor water. The evaporation pond liner was cut, and a soil sample collected from the 0-6-inch depth interval (Photo 9). Each composite subsample, consisting of a minimum of 200 grams (7 ounces) of soil, was placed in a stainless-steel bowl, homogenized, and decanted in laboratory supplied containers (Photo 10). The locations of the 5 composite soil samples are shown on Figure 2. The soil samples were analyzed for the following:

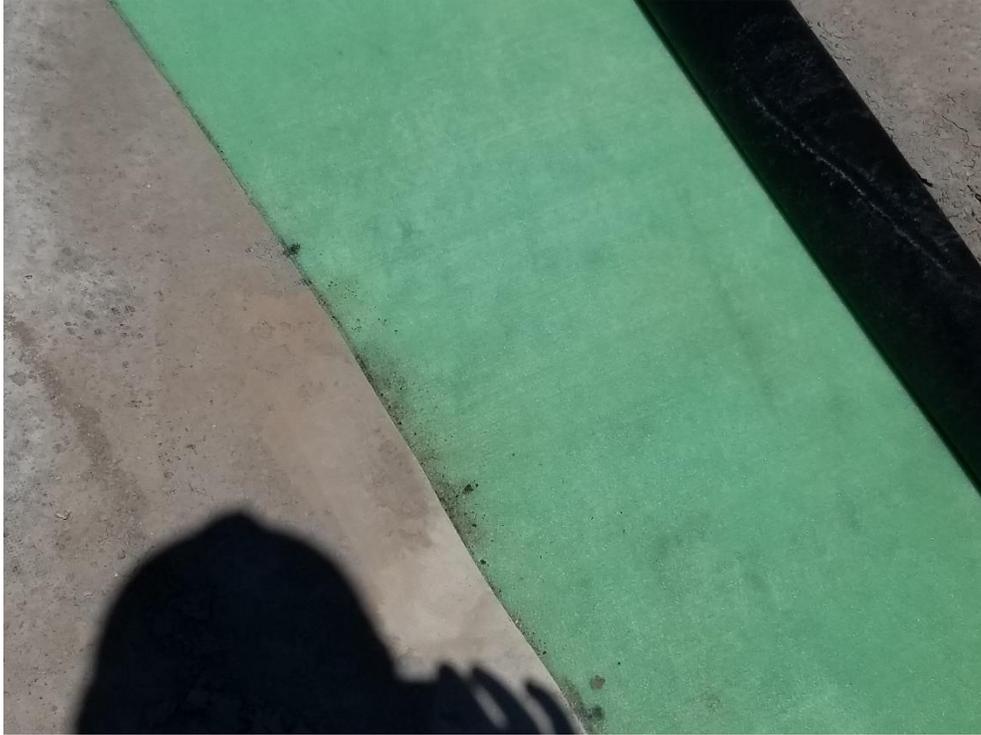
Photo 1: View of Liner Showing two liners separated by a layer of felt

Prior to liner removal, a test pit was excavated through the liner material with the backhoe to determine the liner depth and configuration. The test pit determined that the liner consisted of two layers of liner separated by a layer of felt with no soil layer between the liners (Photos 1 and 2). The liner material was cut into sections using the backhoe and bundled into piles (Photo 3).

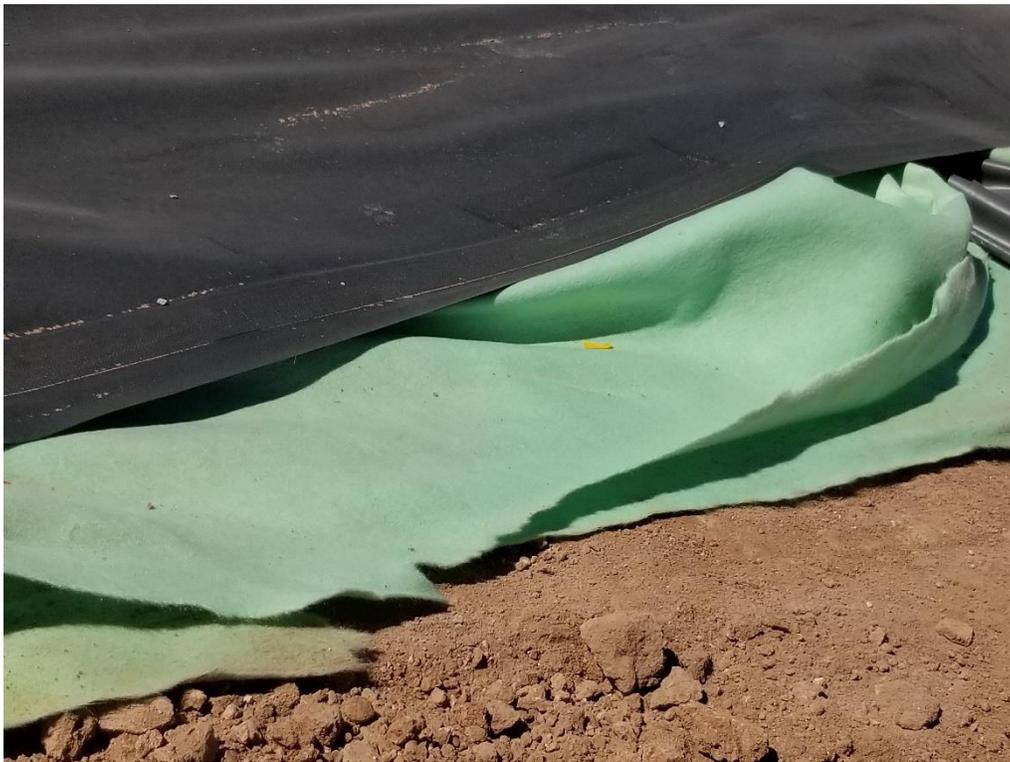
Photo 2: View of felt layer beneath first liner

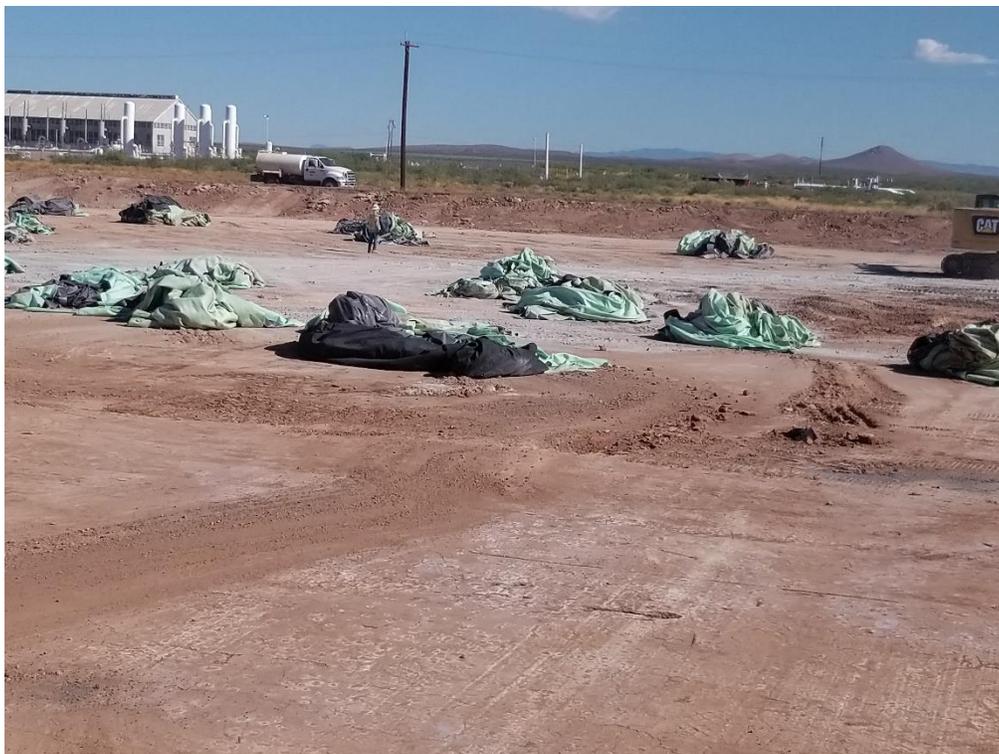
Photo 3: Liner material bundled for transport to roll-off

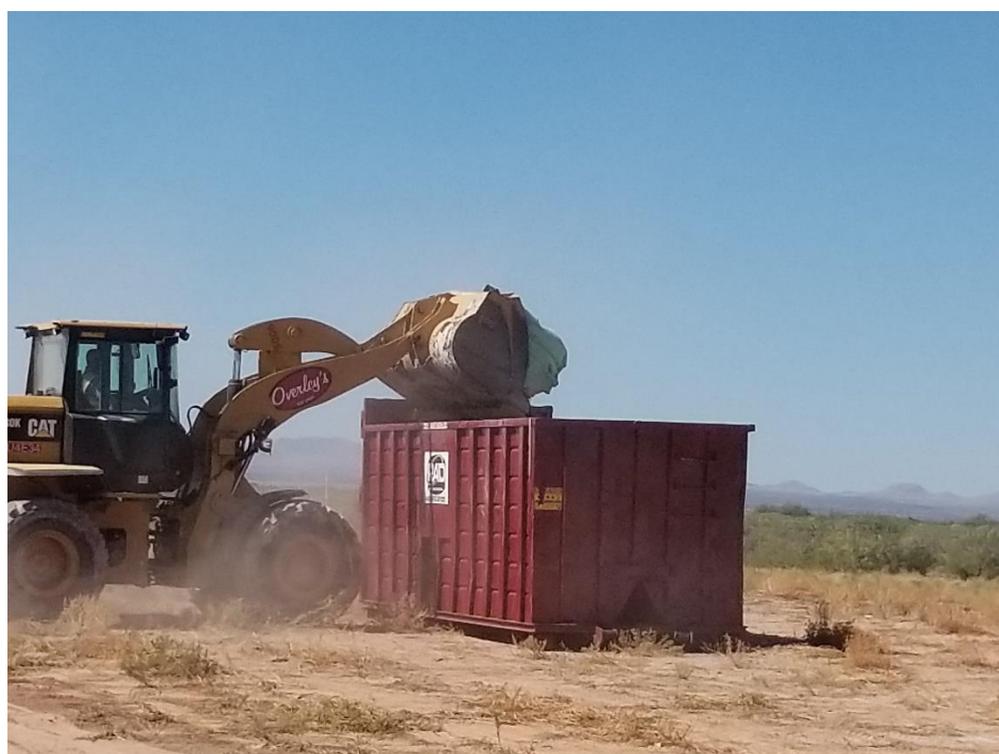
Photo 4: Liner material getting loaded into roll-offs

The liner bundles were then transported to 40 cubic yard roll-offs using a front-end loader and staged west of the evaporation pond (Photo 4). A total of 18 40-cubic yard roll off bins were used to transport the evaporation pond liner material to the Corrlitos Landfill for disposal. The total weight of the liner material removed and disposed of was 108.4 tons. The liner material disposal documentation is provided in Appendix A.

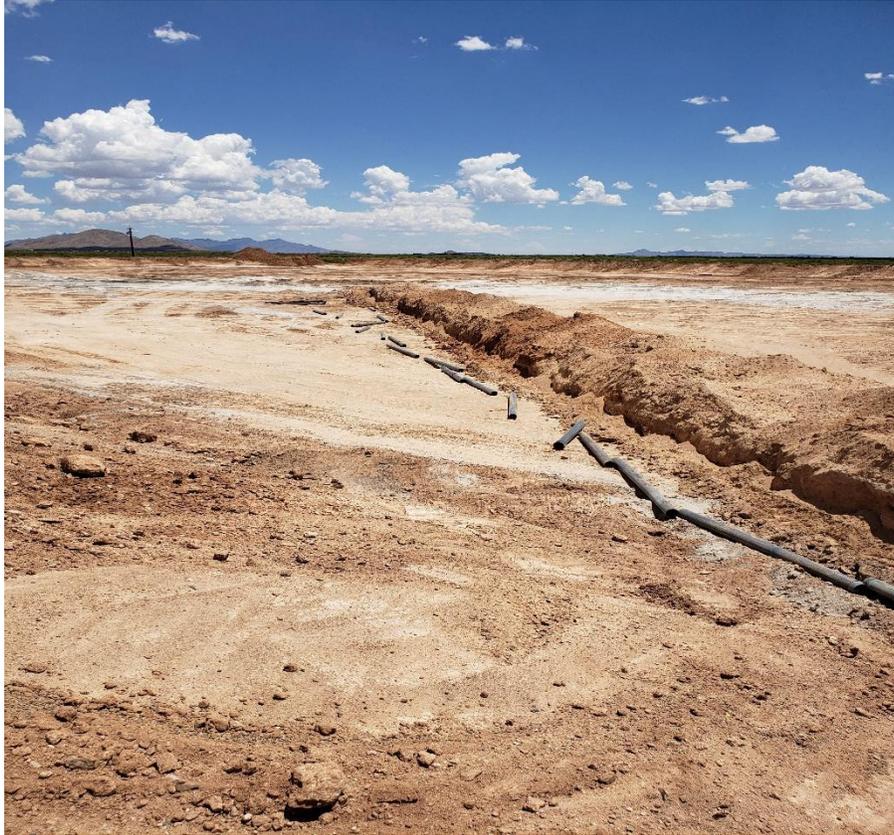
Photo 5: Excavation of 2-inch drain line beneath pond liner

A buried drain line made of 2-inch polyvinyl chloride (PVC) carried water from the compressor station to a valve box located 10-feet outside the northwest corner of the evaporation pond. The valve box-controlled water flow to the evaporation pond. From the valve box, the drain line extended beneath the evaporation pond liner and discharged water through a concrete vent located in the center of the evaporation pond. The drain line, valve box, and concrete discharge vent were excavated for disposal (Photos 5, 6 and 7) and transported in 40-cubic yard roll-offs to the Corrlitos Landfill for disposal. Following excavation, the drain line was cut and plugged with cement where it entered the valve box (Photo 8). The leak detection standpipe located east of the evaporation pond was pulled and backfilled to complete the evaporation pond demo.

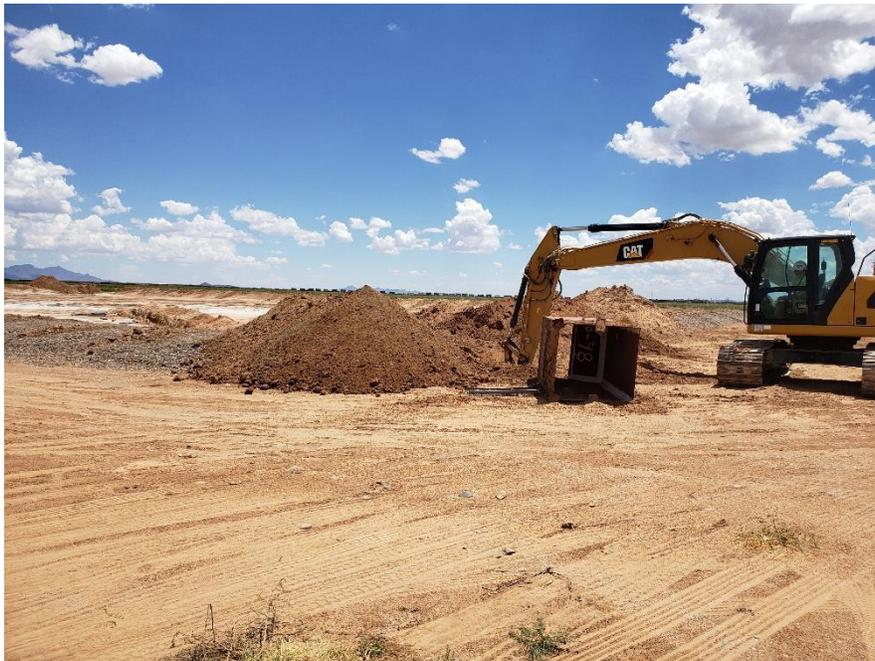
Photo 6: Excavation of drain line valve box

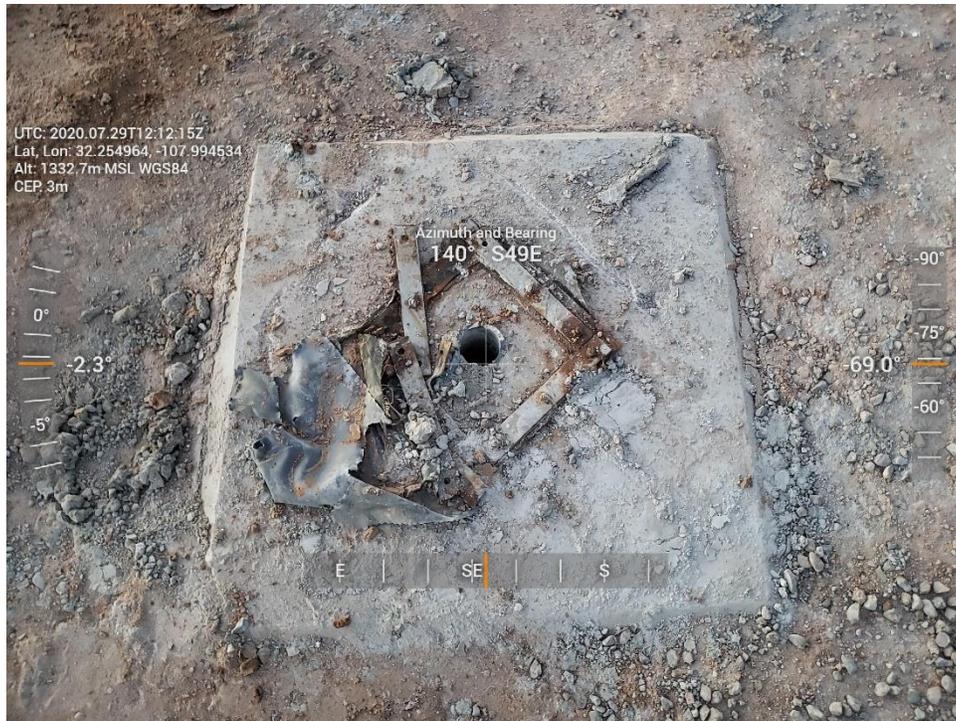
Photo 7: Excavation of concrete discharge vent

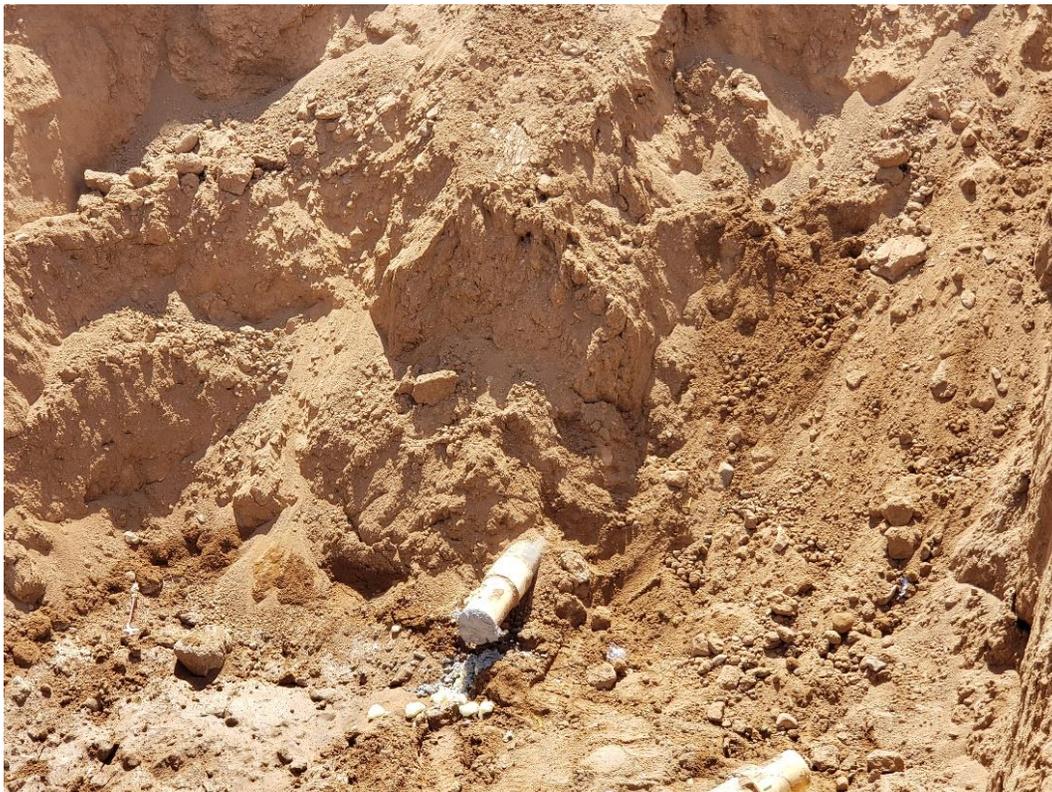
Photo 8: Drain line cut and plugged with concrete

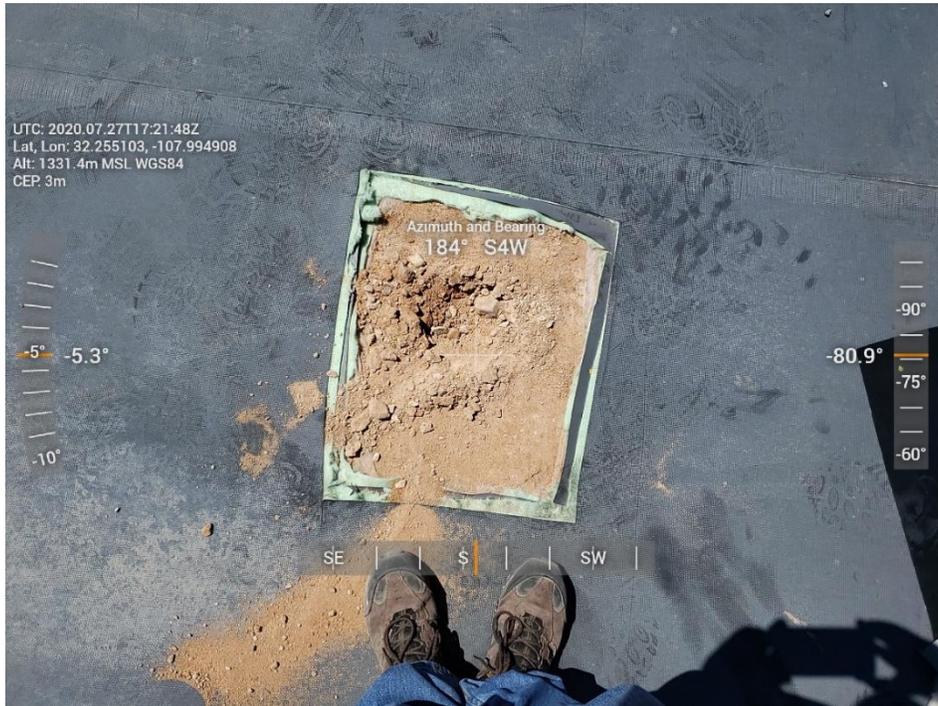
Photo 9: Composite soil sample location

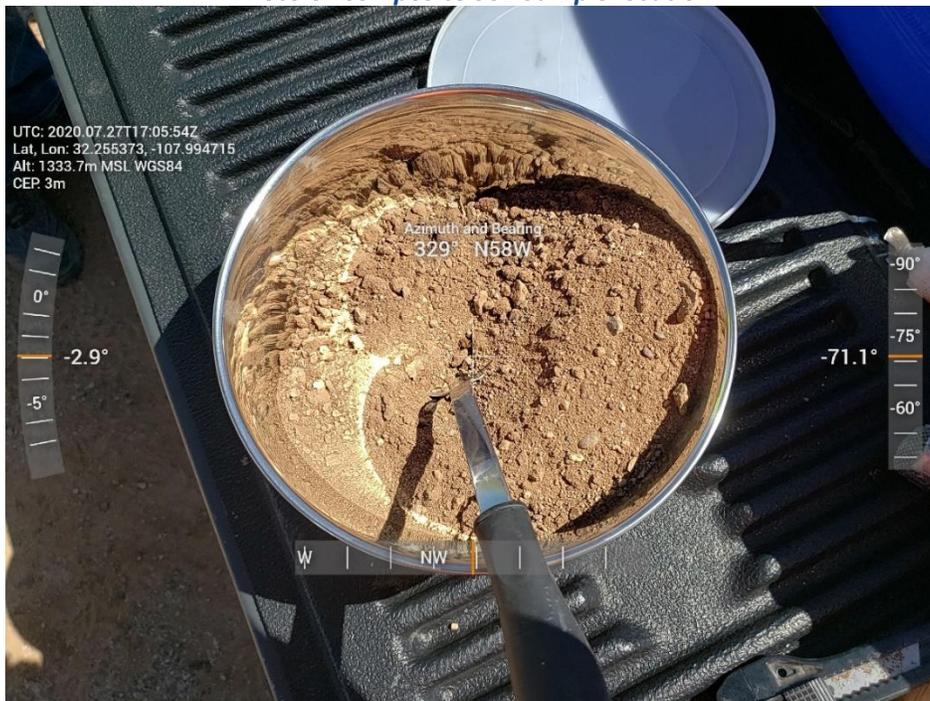
Photo 10: Composite soil sample in stainless steel bowl

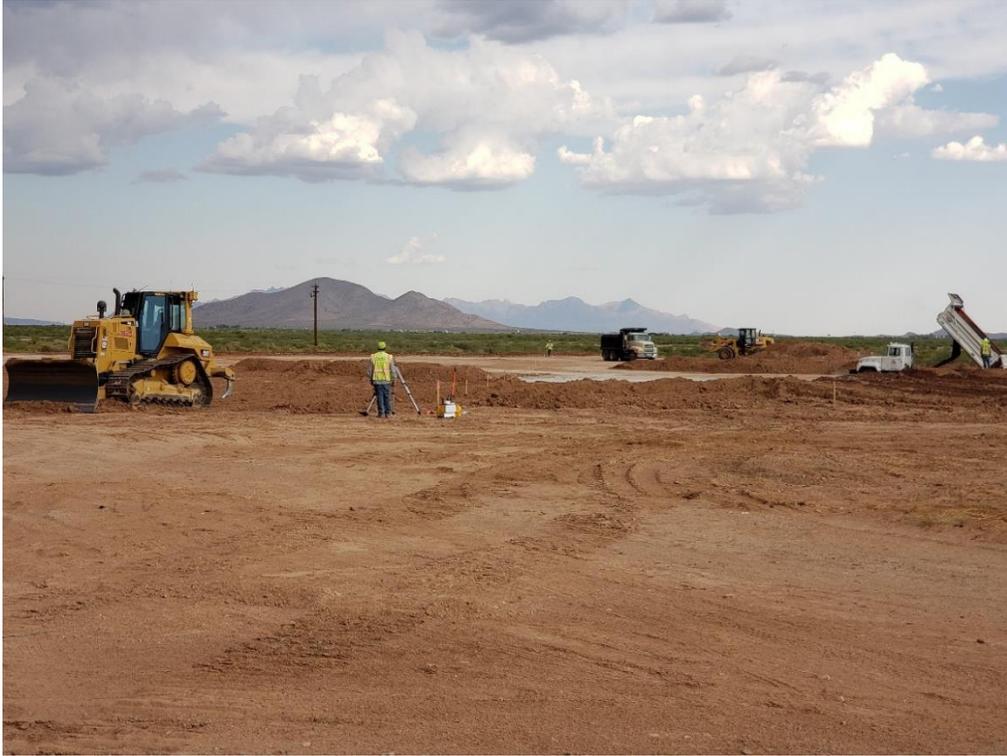
Photo 11: Staking survey to determine grade

The evaporation berm demolition and backfill took place between August 6 and August 9, 2020 by Overlay's. The berm material was pushed into the evaporation pond using a D6 Dozer and front-end loader and spread out in approximate 10-inch lifts and compacted using water to achieve a density comparable with the adjacent undisturbed soils with no voids. Once all the berm material was pushed and compacted into the interior of the evaporation pond, a staking survey was performed to determine additional soil volume requirements to complete backfill (Photo 11). Approximately 1,200 additional cubic yards of soil were imported to the Site to complete the backfill of the evaporation pond (Photo 12). The soil used for backfilling consisted

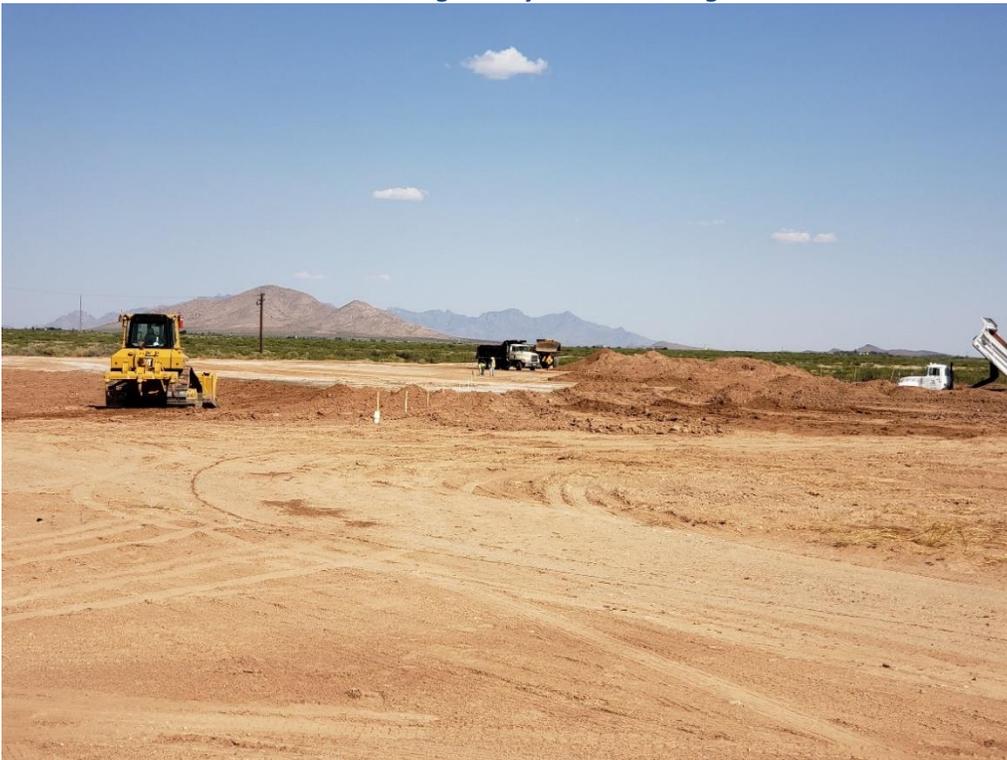
Photo 12: Import soil unloaded for backfill

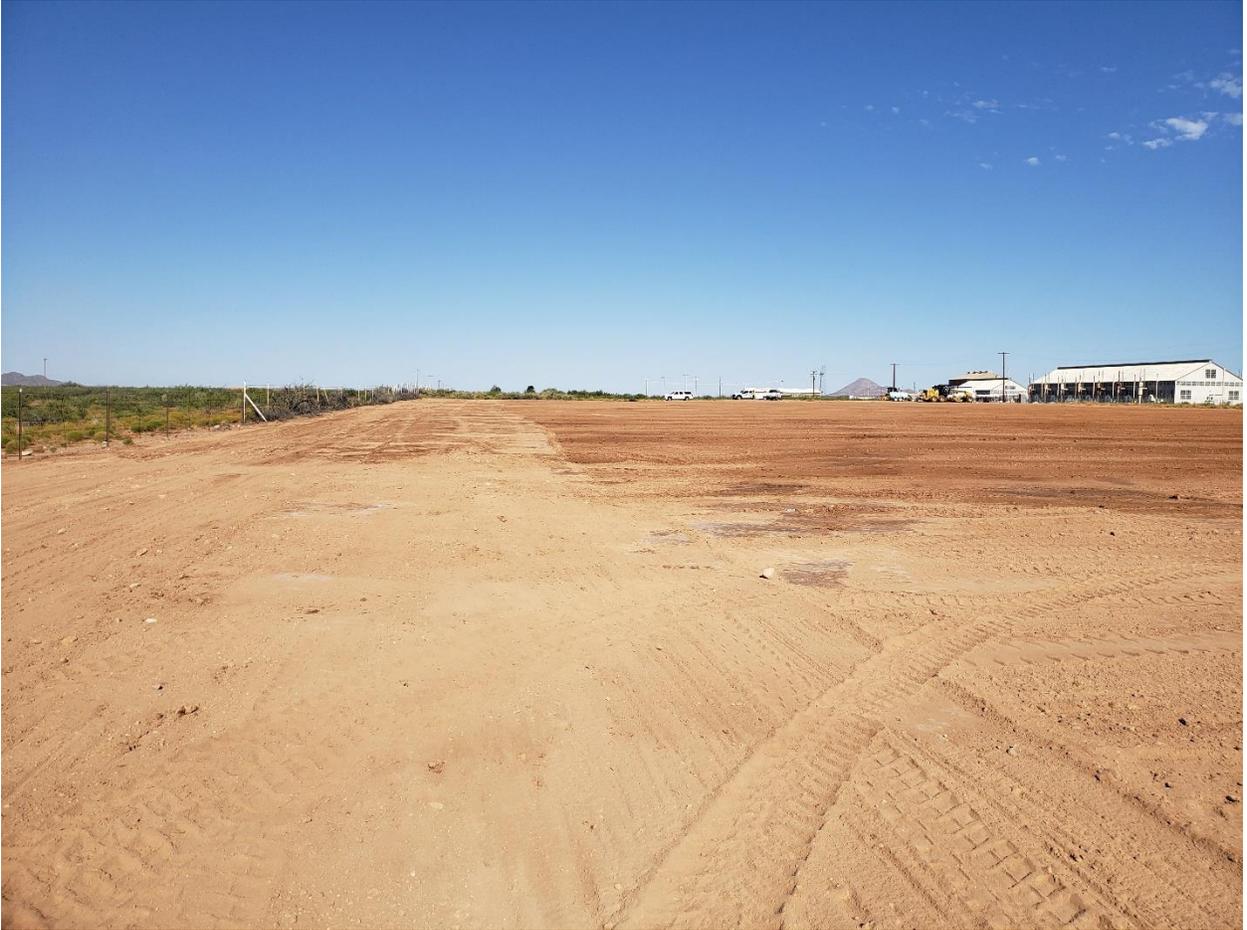
Photo 13: View looking NW at finished grade

of native pit run material obtained from the Deming, New Mexico Municipal Landfill. A motor grader was then used to contour the final grade to match the natural drainage pattern of the area (Photo 13). The import fill material documentation can be found in Appendix B.

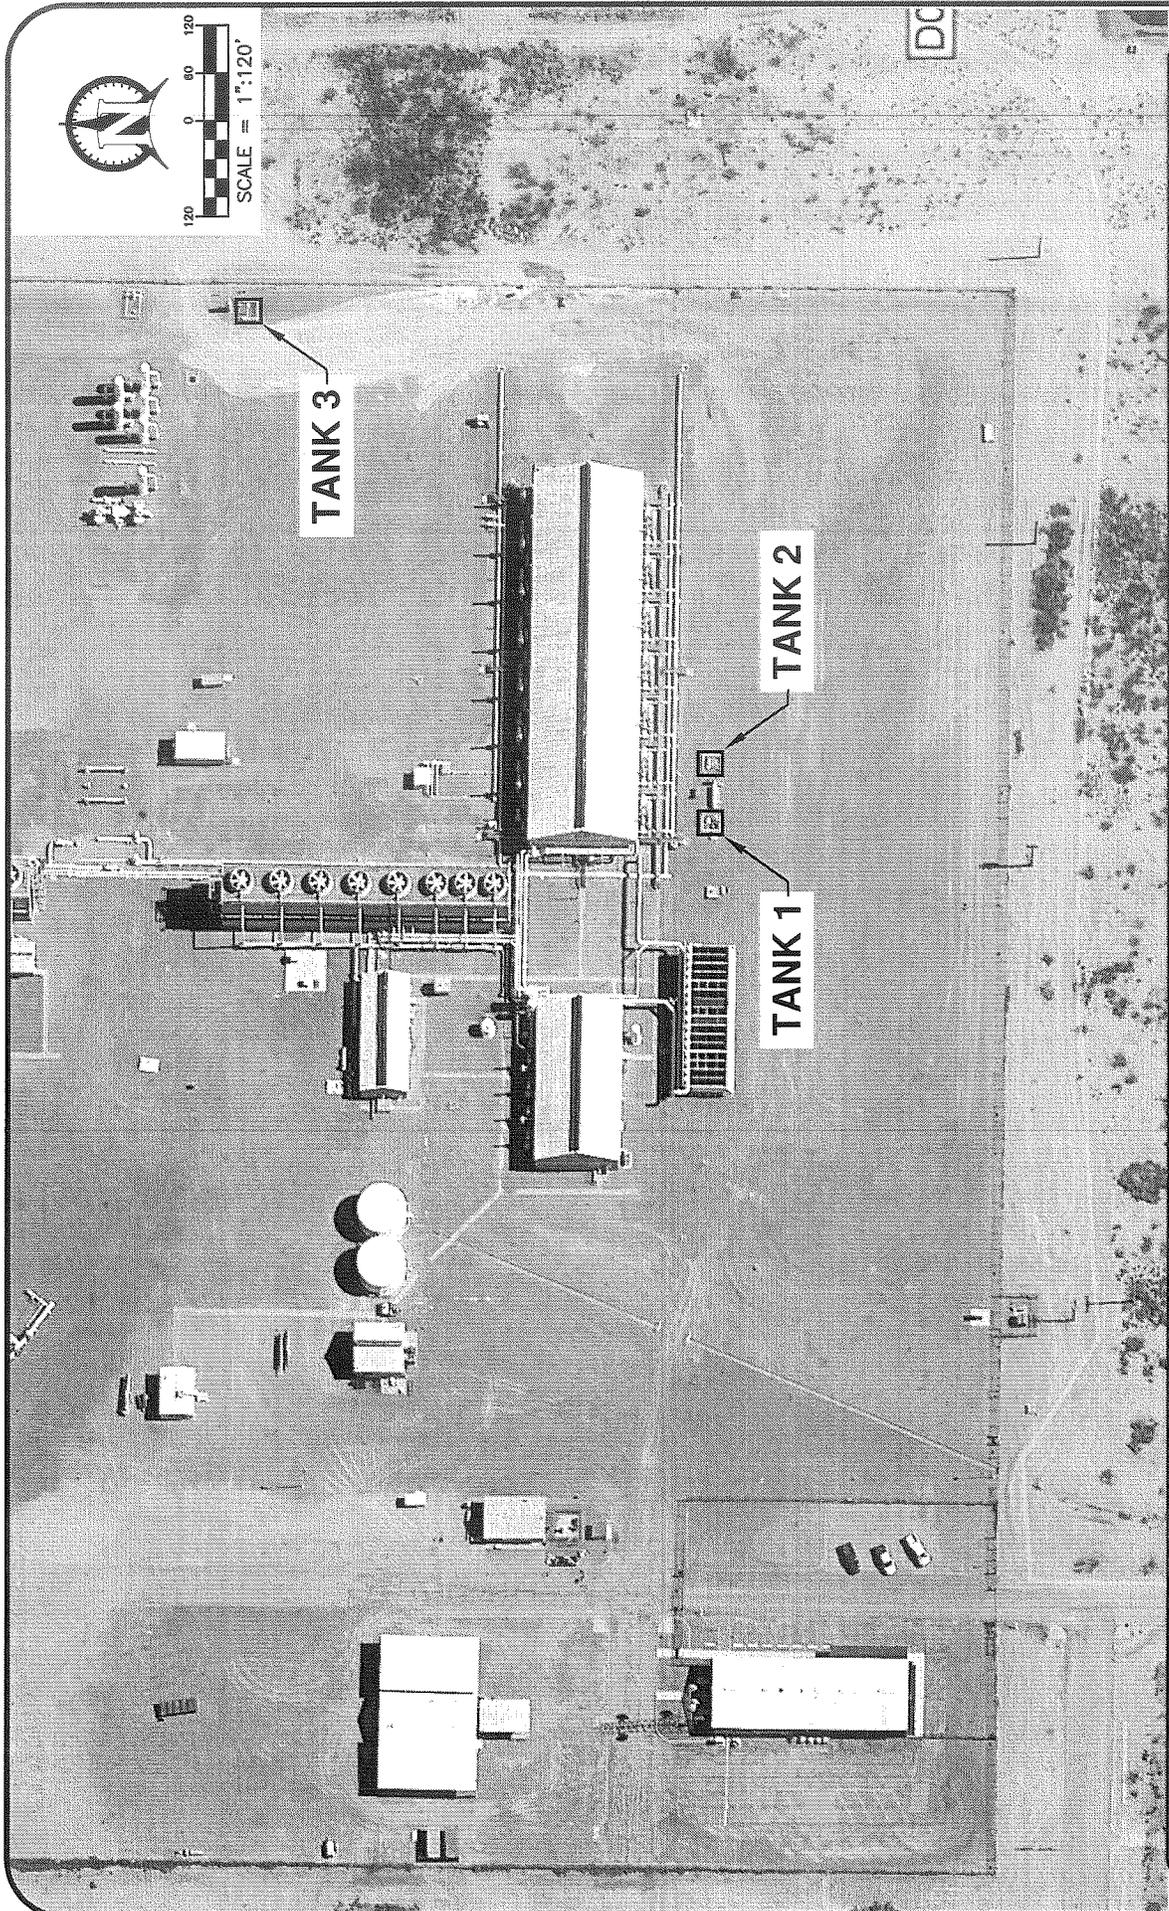
TANK 3

TANK 1

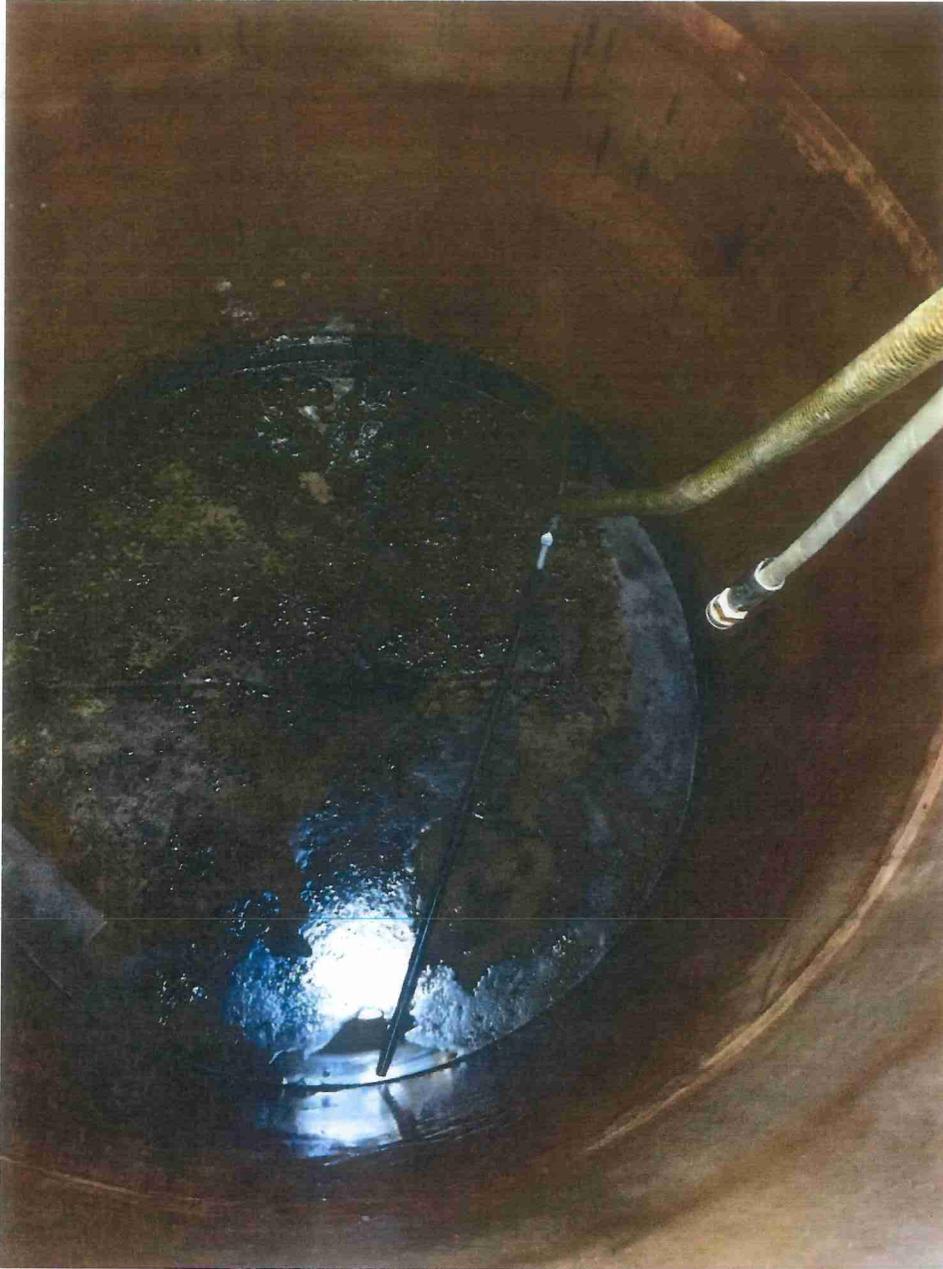
Photograph: 1

Description: View showing removal of fluids from 'Tank 3'.

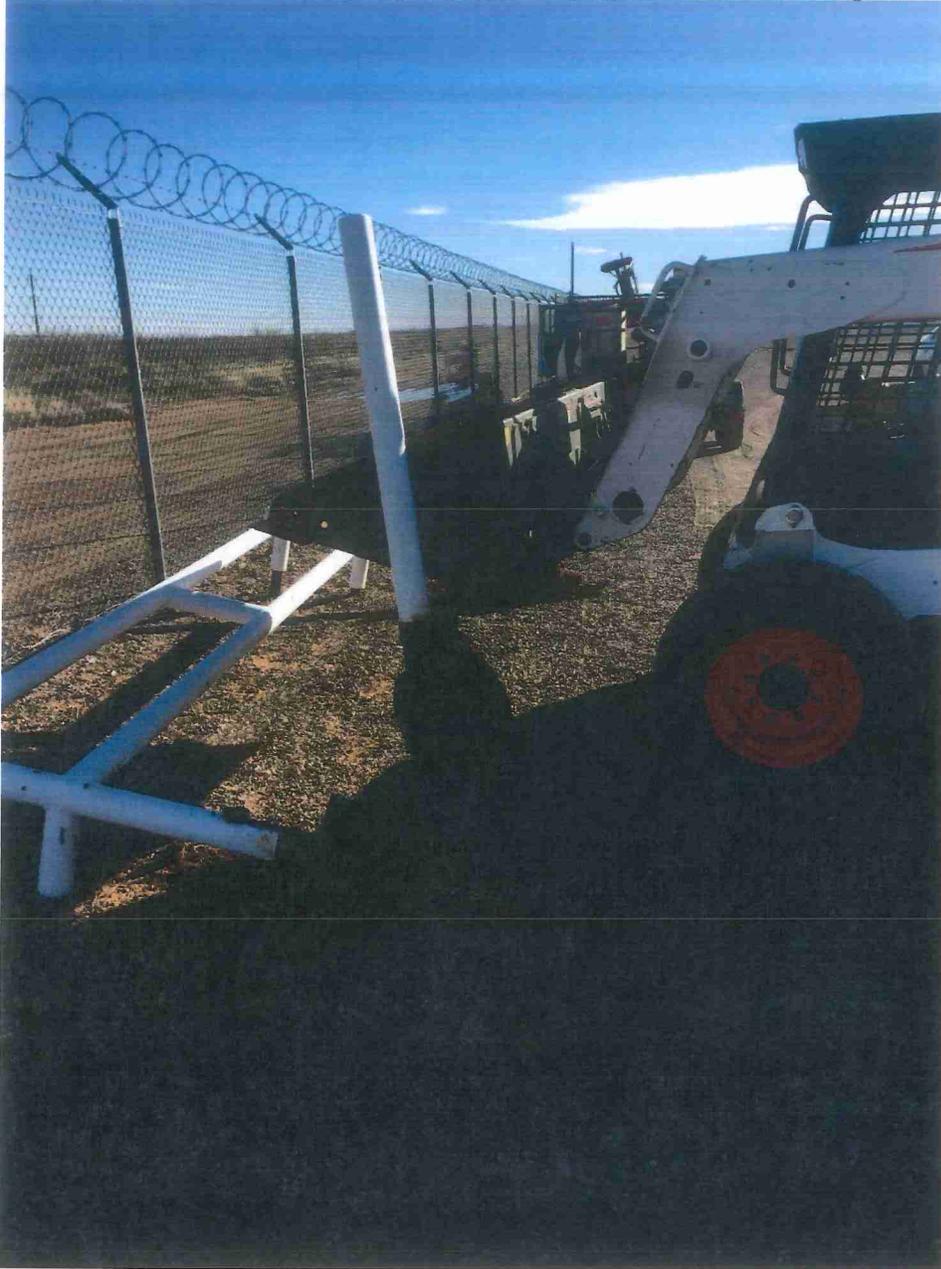
Photograph: 2

Description: View showing typical removal of protective bollards prior to tank removal.

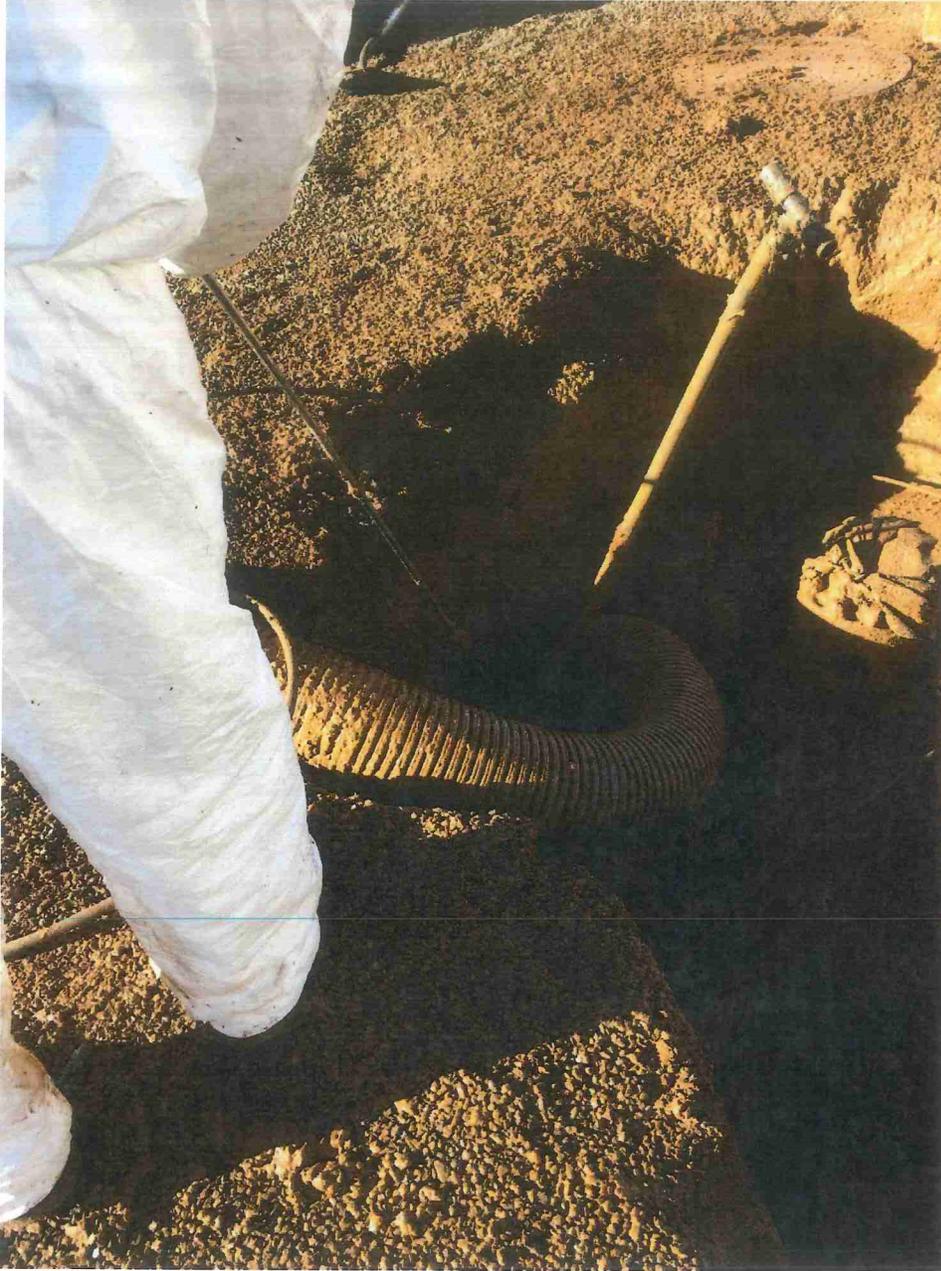
Photograph: 3

Description: View showing the use of vacuum truck to remove surface soils to expose tanks.

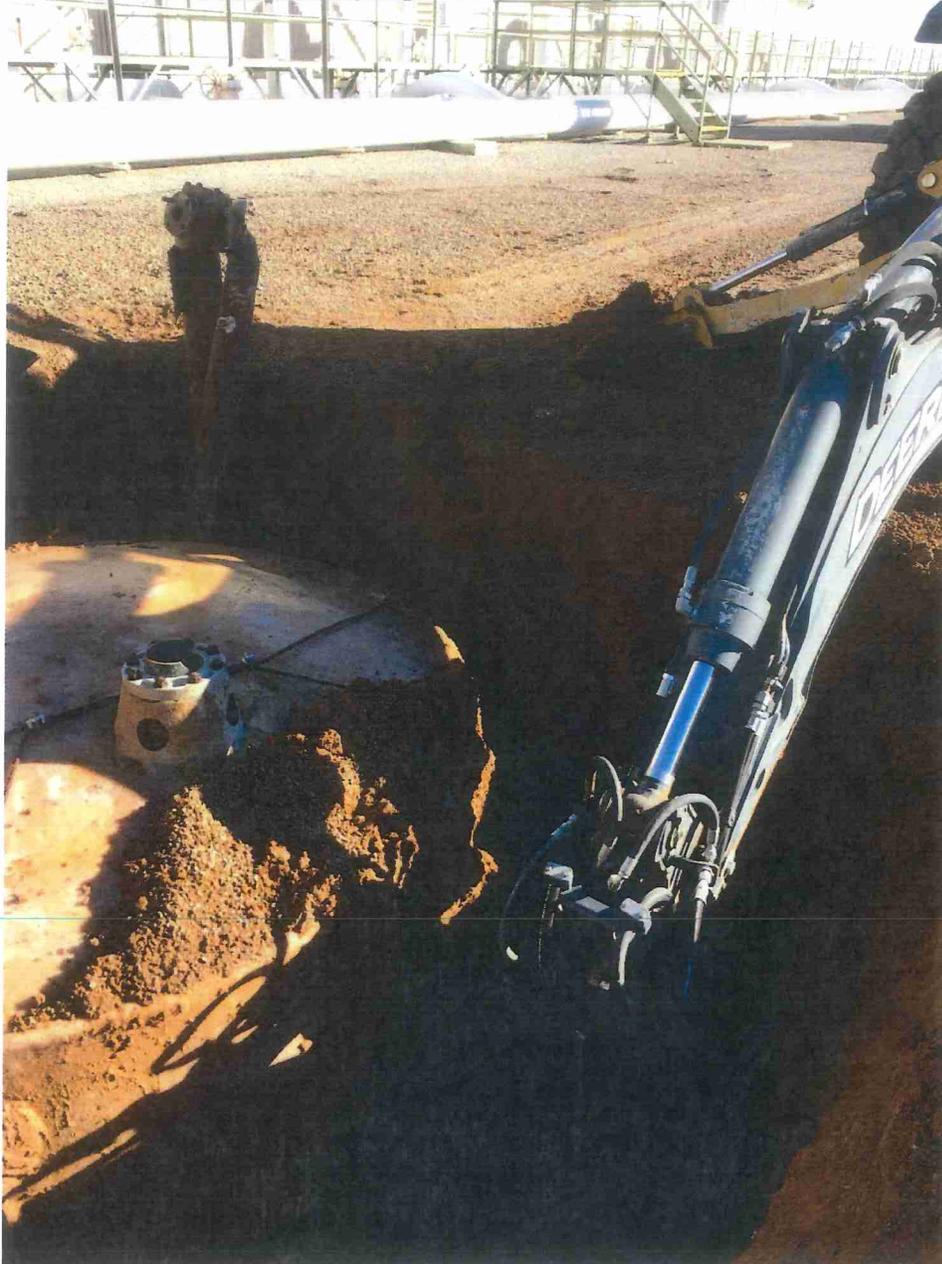
Photograph: 4

Description: View showing exposure of tanks prior to removal.

The tanks were fiberglass vertical cylindrical tanks and were in fair condition. The soil below the tanks was not discolored and did not have a significant hydrocarbon odor.

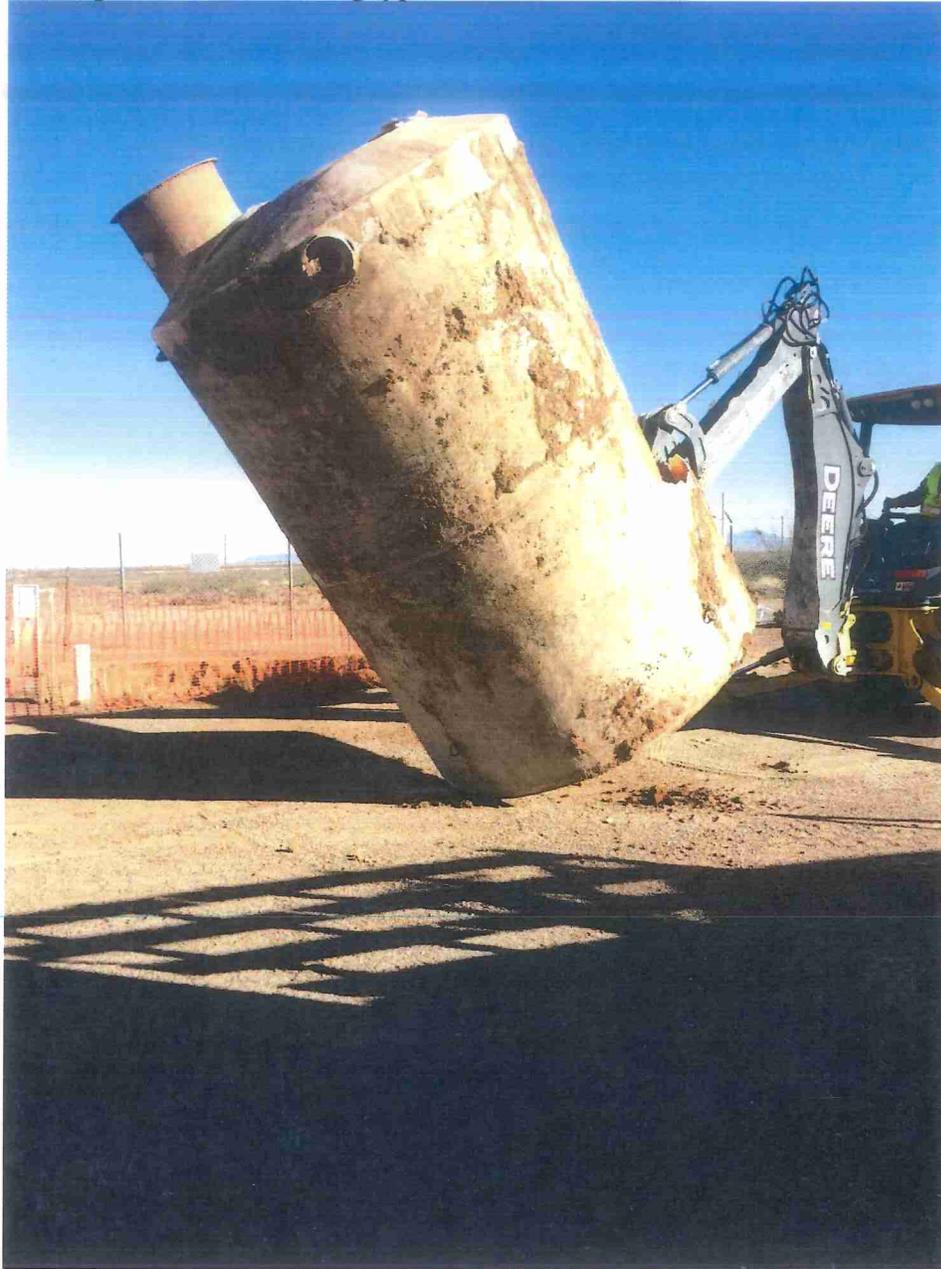
Photograph: 5

Description: View showing typical removal of tanks.

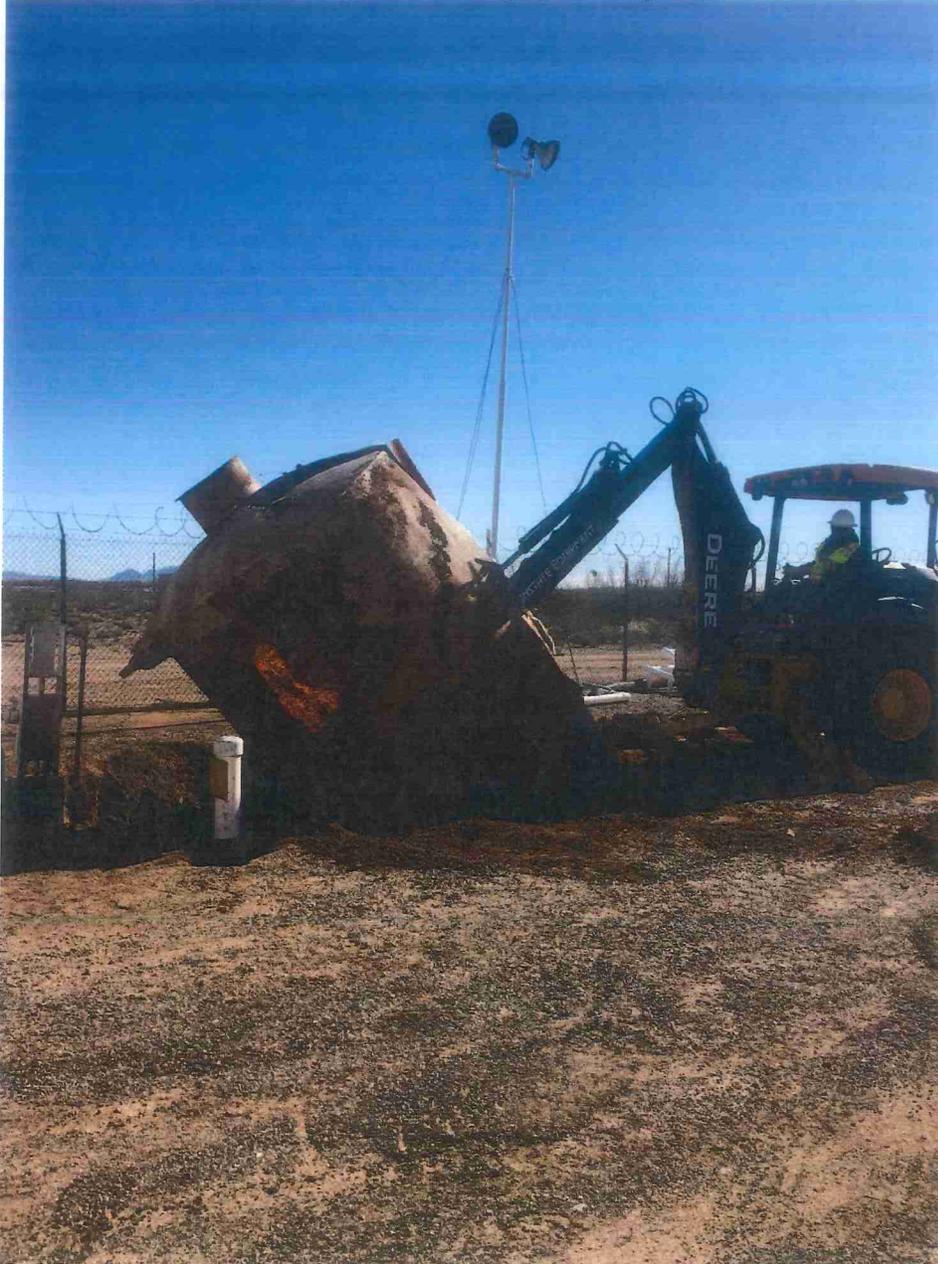
Photograph: 6

Description: Crushing of tanks on-site prior to disposal.
