Kinder Morgan Former Deming Compressor Station Discharge Permit GW-147, Closure Report

September 28, 2020

AECOM Technical Services
6501 Americas Parkway
Albuquerque, NM 87110
aecom.com

Appendix D
Kinder Morgan NM UST Closure Report

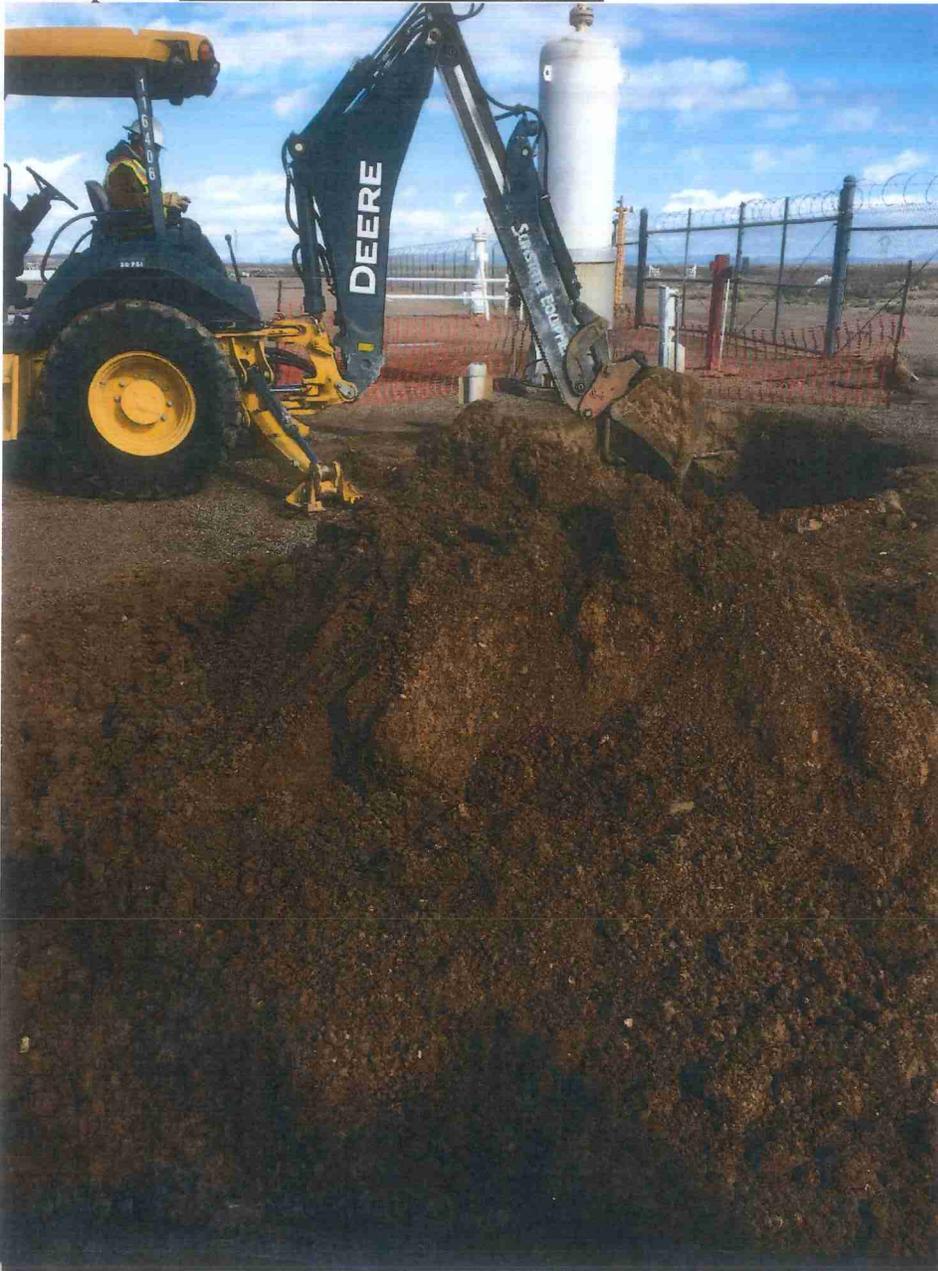
Photograph: 7

Description: Over-excavation of Tank #3 area.

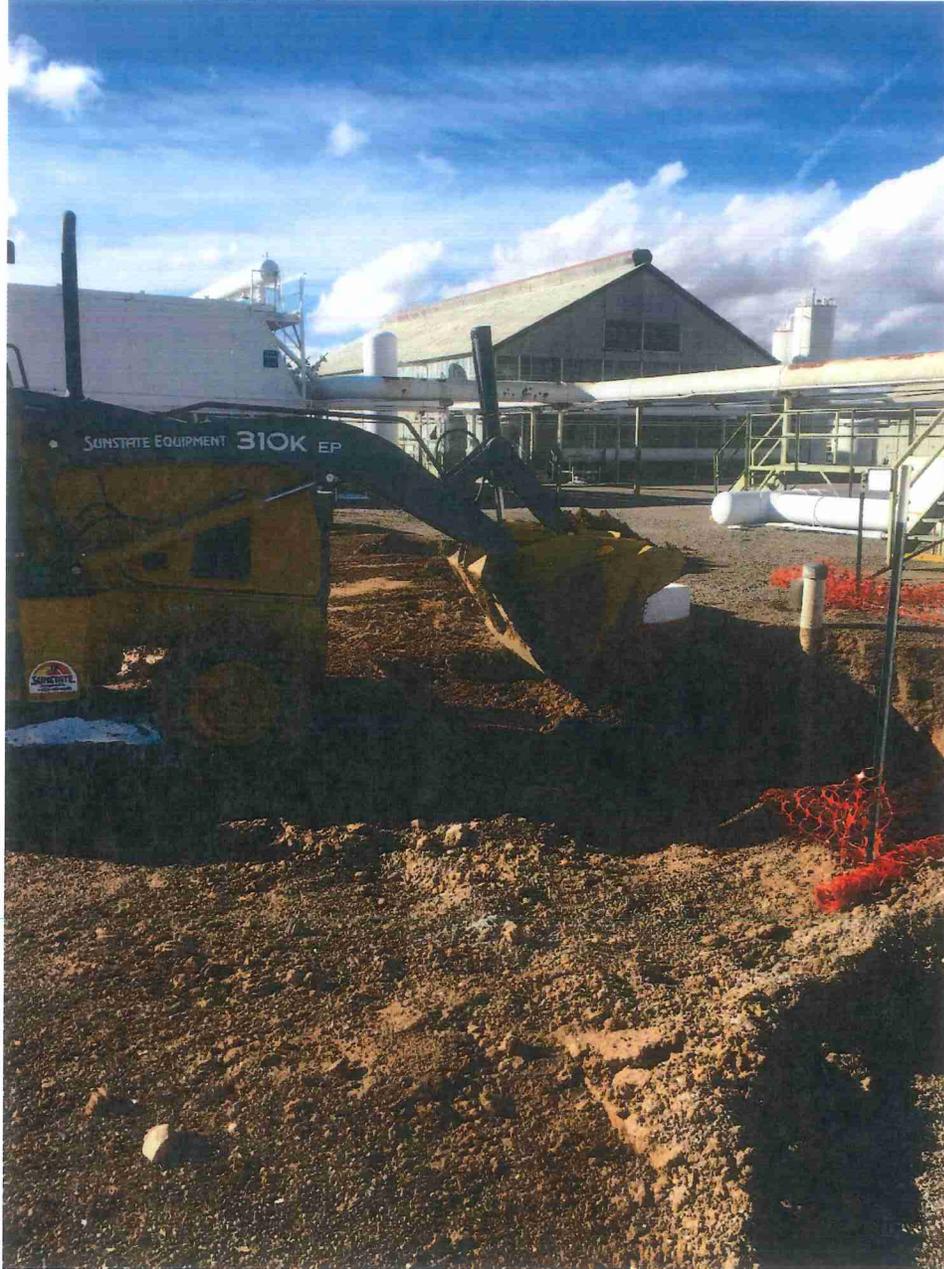
Photograph: 8

Description: Backfilling activities of the former tank locations.

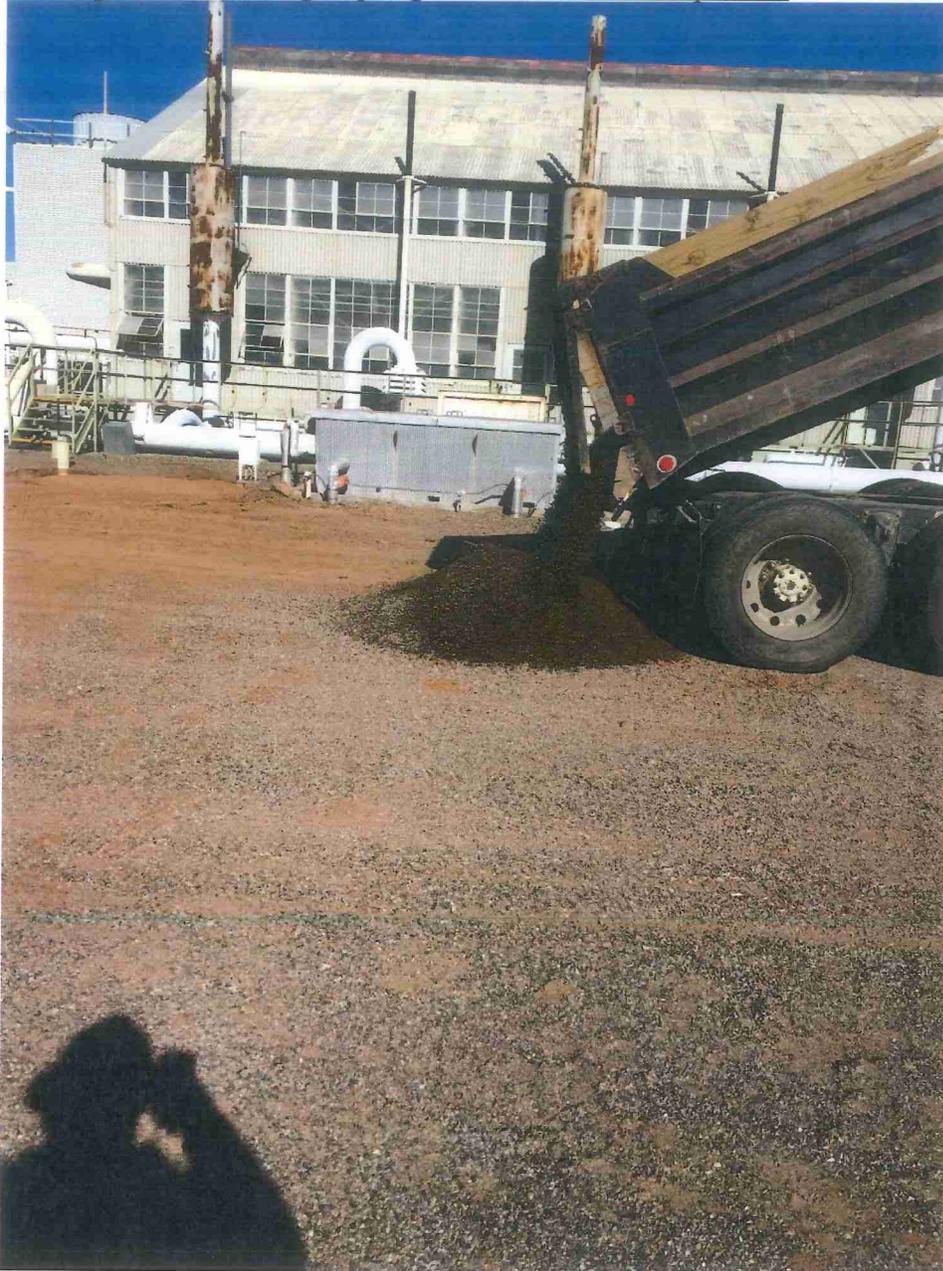
Photograph: 9

Description: Unloading of pea gravel for surface completion.

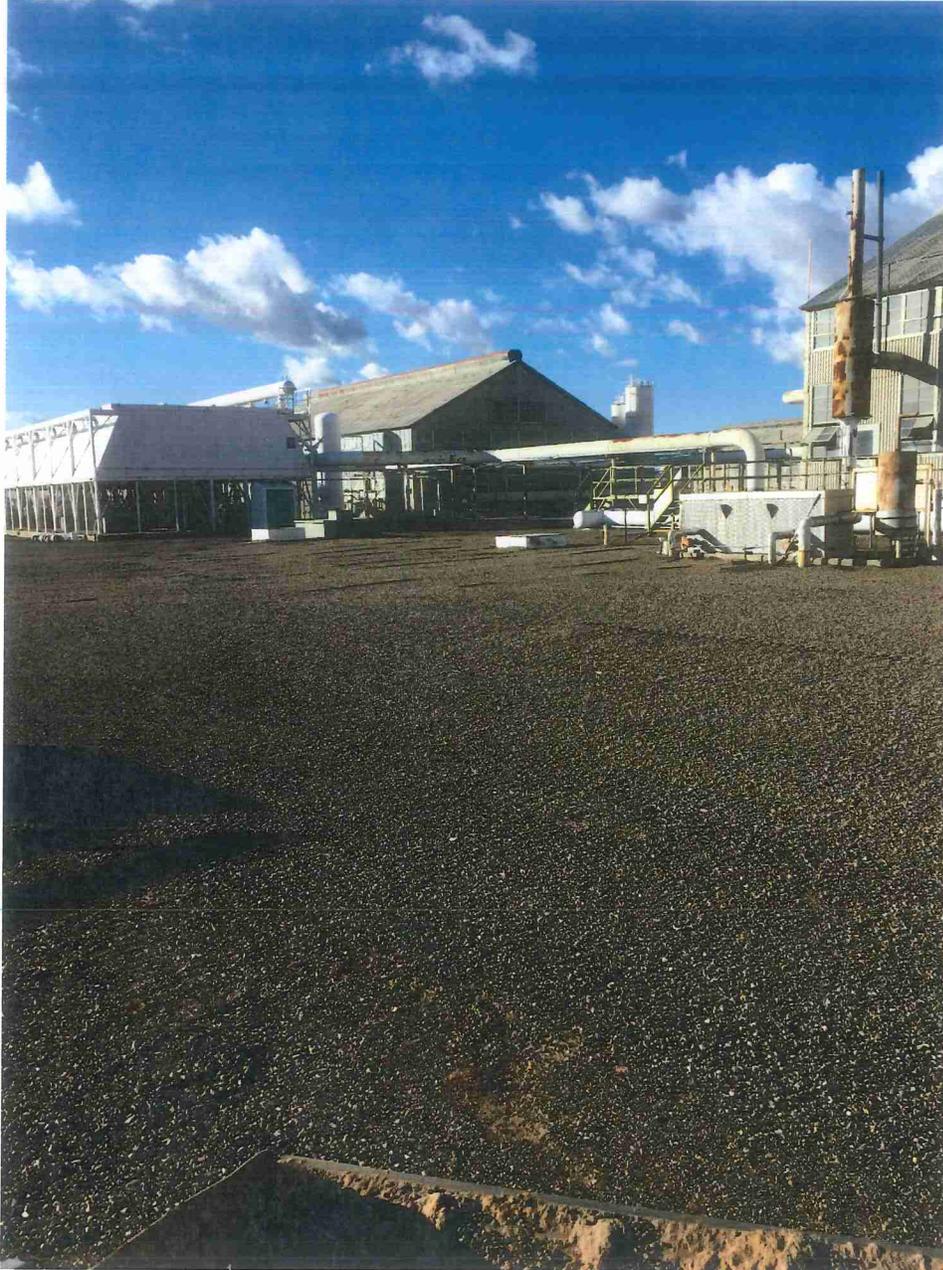
Photograph: 10

Description: Surface completion of former tank areas.

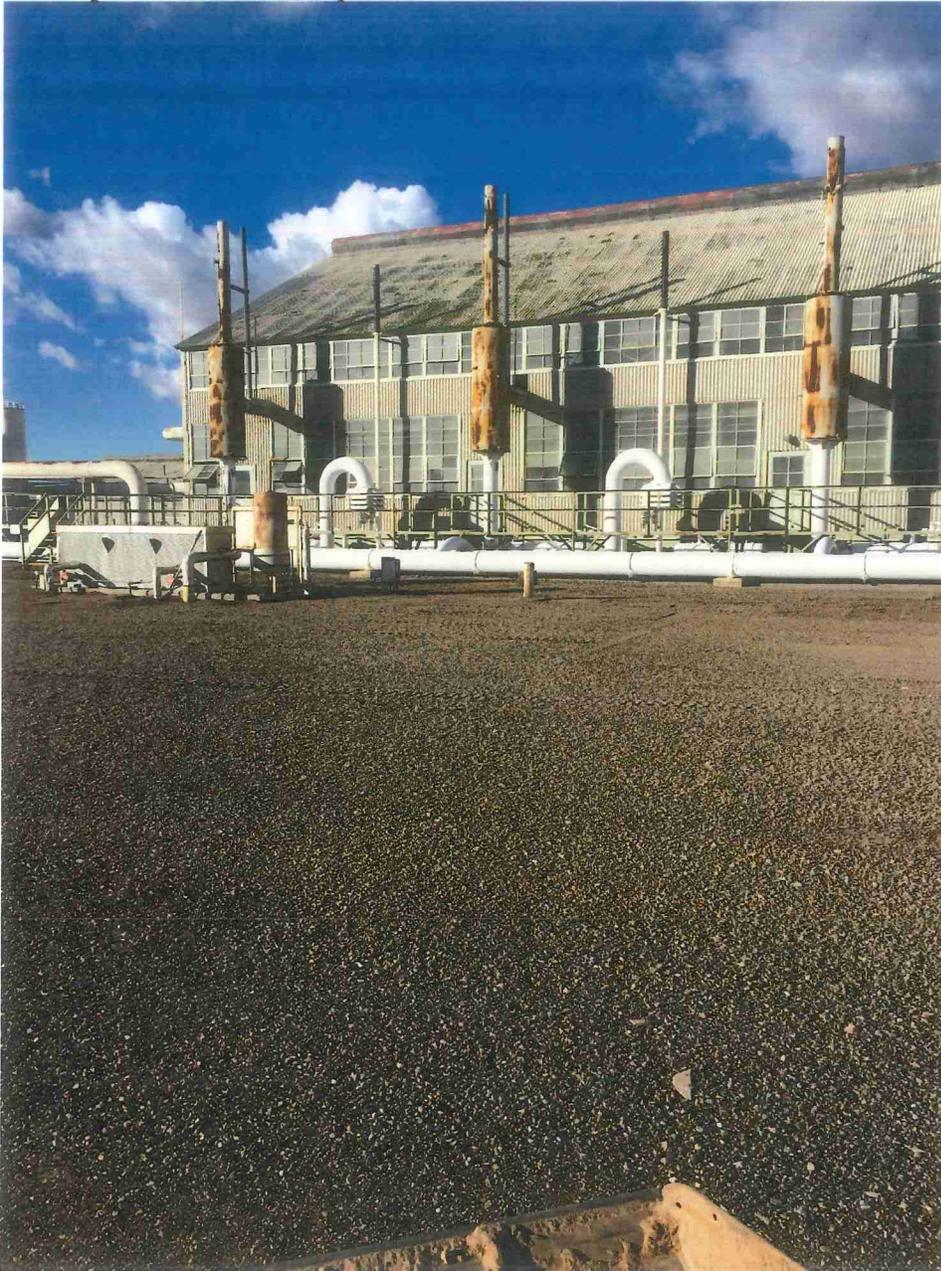
Photograph: 11

Description: Surface completion of former tank areas.
