**COMPLETION REPORT
SUPPLEMENTAL DRILLING AND SAMPLING**

**SUNDANCE SERVICES, INC.
LEA COUNTY, NEW MEXICO**

**ATTACHMENT A
PROJECT PHOTOGRAPHS**

SUNDANCE WEST
SUNDANCE SERVICES INC
LEA COUNTY, NEW MEXICO

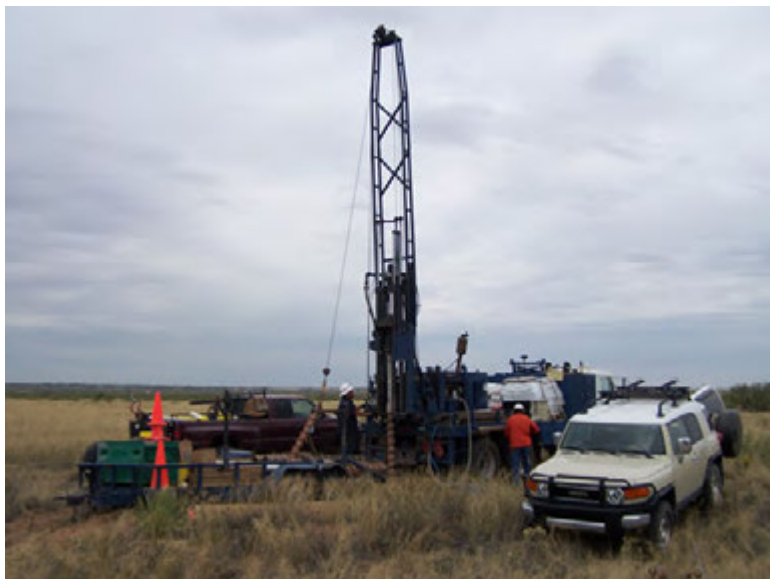
Photograph 1. Rodgers set up on CH-1 with CME-75 HSA and related equipment.

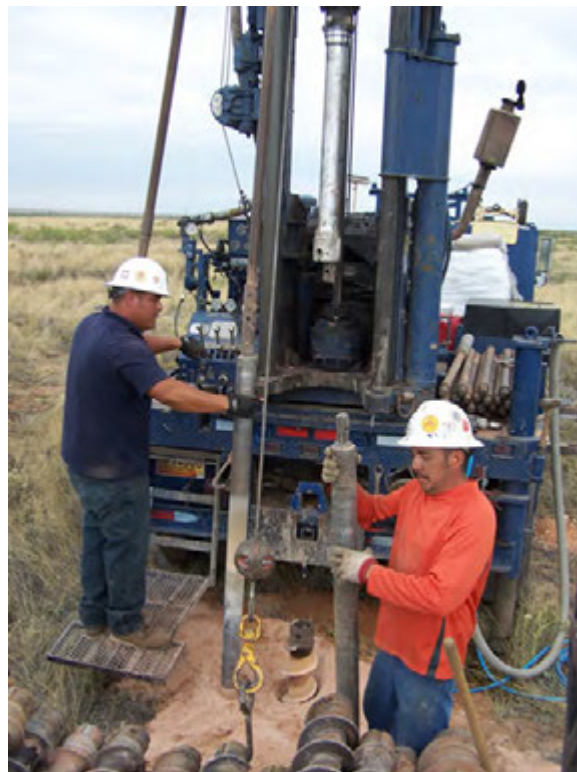
Photograph 2. HSA drilling and continuous core sampling CH-1. Driller and helper each holding 5-foot long sampler.

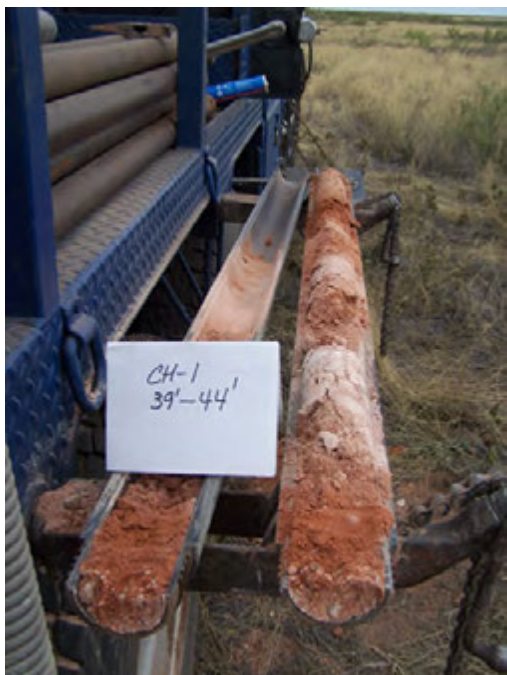
Photograph 3. Core sample of CH-1 at the base of the OAG and top of Chinle.

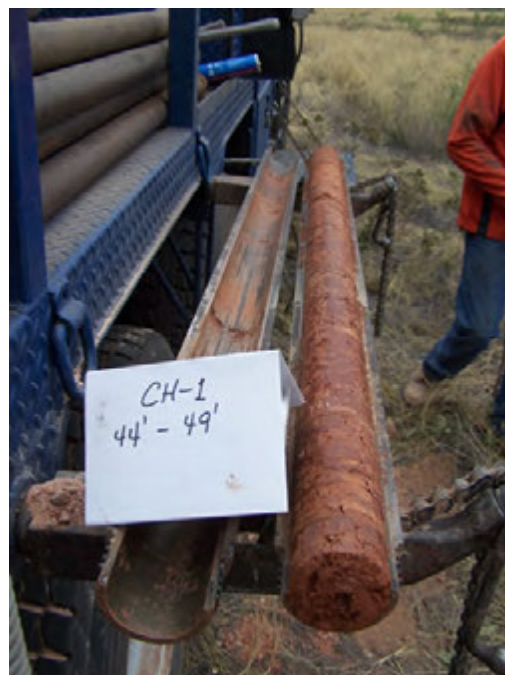
Photograph 4. Core sample of CH-1 at top of Chinle.
