**Permit
Application**

**Volume 4
Part 6 of 11**

PROJECT PHOTOGRAPHS

SUNDANCE WEST
SUNDANCE SERVICES INC
LEA COUNTY, NEW MEXICO

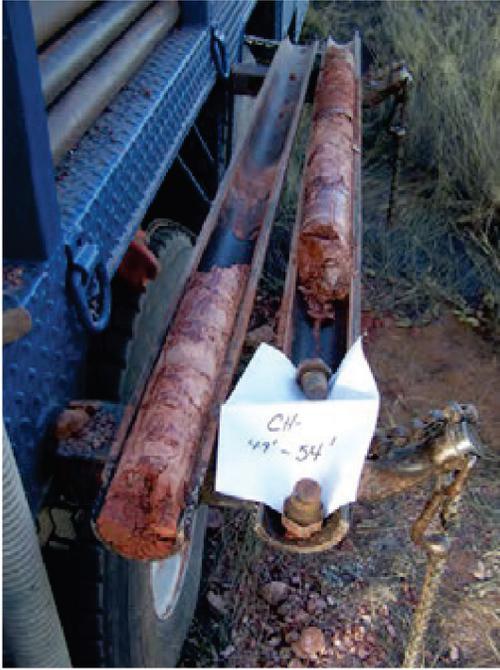
Photograph 13. Core sample of claystone (Chinle) in CH-2.

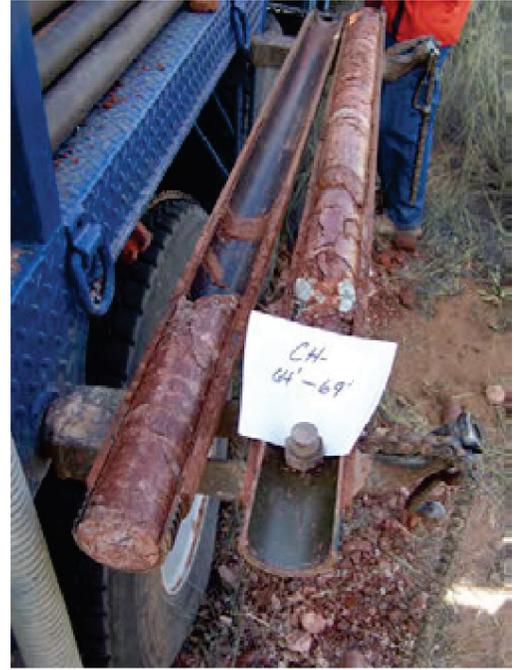
Photograph 14. Core sample of claystone with grey clay inclusions (Chinle) in CH-2.

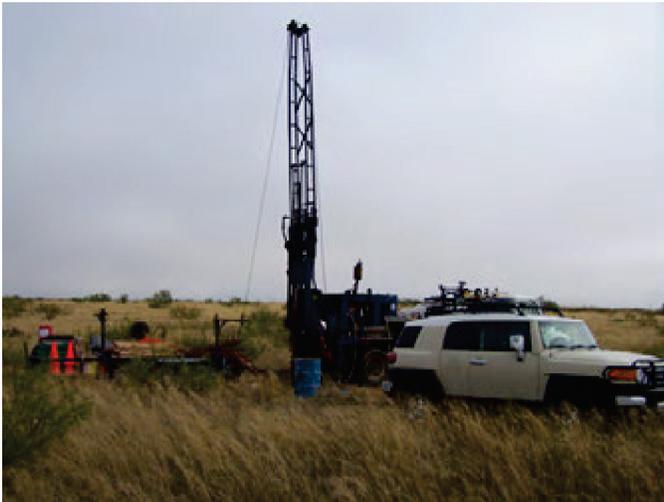
Photograph 15. Rodgers set up to drill CH-3.

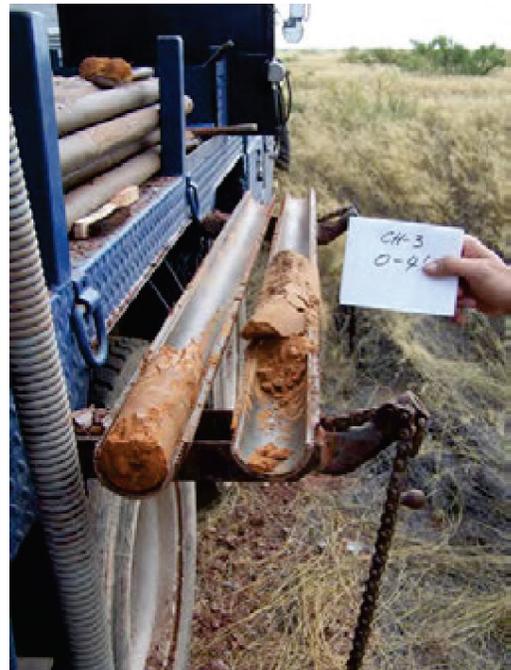
Photograph 16. Core sample of surface sand in CH-3.
