NM1-62

**Permit
Application**

**Volume 4
Part 7 of 11**

SUNDANCE WEST
SUNDANCE SERVICES INC.
LEA COUNTY, NEW MEXICO

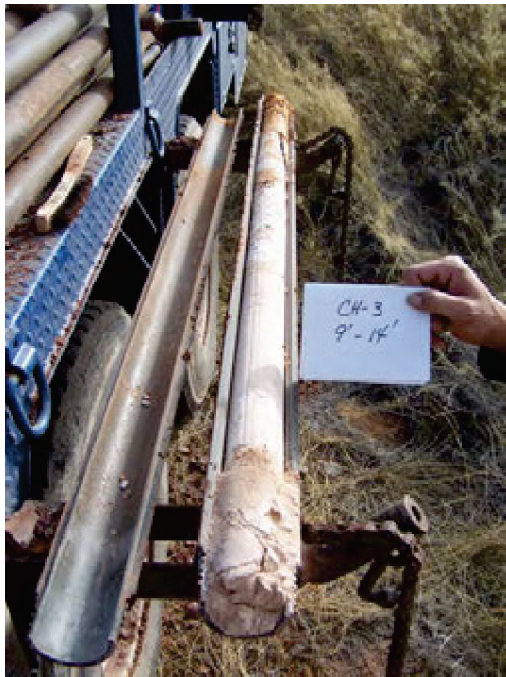
Photograph 17. Core sample of caliche in CH-3.

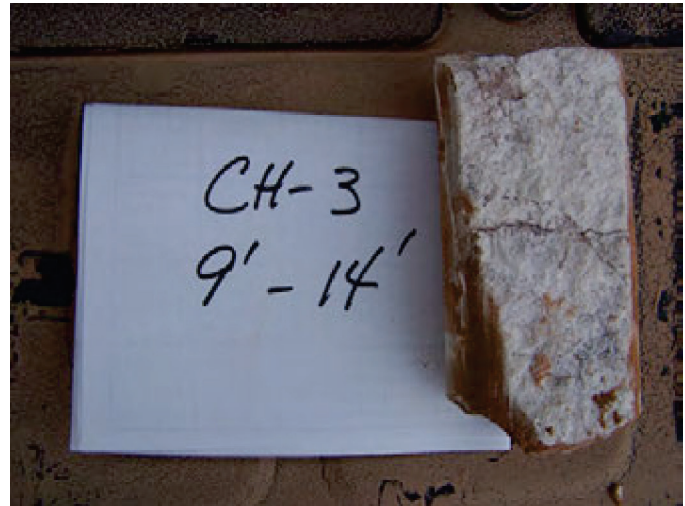
Photograph 18. Core sample of root fibers in caliche in CH-3.

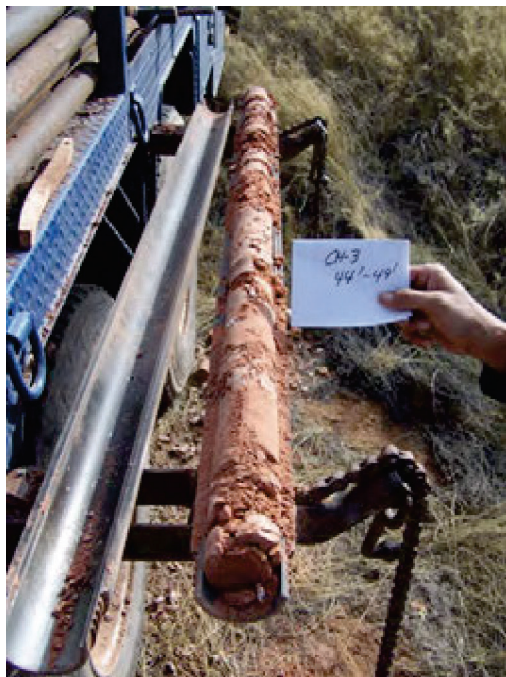
Photograph 19. Core sample of base of OAG and top of Chinle in CH-3.

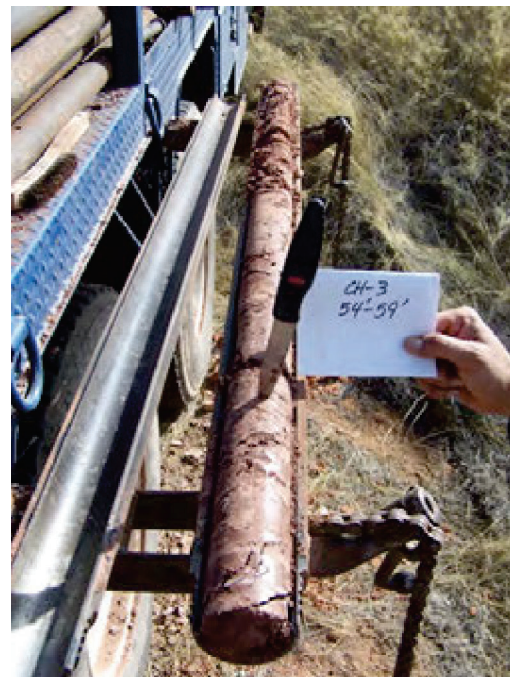
Photograph 20. Core sample claystone (Chinle) in CH-3.
