**Inspection Report
Eunice Treatment Plant
Lea County, NM**

Inspection Date: November 4, 1998

Facility Name: Eunice Treatment Plant

Facility Description: Inactive, former commercial oilfield waste treatment and disposal facility

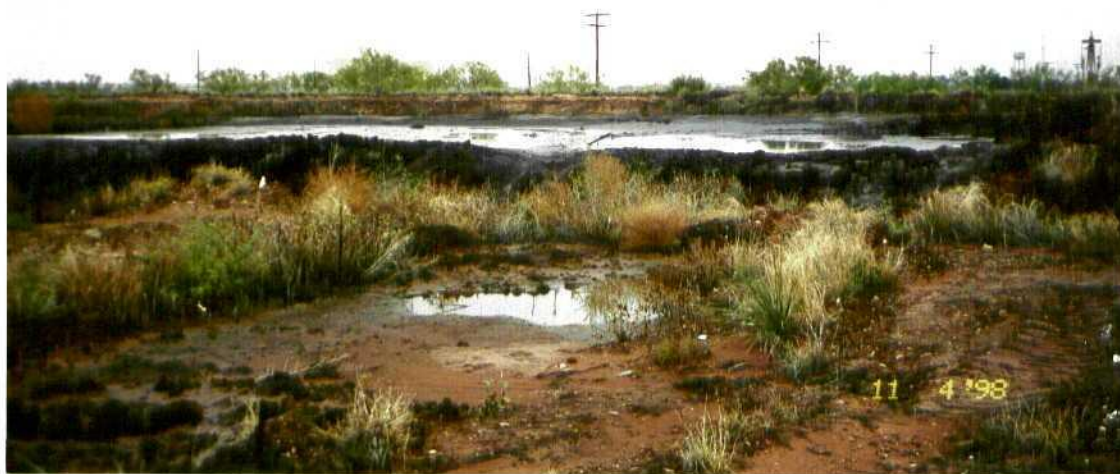
At the time of the inspection, the facility consisted of two large tanks and an unlined pit. It was not apparent at the time whether or not the tanks contained waste oil. The tanks were not equipped with secondary containment. The pit appeared to contain a combination of liquid, sludge, and oil (see Attachment A, photo #'s 1 & 2). The pit was not netted. The berm around the pit was heavily saturated with oil. There was fencing around the site; however, portions of it were missing and access to the site was not restricted. There were several homes located within approximately 1/4 mile from the facility. One of the homes appeared to have a windmill and/or water well.

Photo Number: 1 Photographer: Melissa Smith
Location: Eunice Treatment Plant
Subject: Pit containing liquid, sludge, and oil
City/County: Eunice, Lea County State: NM
Date: 11/04/99 Time: pm Weather: cloudy, cool

- Although the facility has been inactive for several years, there are still tanks on-site which may contain waste oil, and a pit on-site which contains waste oil.
- The tanks are not equipped with secondary containment.
- The pit does not contain any wildlife exclusionary devices, such as netting.
- Although the material in the pit was below the berm, due to the staining of the berm it appeared that the pit had been operated at one time with little or no freeboard.
- The pit was not lined and is saturated with oil. It is within close proximity to residences and may be located over a drinking water aquifer.
- The same site conditions were observed during a similar inspection conducted in September, 1997, by EPA, FWS, and NMOCD.

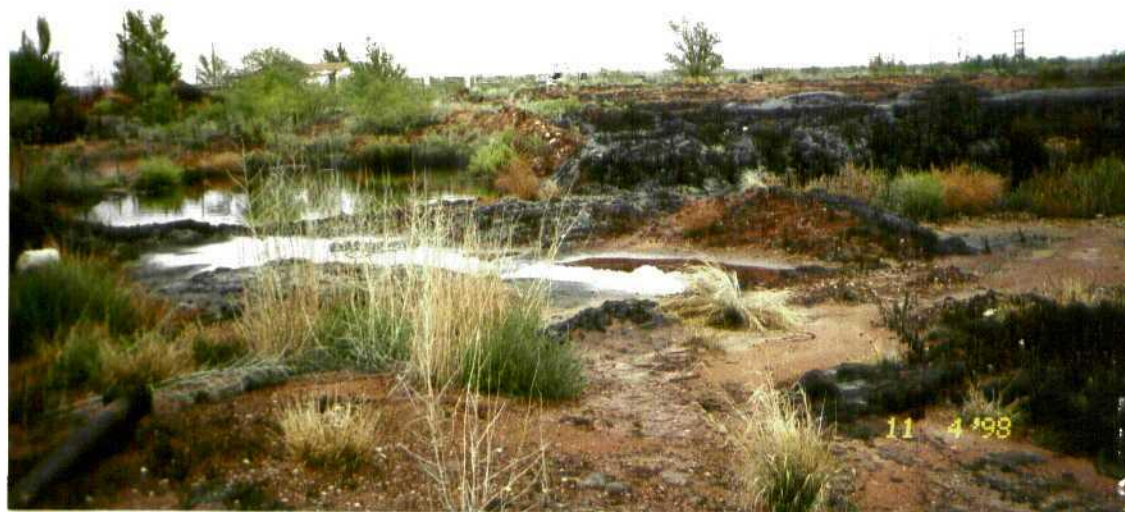
Photo Number: 2 Photographer: Melissa Smith
Location: Eunice Treatment Plant
Subject: Pit containing liquid, sludge, and oil
City/County: Eunice, Lea County State: NM
Date: 11/04/99 Time: pm Weather: cloudy, cool
