RE: Inspection Report
Salty Bills Water Disposal Facility
NE/4, NW/4 of Section 36, Township 22 South, Range 26 East, NMPM
Eddy County, New Mexico

ATTACHMENT 1
INSPECTION REPORT
OCTOBER 28, 1997
SALTY BILL WATER DISPOSAL FACILITY
(NE/4, NW/4 of Section 36, Township 22 South, Range 26 East, NMPM)
Eddy County, New Mexico

SALTY BILL WATER DISPOSAL FACILITY INSPECTION (PHOTOS BY OCD)
NE/4, NW/4, SEC 36, T 22 S, R 26 E, NMPM

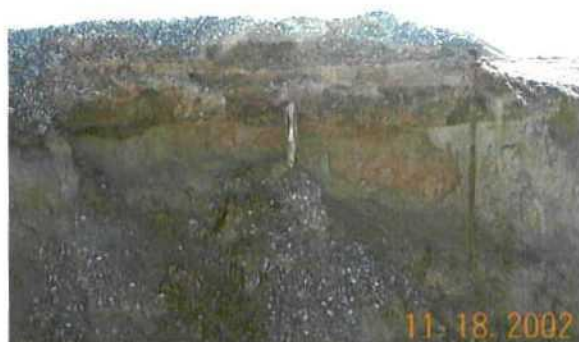
Photo 1. Hydrocarbon stained gravel in the south wall of the sump excavation.

Minor Staining of Hydrocarbons
in Gravel Along pit wall Next to
Former Sump Photo #1 sign Photo #2

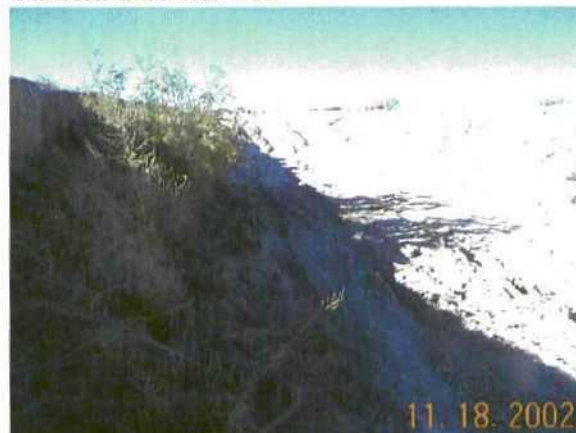
Photo 4. Overflow pit. No visual hydrocarbons. Looking west.

Photo #4 Produced water over Flow pit

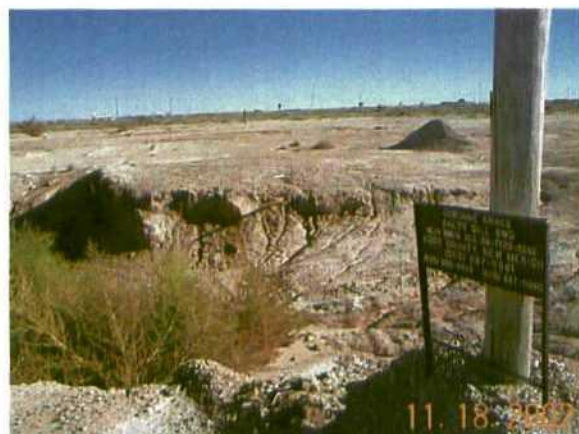
Photo 2. Sump Excavation and Sign. Looking southeast.

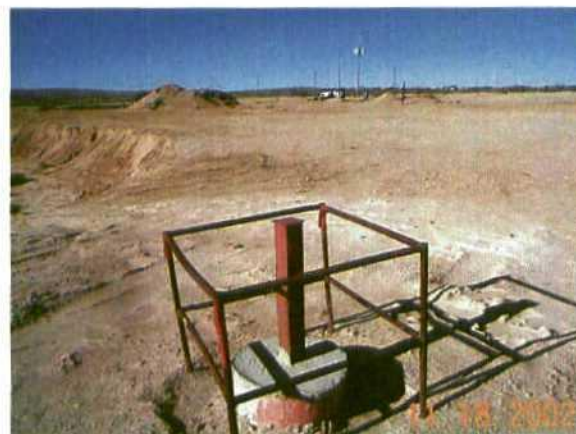
Photo 5. SB-1 monitor well. Looking northwest.

Photo #6 SB #1 Manito - well

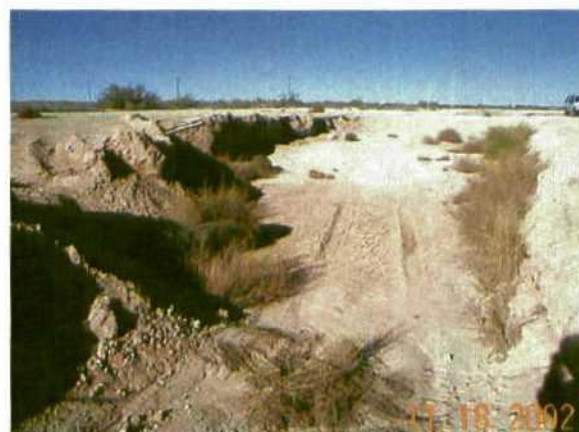
Photo 3. Tank Excavation. Part of Plastic liner remains in west wall. Looking north.

Photo #3 Excavation Below Former Tanks
Fertile SWD Some Plastic liner Still
Present Along West wall of pit.

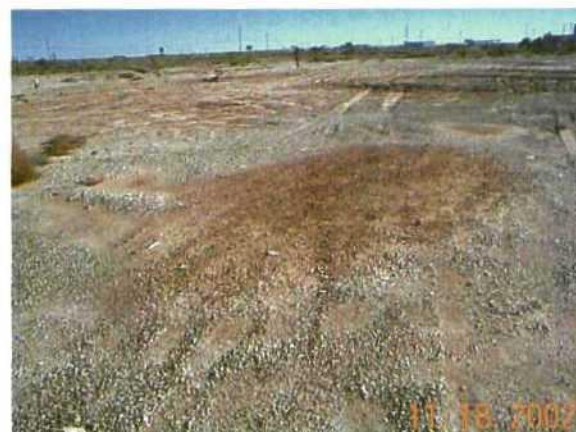
Photo 6. Hydrocarbon stained gravel in the former parking area north of the sump. Looking south-southeast.

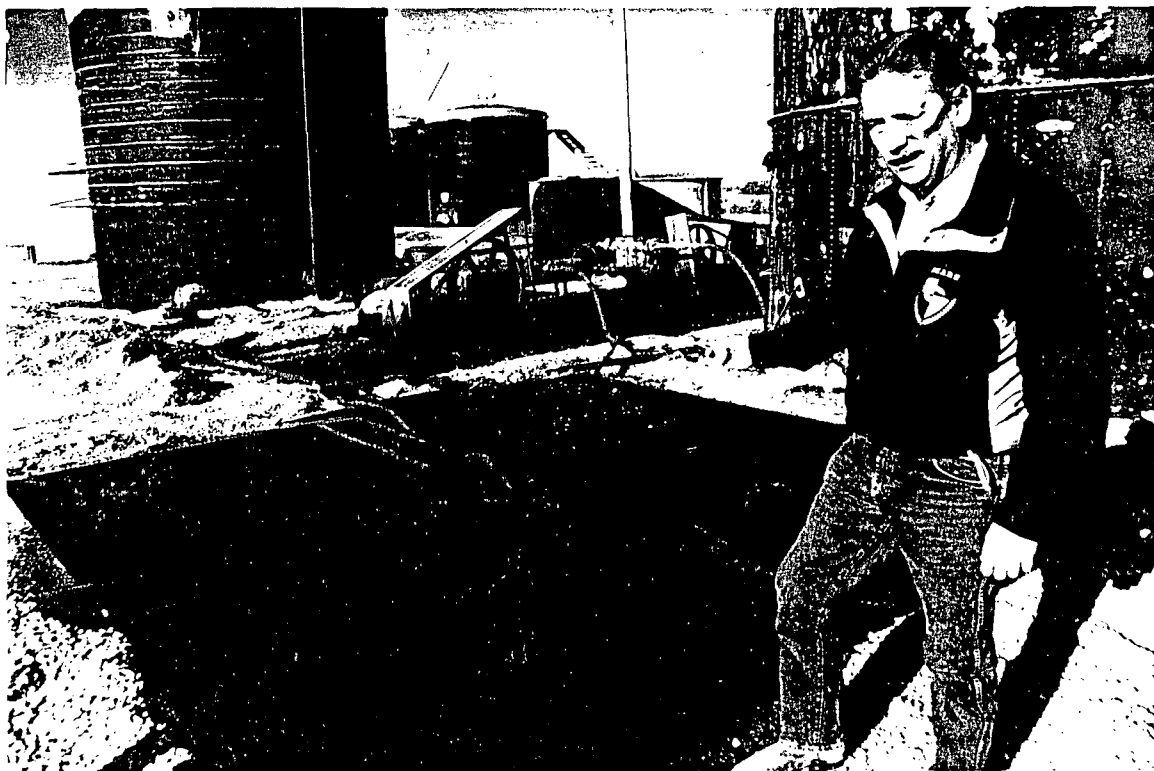
PHOTO NO. 2 DATE: 10/28/97

There was evidence of leaks and/or spills around most of the above grade tanks (see pictures 2, 8, 10, 11, 12, 13, 14, and 20). These pictures show oil saturated soils and salt deposits, evidence of overtopping of tanks, leaking valves, and poor housekeeping practices. Below grade pits and surface containments have been overtopped (see pictures 1, 2, 3, 4, 6, 7, 8, 15, 16, 17, and 18).

All above ground tanks within the facility are lacking adequate berms (see pictures 1, 2, 5, 8, 9, 10, 11, 12, 13, and 14). One small fiberglass tank was leaking and had soil piled up around the base of the tank and on the valve (see pictures 14 and 20).

Most of the tanks drums and containers are not labeled as to their contents and hazards (see pictures 2, 3, 5, 8, 9, 10, 11, 12, and 14).

The pits seem to be at their maximum fill height or have overflowed in the past (see pictures 1, 2, 3, 4, 5, 6, 7, 8, 15, 16, 17 and 18).

The two fiberglass lined pits have wooden sides and are oily along the tops and the soil around the exterior of the pits is saturated with oil and has salt deposits(see pictures 1, 2, 3, 4 and 5).

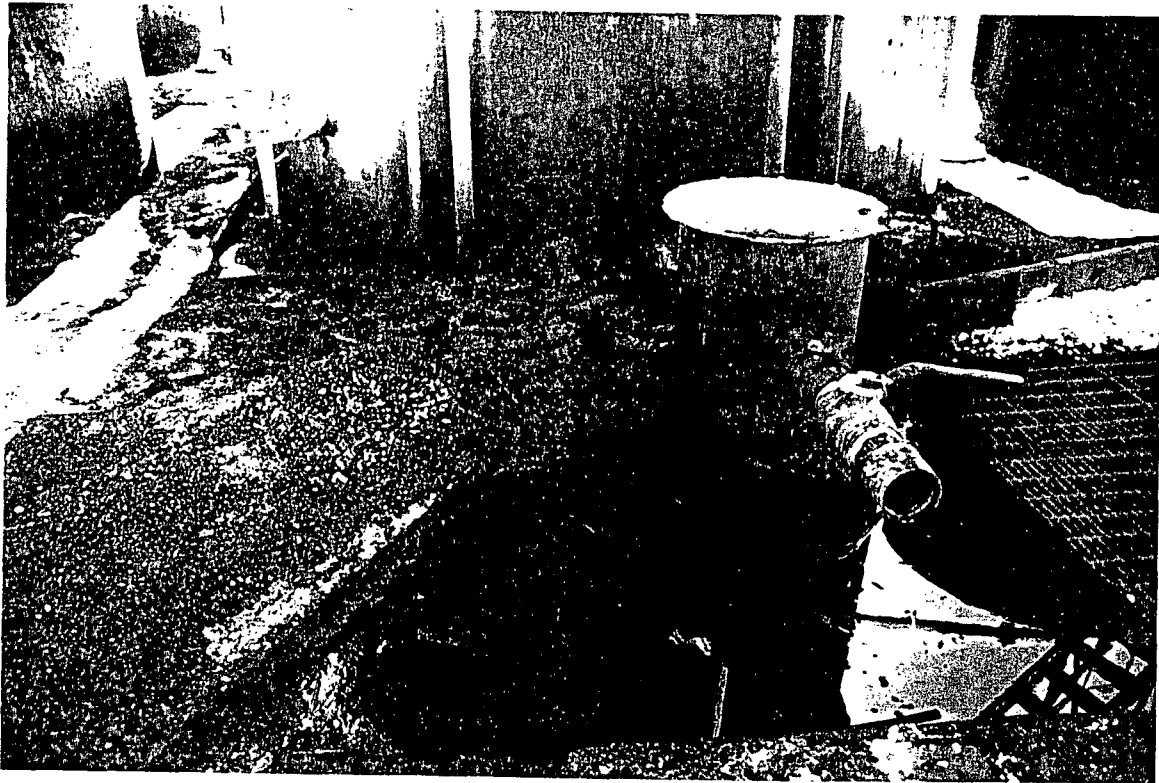
PHOTO NO. 13 DATE: 10/28/97

All pre-existing below grade sumps must demonstrate integrity on an annual basis (see picture 13). Sumps and/or buried barrels below tank valves should be cleaned out and inspected on a regular basis (see picture 13). Prior to installation of new sumps or upon modification the facility must incorporate secondary containment and leak-detection into the design.

Many tanks have stains down the side and oil stained soils around the base that indicate tanks have been overtopped or have leaked (see pictures 8, 9, 10, 11, 12, 13, 14 and 20). The tanks need additional spill collection/prevention systems. These systems should include berms to ensure that any spills or overflows stay within the facility. The facility may add additional features such as tank capacity monitoring devices to prevent overtopping, secondary containment at each valve to catch minor leaks, and locking valves to prevent tampering or off loading when the facility is at capacity.

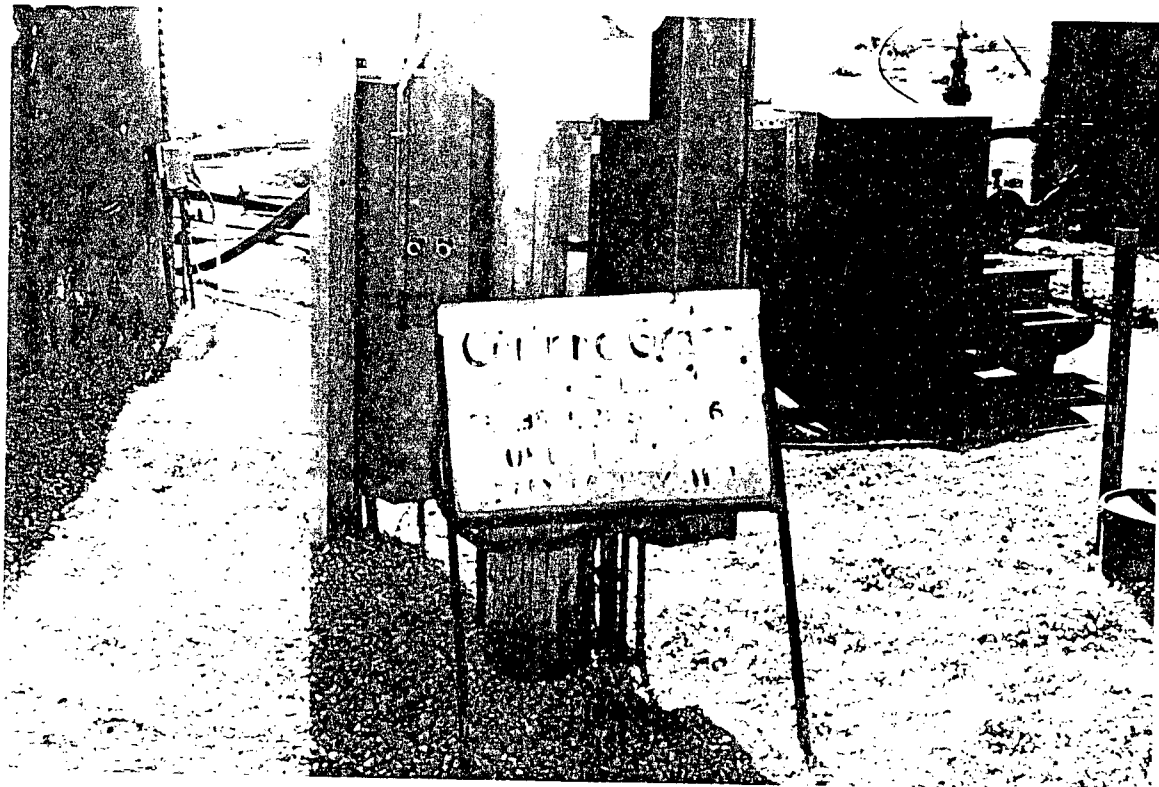
PHOTO NO. 19

The facility sign is no longer legible (see picture 19).
