RE: Closure Report for Pate Trucking Co., Inc. yard, located 3800 S. Eunice Hwy

Yard at 3800 S. Eunice Hwy.

**EPA Class V
Leach Field Closure**

Re: Remediation and Clean up of Yard Located at 3800 S. Eunice Hwy.

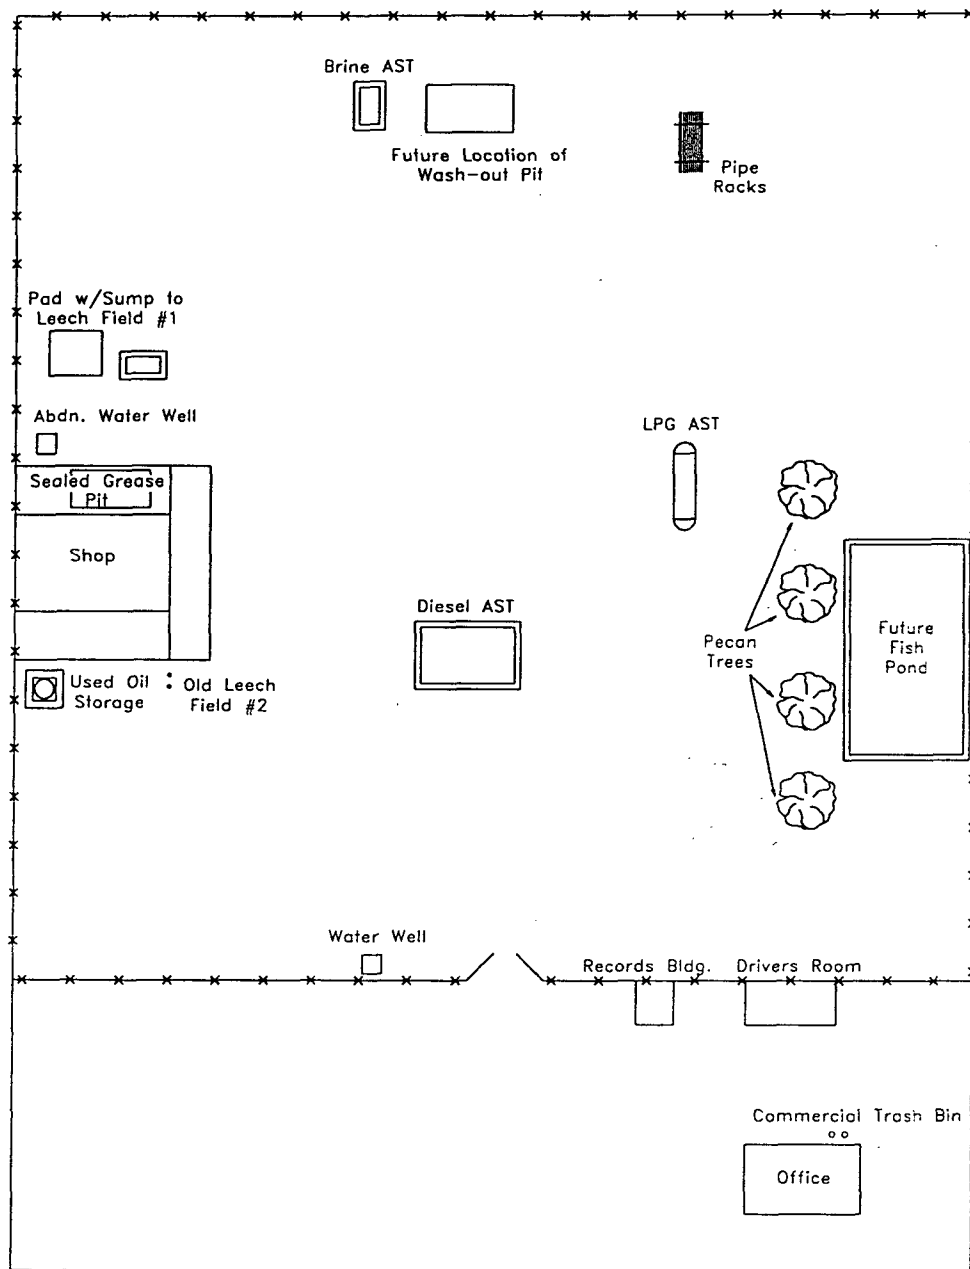
SITE MAP
3800 S. EUNICE HIGHWAY
NW4/SW4 SEC, 14, T19S, R38E
HOBBS, NEW MEXICO

AST = Aboveground Storage Tank
