**GW - 240**

# **INSPECTIONS & DATA**

INTER-OFFICE MEMO

**On site inspection**

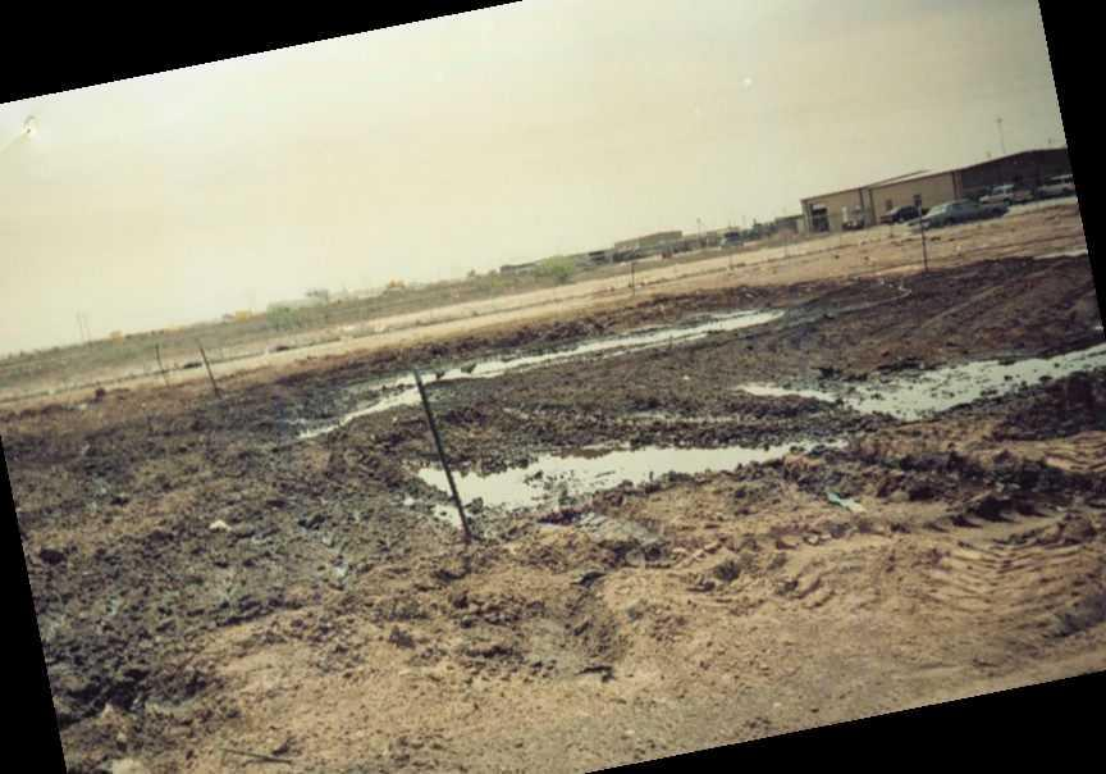
#1

- #1. Looking west, picture show bioremediation landfarm.
- #2. Looking southwest, picture shows bioremediation landfarm.
- #3. Standing on SW corner of landfarm and looking NE. Background area shows green wheat growth from previous land farming operations.

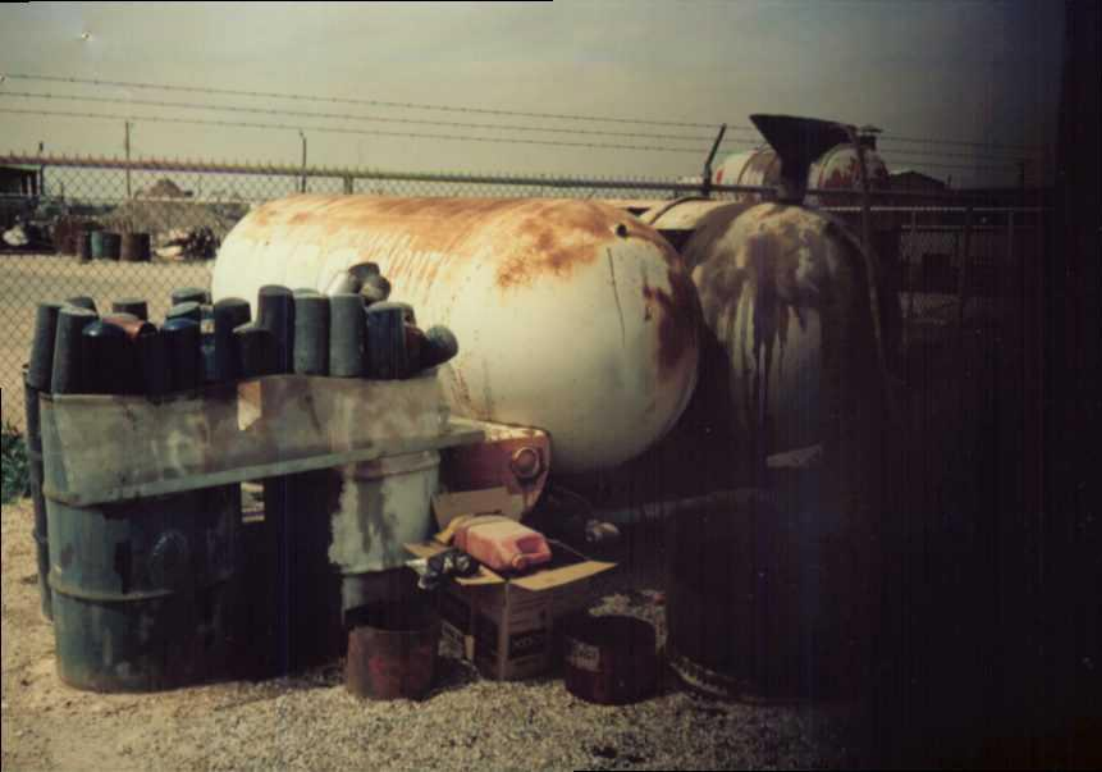
# 4 4/27/95 DIA MOUNT RENTAL

- #4. Used Oil tanks and filters.
- #5. Looking NE- picture foreground shows water and oil storage tanks. No berm but liner is visible in picture. Background shows frac tank and wash-out area.

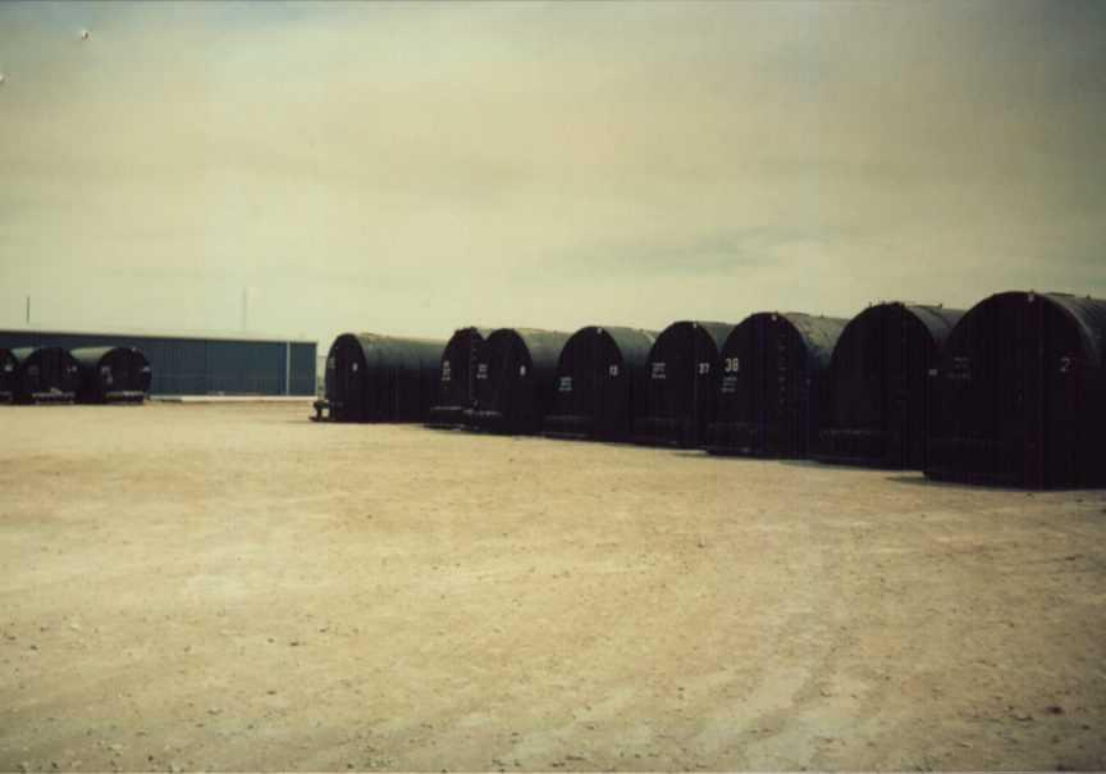
# 7 4/27/95

- #7. Standing in middle of yard looking to the SW picture shows FRAC tanks.
- #8. Standing just south of the tank wash-out area. Picture shows back side of wash out area, old truck used for a pump, shed that contains steamer. Under the small pipe rack shown in foreground is what appears to be the main city water line and meter. Behind that is an undetermined underground device with a pipe connected to it. (possible UST, underground line, leak detector) ?? Unknown at this time.

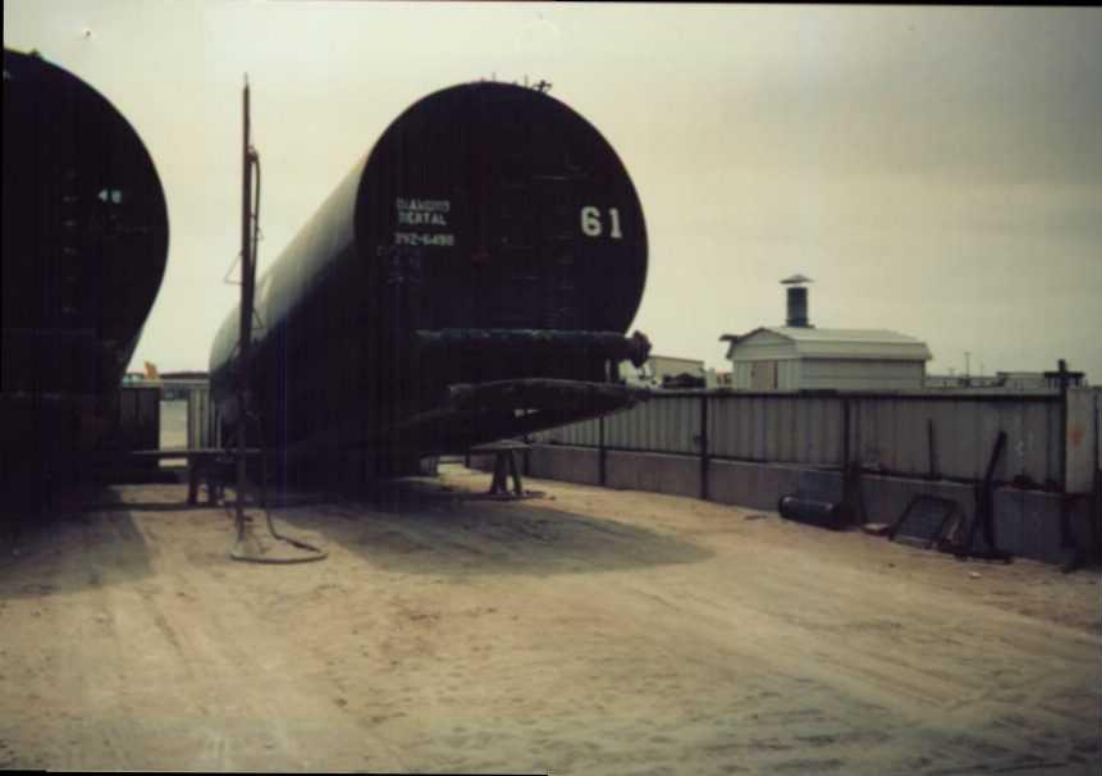
# 9

- #9. Standing just east of the tank wash-out facility. Pictures show tanks draining into concrete sump which is connected to concrete wash-out pit show behind the metal fence.

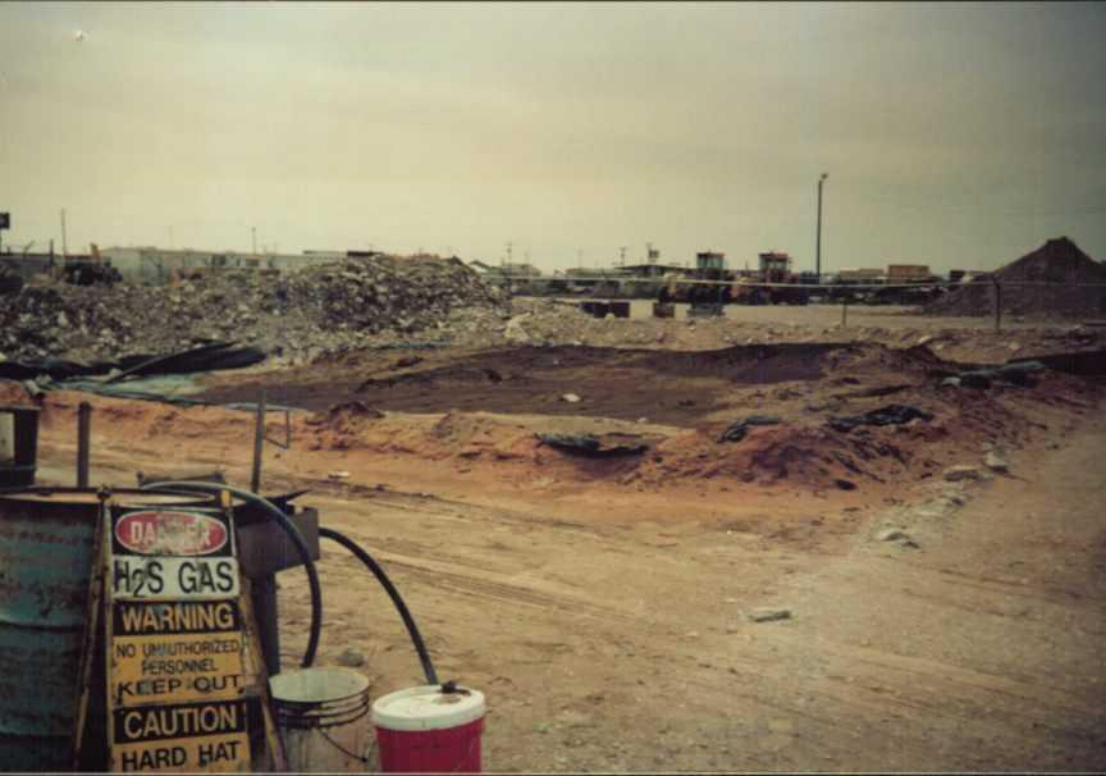
#10 4/27/95

- #10. Standing just east of wash-out pit looking to the NW. Background shows the solids accumulation pit. Does have liner but no leak detection.
- #11. Looking down into concrete wash-out pit, picture looking west.

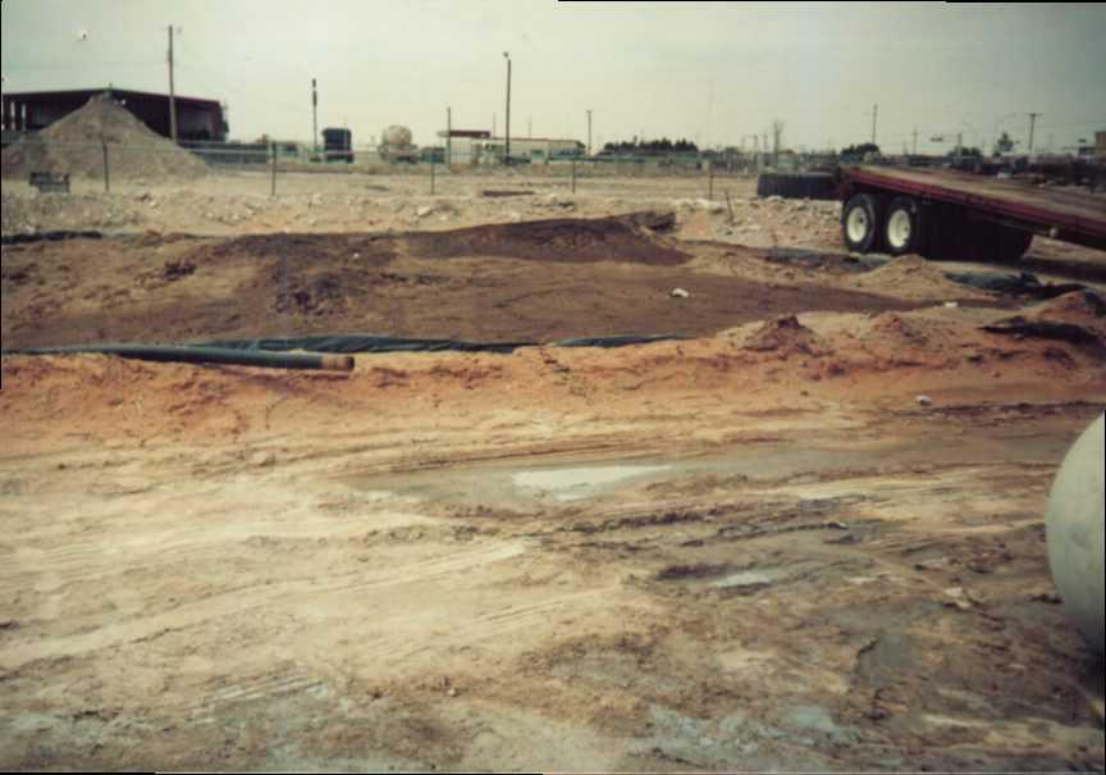
# 12

- #12. Solids accumulation pit. Picture looking to the NE. Foreground shows recent wash water discharge on the ground.
- #13. Picture taken just west of the main Diamond warehouse building looking to the SW. Pictures shows a barrel of automatic transmission fluid (hydraulic fluid). It also shows stained soil below the drum from a recent spill.

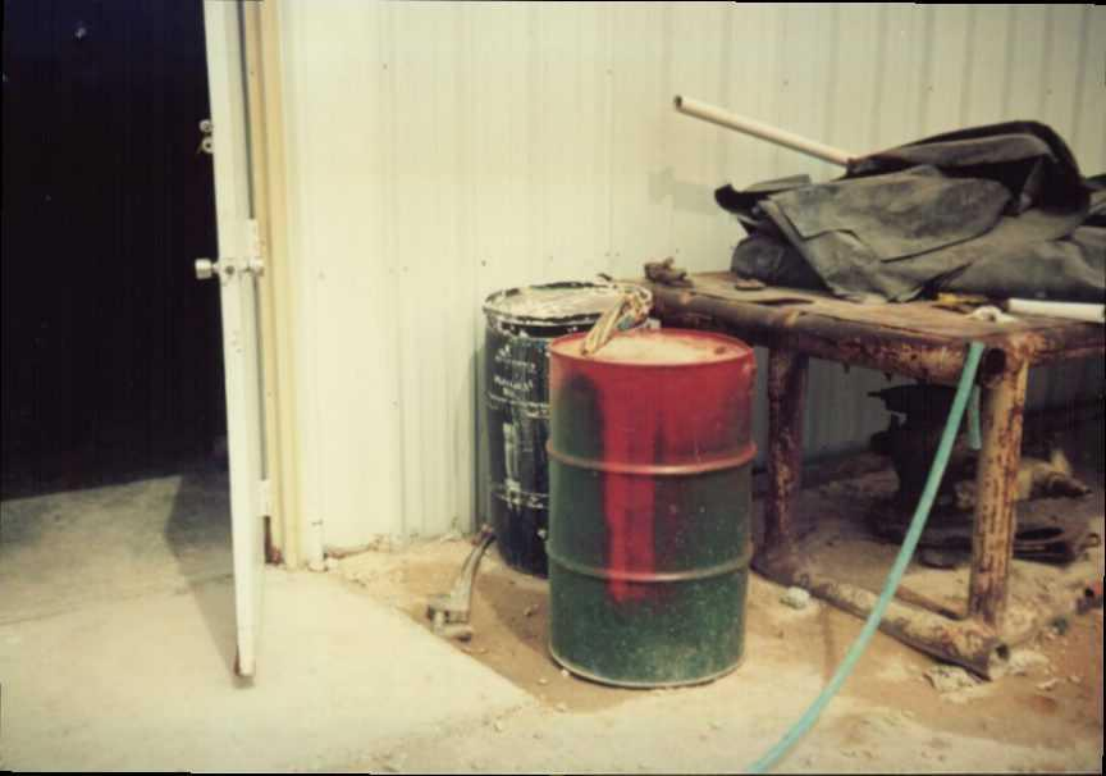
#14 4/27/95

- #14. Picture taken just west of the main Diamond warehouse building looking back to the east. Two old drums of unidentified contents. One drum was thought to be soap and the other drum had contained transmission fluids and now has water in it.

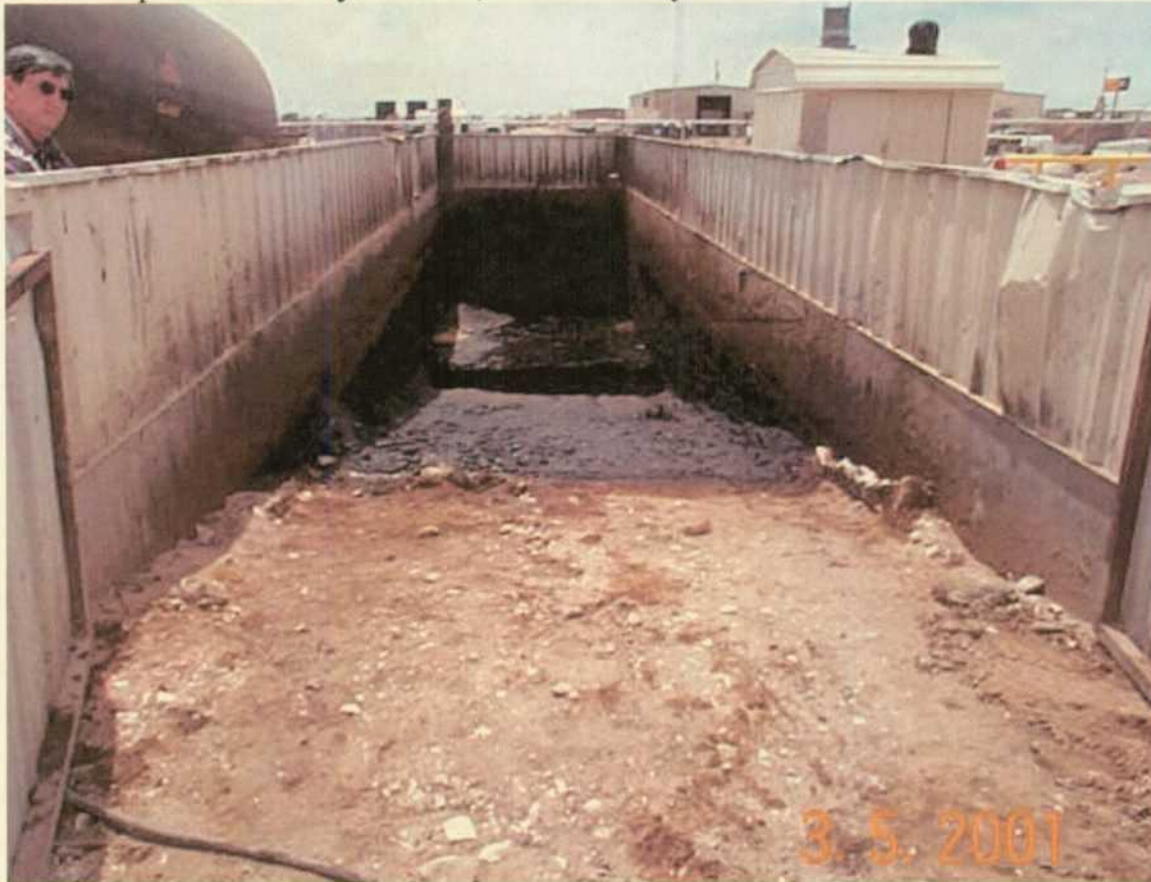
PIC #2 FRAC TANK WASH-OUT COVERABLE SUMP - NO SECONDARY CONTAINMENT -

Pic # 2- Wash Out Pit constructed of concrete has no secondary liner.

6. Below Grade Tanks/Sumps: All below grade tanks, sumps, and pits must be approved by the OCD prior to installation or upon modification and must incorporate secondary containment and leak-detection into the design. All pre-existing sumps and below-grade tanks must demonstrate integrity on an annual basis. Integrity tests include pressure testing to 3 pounds per square inch above normal operating pressure and/or visual inspection of cleaned out tanks and/or sumps, or other OCD approved methods. The OCD will be notified at least 72 hours prior to all testing.
