**Closure Report
Clean Out Pit
Key Energy Services, Inc.
Carlsbad, New Mexico**

**SE ¼ of Section 33 and SW ¼ of Section 34
T21S, R27E, Eddy County, New Mexico**

March 22, 2000

**Safety & Environmental Solutions, Inc.
703 E. Clinton, Suite 103
Hobbs, New Mexico 88240
(505) 397-0510**

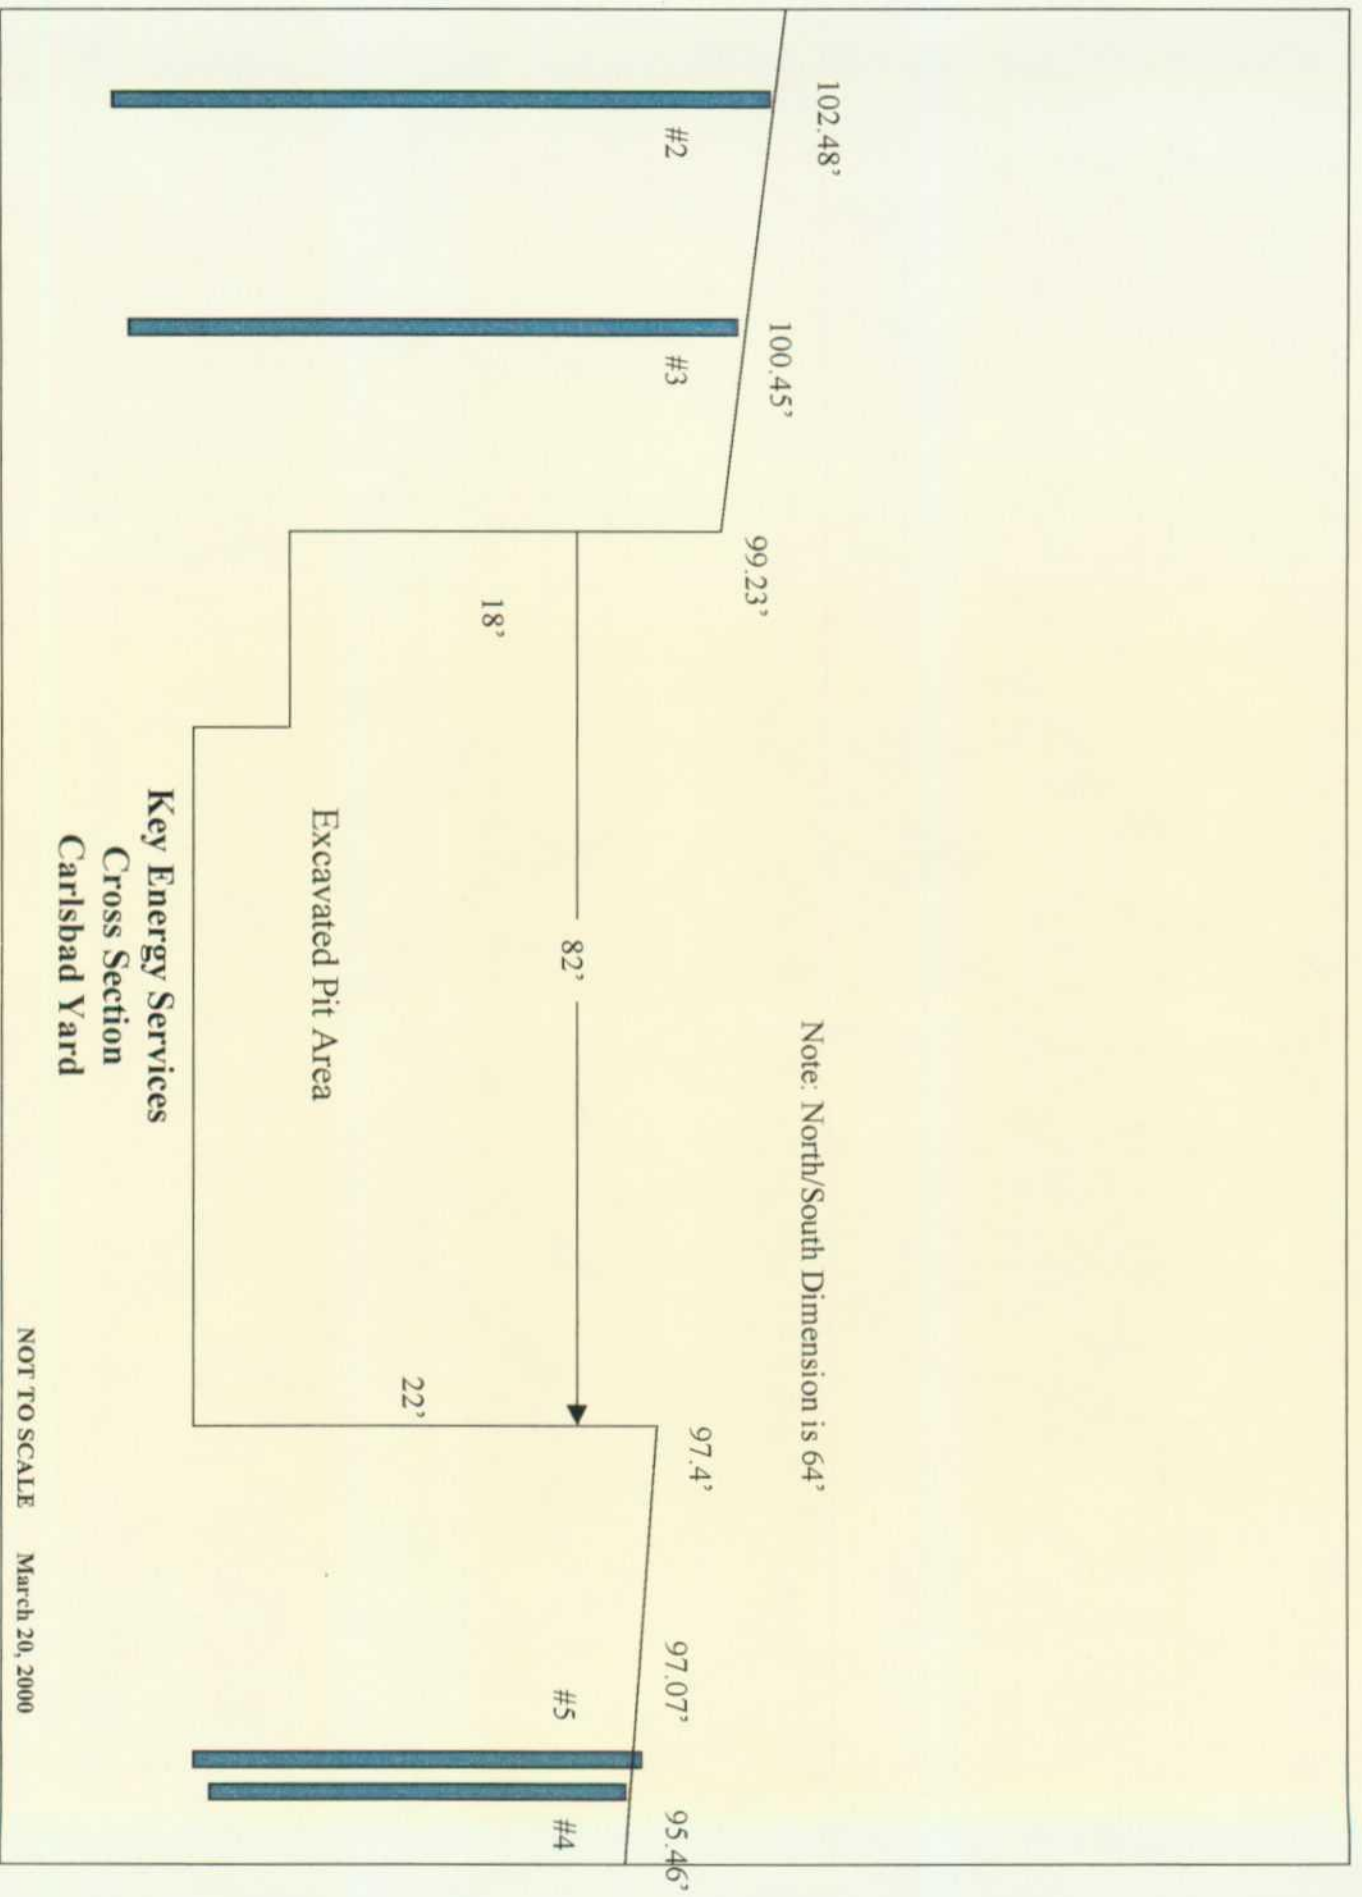
Exhibit 3

Cross Section

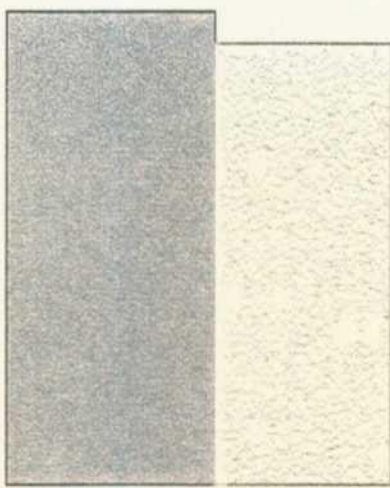
Figure 4
Red Clay Layer Position

27' Brown Clay
30' Gray Clay
34' Red Clay

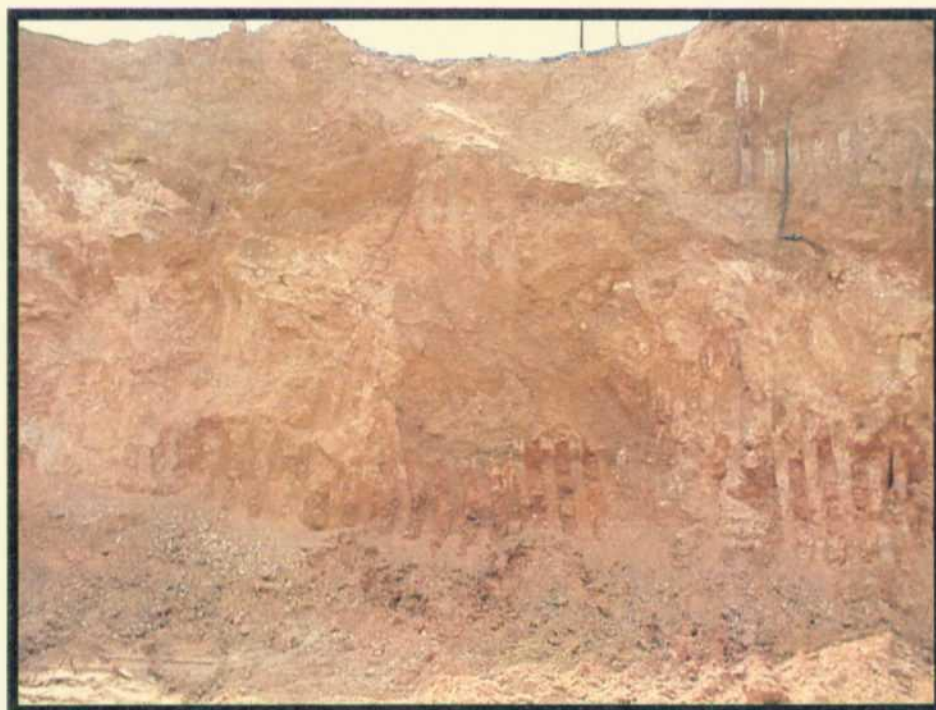
The results for TPH and BTEX clearly indicates the removal of all source hydrocarbons with the exception of the South Wall sample which still contained 2050 ppm TPH. The field testing done on this sample indicated 98 ppm TPH. The results of the field testing had compared within 60 ppm of the laboratory results throughout the project. On March 23, 2000, Cardinal Laboratories re-examined that sample with a result of 112 ppm confirming all hydrocarbon have been removed. (Exhibit 7)

Photo 2 - Final Excavation South Wall

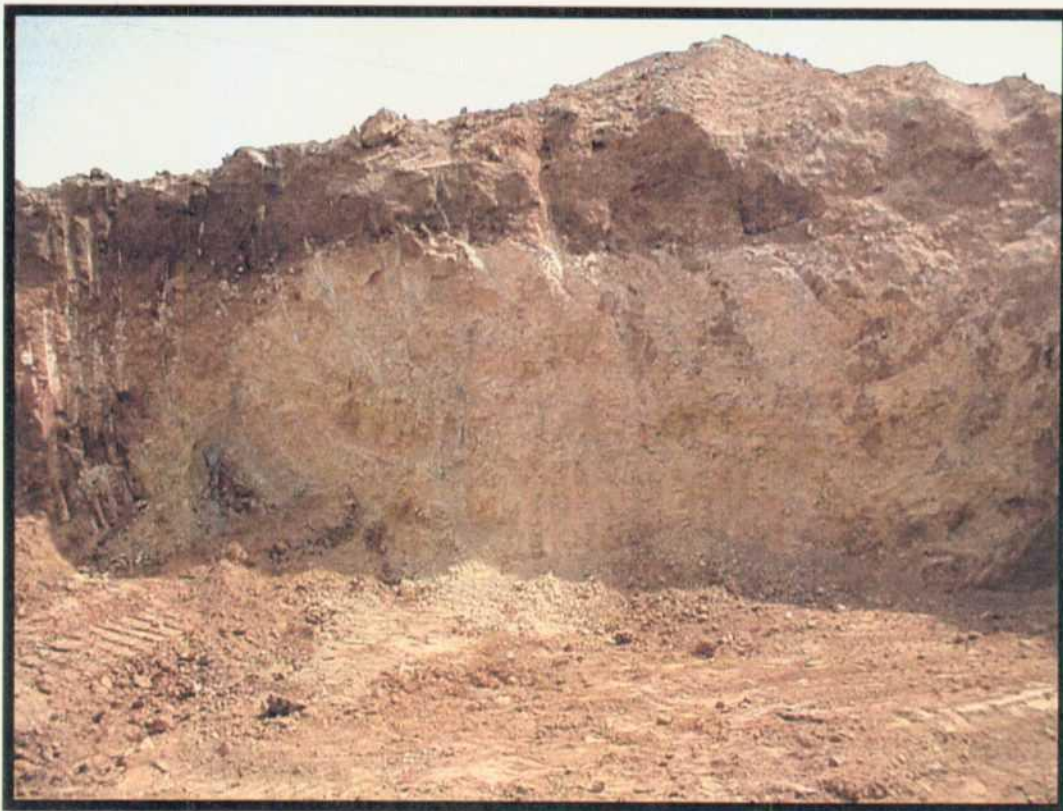
Photo 3 - Final Excavation East Wall

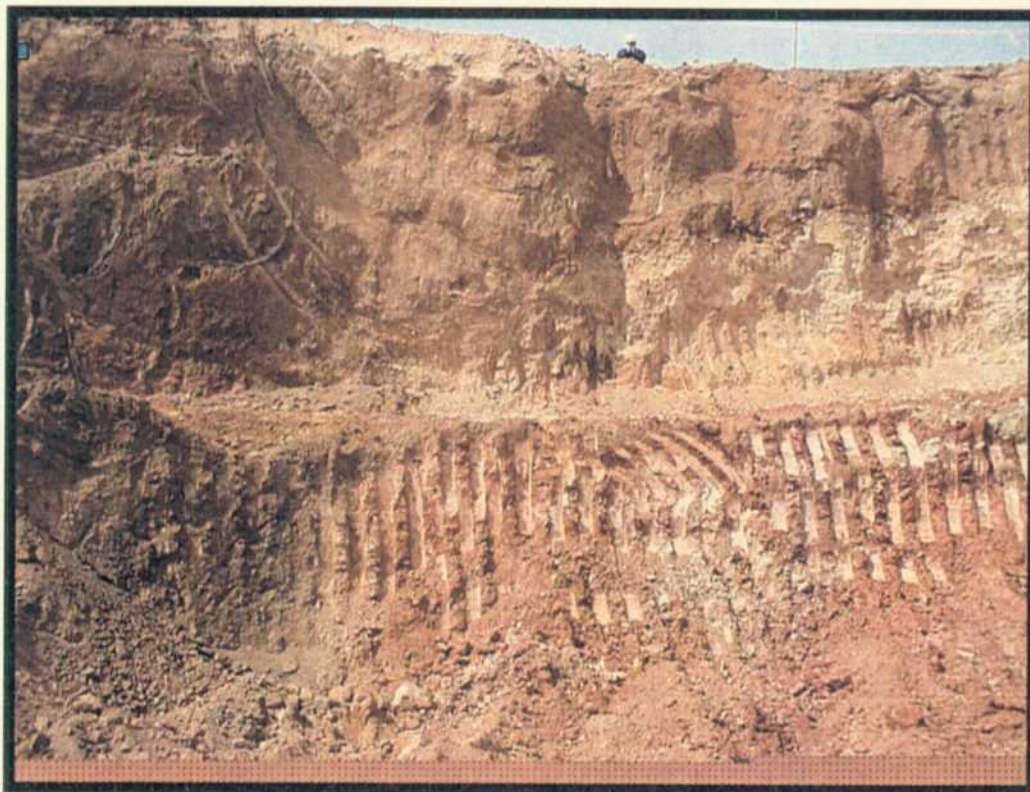
Photo 4 - Final Excavation West Wall

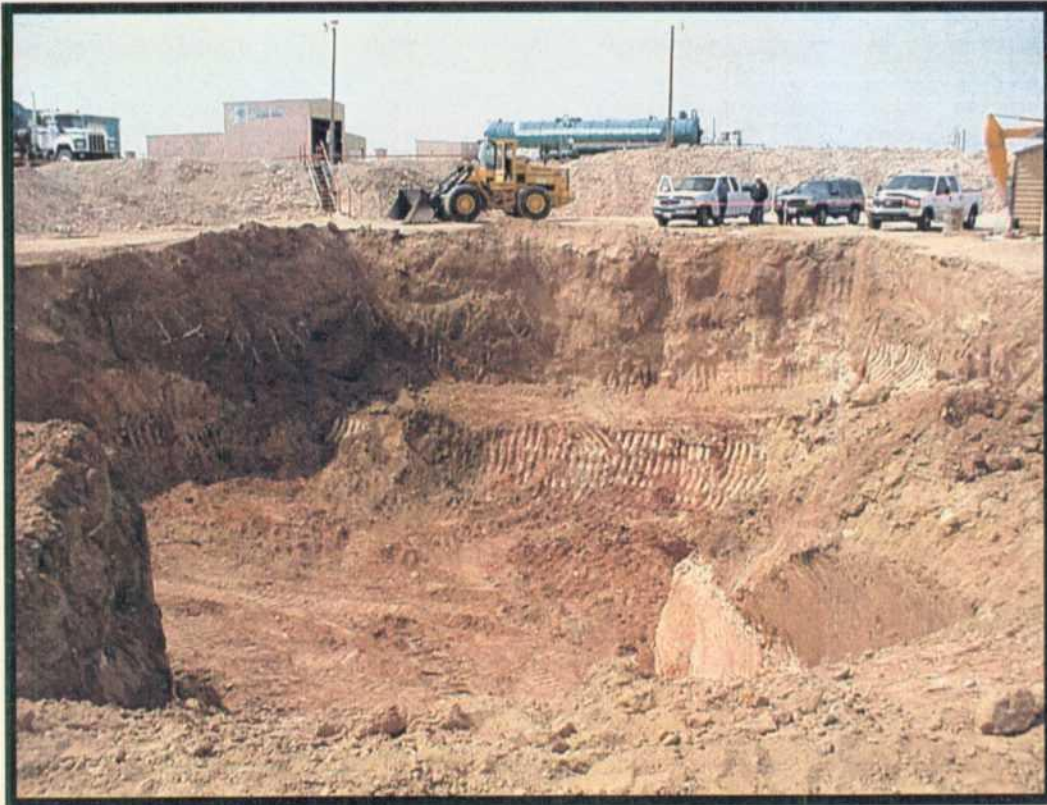
Photo 5 - Final Excavation Down Ramp Looking Southwest

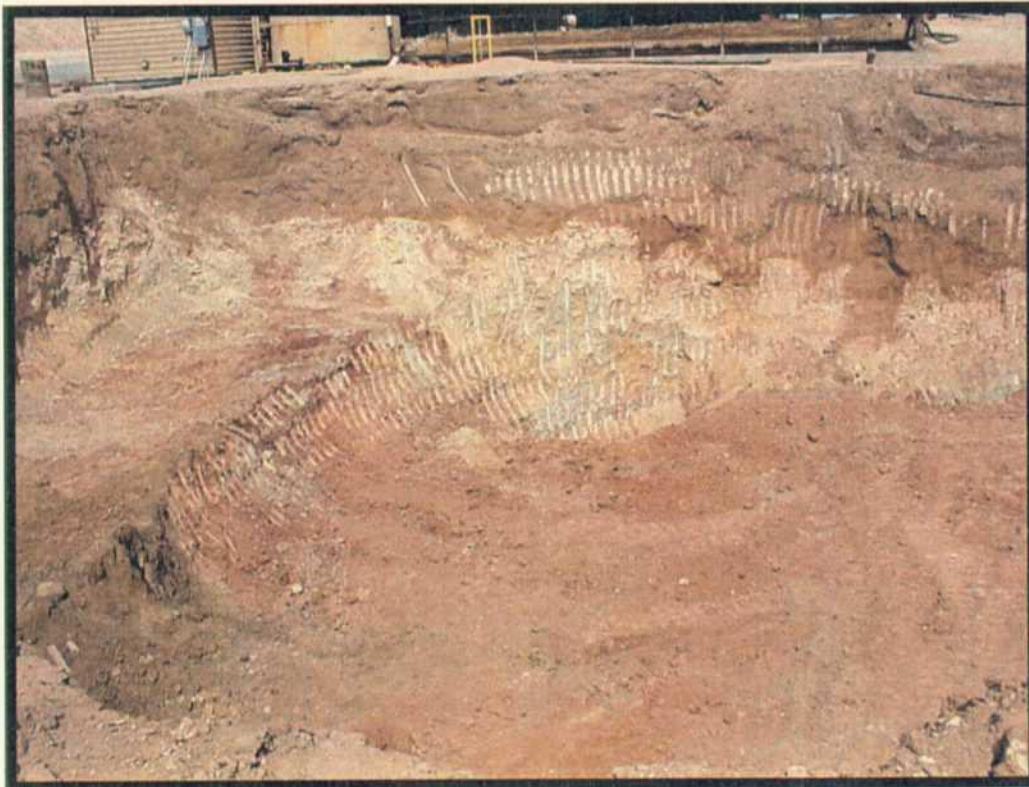
Photo 6 - Final Excavation From South
