**GW - 278**

# OCD ENVIRONMENTAL BUREAU

## SITE INSPECTION SHEET

FACILITY NAME: KEY-CARLSBAD FACILITY

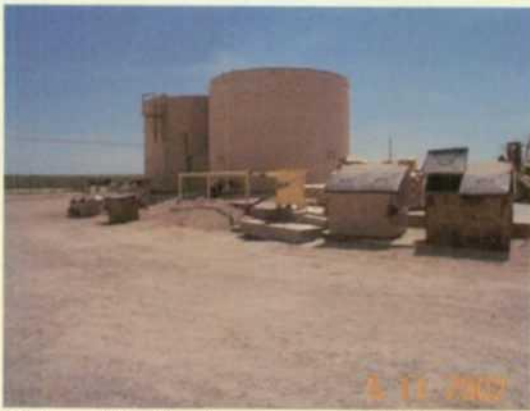
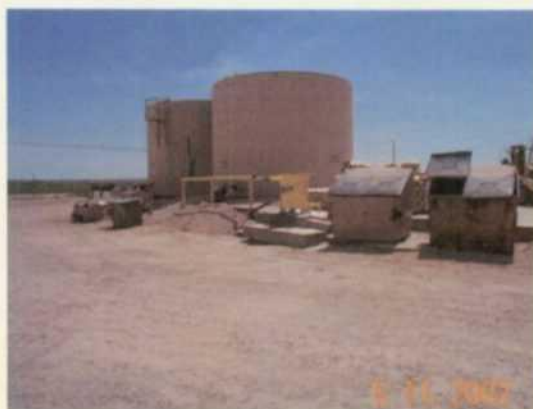
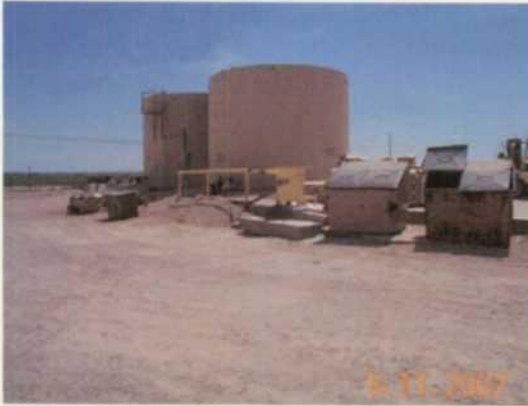
Picture #1- Fresh water and KCL loading area.

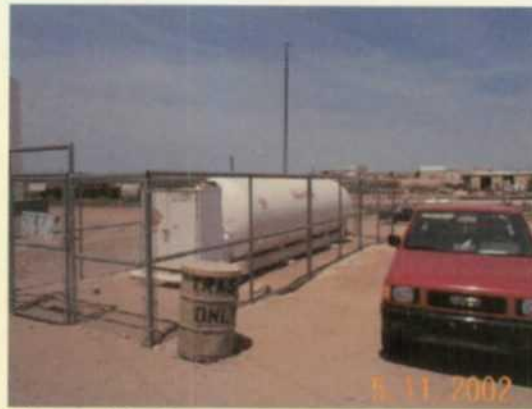
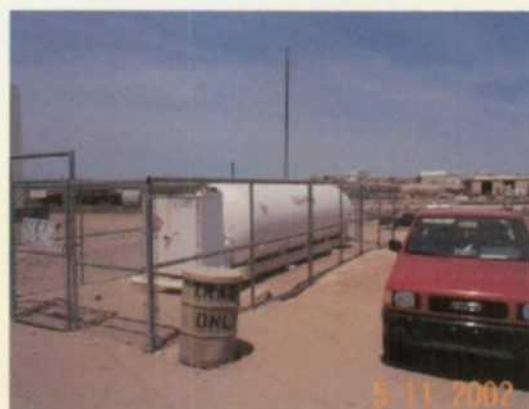
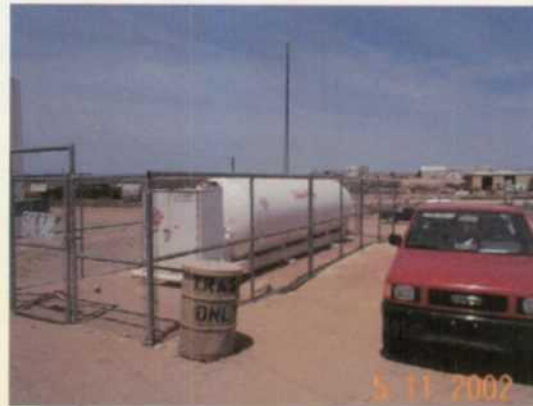
Picture #4- Propane storage area.

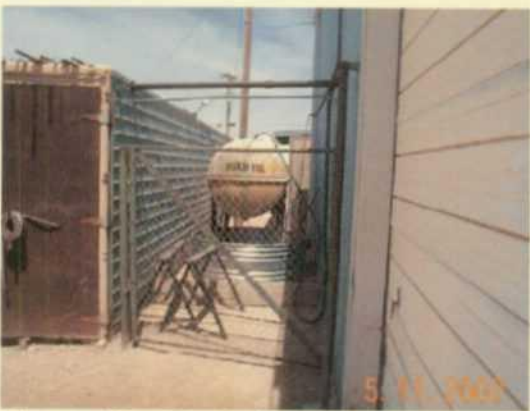
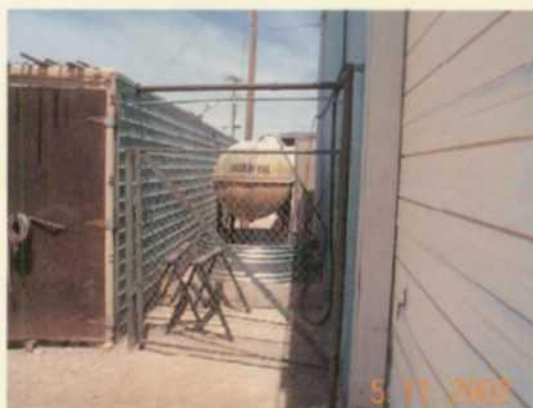
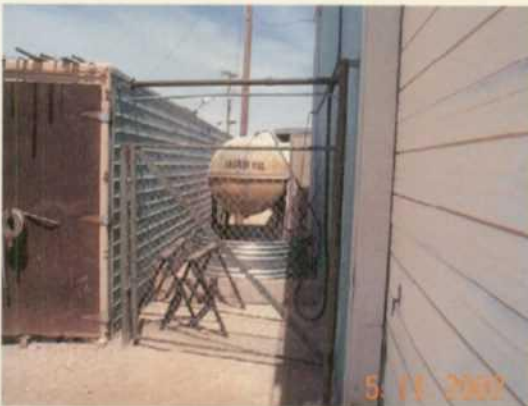
Picture #2 – Used oil tank.

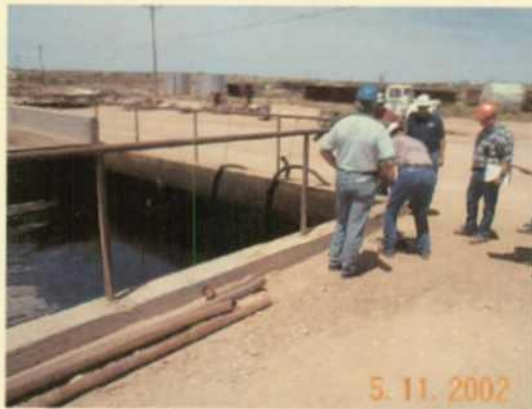
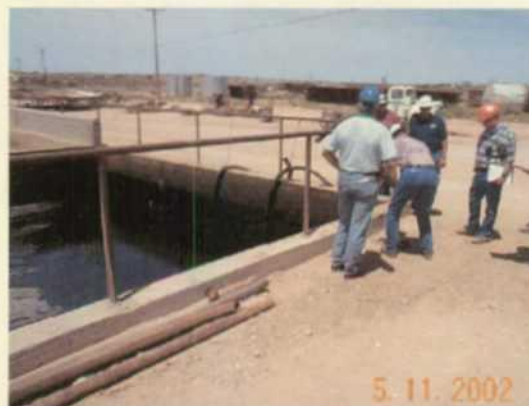
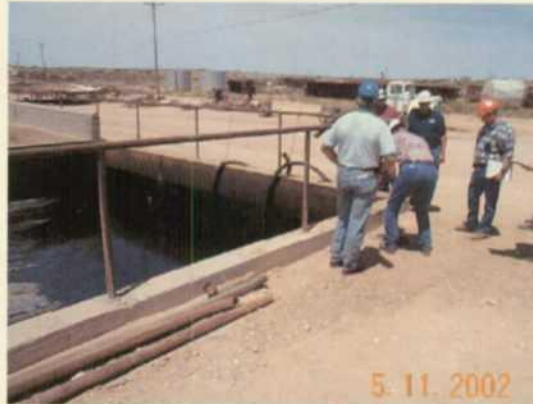
Picture #5- Frac tank wash-out pit.  
Inspecting leak detector.

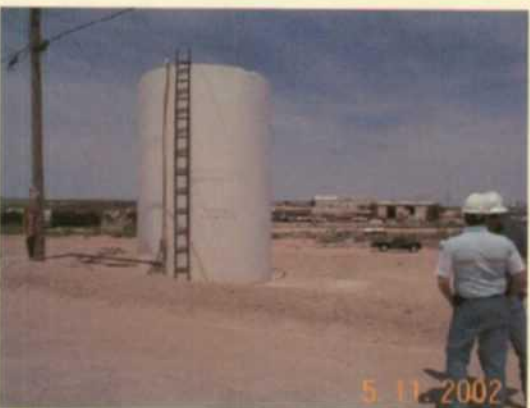
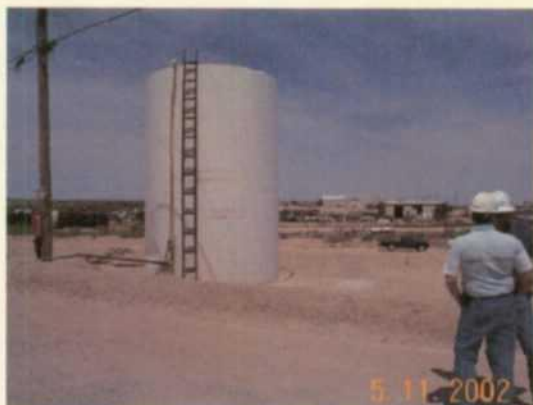
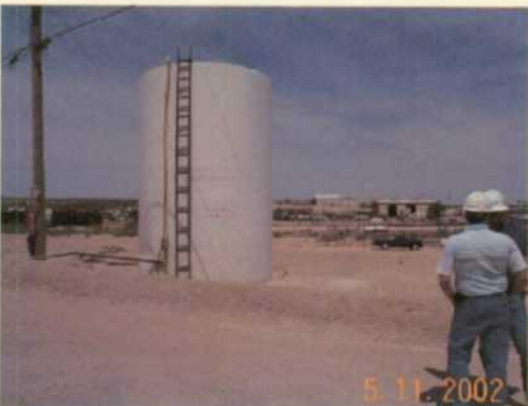
## FUEL ISLAND TANK NEEDS CONTAINMENT

Picture #3- Fuel tank area-needs proper containment.

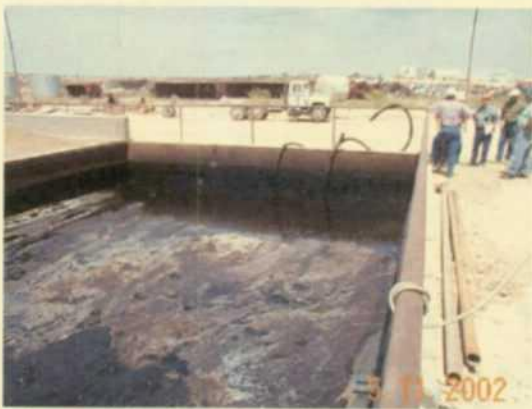
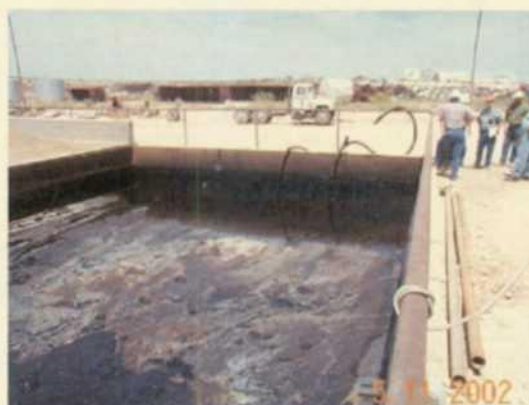
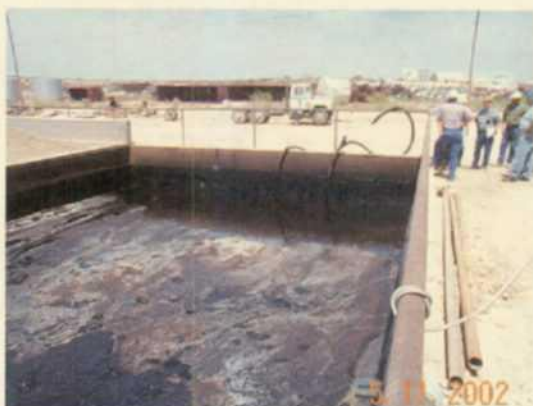
Picture #6 – Concrete wash-out pit with  
secondary containment and leak  
detection.

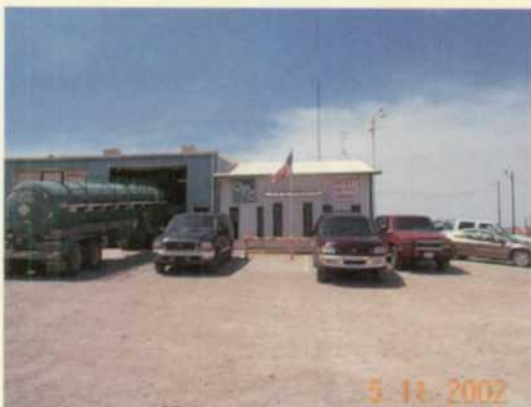
Picture #9- Office and shop.

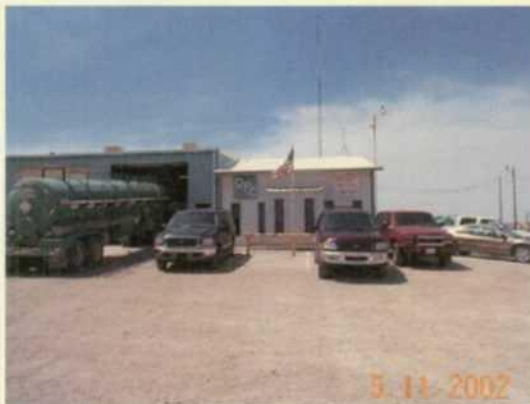
Picture #9- Office and shop.

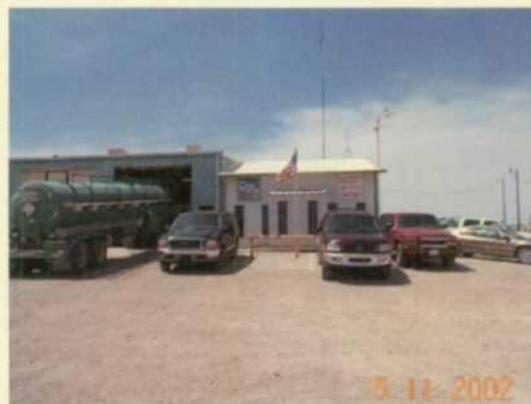
Picture #9- Office and shop.

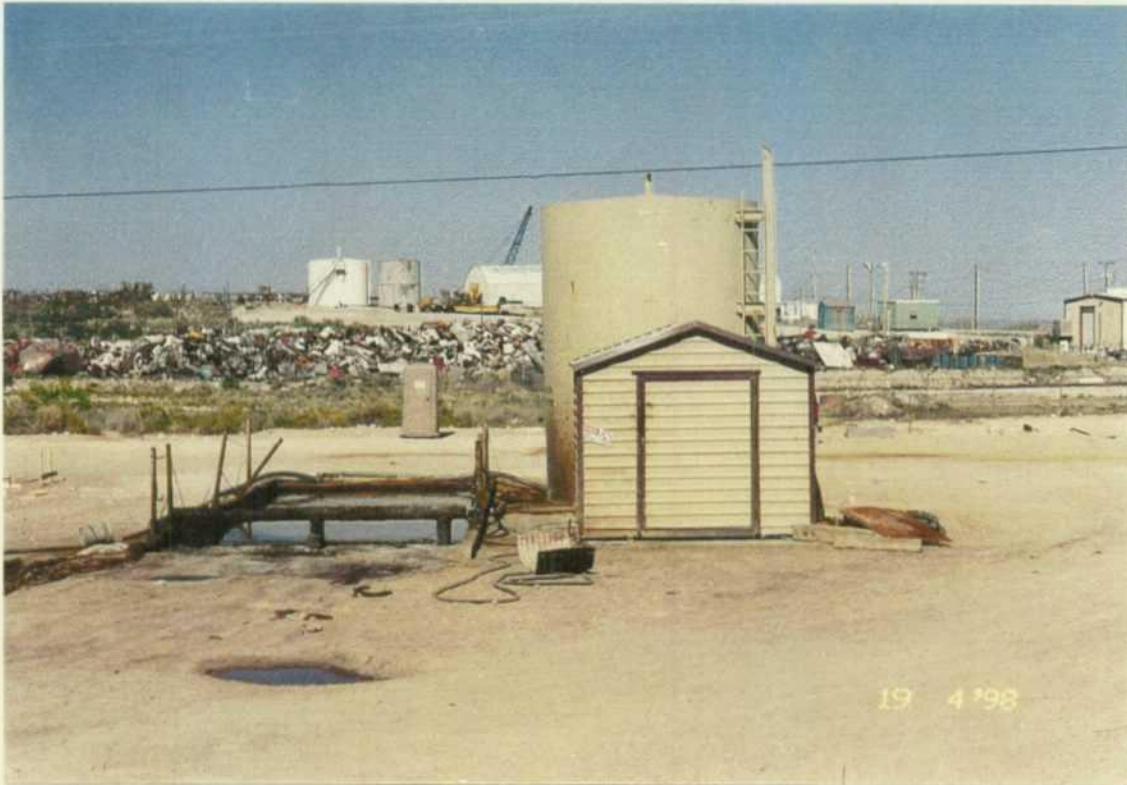
Photo Number: 1 Photographer: N. Jones  
Location: Rowland Trucking Company  
Subject: Existing rinsate pit  
City/County: Carlsbad State: NM  
Date: 04/20/98 Time: 4:30 PM Weather: Sunny

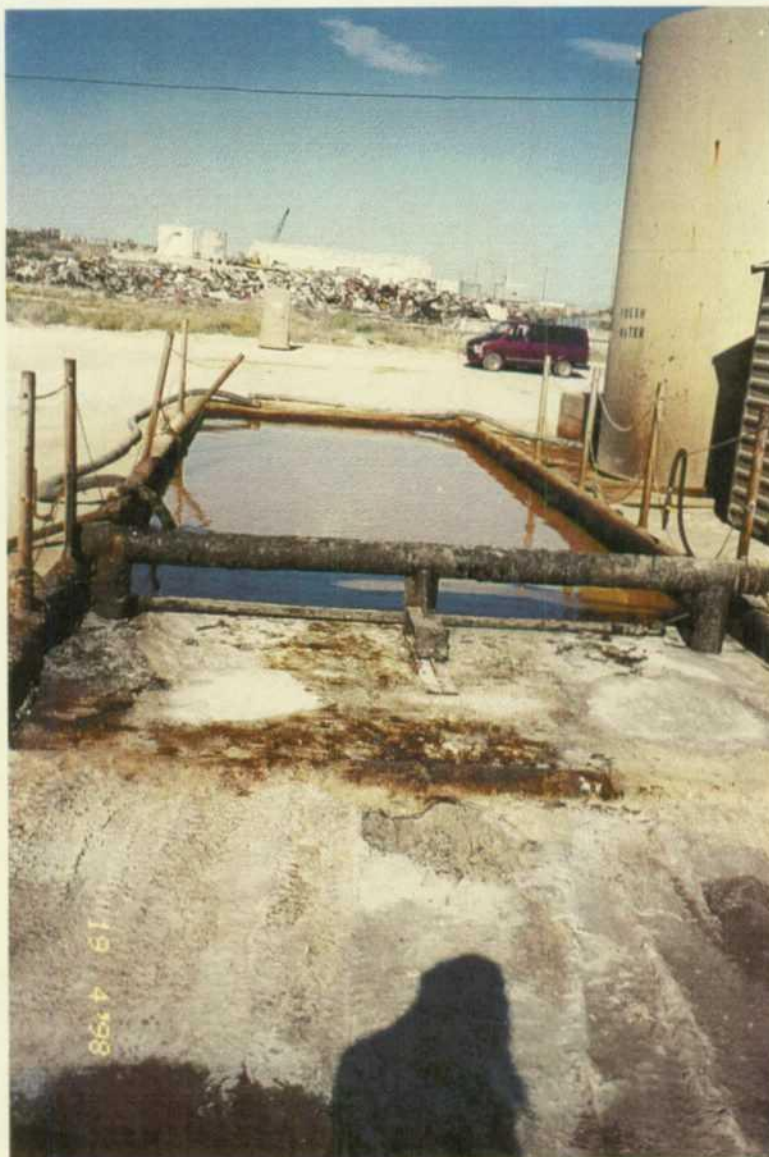
Photo Number: 2 Photographer: N. Jones

Subject: Existing rinsate pit

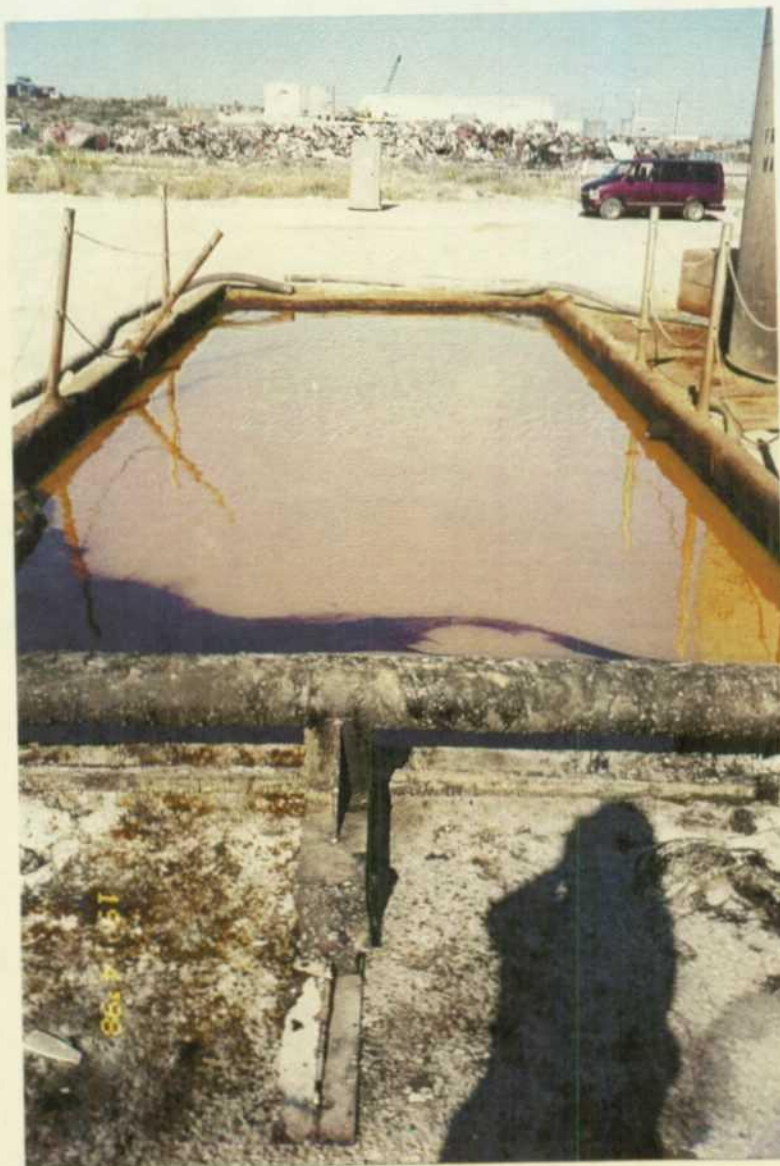
Photo Number: 3 Photographer: N. Jones  
Location: Rowland Trucking Company  
Subject: Close-up of existing rinsate pit  
City/County: Carlsbad State: NM  
Date: 04/20/98 Time: 4:57 PM Weather: Sunny

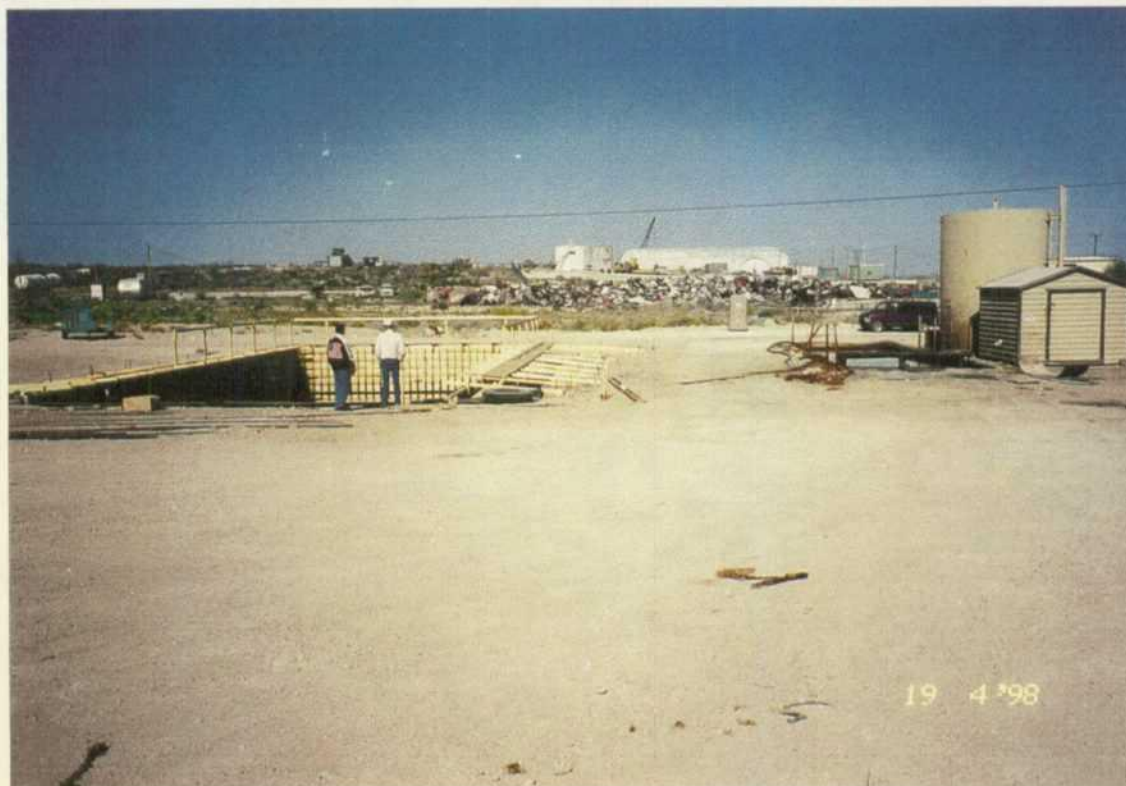
Photo Number: 4 Photographer: N. Jones  
Location: Rowland Trucking Company  
Subject: New rinsate pit under construction  
City/County: Carlsbad State: NM  
Date: 04/20/98 Time: 4:33 PM Weather: Sunny

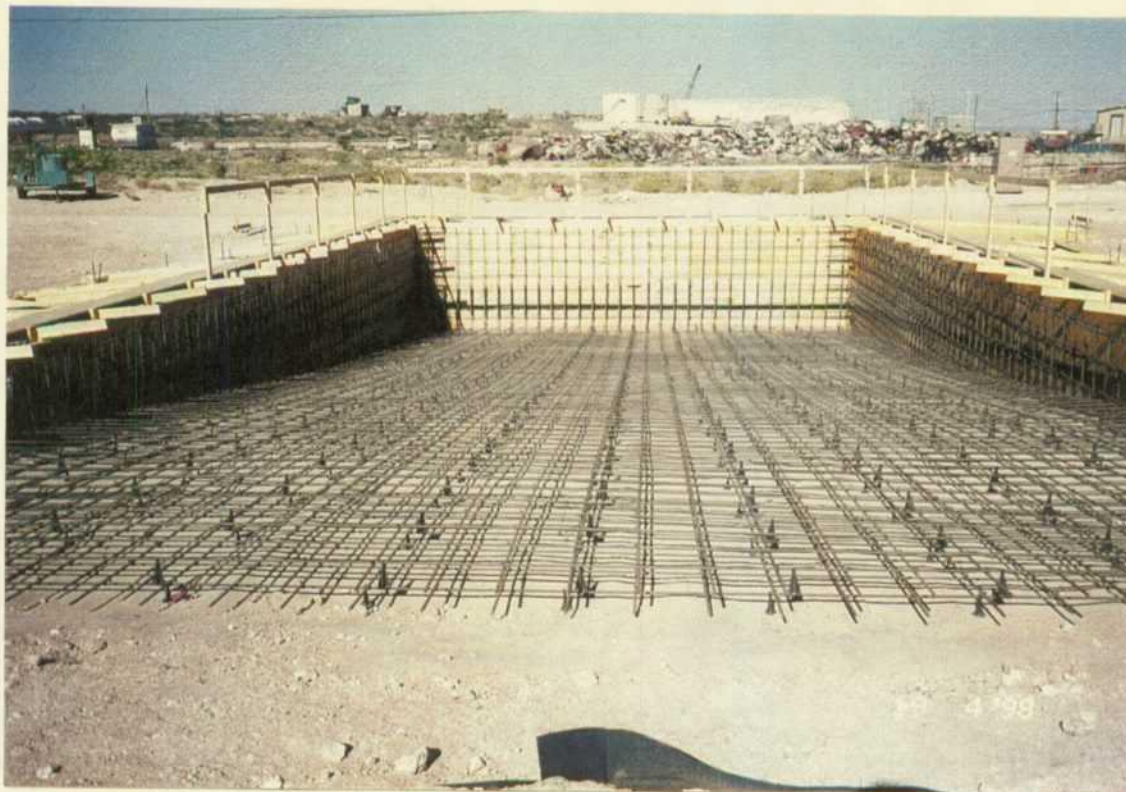
Photo Number: 5 Photographer: N. Jones  
Location: Rowland Trucking Company  
Subject: Close-up of rinsate pit under construction  
City/County: Carlsbad State: NM  
Date: 04/20/98 Time: 4:58 PM Weather: Sunny

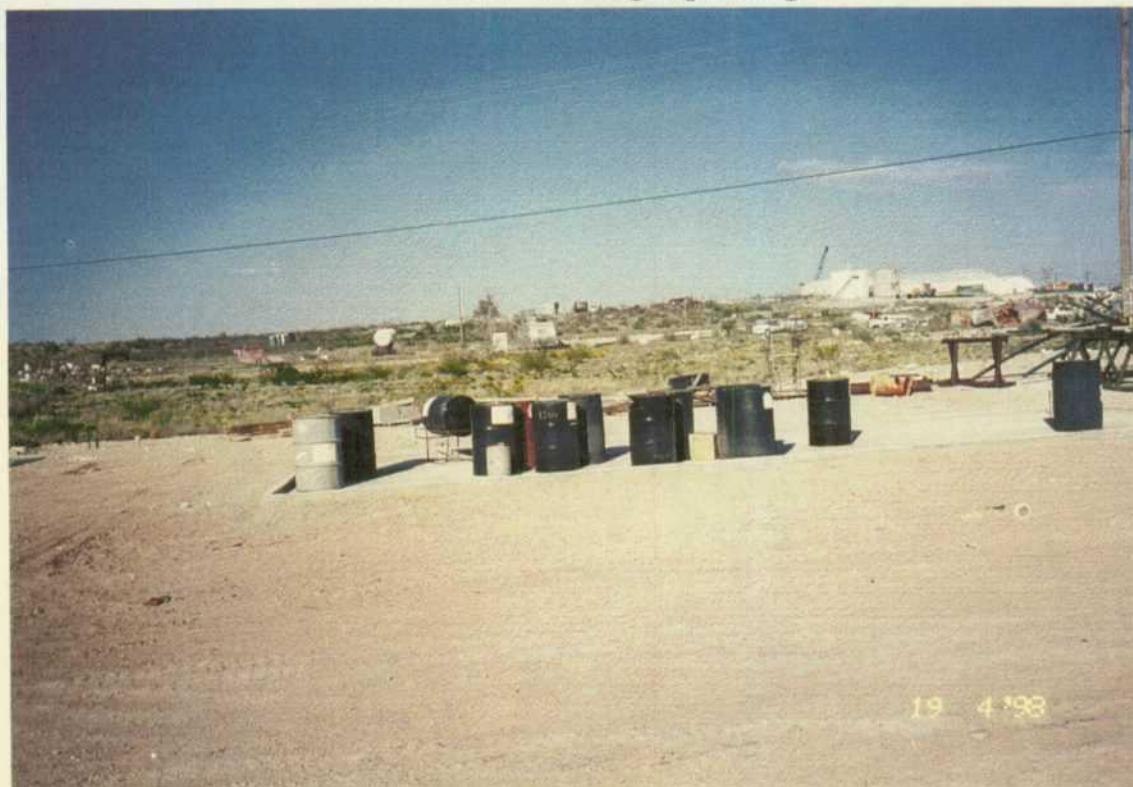
Photo Number: 6 Photographer: N. Jones  
Location: Rowland Trucking Company  
Subject: Drum pad  
City/County: Carlsbad State: NM  
Date: 04/20/98 Time: 5:30 PM Weather: Sunny

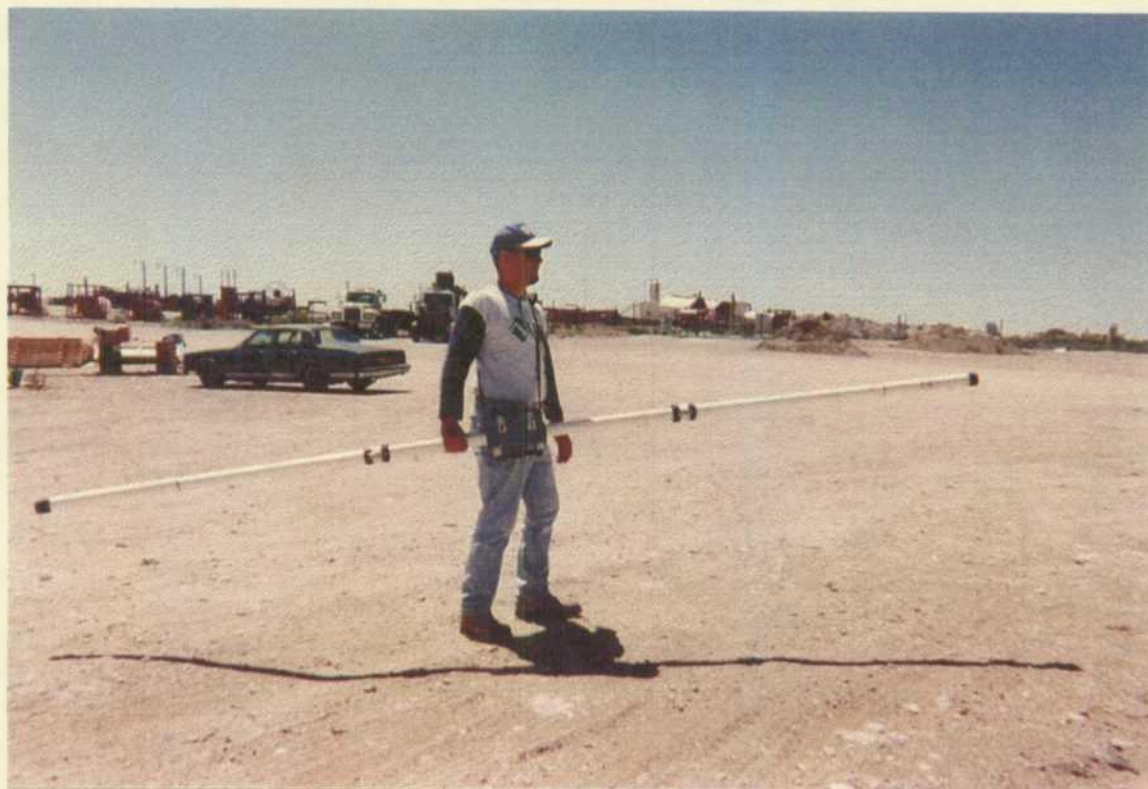
Photo Number: 7 Photographer: A. Garza  
Location: Rowland Trucking Company  
Subject: EM 31 electromagnetic survey  
City/County: Carlsbad State: NM  
Date: 04/22/98 Time: 1:30 PM Weather: Sunny

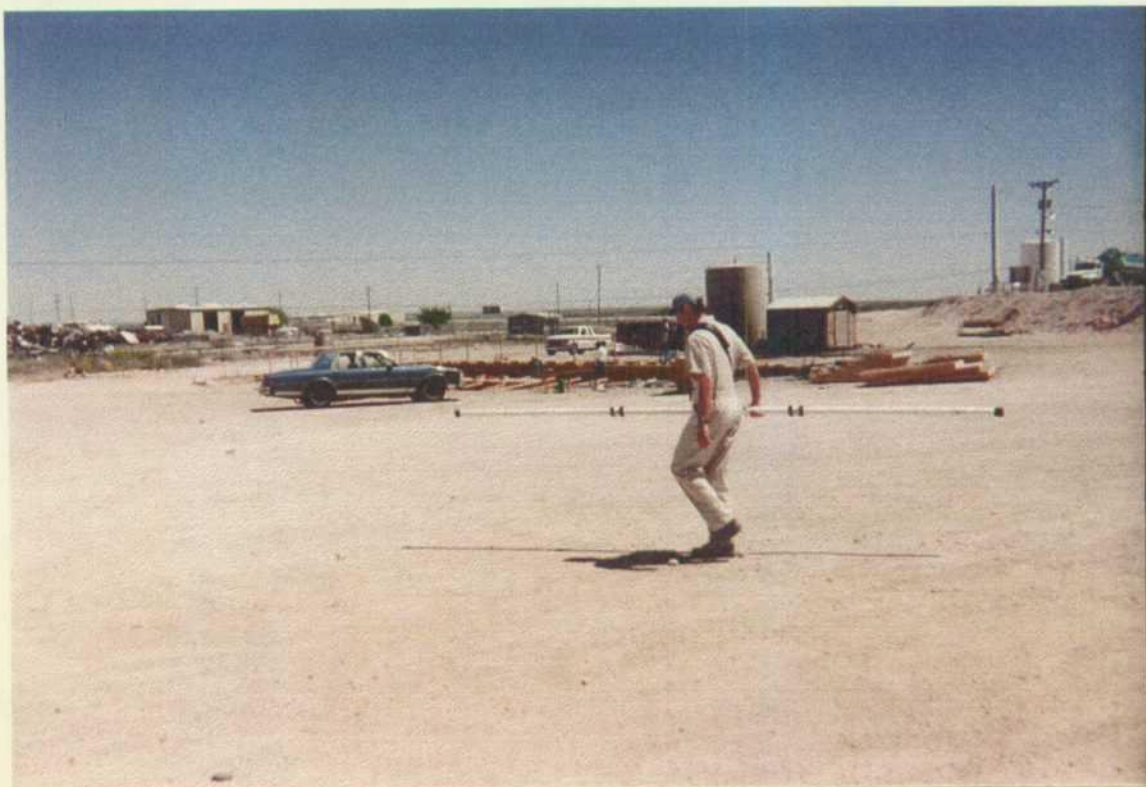
Photo Number: 8 Photographer: L. Vega  
Location: Rowland Trucking Company  
Subject: EM 31 electromagnetic survey  
City/County: Carlsbad State: NM  
Date: 04/22/98 Time: 1:40 PM Weather: Sunny

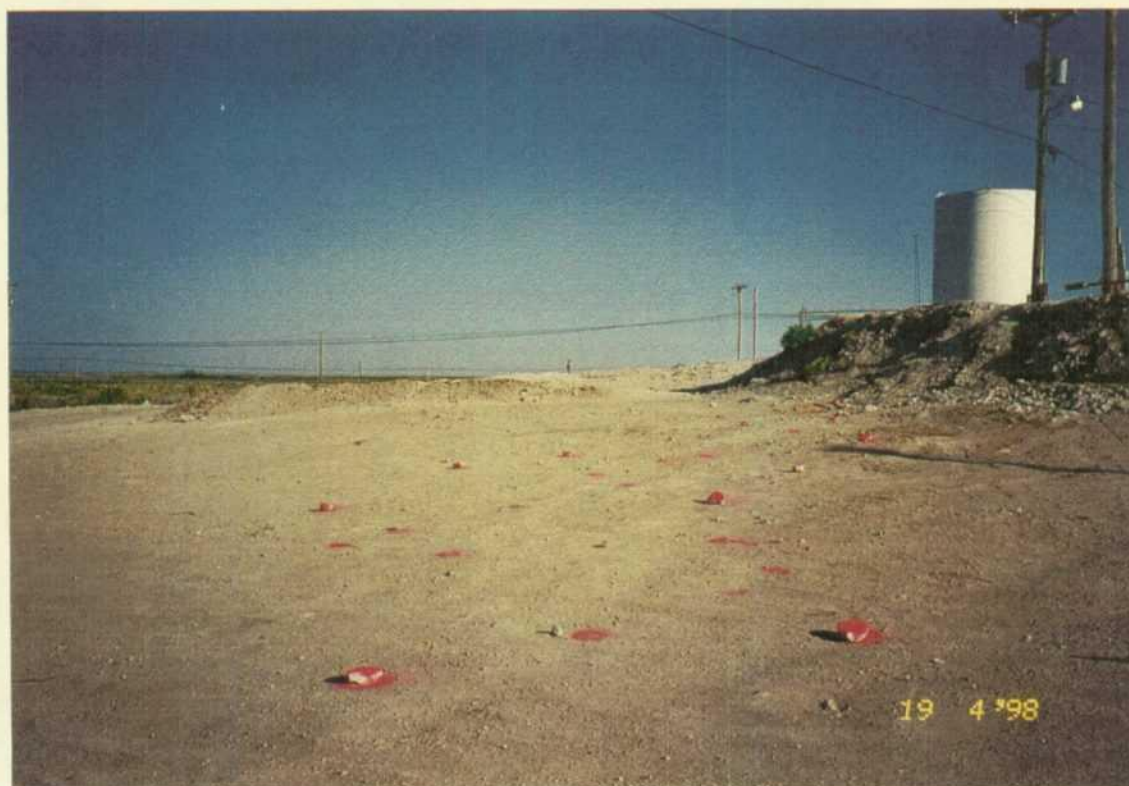
Photo Number: 9 Photographer: N. Jones  
Location: Rowland Trucking Company  
Subject: Area with strongest electromagnetic reading  
City/County: Carlsbad State: NM  
Date: 04/20/98 Time: 5:45 PM Weather: Sunny

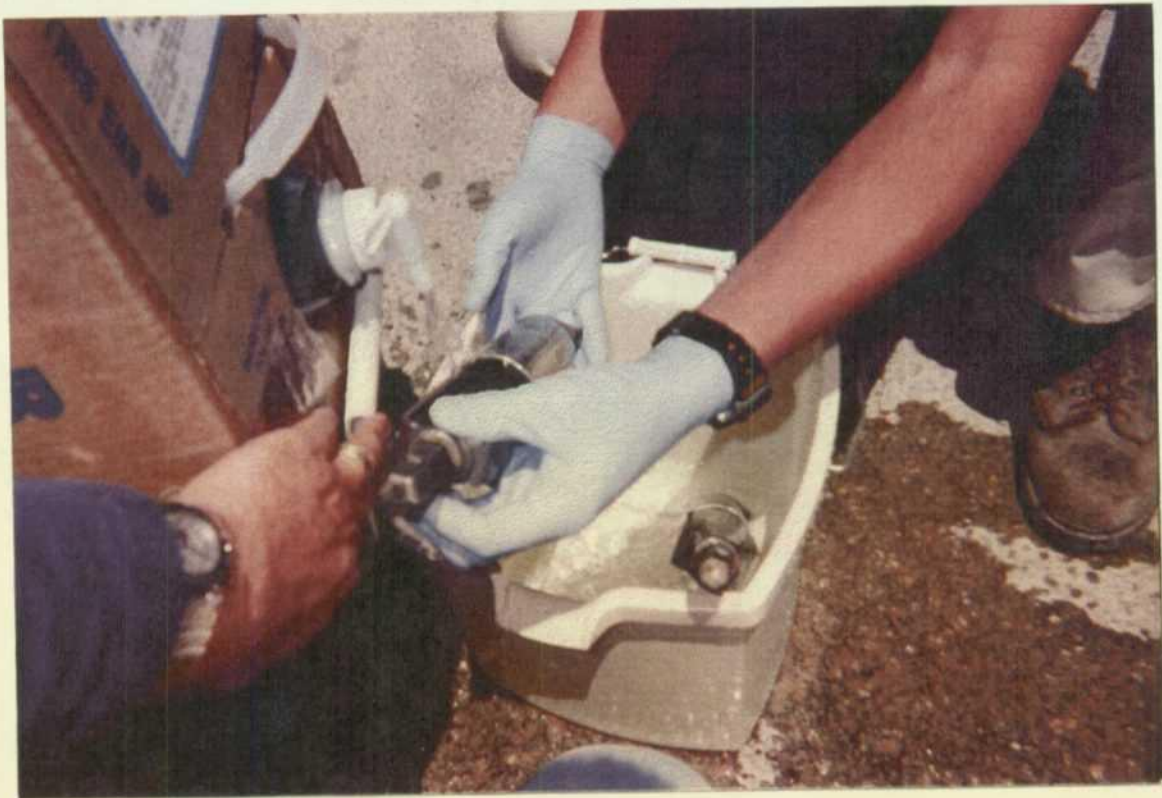
Photo Number: 10 Photographer: L. Vega  
Location: Rowland Trucking Company  
Subject: Tetra Tech personnel collecting equipment rinsate sample  
City/County: Carlsbad State: NM  
Date: 04/22/08 Time: 12:20 PM Weather: Sunny

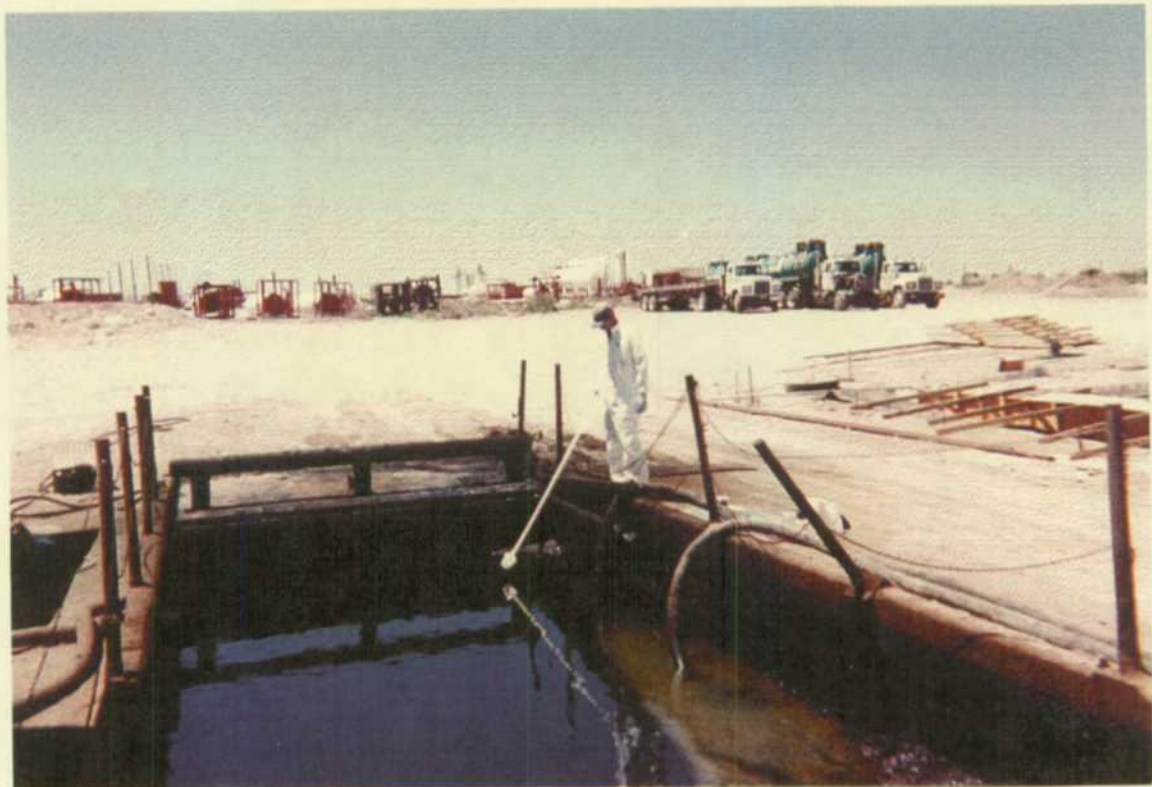
Photo Number: 11 Photographer: L. Vega  
Location: Rowland Trucking Company  
Subject: Tetra Tech personnel collecting samples RTC-SL-01 & RTC-SL-01D  
City/County: Carlsbad State: NM  
Date: 04/22/08 Time: 1:00 PM Weather: Sunny

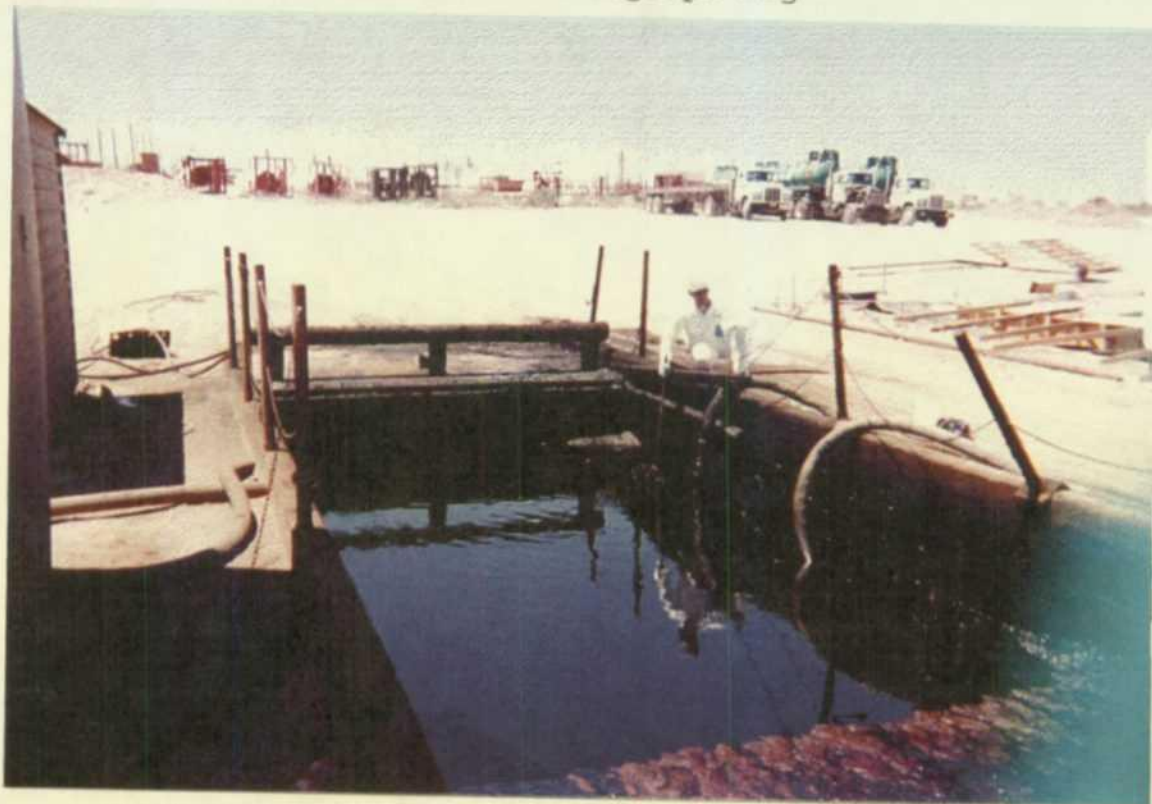
Photo Number: 12 Photographer: L. Vega  
Location: Rowland Trucking Company  
Subject: Tetra Tech personnel collecting samples RTC-SL-01 & RTC-SL-01D  
City/County: Carlsbad State: NM  
Date: 04/22/08 Time: 1:00 PM Weather: Sunny

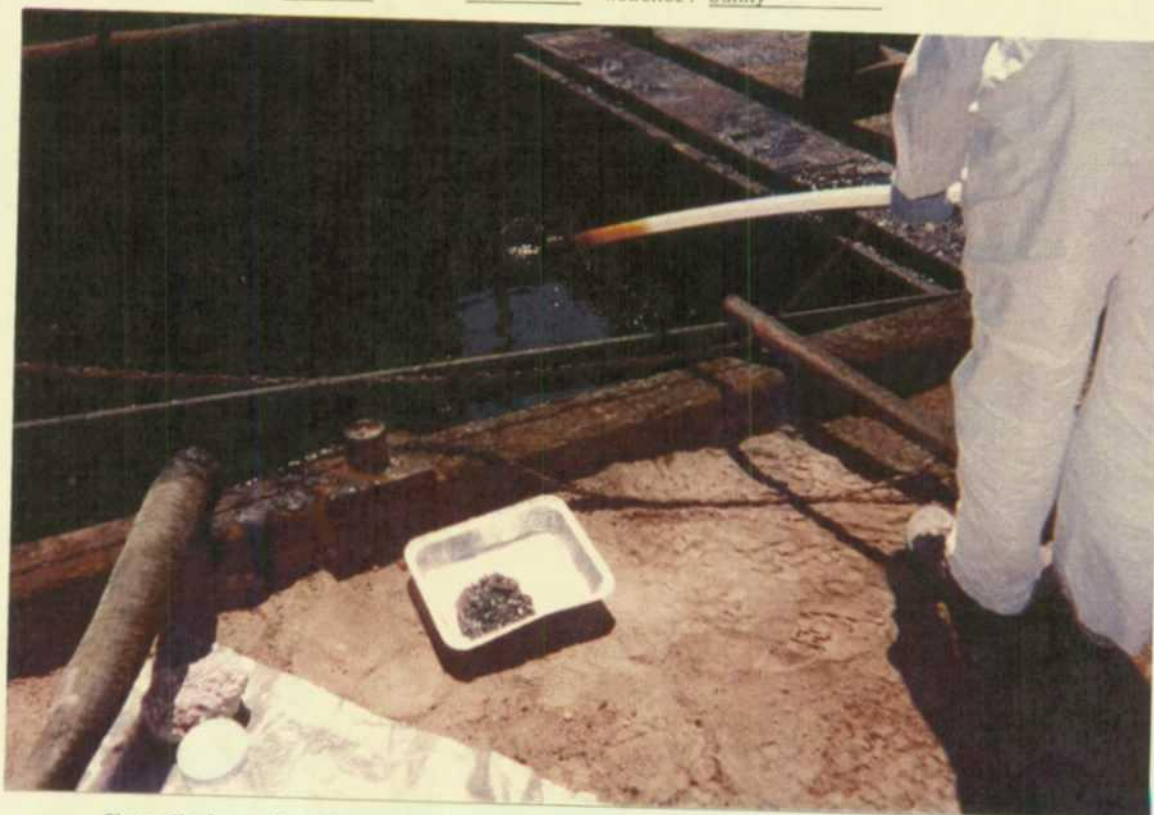
Photo Number: 13 Photographer: L. Vega  
Location: Rowland Trucking Company  
Subject: Tetra Tech personnel collecting samples RTC-SL-01 & RTC-SL-01D  
City/County: Carlsbad State: NM  
Date: 04/22/08 Time: 1:00 PM Weather: Sunny

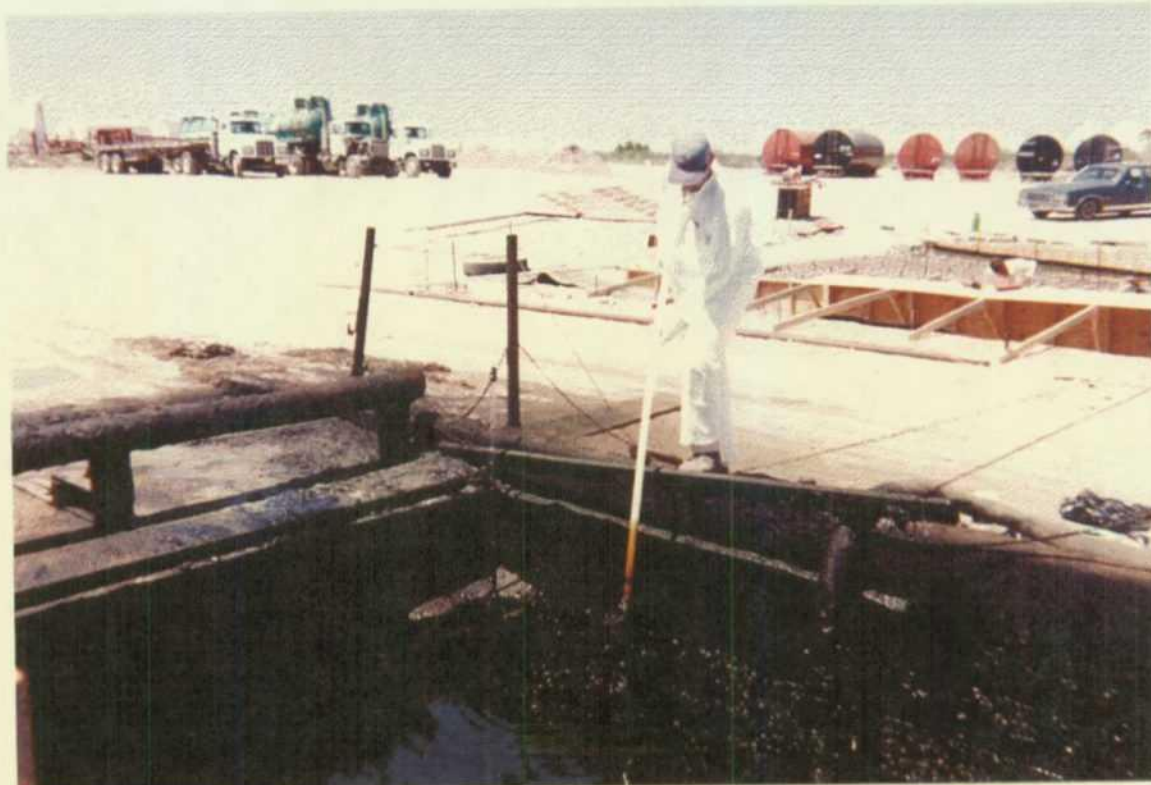
Photo Number: 14 Photographer: L. Vega  
Location: Rowland Trucking Company  
Subject: Tetra Tech personnel collecting samples RTC-SL-01 & RTC-SL-01D  
City/County: Carlsbad State: NM  
Date: 04/22/08 Time: 1:00 PM Weather: Sunny

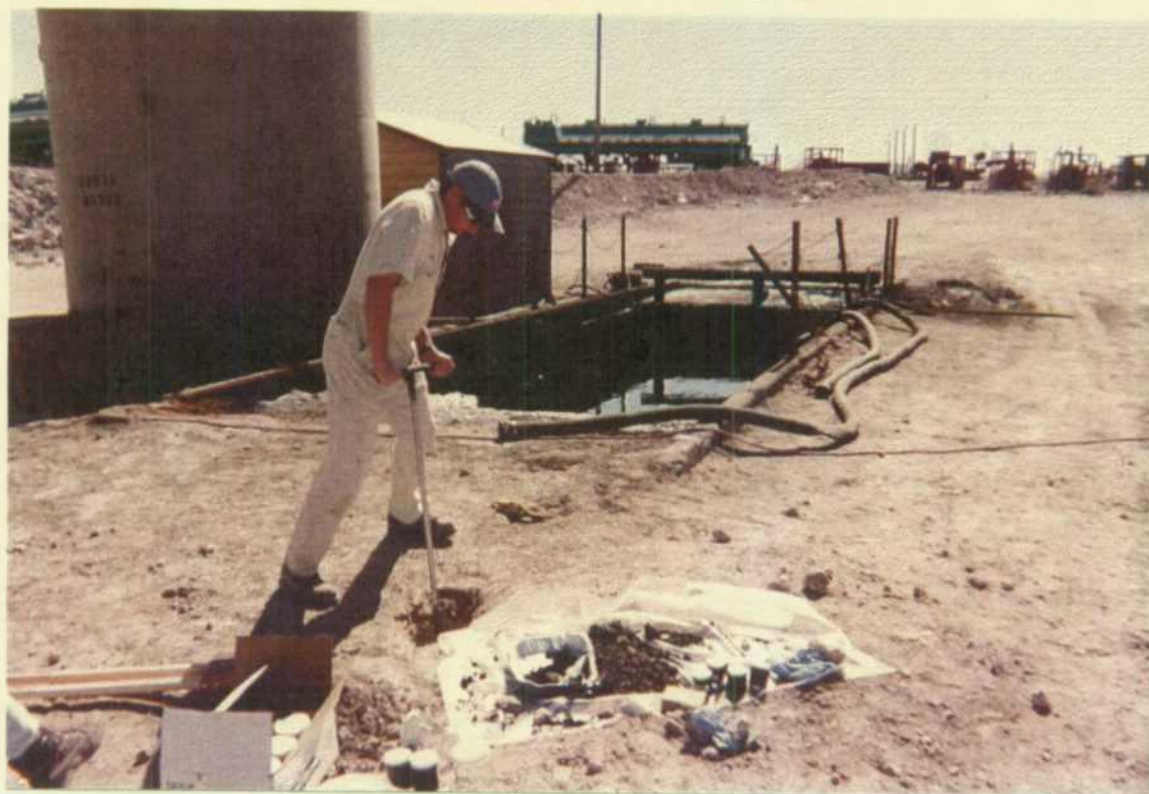
Photo Number: 15 Photographer: L. Vega  
Location: Rowland Trucking Company  
Subject: Tetra Tech personnel collecting samples RTC-SS-02A,AD,B & BD  
City/County: Carlsbad State: NM  
Date: 04/22/08 Time: 3:00 PM Weather: Sunny

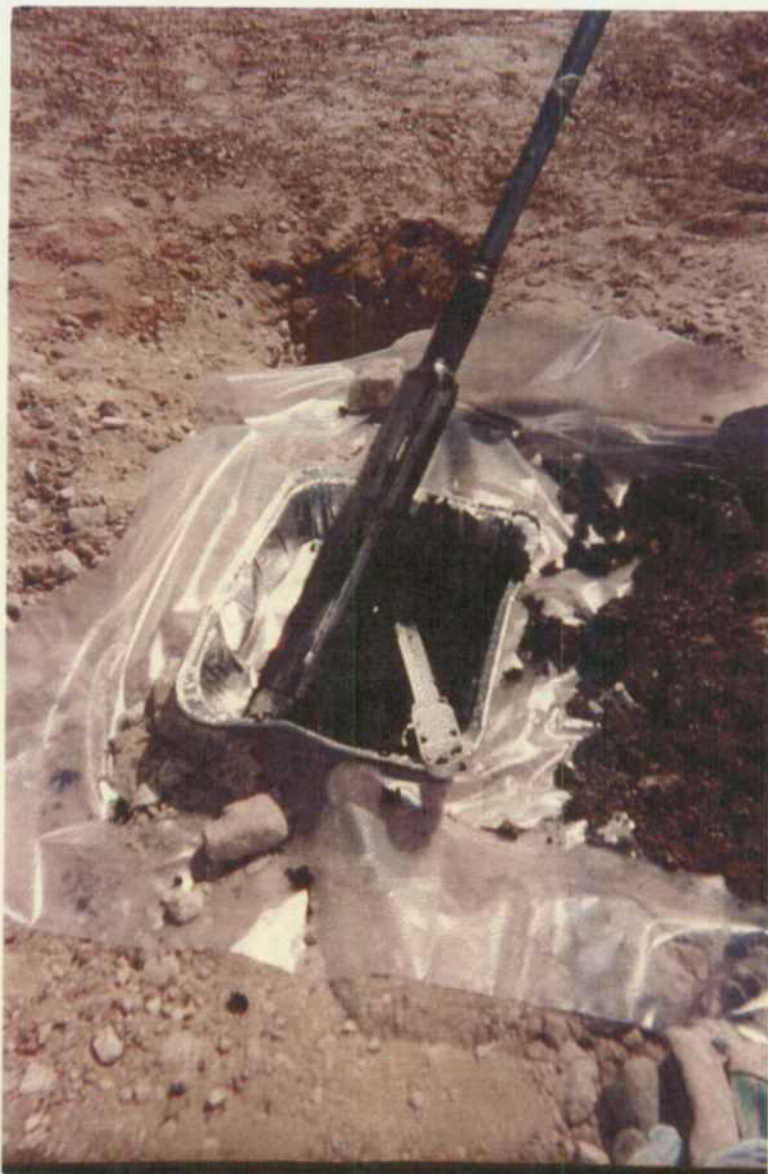
Photo Number: 16 Photographer: L. Vega  
Location: Rowland Trucking Company  
Subject: Tetra Tech personnel collecting samples RTC-SS-02A,AD,B & BD  
City/County: Carlsbad State: NM  
Date: 04/22/08 Time: 3:00 PM Weather: Sunny

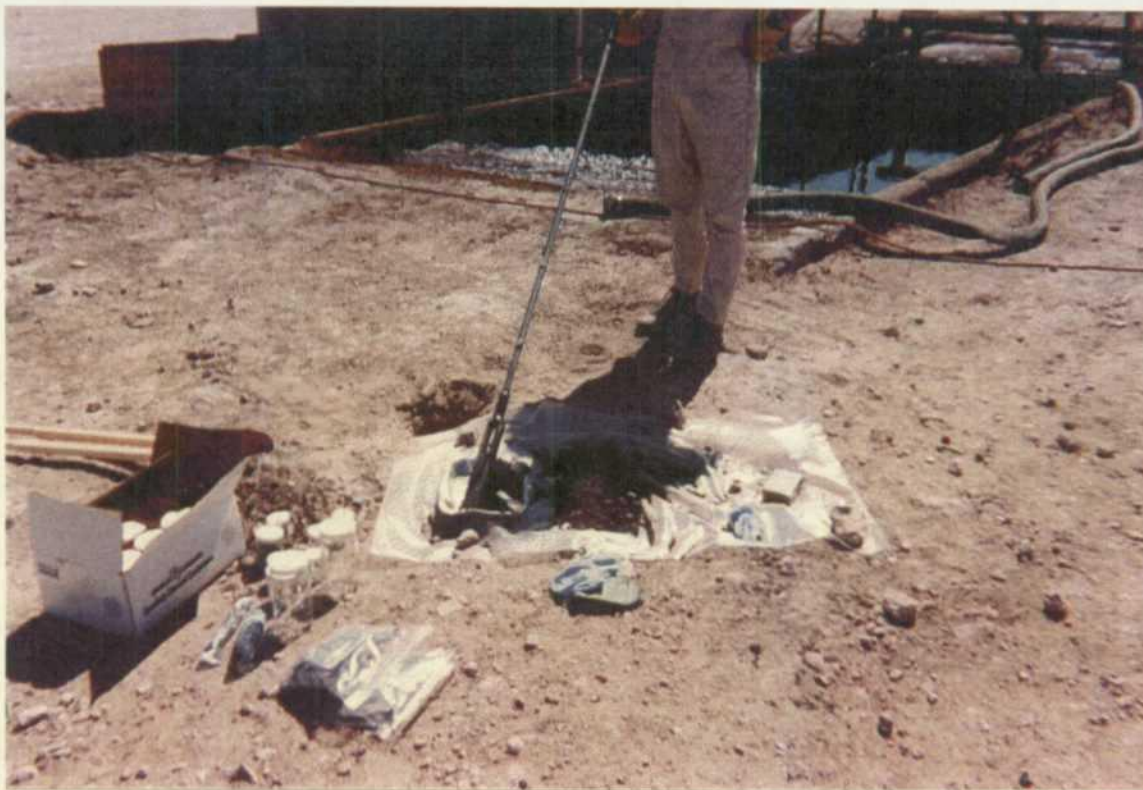
Photo Number: 17 Photographer: L. Vega  
Location: Rowland Trucking Company  
Subject: Tetra Tech personnel collecting samples RTC-SS-02A, AD, B & BD  
City/County: Carlsbad State: NM  
Date: 04/22/08 Time: 3:00 PM Weather: Sunny

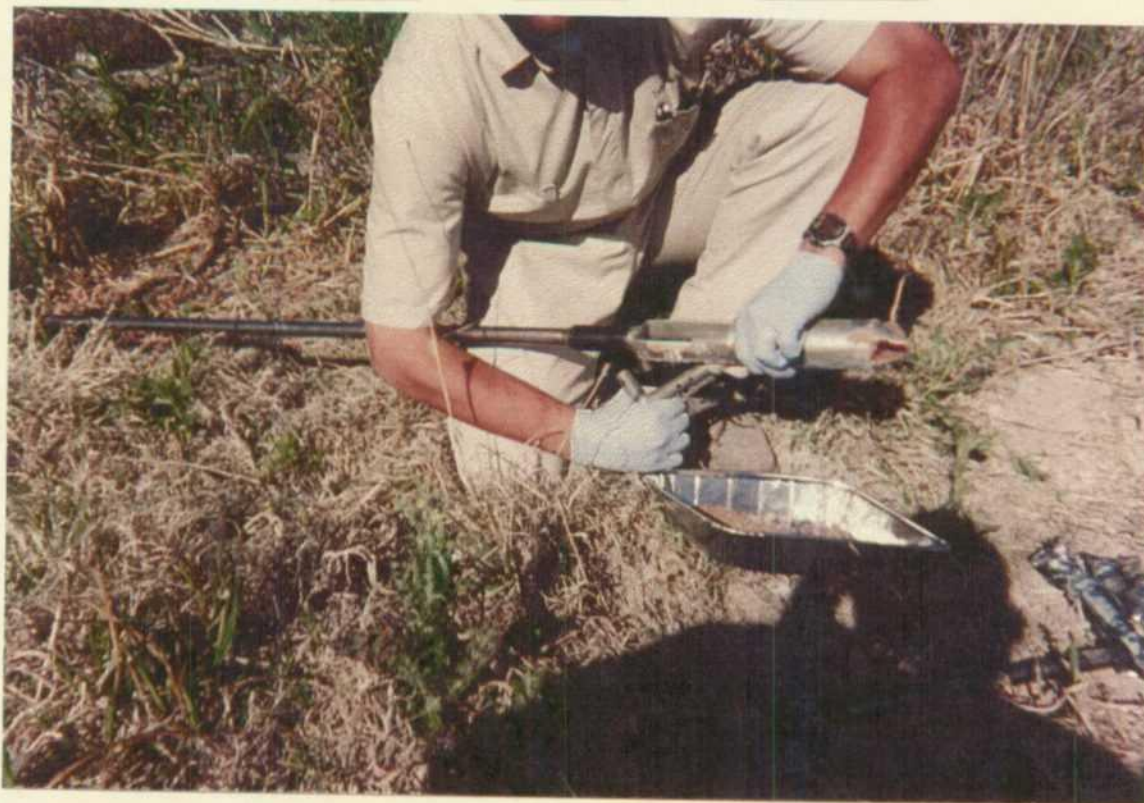
Photo Number: 18 Photographer: L. Vega  
Location: Rowland Trucking Company  
Subject: Tetra Tech personnel collecting samples RTC-SS-03A & RTC-SS-03B  
City/County: Carlsbad State: NM  
Date: 04/22/08 Time: 4:55 PM Weather: Sunny
