KOCH PIPELINE CO., L.P.

Crouch Station

Lea County, New Mexico

Annual Report - April 1, 2000

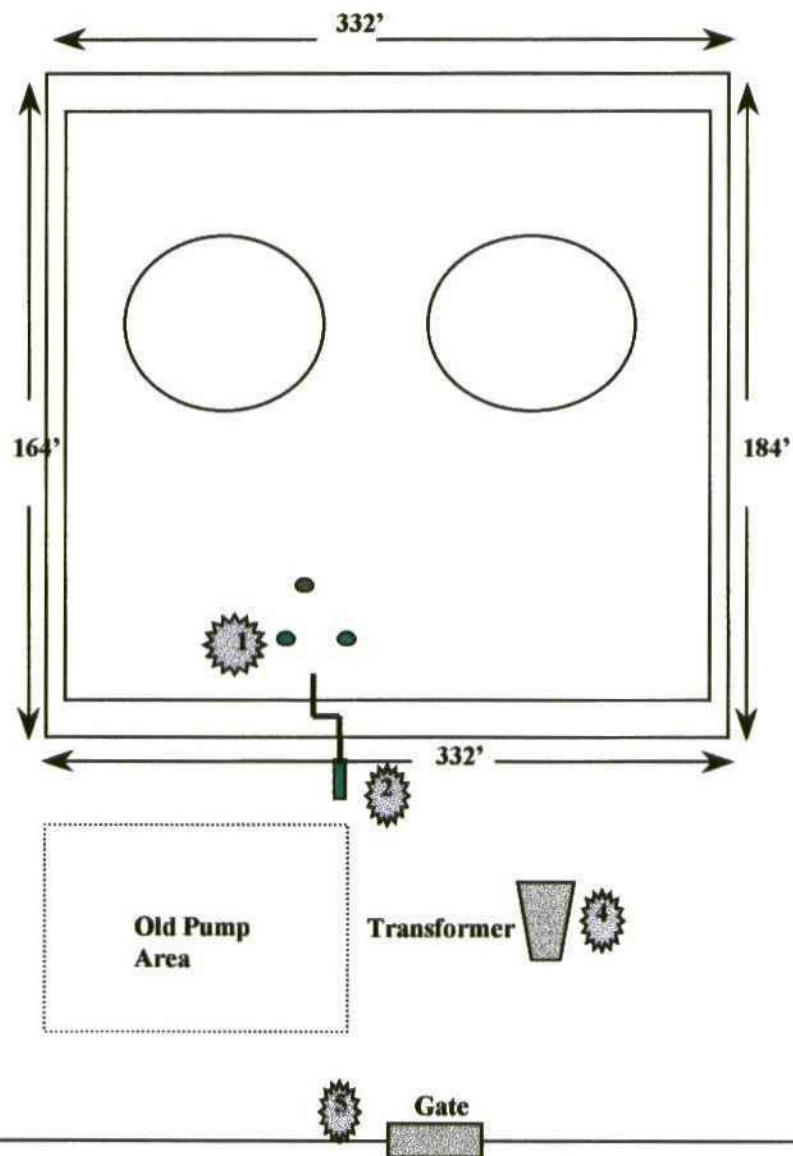
Figure 2
Monitor Wells Site Plan

This report is the result of the requirement of the New Mexico Oil Conservation Division to report the results of the investigation to delineate the possibility of groundwater contamination at the Crouch Station site. Three additional monitor wells were installed at the Crouch Station on May 1 and May 2, 1998, supplementing two monitor wells drilled initially in 1997 by Western Technologies. (See Monitor Well Site Plan)

Monitor Well Site Plan
