KOCH PIPELINE CO., L.P.

Crouch Station

Lea County, New Mexico

Annual Report 1999

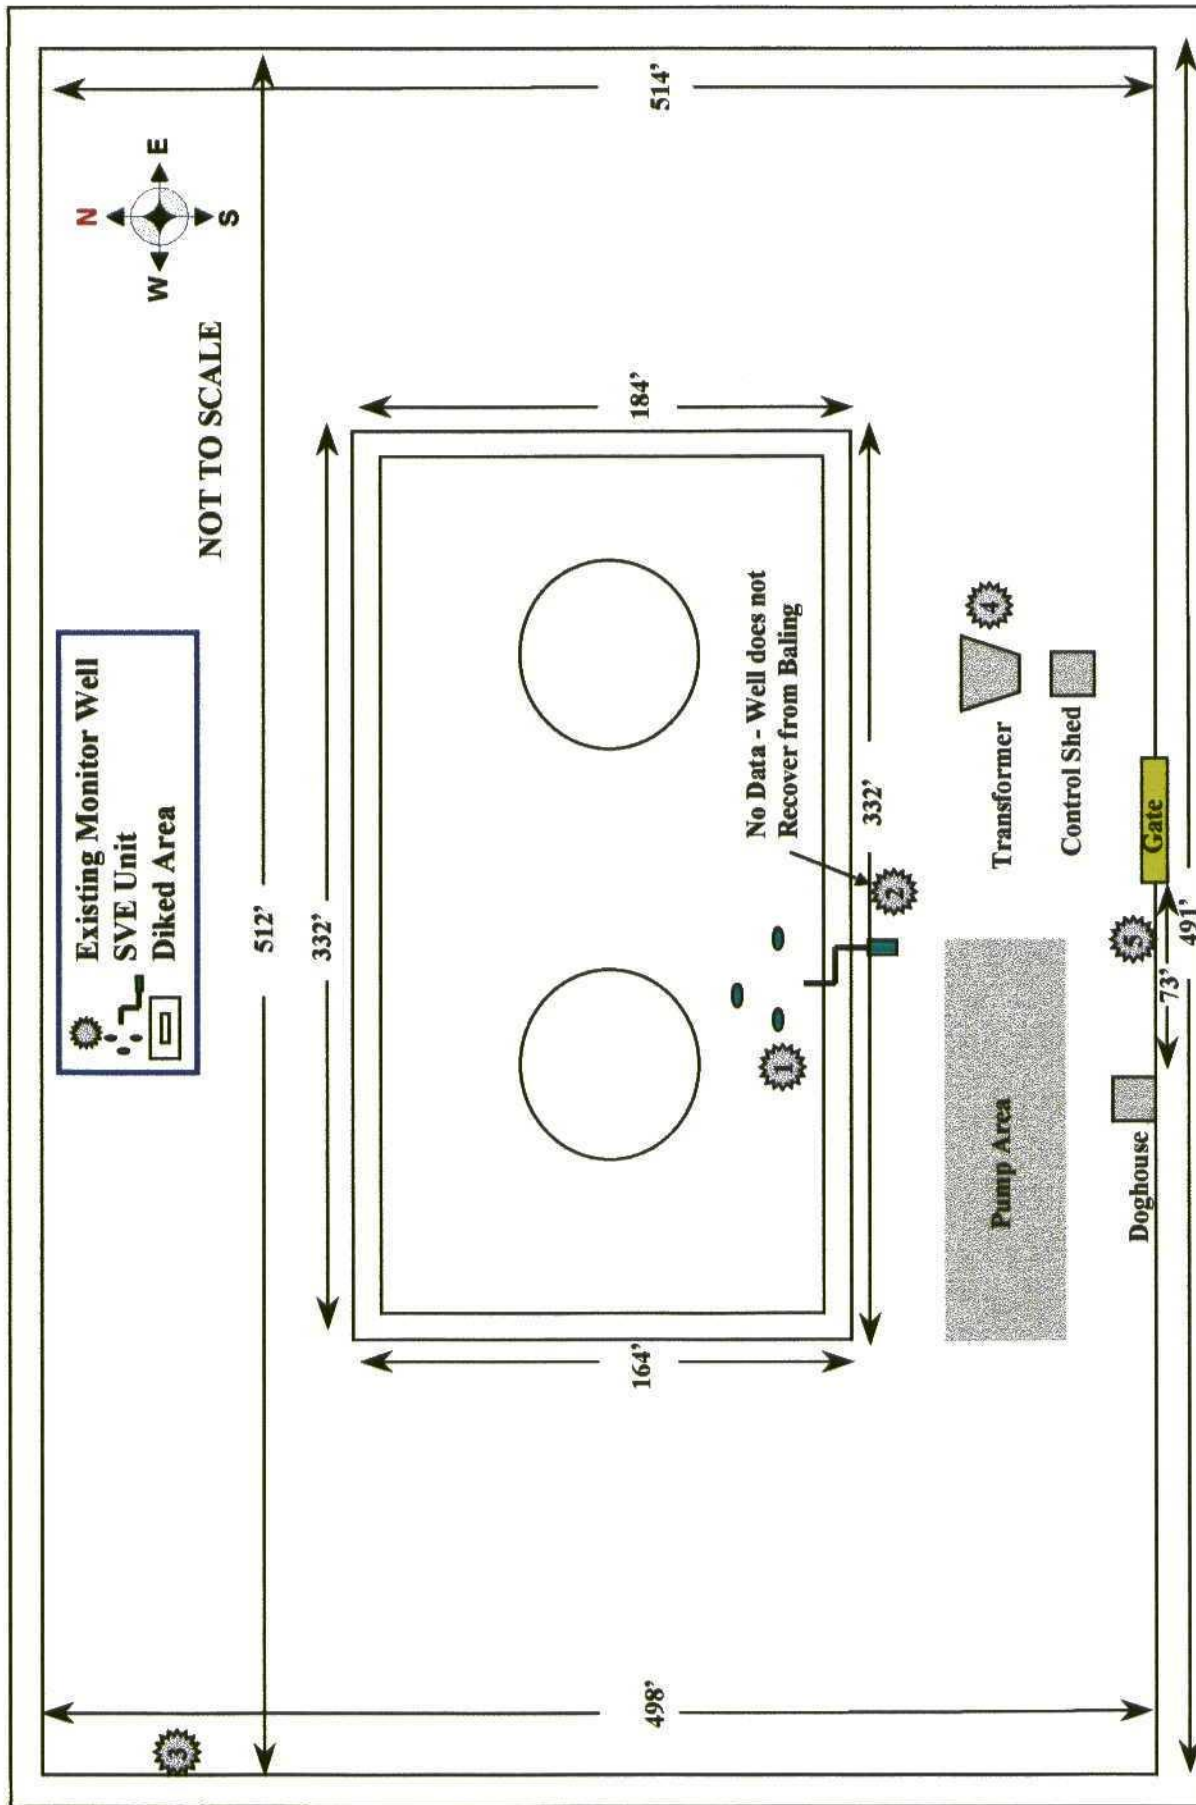
Monitor Well Site Plan

Three additional monitor wells were installed at the Crouch Station on May 1 and May 2, 1998, supplementing two monitor wells drilled initially in 1997 by Western Technologies. (See Monitor Well Site Plan)

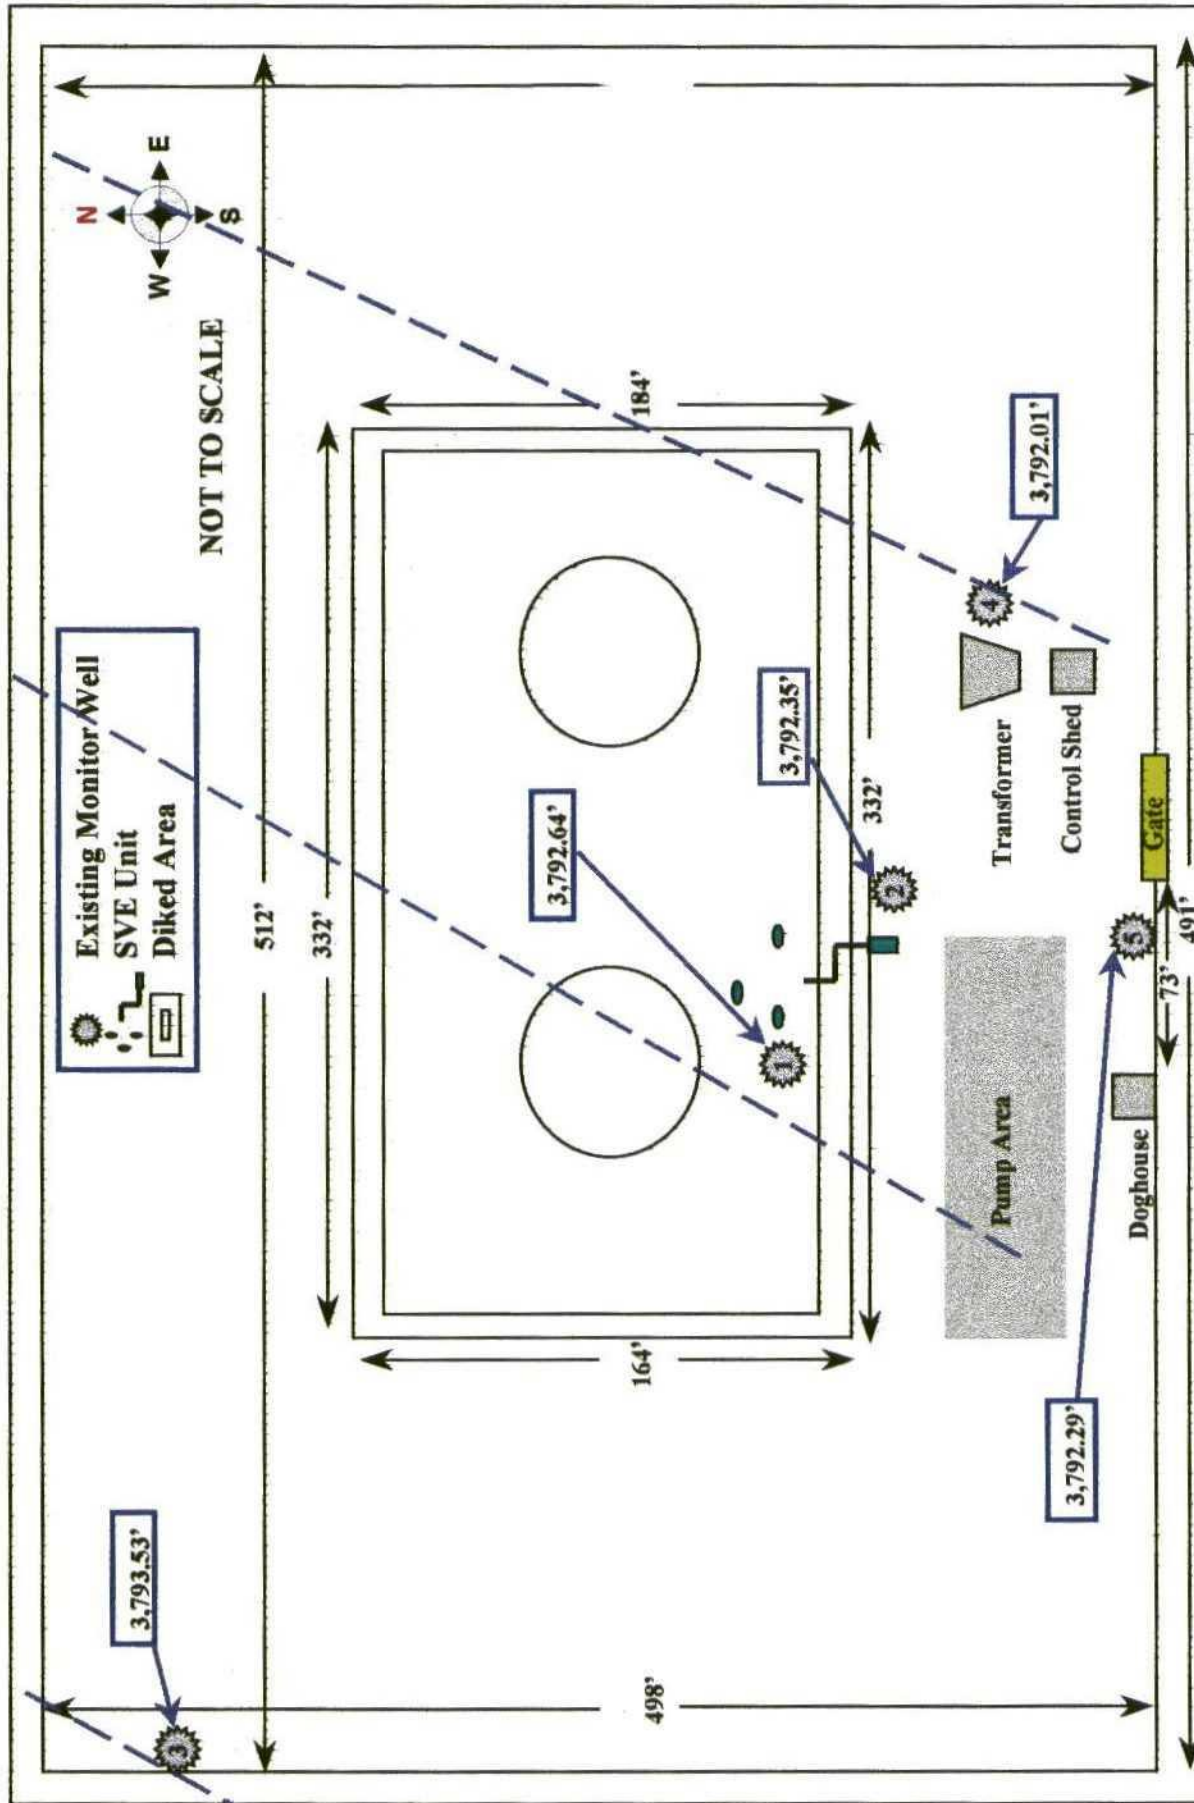
Monitor Well Groundwater
Elevation 2-12-99

As noted by the red highlighting, only the Benzene levels in Monitor Well #3 is above the NMWQCC limits. A water table elevation study was performed at the Crouch Station site in conjunction with the sampling of the monitor wells. (See Water Table Elevation Map Crouch Station) Both the Barium and Chromium levels in all four monitor wells tested were below the NMWQCC limits.

The Benzene contamination has entered the property at the northwest property line in the water table that flows from the northwest to the southeast at a bearing of approximately 140°. This contamination is almost certainly the result of a source that is located clearly outside the property boundaries of the Crouch Station. The obvious suspected source of the contamination entering this area is the historical leak to the northwest of Crouch Station. This leak occurred approximately 10 years ago and is currently undergoing remediation by Texas New Mexico Pipeline Company and Southwestern Public Service. The most current report of sampling of the 18 monitor wells installed at that site indicate the contamination may have traveled past the most down-gradient well.
