PLAYA SITE

Unit L Sec.33, T18S, R38E of Lea Co. NM

SITE ASSESSMENT REPORT

RE: MSA of the Playa Located in Unit L Sec.33, T18S, R38E of Lea Co. NM

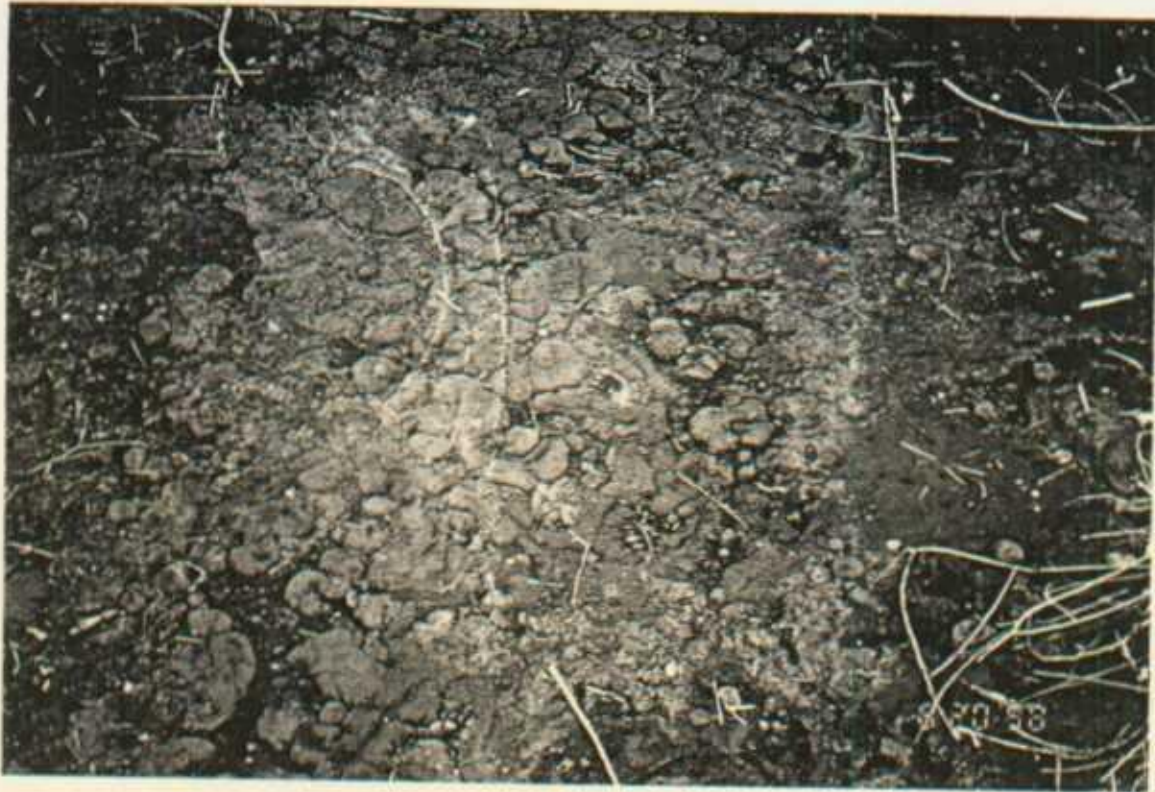
6. The impacted area on the north side of the Playa will continue to cross contaminate the site with leachable and floatable hydrocarbons as long as that source material remains in the Playa.

Source Material North Side

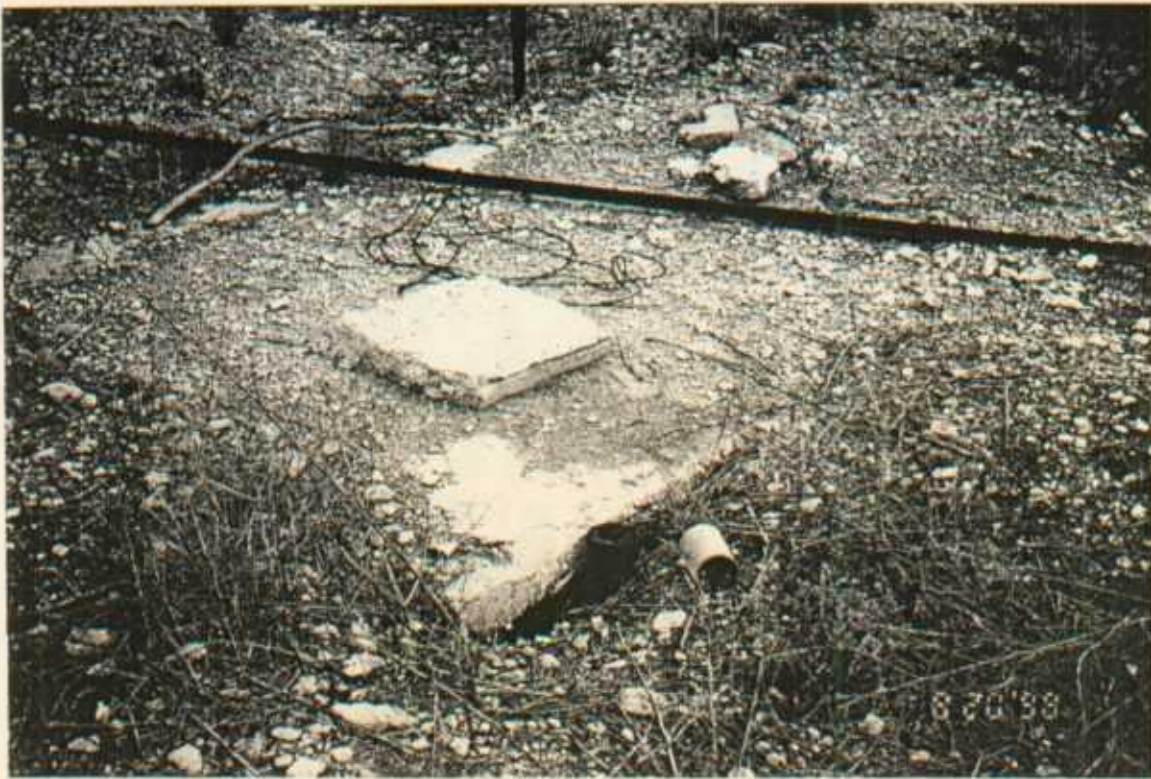
The well located on the south side of the playa and the old septic pit in the southwest corner show some evidence of impact that has happened in the past. A soil sample was taken in this area using a hand auger to collect the samples. This soil boring is HAB # 2 with samples taken from 4" to 6" in depth and at 2' you may refer to the site map for the location. This sample showed MCL's for TPH that were above the NMOCD guidelines for clean up.

Septic pits Southwest Corner

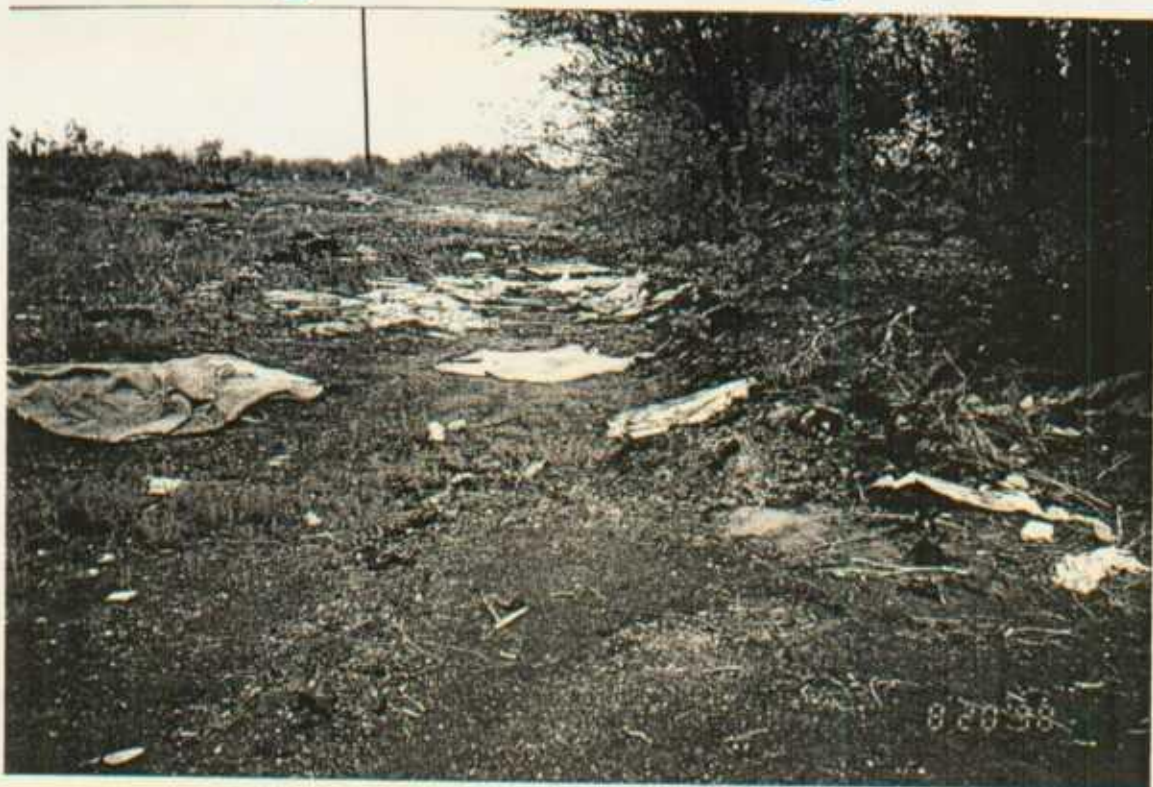
2. There is domestic waste scattered over the site that is not from the Oil and Gas Industry.

Domestic Waste

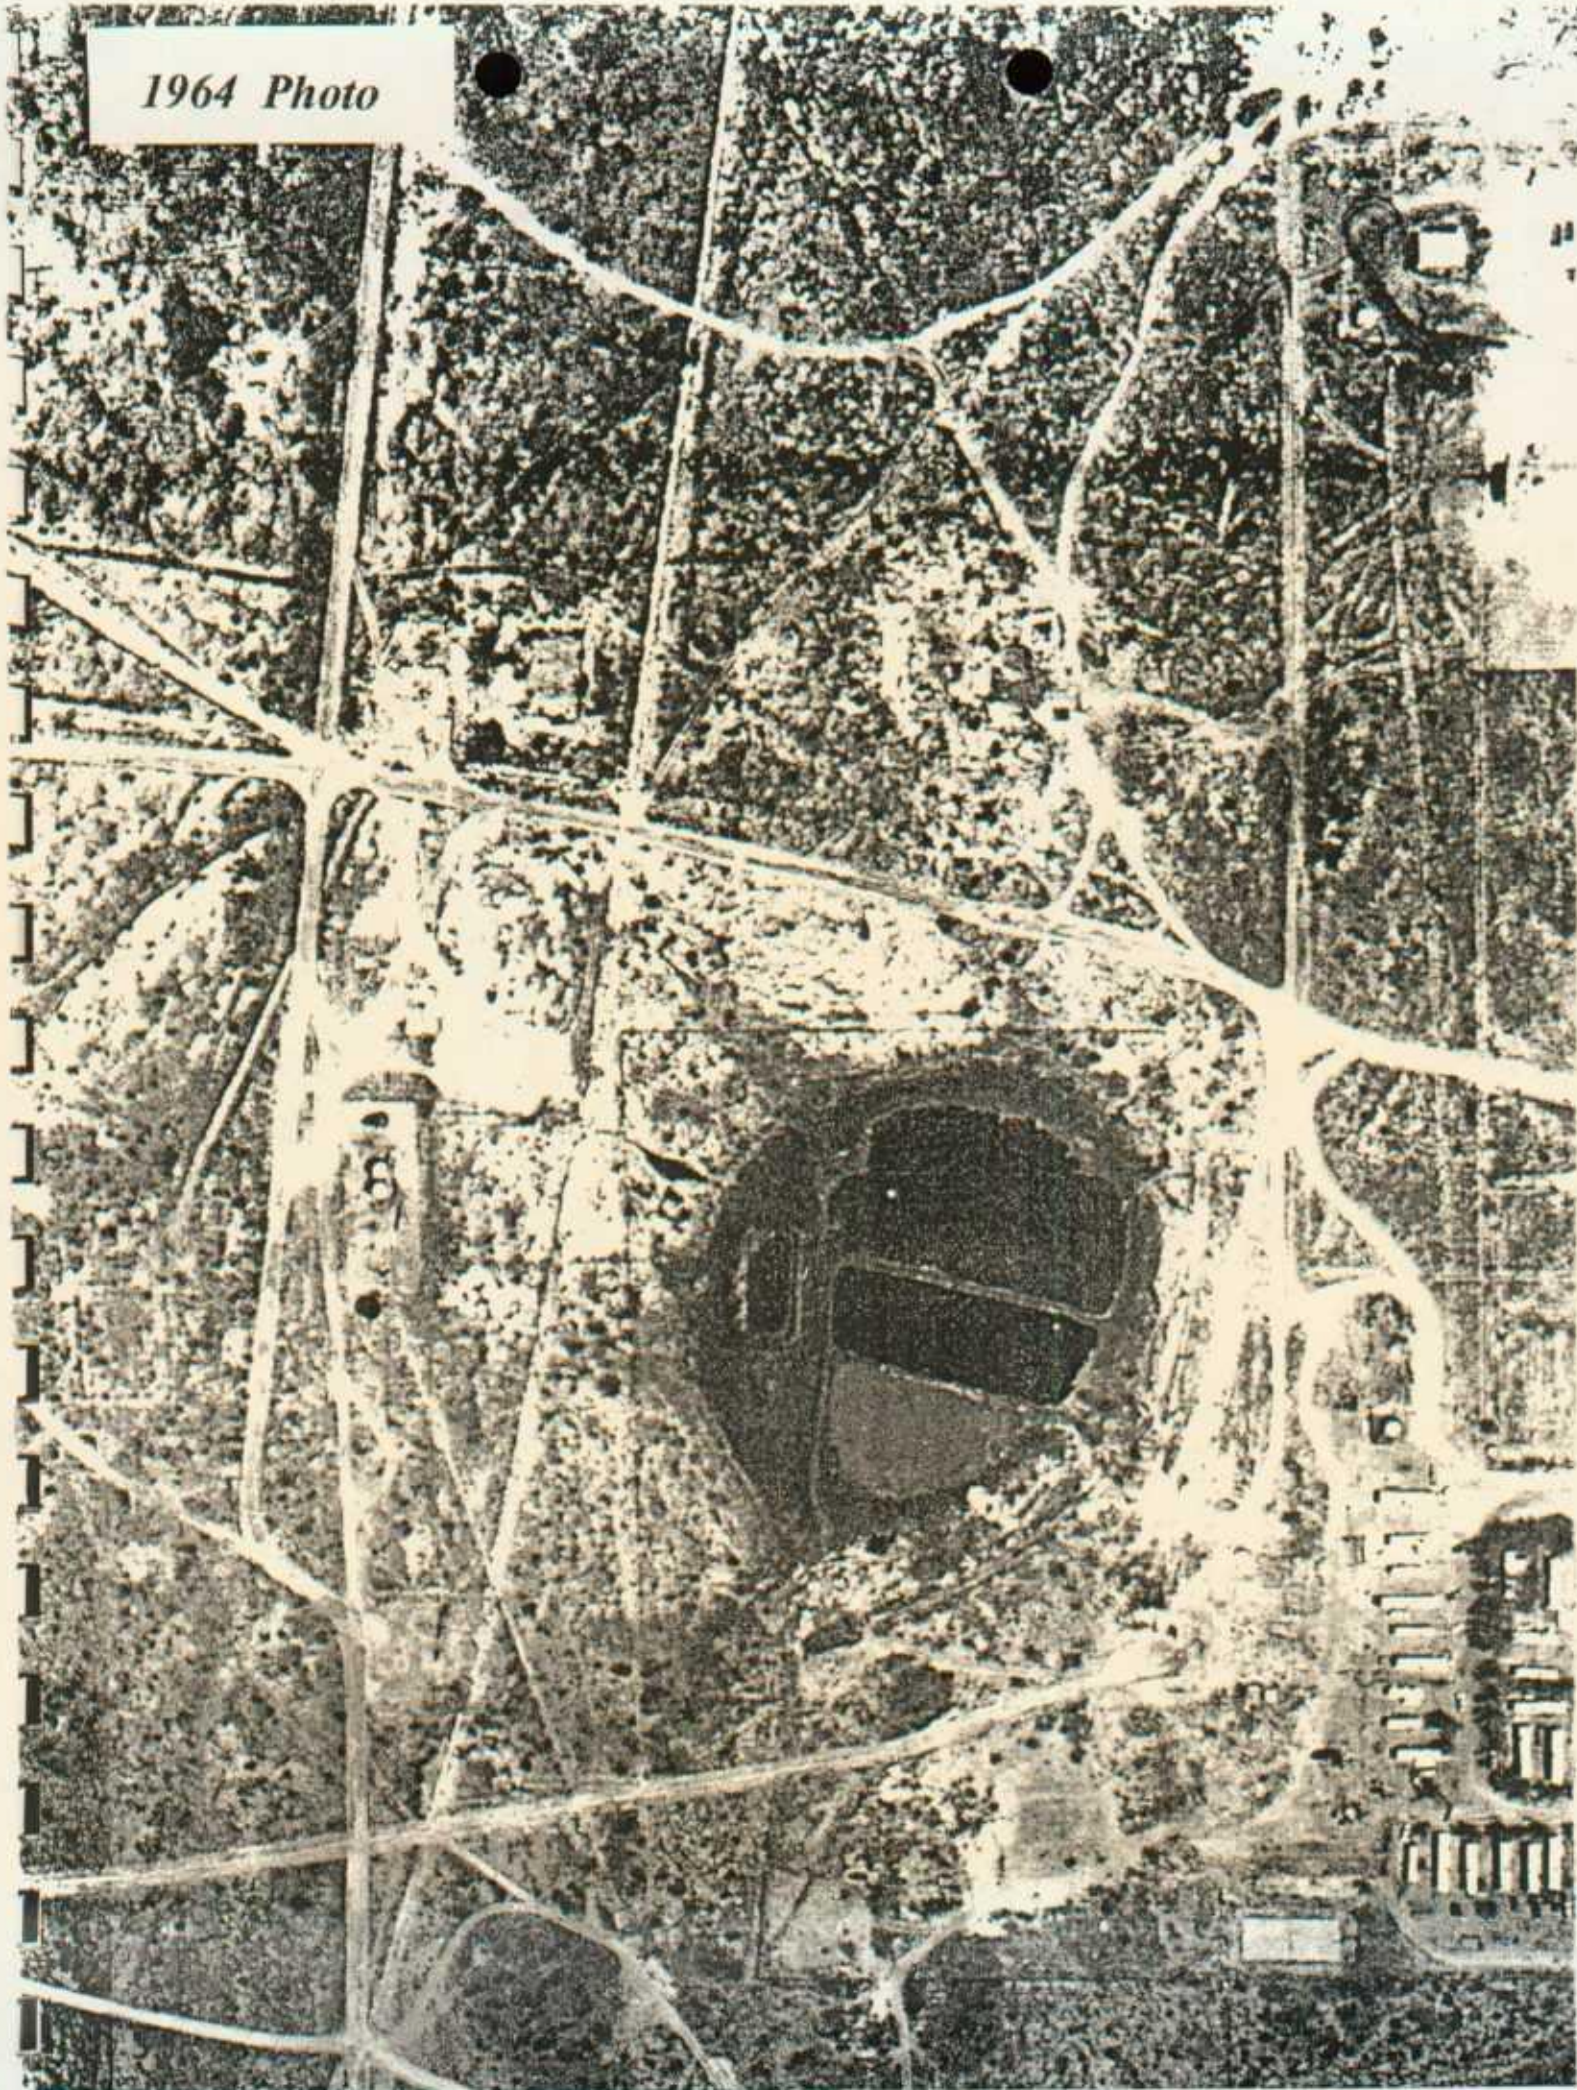
1964 Photo

A review of the aerial photos from 1964 shows that there may have been some pits in the Playa that are undefined as to there use at this time. This photo shows that there may have been some type of release on the north side of the Playa that has run into the Playa from the north. The 1978 photos show that the pits have been taken out of service with signs of dirt work in the Playa. This photo shows signs that impacted or source material has been pushed across the Playa from the north. This was confirmed during the site walk. The 1988 photos still show the scars of the old pit on the north side of the Playa.
