9/15/2004

**FINAL
REPORT**

**RICE OPERATING COMPANY
JUNCTION BOX FINAL REPORT**

BD M-16 vent

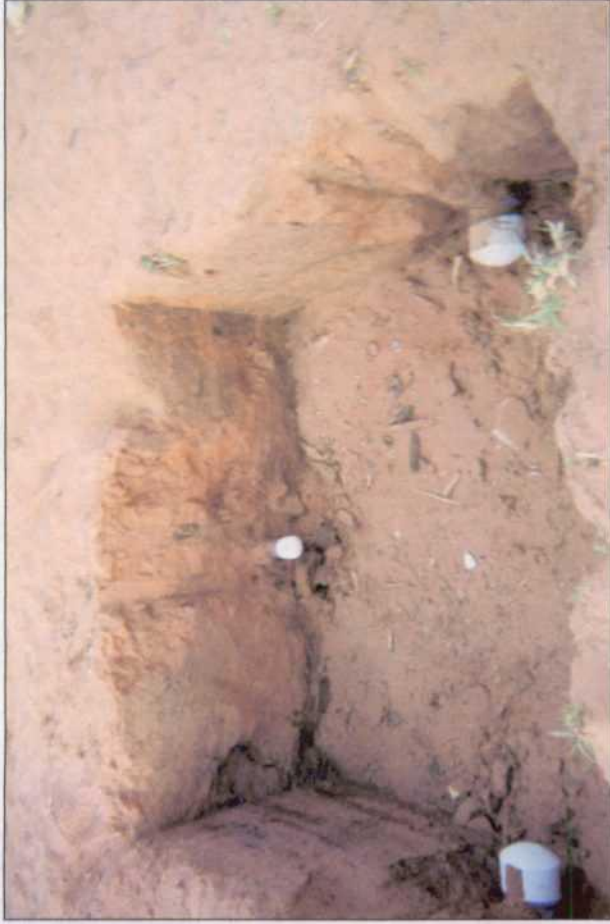
Box and connections removed 11/5/2003

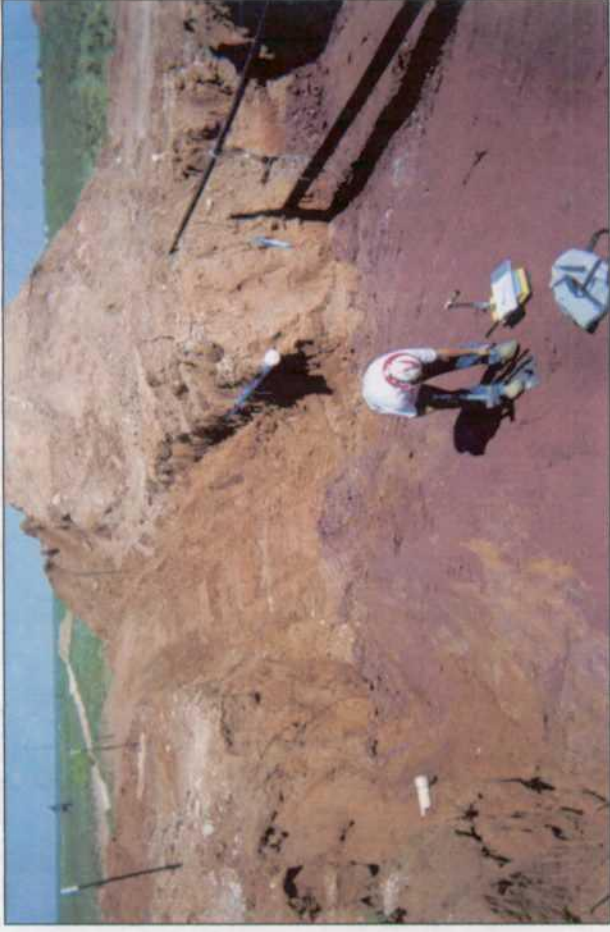
Testing compacted clay at 6 ft 5/10/2004

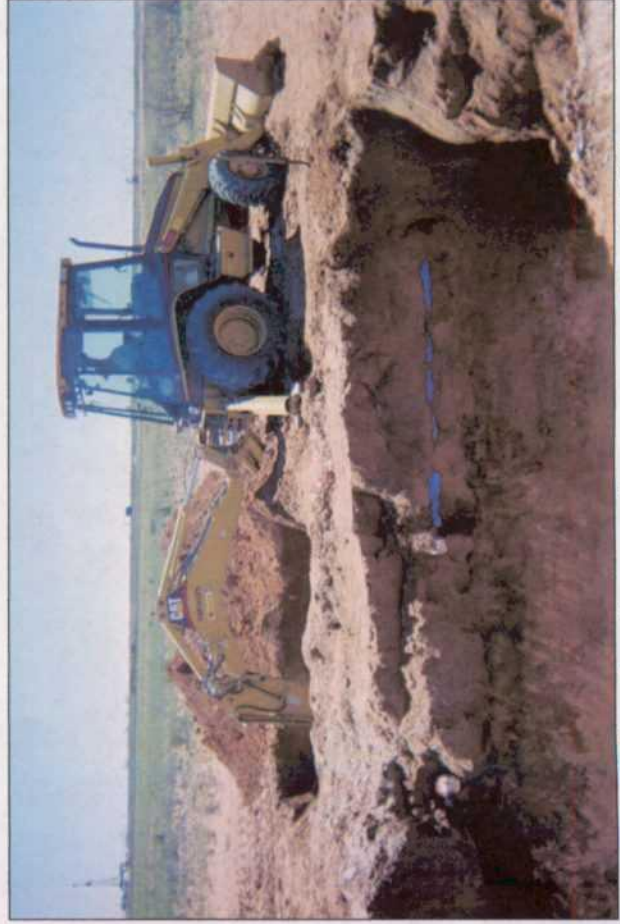
Delineation & excavation

March 2004

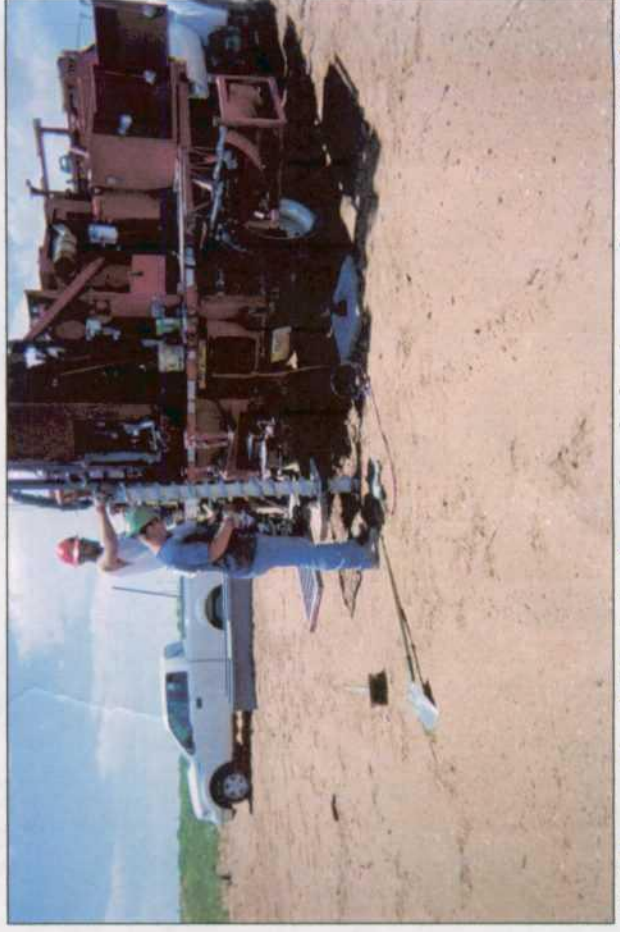
Soil bore at backfilled site (new box in background) 6/2/2004

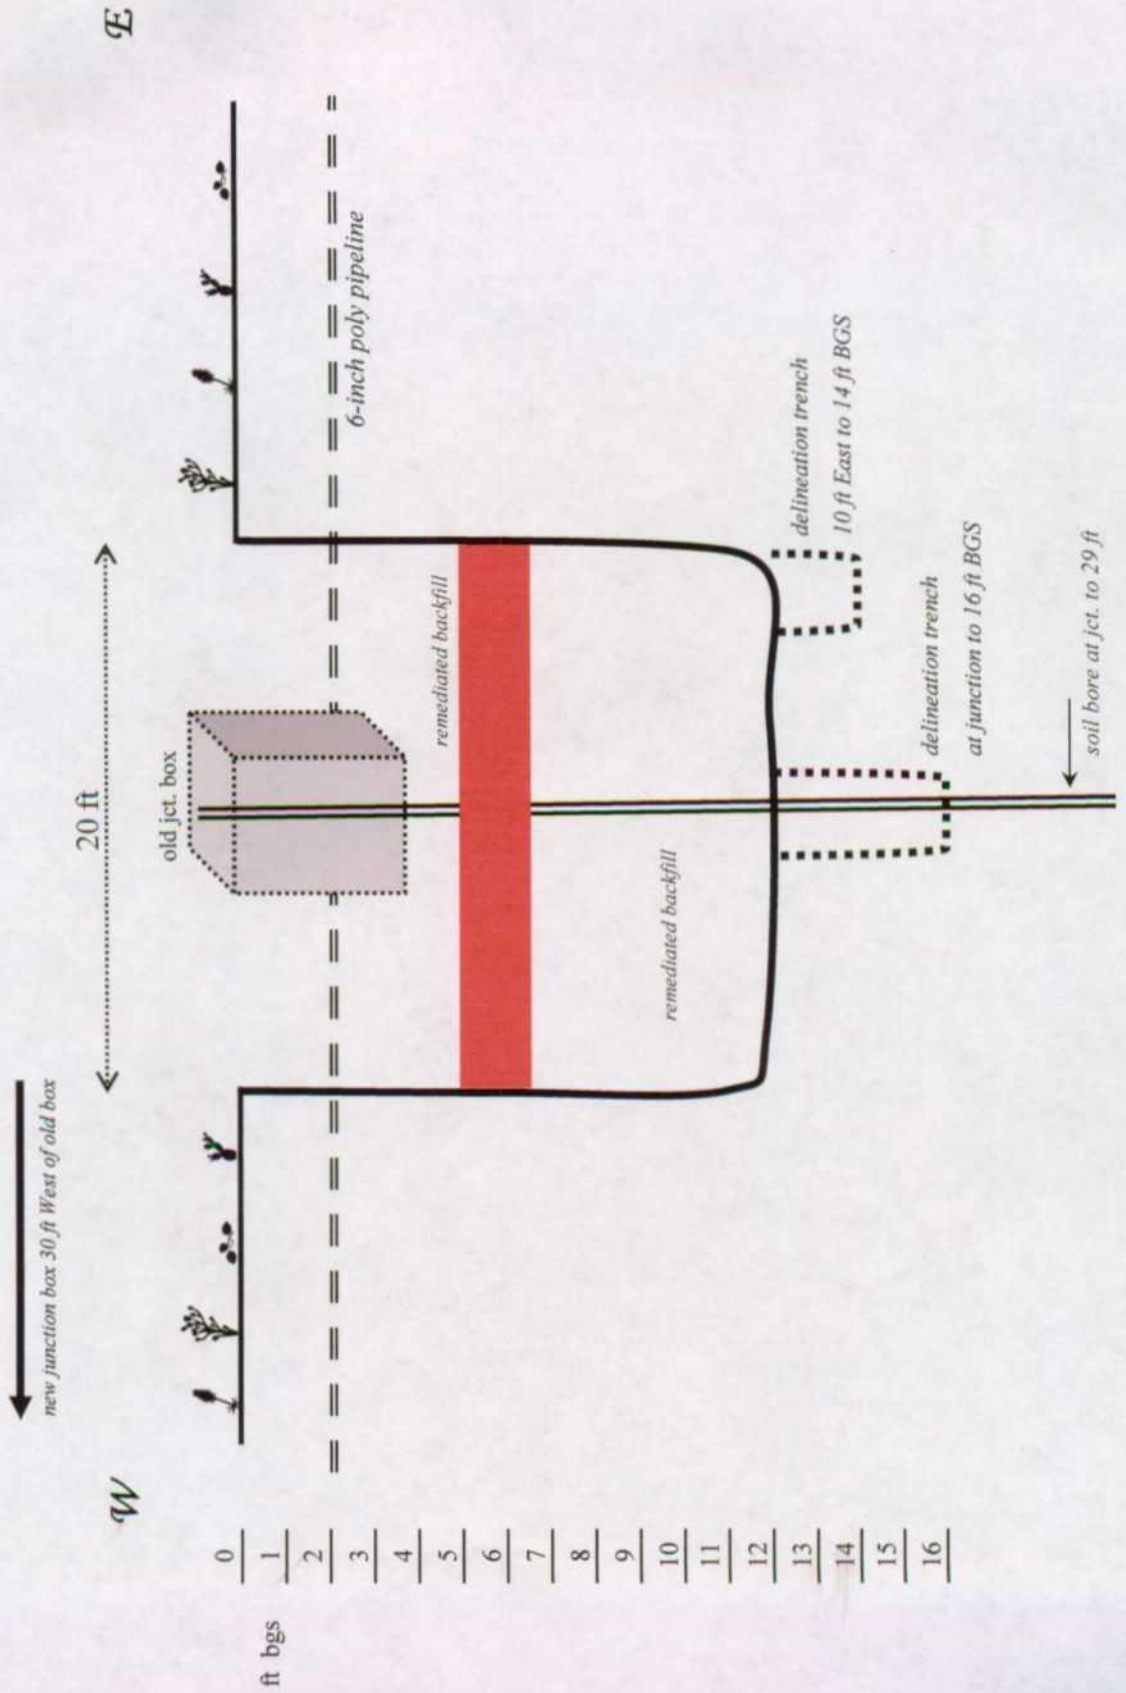
Excavation Cross-Section

25 x 20 x 12-ft-deep

Soil Excavated 222 cubic yards Excavation Length 25 Width 20 Depth 12 feet

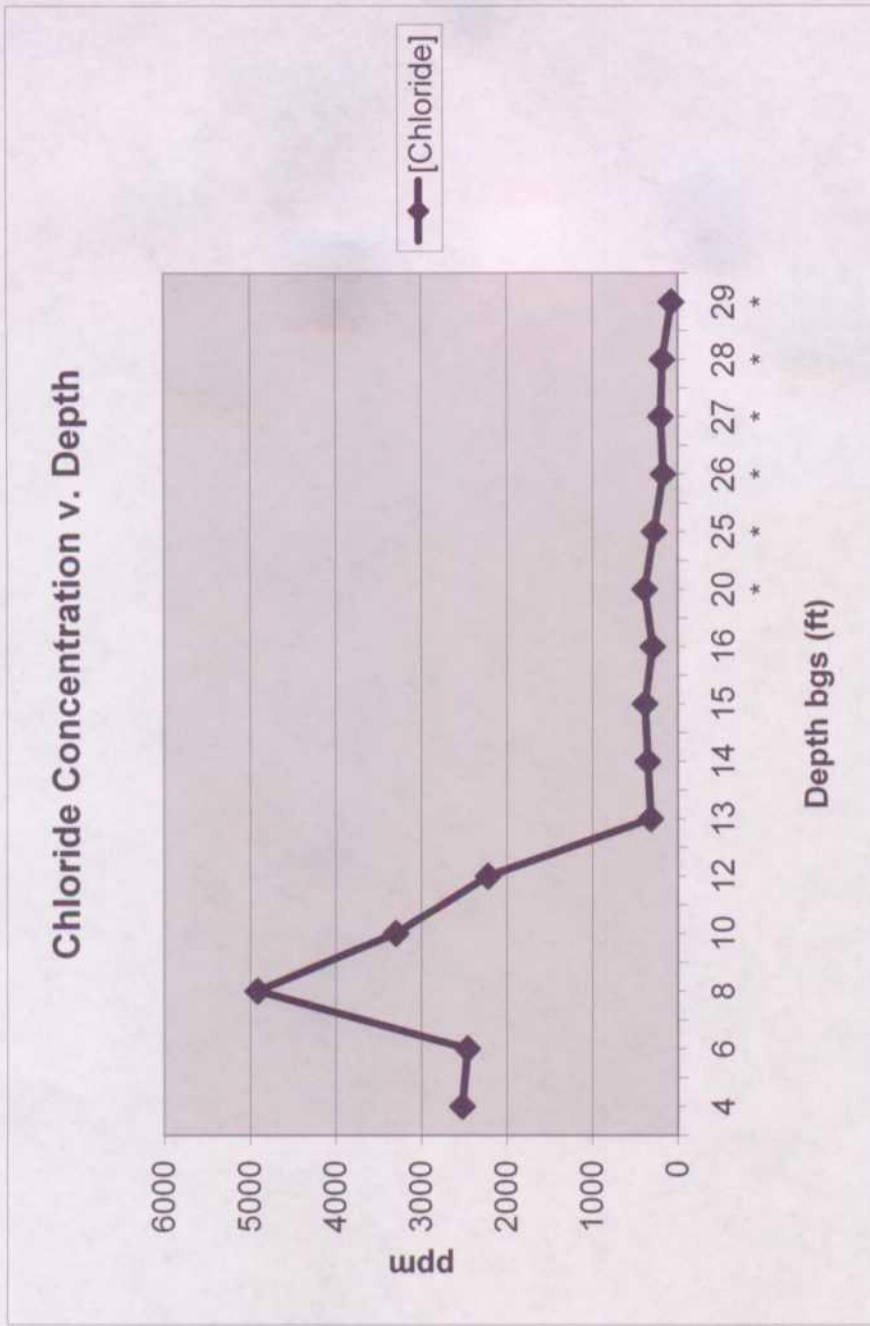
Vertical Delineation at Source

Depth bgs (ft)	[Cl ⁻] ppm
4	2523
6	2463
8	4913
10	3296
12	2220
13	315
14	350
15	382
16	293
20*	389
25*	276
26*	173
27*	200
28*	184
29*	78

* Soil bore samples

Groundwater = 72 ft

General Description of Remedial Action: This junction box site was delineated using a backhoe while chloride field tests and PID field screenings were conducted at regular intervals. Chloride concentrations exhibited an inconclusive trend vertically to 16 ft BGS with elevated readings from 4-12 ft as an area of concern. All PID readings were minimal and TPH lab analysis confirmed concentrations well below NMOCD guidelines. A soil bore was initiated on 6/2/04 to investigate chloride concerns. A conclusive trend of decline was observed (see graph) and the bore was stopped at 30 ft BGS. The 20 x 25 x 12-ft-deep excavation was backfilled with the excavated soil that was landfarmed on site to 6 ft BGS. At 6 ft, a compacted clay barrier was installed and the remainder of the hole was backfilled and contoured to the surface. An identification plate has been set on the surface to identify the clay barrier below. The disturbed surface will be seeded with a blend of native vegetation and will be monitored for growth. A new watertight junction box has been built 30 ft west of this site.
